NASA TM X- 72797

EVALUATION OF HIGH PRESSURE WATER BLAST WITH ROTATING SPRAY BAR
FOR REMOVING PAINT AND RUBBER DEPOSITS FROM AIRPORT RUNWAYS,
AND REVIEW OF RUNWAY SLIPPERINESS PROBLEMS CREATED BY RUBBER
CONTAMINATION

Walter B. Horne, Langley Research Center and
Captain Guy D. Griswold, Base Civil Engineers
Langley Air Force Base

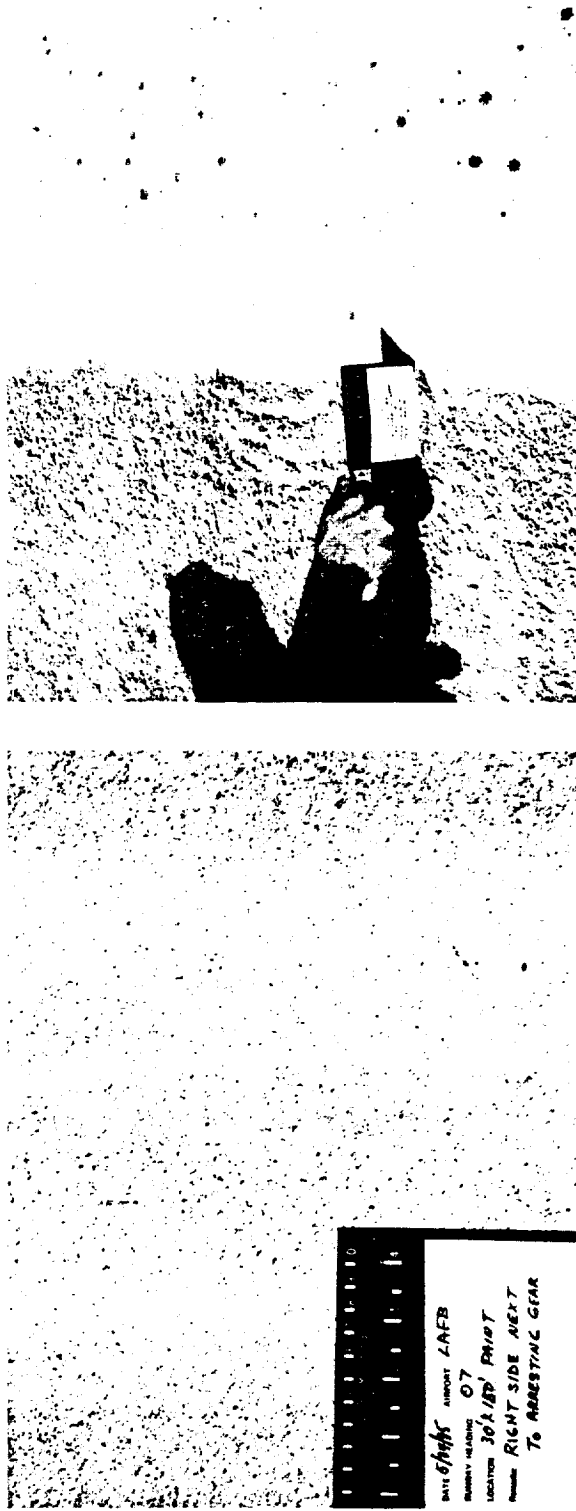
Paint removal.- Visual observations and photographs taken during and after paint removal on runways 7/25 and 17/35 (see figure 1, 4, and 5), indicated that the high pressure water blast with rotating spray bar did an excellent job of removing bulk paint from the runway marking areas. The bulk paint was broken up into small particle sizes (see figure 4) which were easily removed from the runway by runway vacuum sweepers, especially when the pavement surface dried out.

In most runway marking areas, a faint residual paint stain remained after two passes of the cleaning equipment. Close visual inspection of the stains showed that the stains appeared to be below the top of the pavement surface texture, and impregnated vertical or nearly vertical slopes of pavement surface granules. These surfaces were probably not exposed to direct impingement by the high velocity water jets of the rotating spray bar. Figure 5 shows a photograph taken of the approach end of runway 17 during re-painting of the threshold bar markings after paint removal. This photograph shows some slight discoloration of the pavement surface in the paint removed areas produced by the residual paint stains. Base civil engineering judged the stain problem to be insignificant and felt that paint removal achieved on the runways satisfied its paint removal specifications. No pavement surface damage attributable to the paint removal equipment could be found on either runway 7/25 or runway 17/35 after the paint removal program was completed.

a) TYPICAL RUNWAY PAINT STRIPE SURFACE BEFORE PAINT REMOVAL. A. T. D. = 0.01 IN. b) LOOSE PAINT PARTICLES ON RUNWAY SURFACE AFTER PASS BY HIGH PRESSURE WATER BLAST

FIGURE 4. - PHOTOGRAPHS OF PAINT STRIPE SURFACE ON LAFB RUNWAY 7/25 BEFORE AND AFTER PASS BY HIGH PRESSURE WATER BLAST USING A ROTATING SPRAY BAR

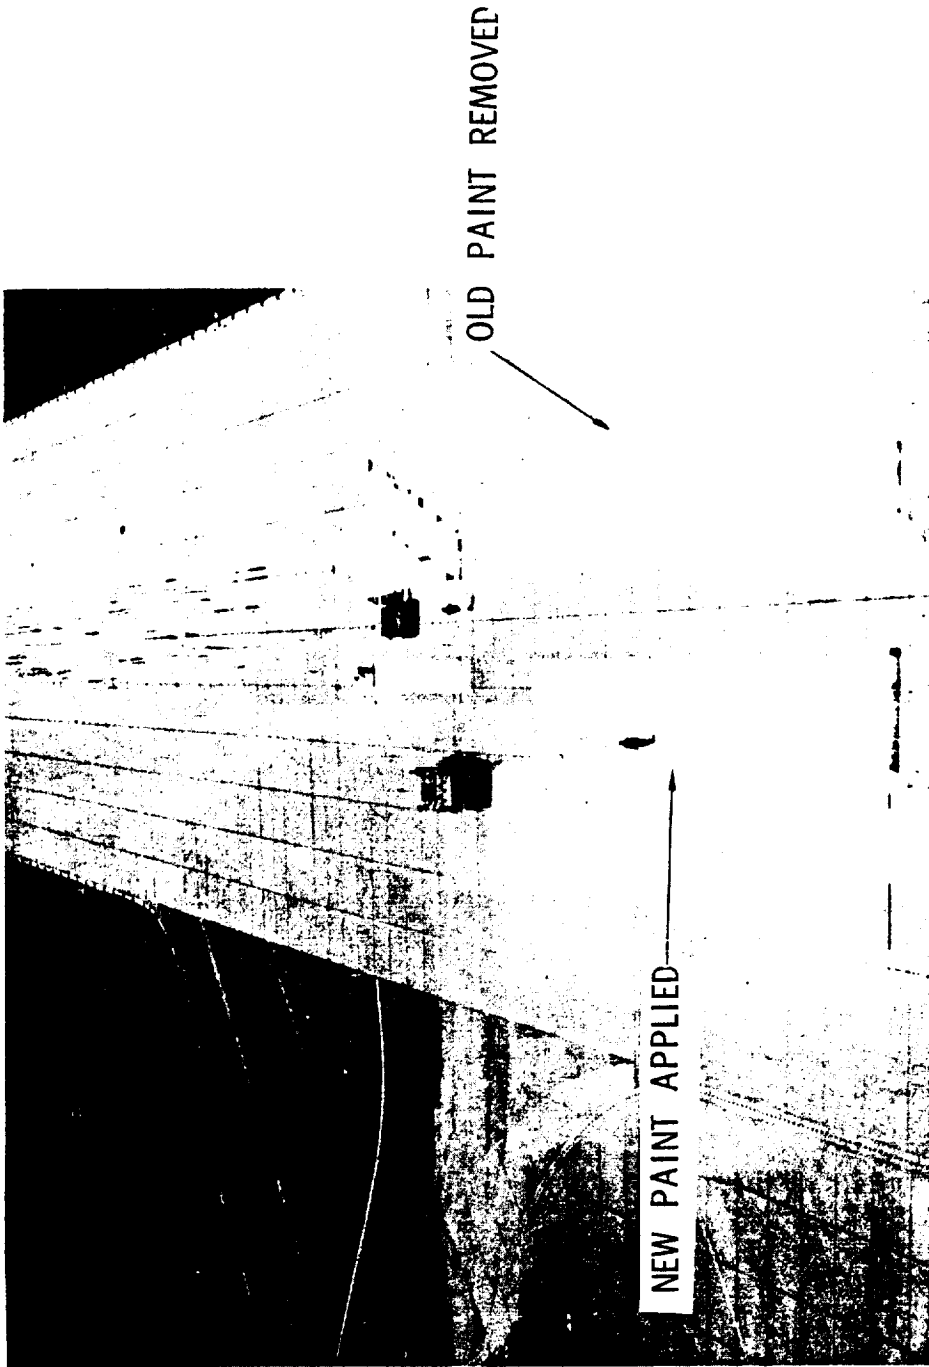
FIGURE 5. - PHOTOGRAPH OF APPROACH END LAFB RUNWAY 17 DURING RE-PAINTING OF RUNWAY MARKINGS AFTER PAINT REMOVAL PROGRAM, MAY 30, 1975. OLD PAINT REMOVED BY HIGH PRESSURE WATER BLAST USING ROTATING SPRAY BAR

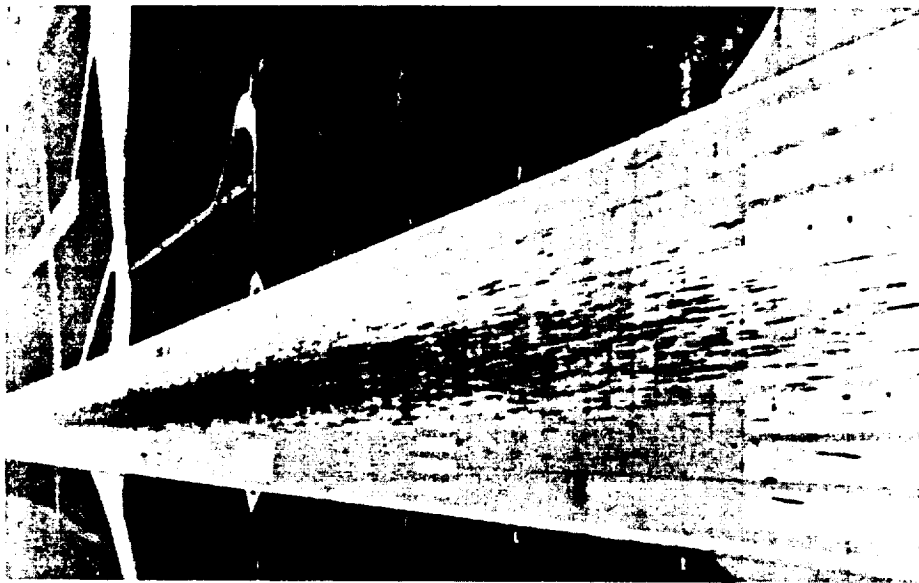
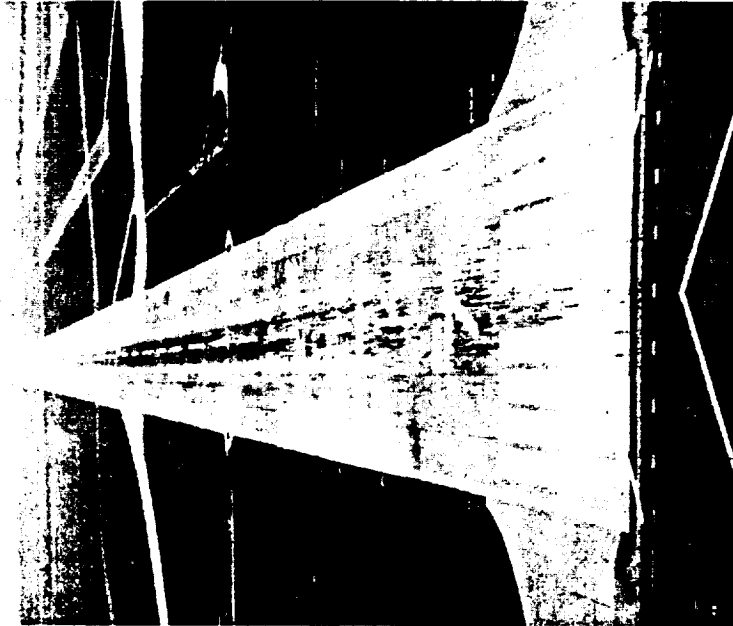
Rubber removal.- Visual observations and photographs made before and after rubber removal on runway 7/25 (see figures 6 and 7) suggest that the high pressure water blast with rotating spray bar did an excellent job in removing bulk rubber deposits from the runway aircraft touchdown areas. Visual inspection and photographs 6 and 7 also indicate that faint residual rubber stains are frequently left in the cleaned rubber-contaminated pavement surface after a single pass of the rubber removal equipment. As previously mentioned, these stains are felt to be the result of the high velocity water jets of the rotating spray bar not being able to directly impinge on vertical or nearly vertical faces of the pavement surface granules. Base civil engineering judged that the just described rubber removal achieved by the high pressure water blast with rotating spray bar met its 95% rubber removal specification requirement. Comparison of photographs in figures 6, 7, and 8 suggest that the rubber removal achieved at the approach end of runway 7 by the high pressure water blast with rotating spray bar was approximately equivalent to the rubber removal obtained by chemical treatment given this runway in 1970 (discussed later in the paper). It can be seen from these photographs that a uniform rubber removal was obtained by both chemical and the test rubber removal treatments. There was no evidence with these treatments of non-uniform rubber removal such as streaking or grooving that was reported for mechanical grinding (reference 4) and high pressure water blast with stationary spray bar (reference 5 and 6) treatments. No pavement surface damage attributable to high pressure water blast with rotary spray bar was evident on runway 7/25 after the rubber removal program was completed. The high velocity water jets from the spray bar did, however, loosen some small pieces of concrete contained in previously cracked areas of the concrete pavement. These particular areas of the concrete pavement would have been corrected by routine runway maintenance. The water blast rubber removal just accelerated the loosening or unraveling process in the broken concrete pavement area.

a) BEFORE RUBBER REMOVAL; MAY 15, 1975

b) AFTER RUBBER REMOVAL; MAY 30, 1975

FIGURE 6. - PHOTOGRAPHS OF APPROACH END LAFB RUNWAY 7 BEFORE AND AFTER PAINT AND RUBBER REMOVAL PROGRAM MAY, 1975. PAINT AND RUBBER DEPOSITS REMOVED BY HIGH PRESSURE WATER BLAST USING A ROTATING SPRAY BAR

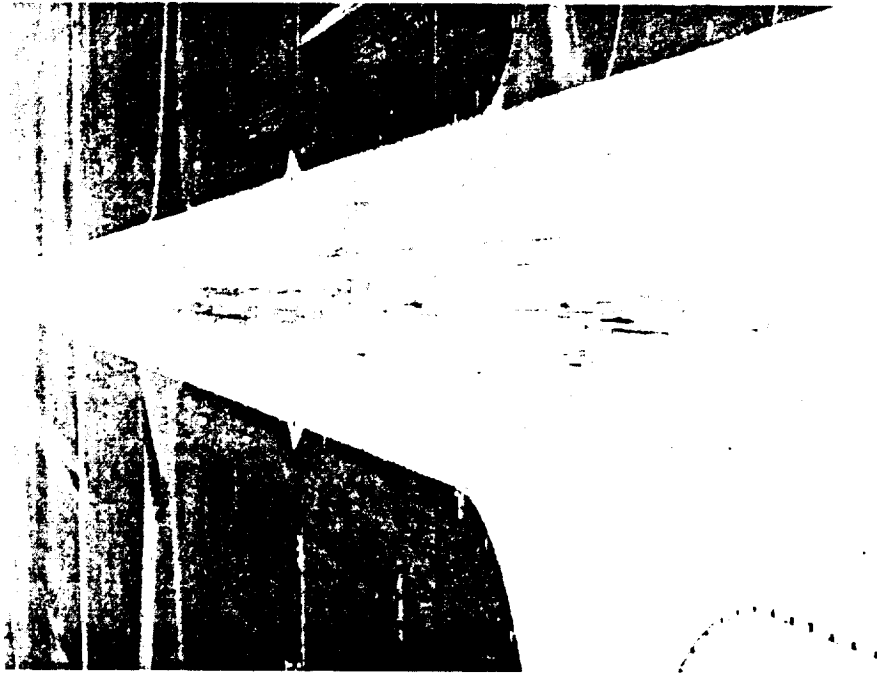
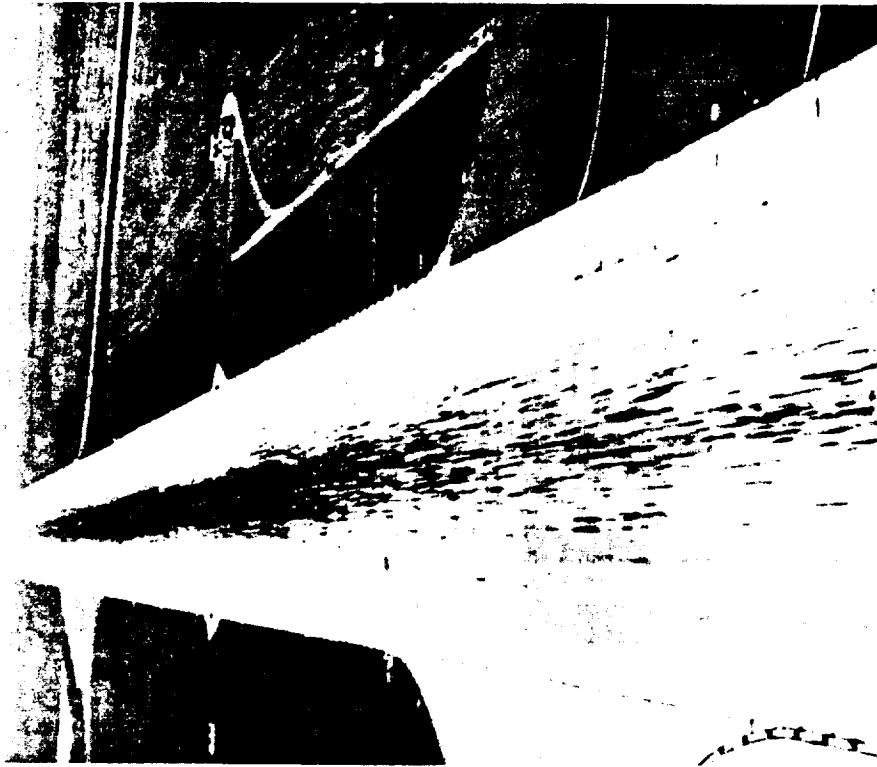
a) BEFORE RUBBER REMOVAL; MAY 15, 1975 b) AFTER RUBBER REMOVAL; MAY 30, 1975

FIGURE 7. - PHOTOGRAPHS OF APPROACH END LAFB RUNWAY 25 BEFORE AND AFTER PAINT AND RUBBER REMOVAL PROGRAM MAY 1975. PAINT AND RUBBER DEPOSITS REMOVED BY HIGH PRESSURE WATER BLAST USING A ROTATING SPRAY BAR

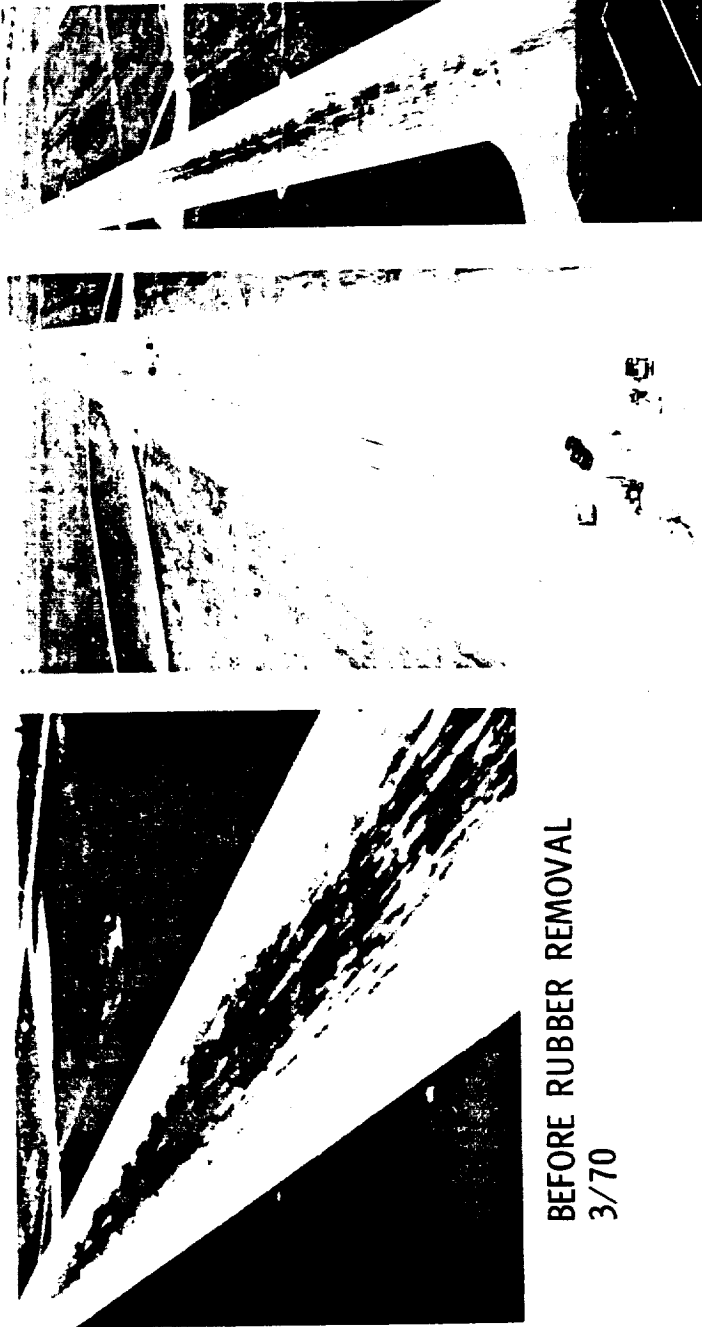
BEFORE RUBBER REMOVAL
3/70

4 DAYS AFTER
RUBBER REMOVAL
9/3/70

≈ 4 MONTHS AFTER
RUBBER REMOVAL
1/15/71

FIGURE 8. - PHOTOGRAPHS OF APPROACH END RUNWAY 7 AT LANGLEY AFB BEFORE AND AFTER RUBBER REMOVAL BY CHEMICAL TREATMENT.

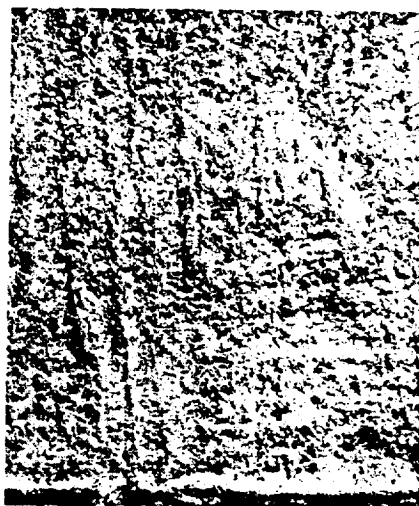
d) Runway 25: Medium Rubber Deposits; A.T.D. = 0.006 in. Test Zone 1

FIGURE 9. - TYPICAL SURFACE RUBBER DEPOSITS ON APPROACH ENDS OF LAFB RUNWAY 7/25 BEFORE RUBBER REMOVAL PROGRAM. PHOTOGRAPHS TAKEN MAY 24, 1975.

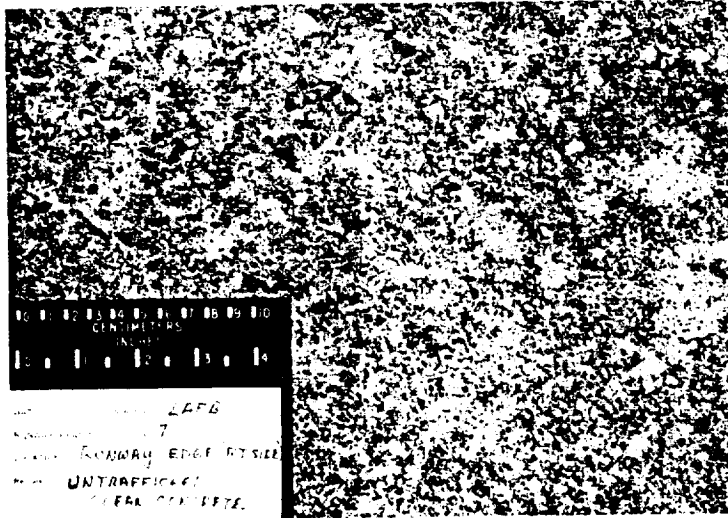
a) Surface Not Subjected To Aircraft Traffic
 Test Zone 3; A. T. D. = 0.010 - 0.014 in.

FIGURE 10. - Typical Surface Textures of LAFB Runway 7125 (Portland Cement Concrete) In Uncontaminated (No Rubber Deposit) Areas.

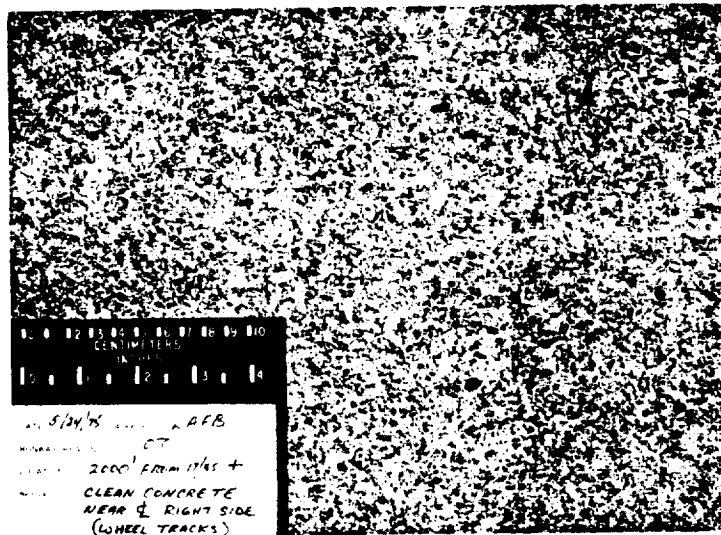
b) Surface Subjected to Aircraft Traffic
 Test Zone 2; A. T. D. = 0.010 - 0.014 in.

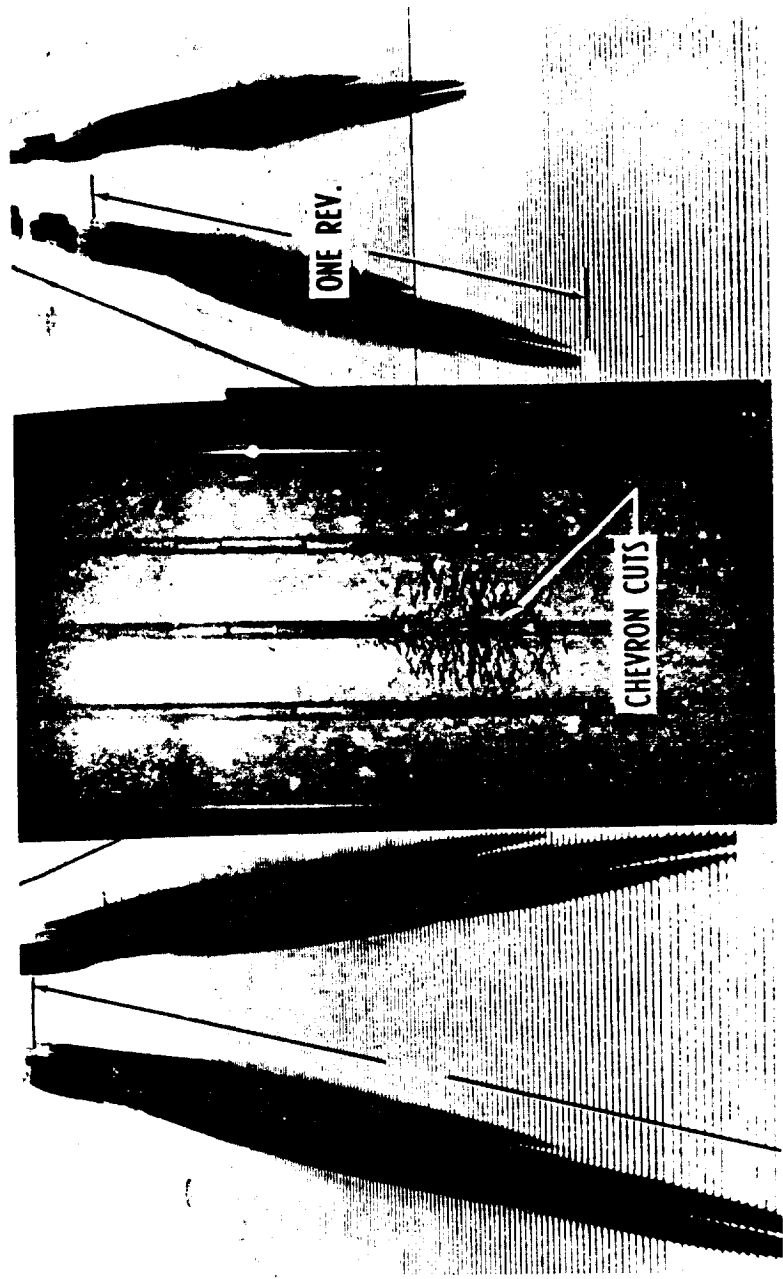
Visual observation of the tires of aircraft parked at airports having grooved runways suggest that only the larger diameter aircraft tires, and of these, only those employing high inflation pressures, develop chevron cuts on grooved runways. Reference 16 points out that the degree of chevron cutting of tire treads is also affected by the magnitude of the aircraft touchdown speed. Reference 16 states that for each combination of tire and grooved pavement surface, there is a ground speed below which no chevron cutting occurs, and above which the extent of the chevron cut damage increases with increased speed.

FIGURE 20. - TIRE DAMAGE FROM WHEEL SPINUP AT TOUCH DOWN ON DRY GROOVED RUNWAY

WALLOPS GROOVED CONCRETE, $1 \times \frac{1}{4} \times \frac{1}{4}$ in. GROOVE PATTERN;
CV-990 JET TRANSPORT MLG TIRE; SIZE 41 X 15.0 - 18; $p = 160 \text{ lb/in.}^2$;
 $V_G = 125 \text{ knots}$; $V_v = 4 - 5 \text{ ft/sec}$
