Technical Memorandum 33-733

*Single- and Dual-Carrier Microwave
Noise Abatement in The Deep Space Network*

JET PROPULSION LABORATORY
CALIFORNIA INSTITUTE OF TECHNOLOGY
PASADENA, CALIFORNIA

August 1, 1975

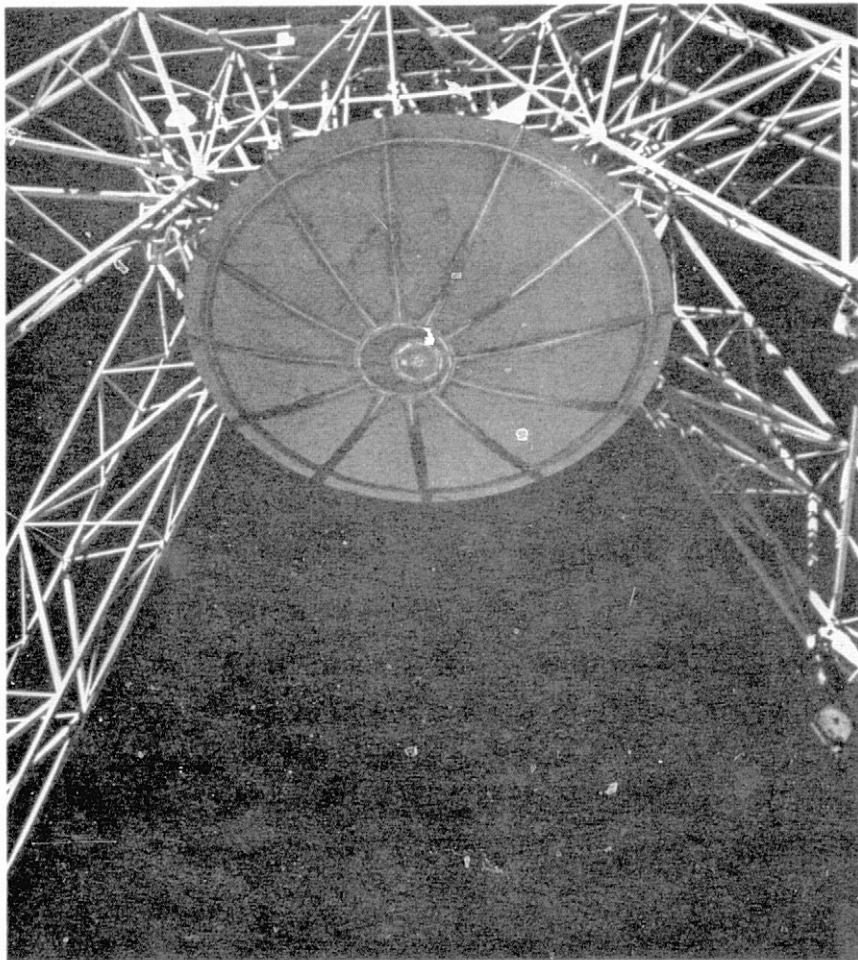
Figure 1. DSS 14 subreflector and apex region

Additional test data obtained at this time indicated considerable S-band leakage (on the order of -23 dB) through the DSS 14 Cassegrain subreflector panel seams despite the 50 mm-wide aluminum tape used to "seal" these

The preferred solution to a large number of nonessential items was simple elimination. When elimination was not possible, modification was next preferred, with a few items requiring redesign. Although some obviously unbonded hardware was most easily modified by welding, in general, extensive use of this more costly and time-consuming solution was not a part of the early program. Difficulties in upgrading many deficient areas were experienced. Daily tracking commitments by the station precluded major overhauls; most work needed to be completed between spacecraft passes. Perhaps the most difficult undertaking during this period was upgrading the subreflector joints. Figure 1 shows the DSS 14 antenna apex region with subreflector joints retaped using conductive epoxy along the tape edges for ohmic bonding.

10. Subreflector panel joints improved using conductive epoxy along aluminum tape edges for positive (ohmic) bonding.
 11. Removed heavy loose stored subreflector hoist equipment at the quadripod apex to reduce vibration of the light-skinned subreflector surface.

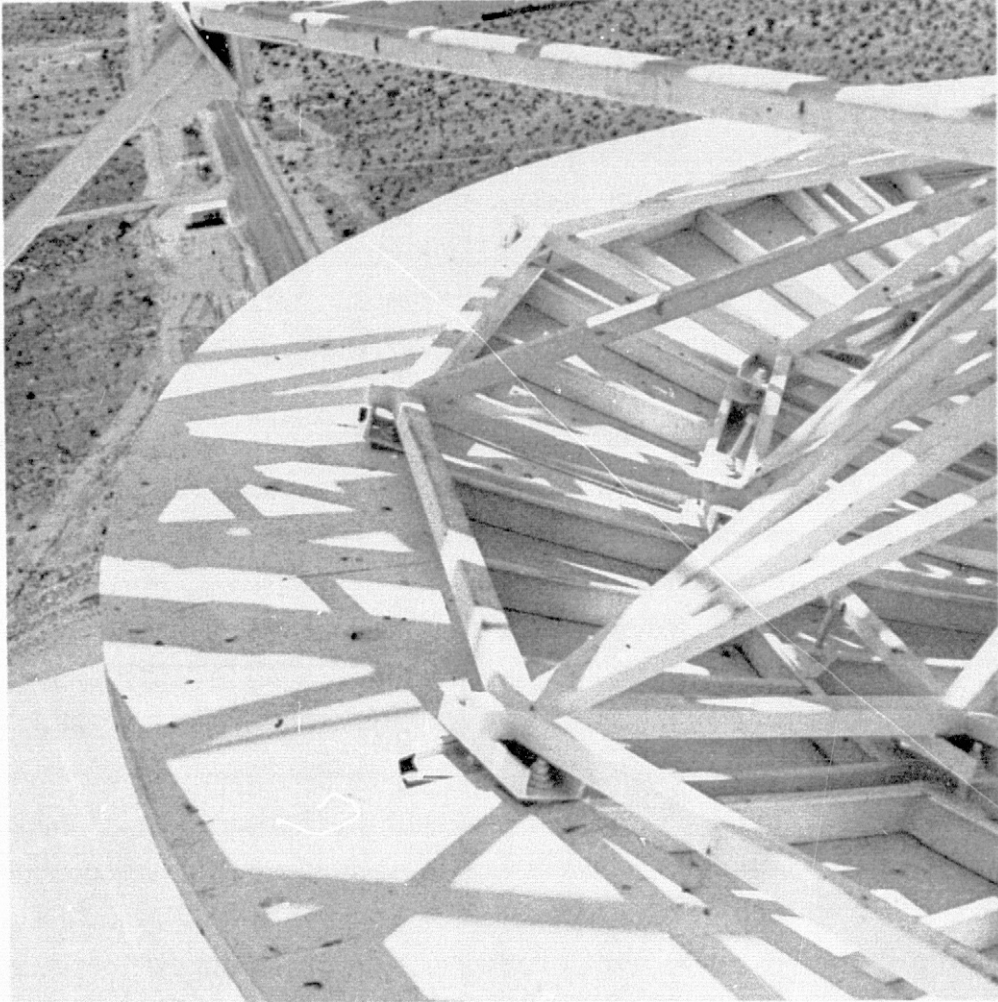
Figure 27. All-welded subreflector diffraction shield DSS 14

(1) Work Done. At the apex, after finding that the aluminum tape repairs to the subreflector seams had fractured, the subreflector was removed to the ground and all seams in the reflector surface welded. An all-welded diffraction shield was added to the backside perimeter of the subreflector, thereby providing a reliable conductor over a radial distance of at least 2 wavelengths on the "twilight" side (Figure 27). Additional structural joints were welded that were located outside of the subreflector shadow zone (defined to be a vertical cylinder extending above the subreflector and roughly 2 meters less

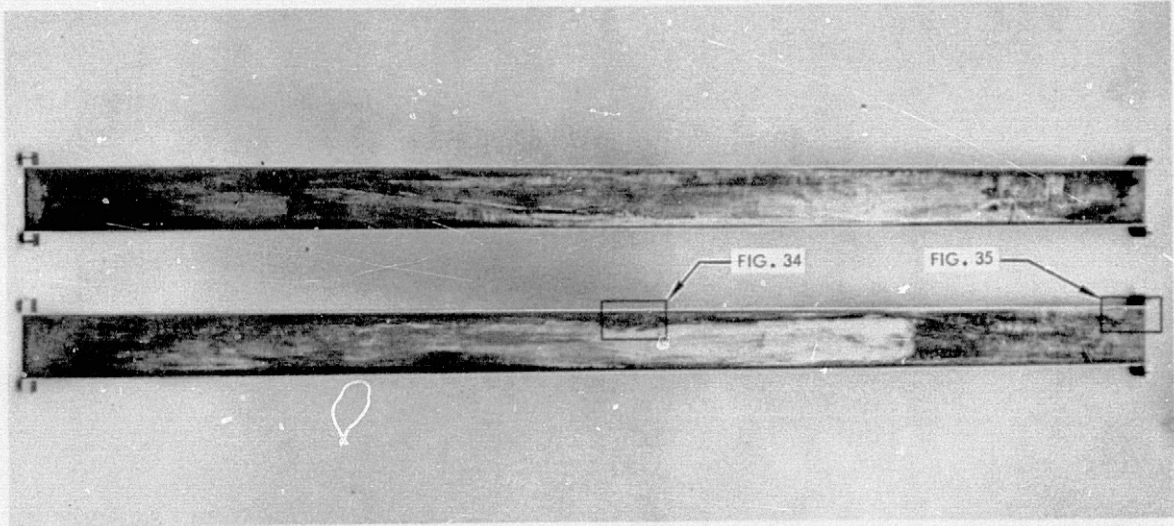
Figure 33. Long waveguide, longitudinally parted with closeup areas

²⁶ Visual inspection, achievable only after the part had cooled, did not immediately reveal the chip. This was in part due to the long length of the waveguide (2-3 meters), but further, this chip behaved in a bimetallic manner, and retreated flush with the surface upon cooling. Subsequent checking of other waveguides revealed several additional such chips.
