NASA CR-134769

ANALYSIS OF TURBOFAN ENGINE PERFORMANCE DETERIORATION
AND PROPOSED FOLLOW-ON TESTS

G. P. Sallee, H. D. Kruckenberg, and E. H. Toomey

AMERICAN AIRLINES, INC.

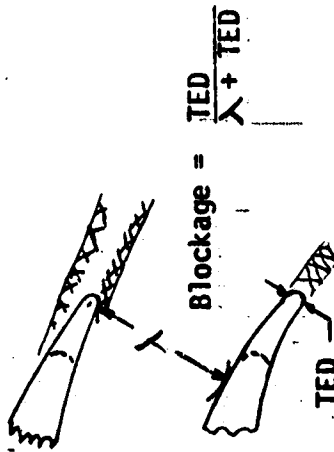
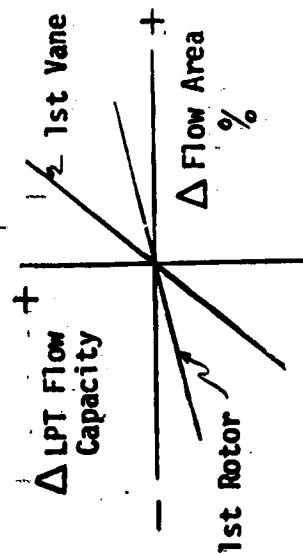
Figure 21. Turbine Shadowgraph Analysis of JT3D

- o ALL AIRFOIL CONTOURS WERE WITHIN THE ALLOWABLE TOLERANCE BAND.
- o TRAILING EDGE BLOCKAGE WAS GREATER THAN NOMINAL.

- o FLOW AREAS WERE CLOSED RELATIVE TO NOMINAL.

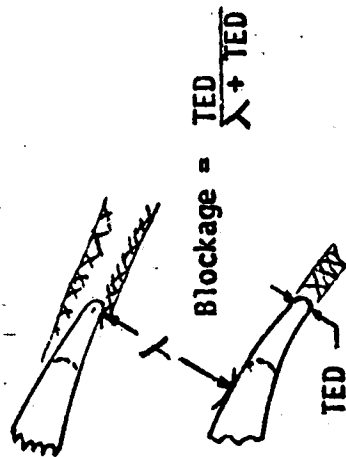
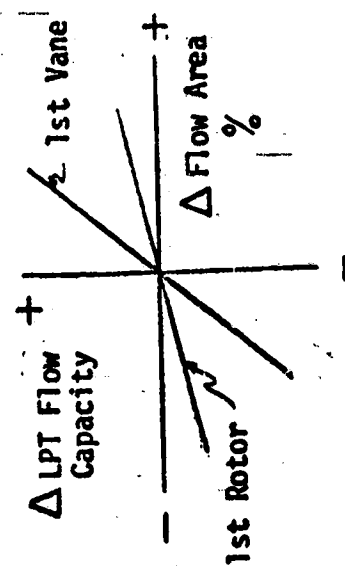
Figure 22. Turbine Shadowgraph Analysis of JT8D

- o ALL AIRFOIL CONTOURS WERE WITHIN THE ALLOWABLE TOLERANCE BAND.
- o TRAILING EDGE BLOCKAGE WAS GREATER THAN NOMINAL.

- o FLOW AREAS WERE CLOSED RELATIVE TO NOMINAL.

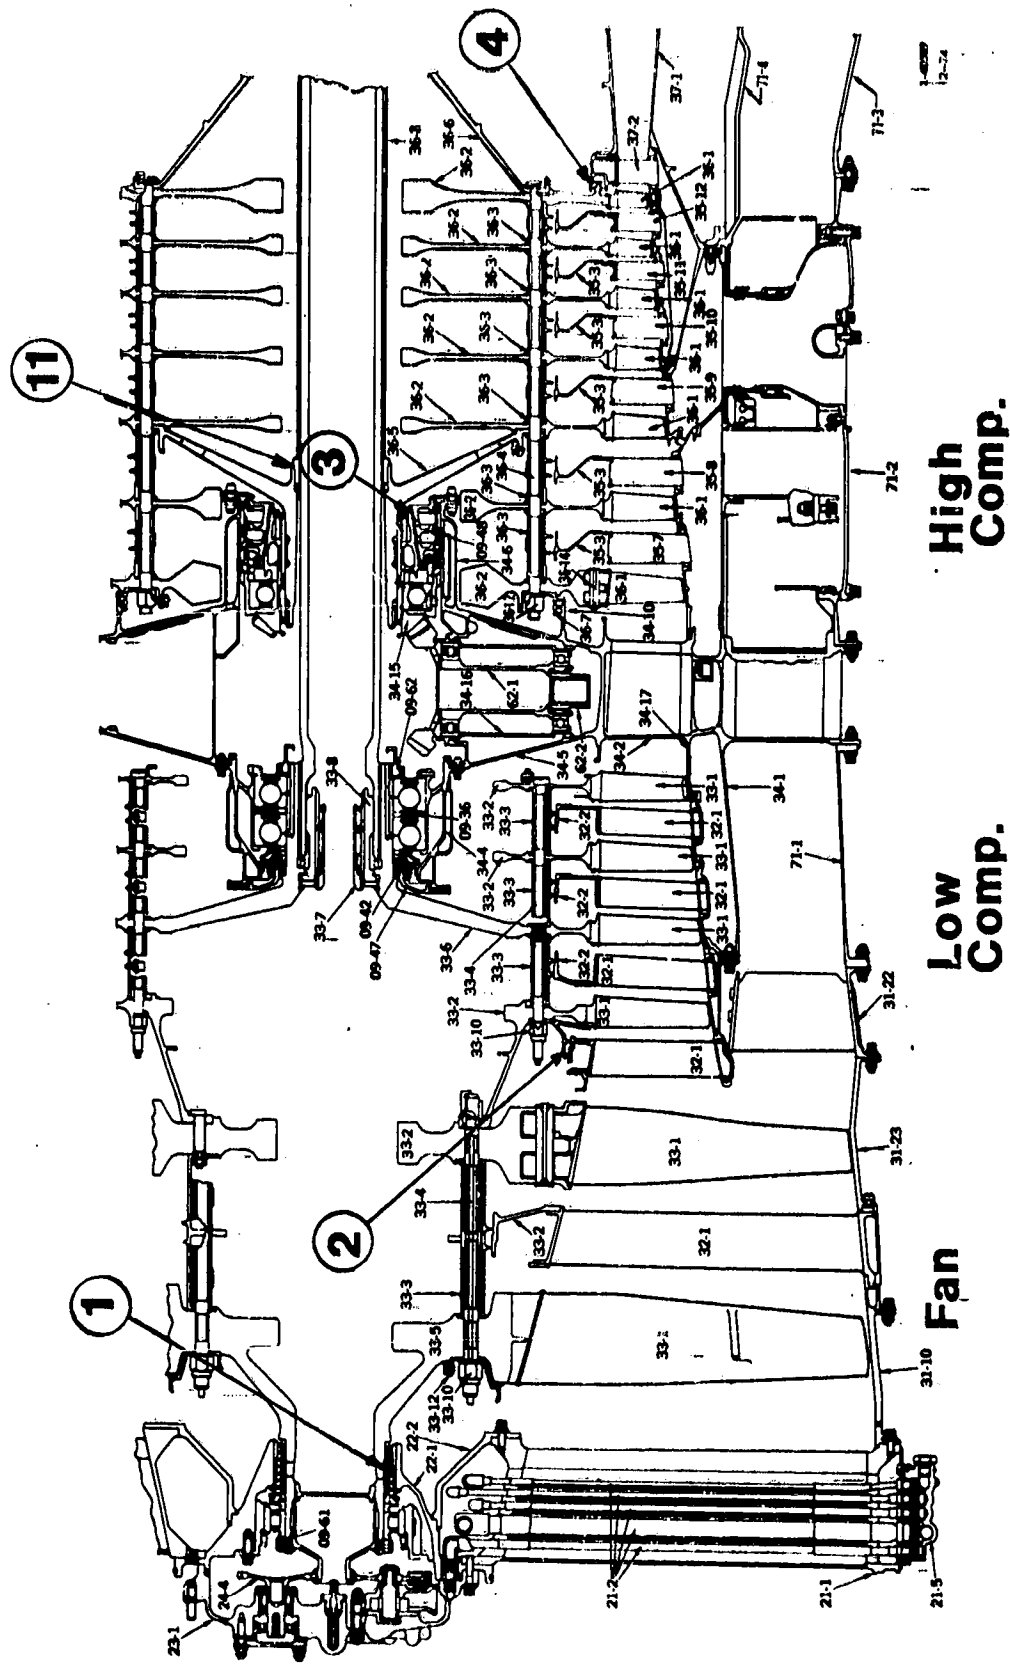
FIGURE 41 - JT8D FAN, LOW COMPRESSOR & HIGH COMPRESSOR
AREAS OF MEASURED SEAL TOLERANCES

In summary, engine S/N 667783 exceeded the P&WA manual limits concerning individual blade tip clearances for the 1st and 2nd fan blades and for the 1st through 3rd turbine blades. The various seal areas in Figures 43 through 45 were found to be within manual limits with exception of the 7th to 8th stage fwd seal land diameter and the 15th and 16th stage aft seal land diameter which exceeded manual limits. The performance data for this engine is given in the main report.

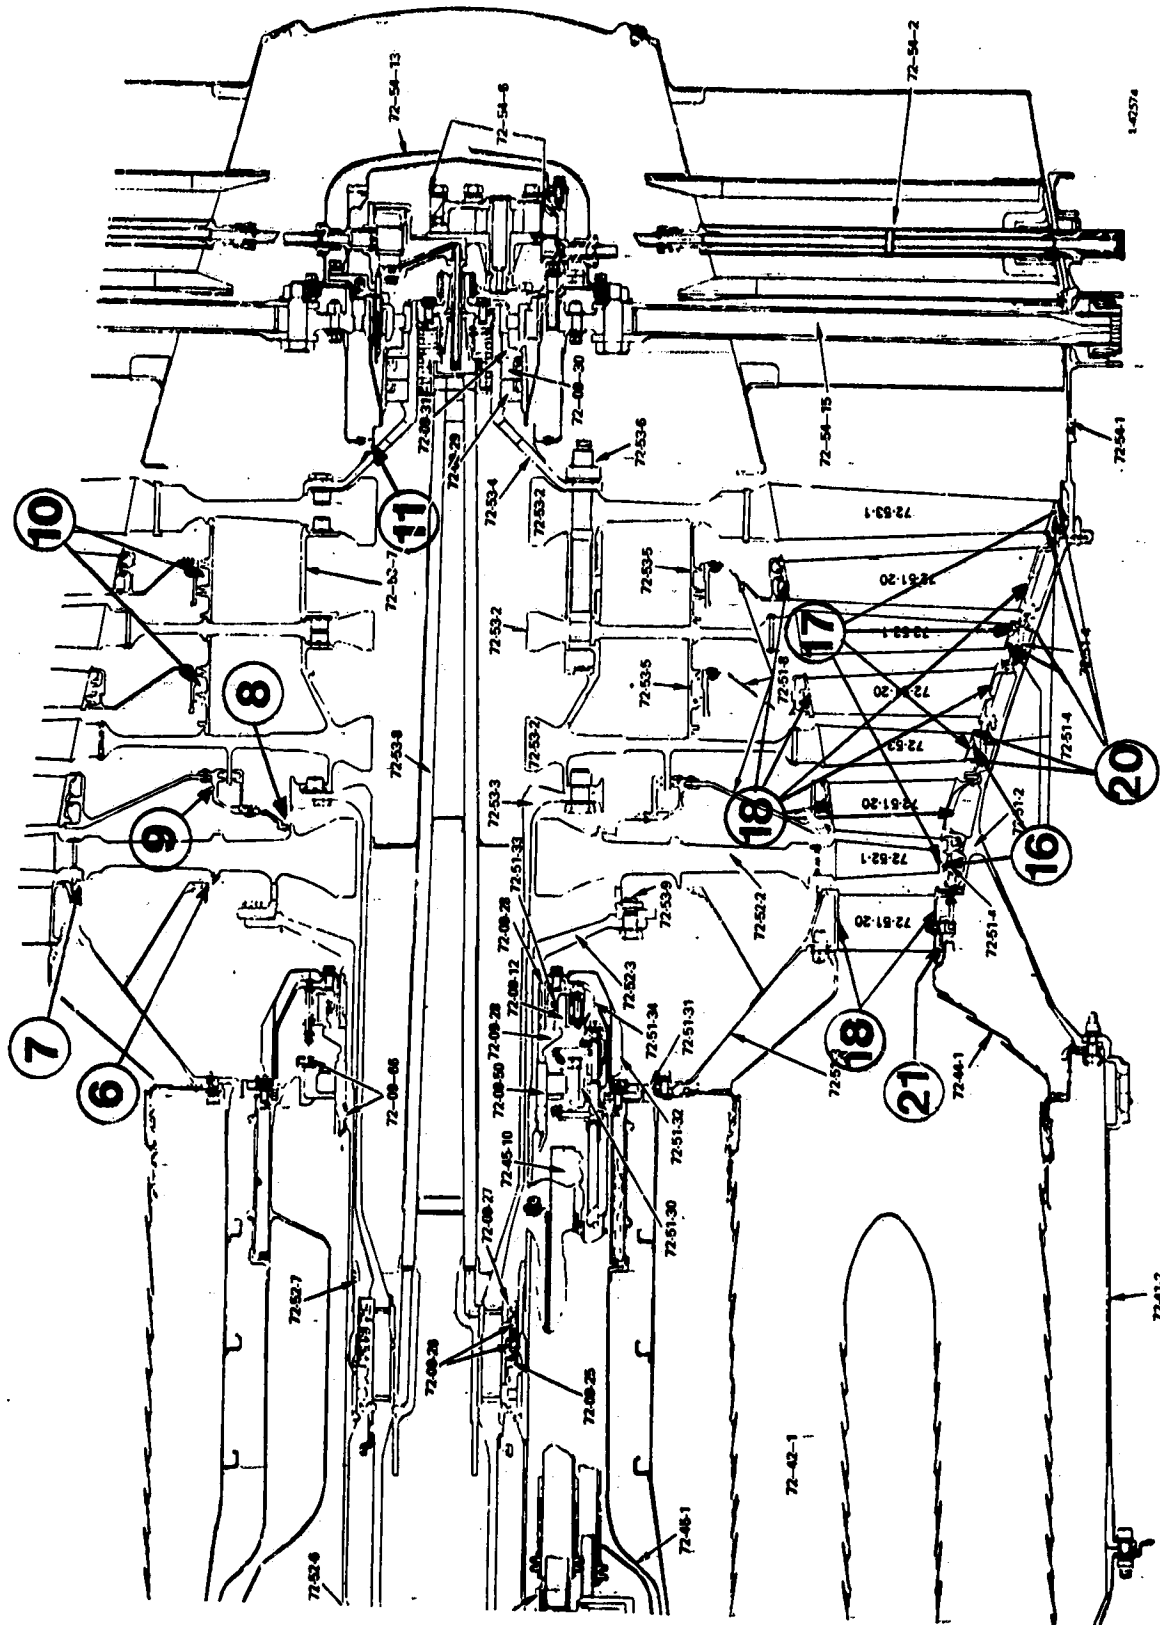
FIGURE 45 - JT3D HIGH & LOW TURBINE AREAS OF MEASURED SEAL & BLADE TIP TOLERANCES

The seals in the turbine area as indicated by numbers 6 through 11, 17, 20, and 21 were found to be within the P&WA check and repair limits. Approximately 50% of the tolerances fell within the check and repair limits while the remainder were within P&WA reference dimensions (manufacturing limits). Both the first and second stage turbine tip blade clearances (number 16) were found to exceed both the minimum and maximum limits for some of the blades. However, the average tip clearance for the 1st and 2nd turbine blades was found to lie within the P&WA manual limits. The third stage rear turbine tip blade clearance was exceeded by some blades, but the average value for all the blades was within P&WA manual limits. The fourth stage turbine blade tip clearances were found to be okay.
