NASA TM X-64928

REPAIR OF MAJOR SYSTEM ELEMENTS ON SKYLAB

By Robert E. Pace, Jr.
Materials and Processes Laboratory

October 1974

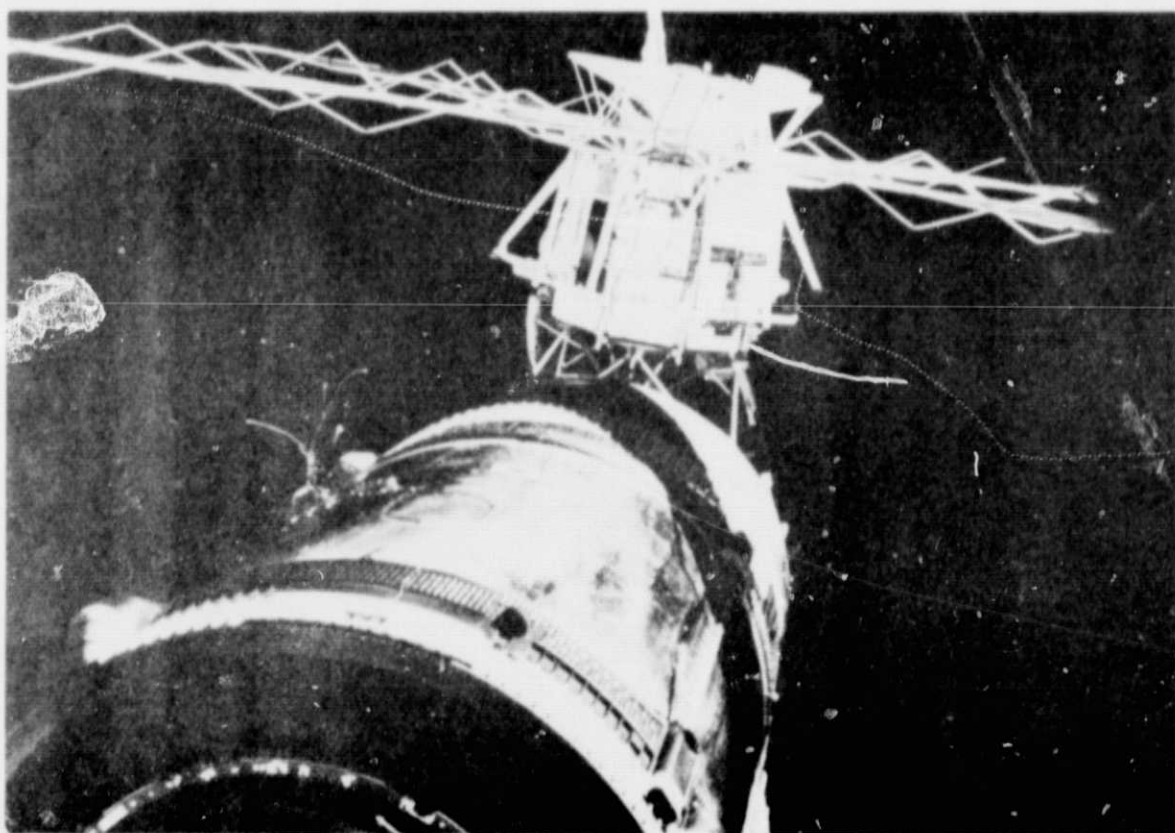
Figure 2. Skylab 2 fly-around inspection. (View of damaged workshop showing unshielded area where parasol was later deployed. The jammed solar wing is at lower right.)

After the SL-2 crew performed their rendezvous with the Skylab, they did a fly-around inspection describing the condition of the damage and making photographs. Live TV coverage was transmitted to the ground for 15 min. The crew confirmed that the meteoroid shield was missing, OWS solar array wing 2 was missing, and that solar array wing 1 was partially deployed. Figure 2 shows a view of the damaged Skylab.

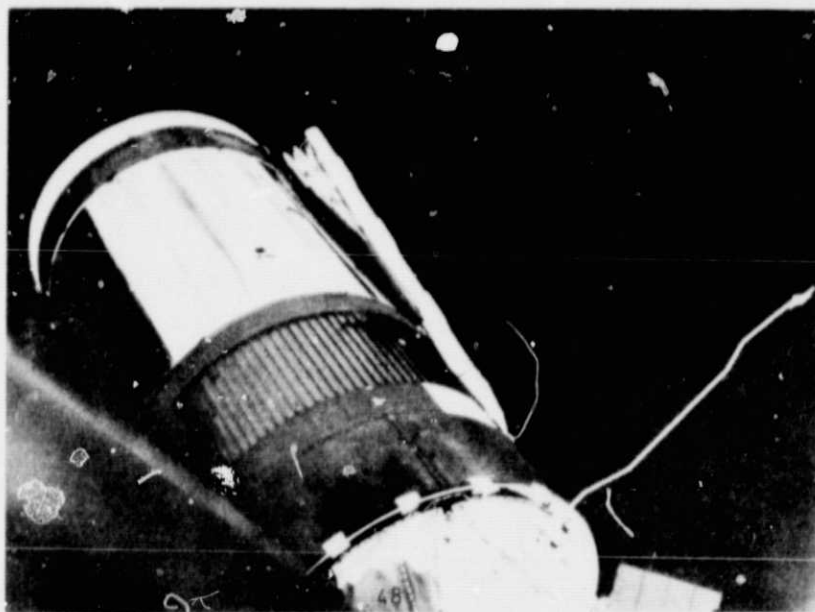
Figure 3. Solar array wing 1 partially deployed.

Figure 3 shows solar array wing 1 partially deployed. Closer inspection by the crew revealed that the solar array beam was restrained by a small piece of aluminum alloy strap from the meteoroid shield. The crew attempted to free the wing during a standup EVA from the CSM, using a 3.04 m (10 ft) pole with a hook on the end for prying and pulling. This attempt failed and the wing deployment activities were deferred to a later EVA. Meanwhile work was still in progress on procedures to be used to free the solar array wing. The fly-around television pictures and crew description of the damage provided the basis for the procedures. This contingency repair involved releasing the beam by cutting the aluminum strap and deploying the beam to the normal operation position. The procedures were developed and demonstrated in the neutral buoyancy facility at the Marshall Space Flight Center (MSFC) with astronauts using tools identical to those on board.

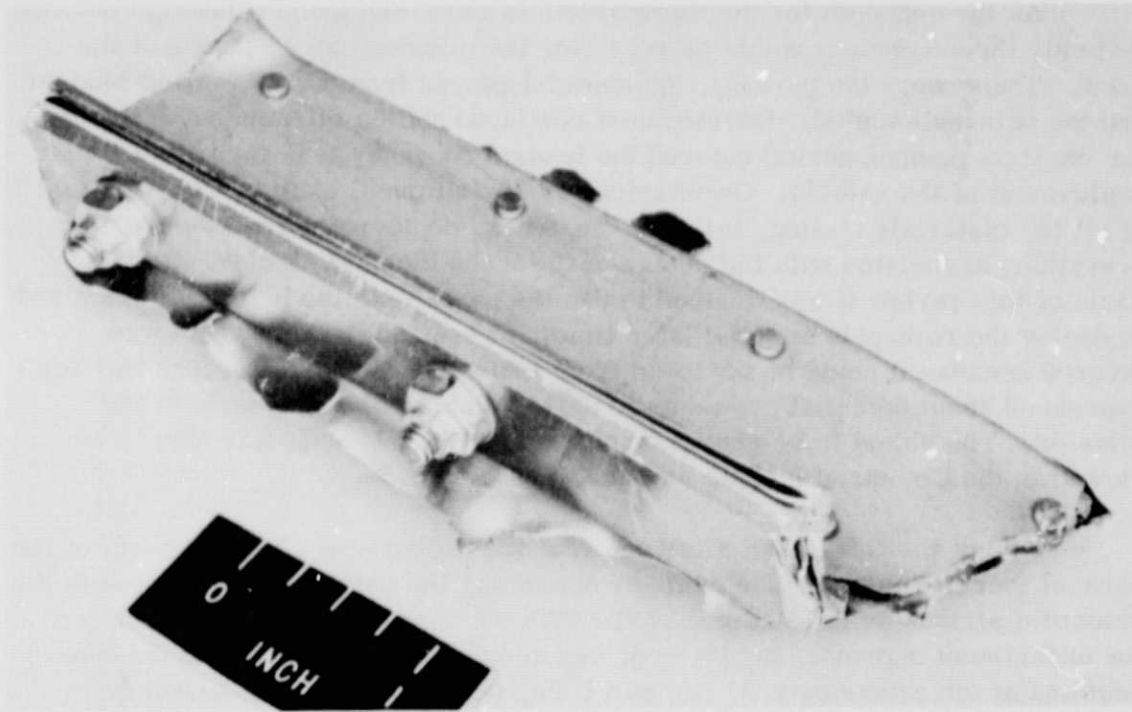
Figure 6. Sample segment of the aluminum (Al 7075-T6) strip that held the solar wing.

this cutter tool being tested by MSFC engineers. The cutter end was attached to the debris and the Commander, using the pole as an aid, translated to the cutter end. Then, with the Commander managing the cutter, the Science Pilot cut the aluminum strap using the rope for control. A typical sample of the aluminum strip that held the solar wing is shown in Figure 6.

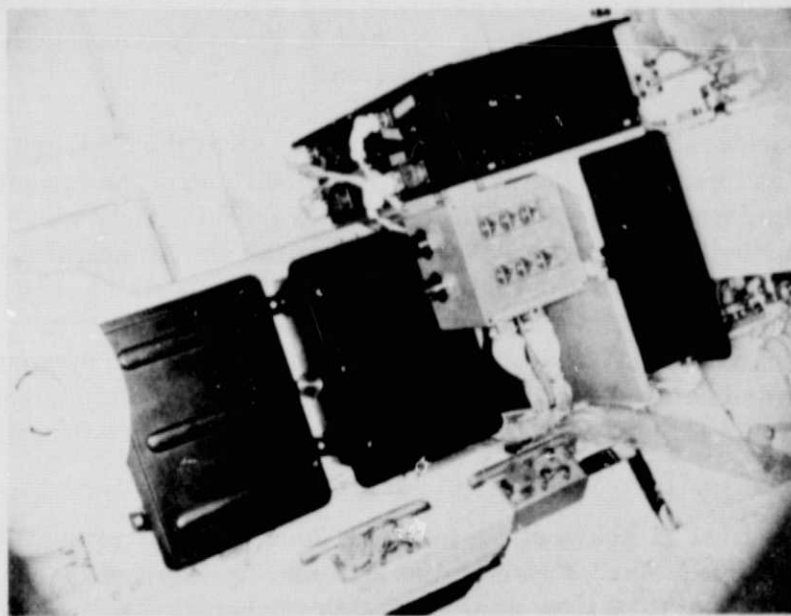
Figure 14. The six gyros mounted in the backup MDA hardware.

Following switchover from launch vehicle attitude control to Skylab control, it became apparent that some of the RGPs were behaving abnormally. The redundancy management rate integral discrepancies showed that several RGPs had out-of-spec drift. Additionally, telemetry showed that the Z_1 RGP was excessively hot. The drift rates were as high as 18 deg/hour, two orders of magnitude above specification. The high drift rates made it difficult to maintain the correct attitude for thermal control during the first 10 days after SL-1 launch. The high drift rates were compensated for by changes in the ATMDC software uplinked from the ground; however, the drift rates often changed suddenly. This caused difficulty until the new rates could be measured and compensated. As time passed in the mission, the magnitude of the drift rate changes decreased. Eventually the X_1 , Y_1 , and Z_3 RGPs became stable and were used through the remainder of the mission.

After considerable investigation, it was found that the high drift rates were caused by gas bubbles in the rate gyro flotation fluid. The formation of bubbles in the fluid was apparently caused by a design deficiency which exposed the float chamber bellows to the hard vacuum of space and by entrained gases present in the flotation fluid. Corrective action included tests to verify the theory of bubble formation and a design modification which sealed the float cavity from the hard vacuum of space. The design modification consisted of replacing the vented bellows end up cap with an unvented end cap so that internal float pressure would remain near the original float fill pressure despite external pressure changes.

Within the first 21 hours of the mission, four RGPs were overheating. Subsequently, two more showed identical symptoms. A detailed thermal analysis was performed relating RGP base plate heat sink temperatures of RGP temperatures. It was determined that base plate temperatures of 14° C corresponded to RGP temperatures of about 110° C. Also, a hot RGP was powered down, allowed to cool, and then powered up. The RGP temperature was seen to increase and become off-scale high. It was concluded that the six RGPs in question had

During SL-2 an expedited effort was begun to prepare a package of RGPs that could be added to the APCS should additional failures threaten the program. This package containing six RGPs became known as the "six-pack." The gyros in this package contained a design fix for the bubble problem encountered in flight. It was decided to mount the six-pack in the MDA on a mount provided for an experiment. This location was close to the center of gravity, could be aligned within limits, was close to the ATM control and display console for system interconnect, and was near a high power outlet. The installation required IVA and EVA with participation of all three crewmen. The rate gyro six-pack was mounted in the MDA as shown in Figure 14 and was connected to the ATM control and display console.

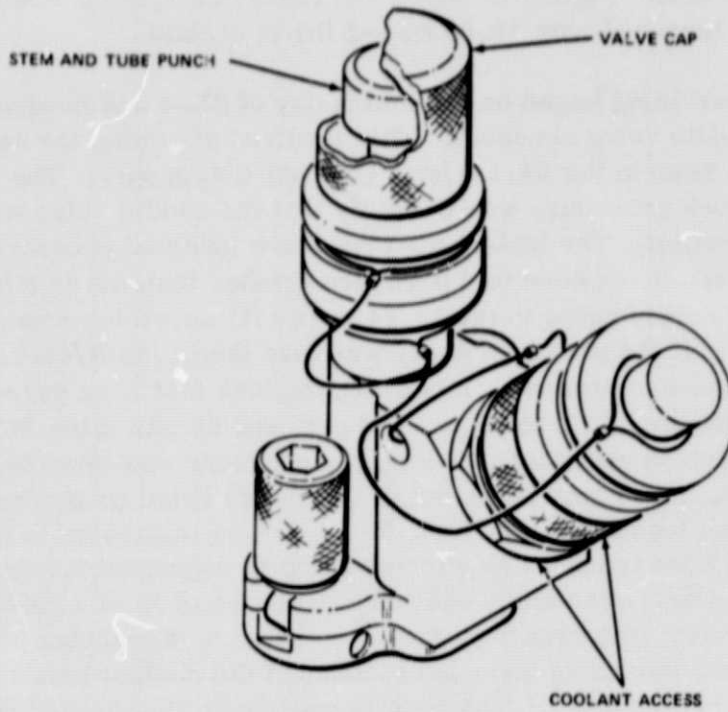
Figure 17. Saddle valves.

On the ninth day of SL-3, a coolant leak in the primary coolant loop was indicated by a low pump inlet pressure warning. Ground analysis indicated a long term decrease in pressure. The crew attempted to ascertain the location of the coolant leak by removing panels and unwrapping insulation from suspect lines. Wrapped lines were visually inspected for bulging, color changes, and wetness but no evidence of leakage was found. During EVA, the crew inspected the accessible exterior areas, especially the radiators, for evidence of coolant leakage but none was found.

On the 27th day of SL-3 the primary loop was shut down to prevent pump cavitation and possible damage after the pump inlet pressure had reached a low of 3.45 N/cm^2 (5 psia). Flight data also indicated that the secondary loop possibly was leaking but was still operational and providing the required cooling. The leakage rate was determined to be so small that the coolant loops could remain operational by replenishing the coolant. Since the coolant loops were not designed for onboard reservicing, efforts were initiated by ground personnel to devise a way to reservice the loops, develop the hardware and demonstrate its capability in time for launch of SL-4.

The procedure developed included stripping insulation from a coolant line near the cabin heat exchanger in the airlock module, piercing the line with a saddle valve assembly (Fig. 17) which had a quick disconnect for attaching a service hose and forcing coolant from a small storage tank by applying pressure from a 24.13 N/cm^2 (35 psi) source through a bellows arrangement. Parts for the reservice equipment were primarily qualified by similarity to equipment used in other Airlock Module applications. The tank was adapted from a

Command Module fuel tank. Figure 17 shows the reservice system schematically. The tank was launched with 19.05 kg (42 lb) of coolant.

The in-flight servicing began on the fourth day of SL-4 and progressed smoothly through a saddle valve checkout. This involved attaching the saddle valve and the leak test hose to the 24.1 N/cm² (35 psi) GN₂ supply. The purpose of the leak check procedure was to verify that the saddle valve was not leaking prior to penetration. The leak check procedure involved pressurizing the saddle valve and leak check hose to a pressure greater than 20.68 N/cm² (30 psig), closing the supply valve in the 18.24 m (60 ft) servicing hose, and monitoring for 30 min. If the pressure decay was less than 1.38 N/cm² (2 psi), the servicing was to proceed. However, the leak test hose gage indicated an initial pressure of 22.75 N/cm² (33 psi) and 35 min later 21.03 N/cm² (30.5 psi). After an additional 20 min, the pressure was down to 17.23 N/cm² (25 psi). Thus, a leak was indicated in the saddle valve or the leak check hose. To determine the location of the leak, the crew was instructed to disconnect the leak check hose from the saddle valve and to repressurize the leak check hose. The leak check hose alone showed a pressure drop of 1.38 N/cm² (2 psi), indicating a leak. The crew was then instructed to disconnect the leak check hose from the servicing hose and to connect the coolant servicing tank and the coolant servicing hose. The system was carefully checked out and the coolant valves were then opened to supply coolant to the saddle valve under pressure prior to piercing of the coolant line. No coolant leakage was observed; the primary coolant line was then pierced and the servicing proceeded satisfactorily.

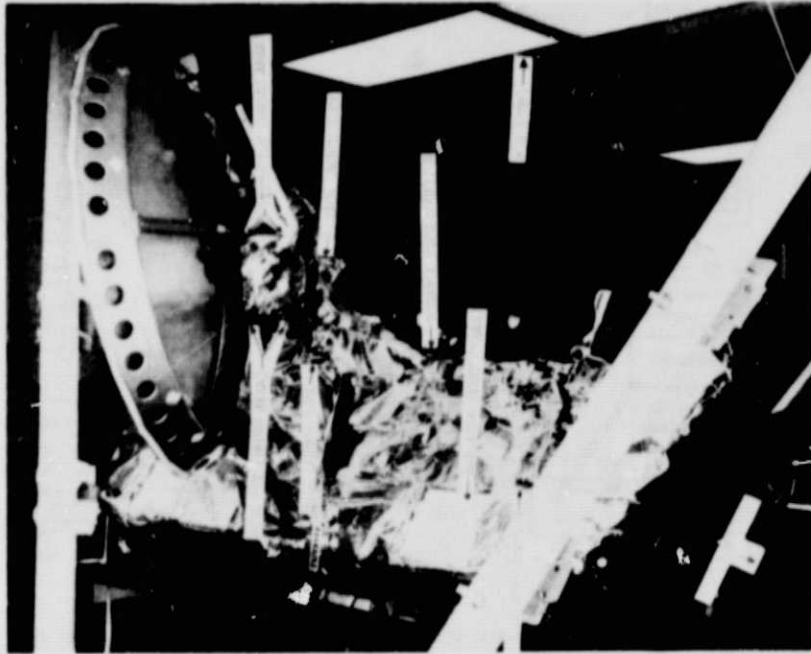
Figure 19. S193 antenna.

A failure occurred earlier during EREP pass 40 on mission day 49 of SL-3 which manifested itself by erratic antenna motion. A subsequent in-orbit SL-3 telemetry test gave ground engineers additional data to analyze the problem and begin working toward a solution. A -10 volt reference in the gimbal servo system was found to be at -1.0 volt. Circuit analysis indicated that the failure was most likely a short in either the pitch or roll gimbal potentiometers, or both. These potentiometers were accessible from outside the experiment (Fig. 19). Following the analysis, NASA decided to perform an EVA to attempt to correct this problem and at least get partial use of the S193 experiment.

On the seventh day of SL-4 the Science Pilot and Pilot performed the first of four EVAs of the SL-4 mission. The total duration of the EVA was 6.5 hours with the last 3.5 hours dedicated to a repair of S193, the Microwave Radiometer Scatterometer Altimeter. The S193 experiment was a complex electronic active and passive microwave radar instrument with a two-axis gimbaled antenna which viewed the earth as part of the Earth Resources Experiment Package. It was mounted external to the Skylab vehicle on the Airlock Module truss. Figure 19 shows the antenna in a flight configuration.
