LR-26580

JULY 1974

**FLIGHT SERVICE EVALUATION
OF PRD-49/EPOXY COMPOSITE PANELS
IN WIDE-BODIED COMMERCIAL TRANSPORT AIRCRAFT**

**FIRST ANNUAL
FLIGHT SERVICE EVALUATION REPORT**

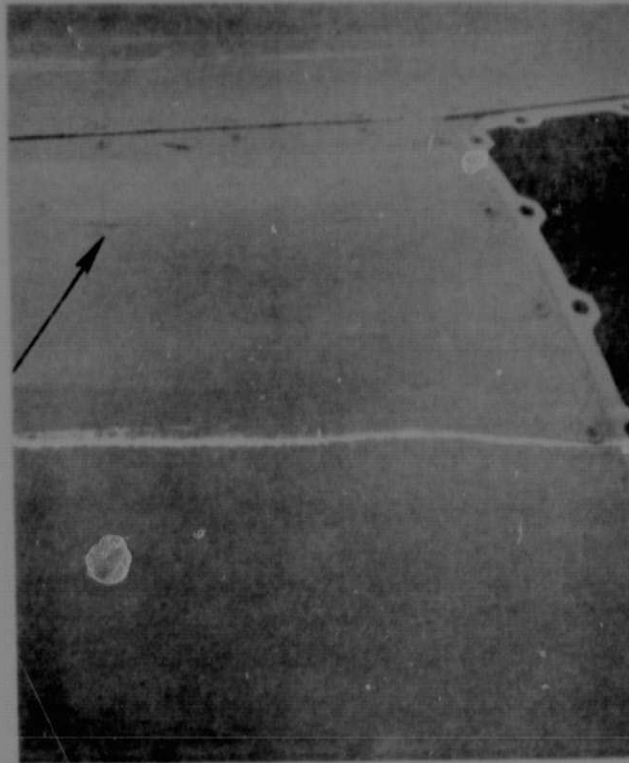
There were some minor indentations on the exterior surface of the panels, but similar damage was also observed on adjacent fiberglass panels. In one instance there was a 2.54 centimeter (one inch) crack in the exterior skin of the left panel as shown in Figure II. Minor repair will be required to cover the hole.

Figure II Crack in Wing-to-Body Fairing

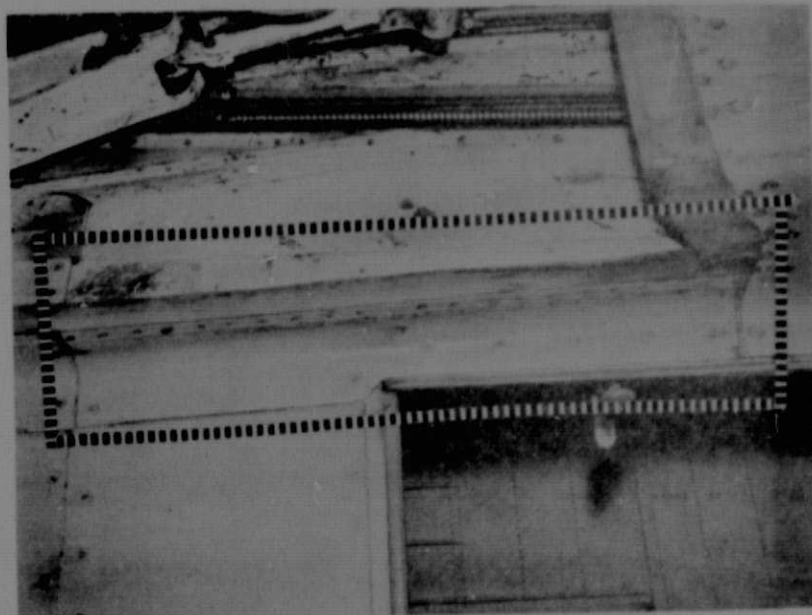
A few attachments were removed from the panels and the fastener holes that were observed were in good condition. Figure III shows the right hand panel installed on the aircraft.

Figure III Wing-Body Fillet Installed on Aircraft

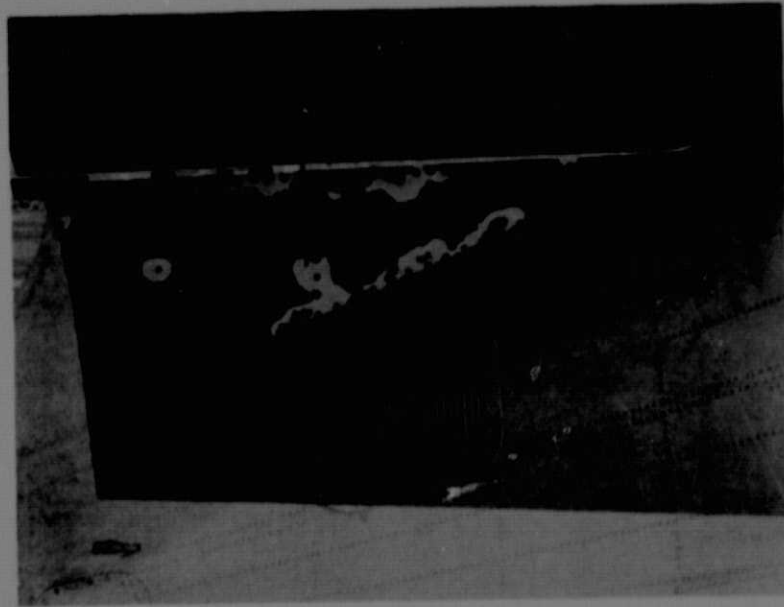
Some paint had been removed from the exterior surface of the right hand panel as shown in Figure IV. Therefore, it was decided to remove the panel for closer examination. The paint topcoat and primer were not adhering to the flame sprayed aluminum surface. A few fiberglass panels also have had paint adhesion problems which have been traced to inadequate release agent removal. Since these panels contained the elevated temperature resistant resin, they had to be cured at a higher temperature which creates some difficulty in getting the flame spray coating to release from the tool. However, this problem has been resolved on subsequent production lots. All loose paint was removed and the panel was repainted prior to re-installation.

Figure IV Center Engine Fairing

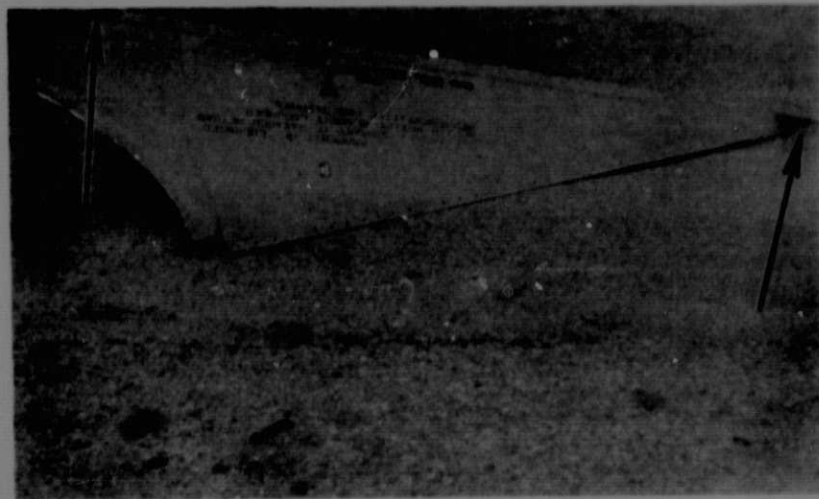
It was also observed that a single ply of fabric had been bonded to both ends of the panel as shown in Figure V. However, there is no record of this rework at either the Lockheed or Air Canada facilities. The repair material used and the time of its application are still unknown.

Figure V Center Engine Fairing with Added Material at Ends

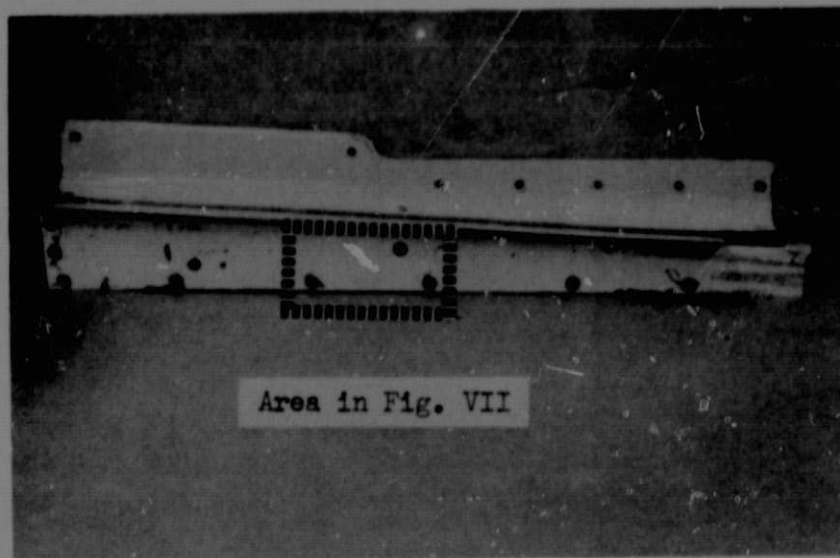
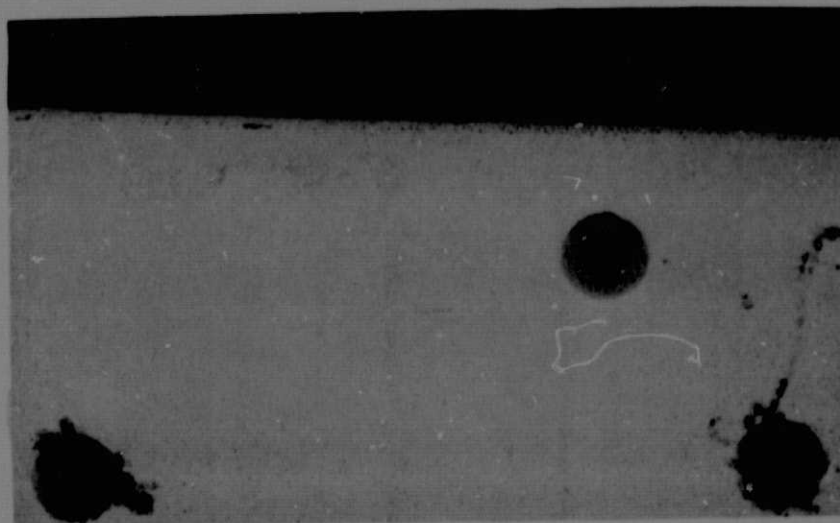
The only damage to the fillets was some elongation of the holes in the right hand panel as shown in Figures VI and VII. These holes will be repaired by sanding down the frayed fibers, solvent cleaning and completely filling the holes with the abovementioned resin system containing five percent glass fibers. Elongation of fastener holes in any of these panel configurations is not peculiar to PRD-49. More severe hole damage has been witnessed on other fiberglass fillet panels.

Figure VI Wing-Body Fillet with Elongated Holes

Figure VII Close-up of Wing-Body Fillet with Elongated Holes

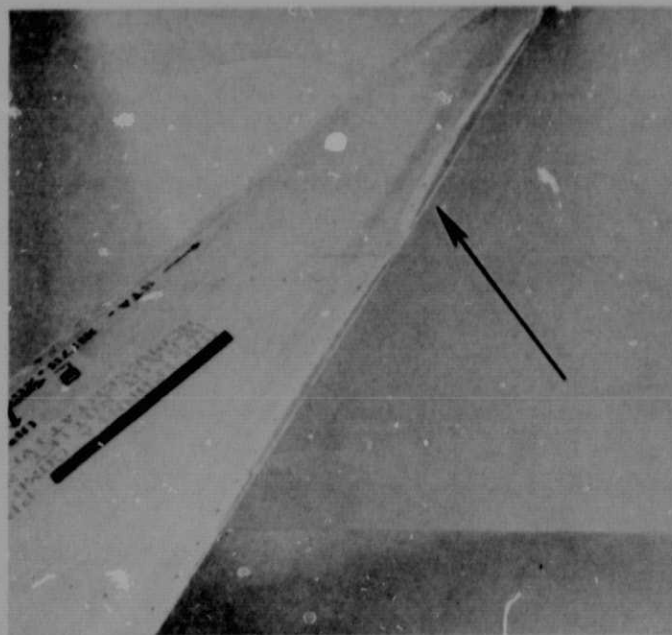
The panel on the right side had one ply of the fabric delaminated along the edge as shown in Figure VIII. On close examination it can be seen that a fillet of sealing compound was still adhering to the edge of the panel along the delaminated areas.

Evidently the adhesion of the sealing compound to the laminate and metal substructure placed a peeling force on the resin matrix causing it to peel back as the panel was removed.

Figure VIII Delamination on Center Engine Fairing

The delaminated ply will be bonded back together with a resin capable of withstanding the 422°K (300°F) service environment.
