Document No. QTR-72-1039
Revision _____
Release Date DEC 5 1972

QUALIFICATION TEST REPORT
BUMP PROTECTION HAT
(SUBASSEMBLY OF
T020/M509 HEAD PROTECTIVE ASSEMBLY)

CONTRACT NAS 9-11905

GENERAL ELECTRIC
APOLLO AND GROUND SYSTEMS
HOUSTON PROGRAMS
Houston, Texas

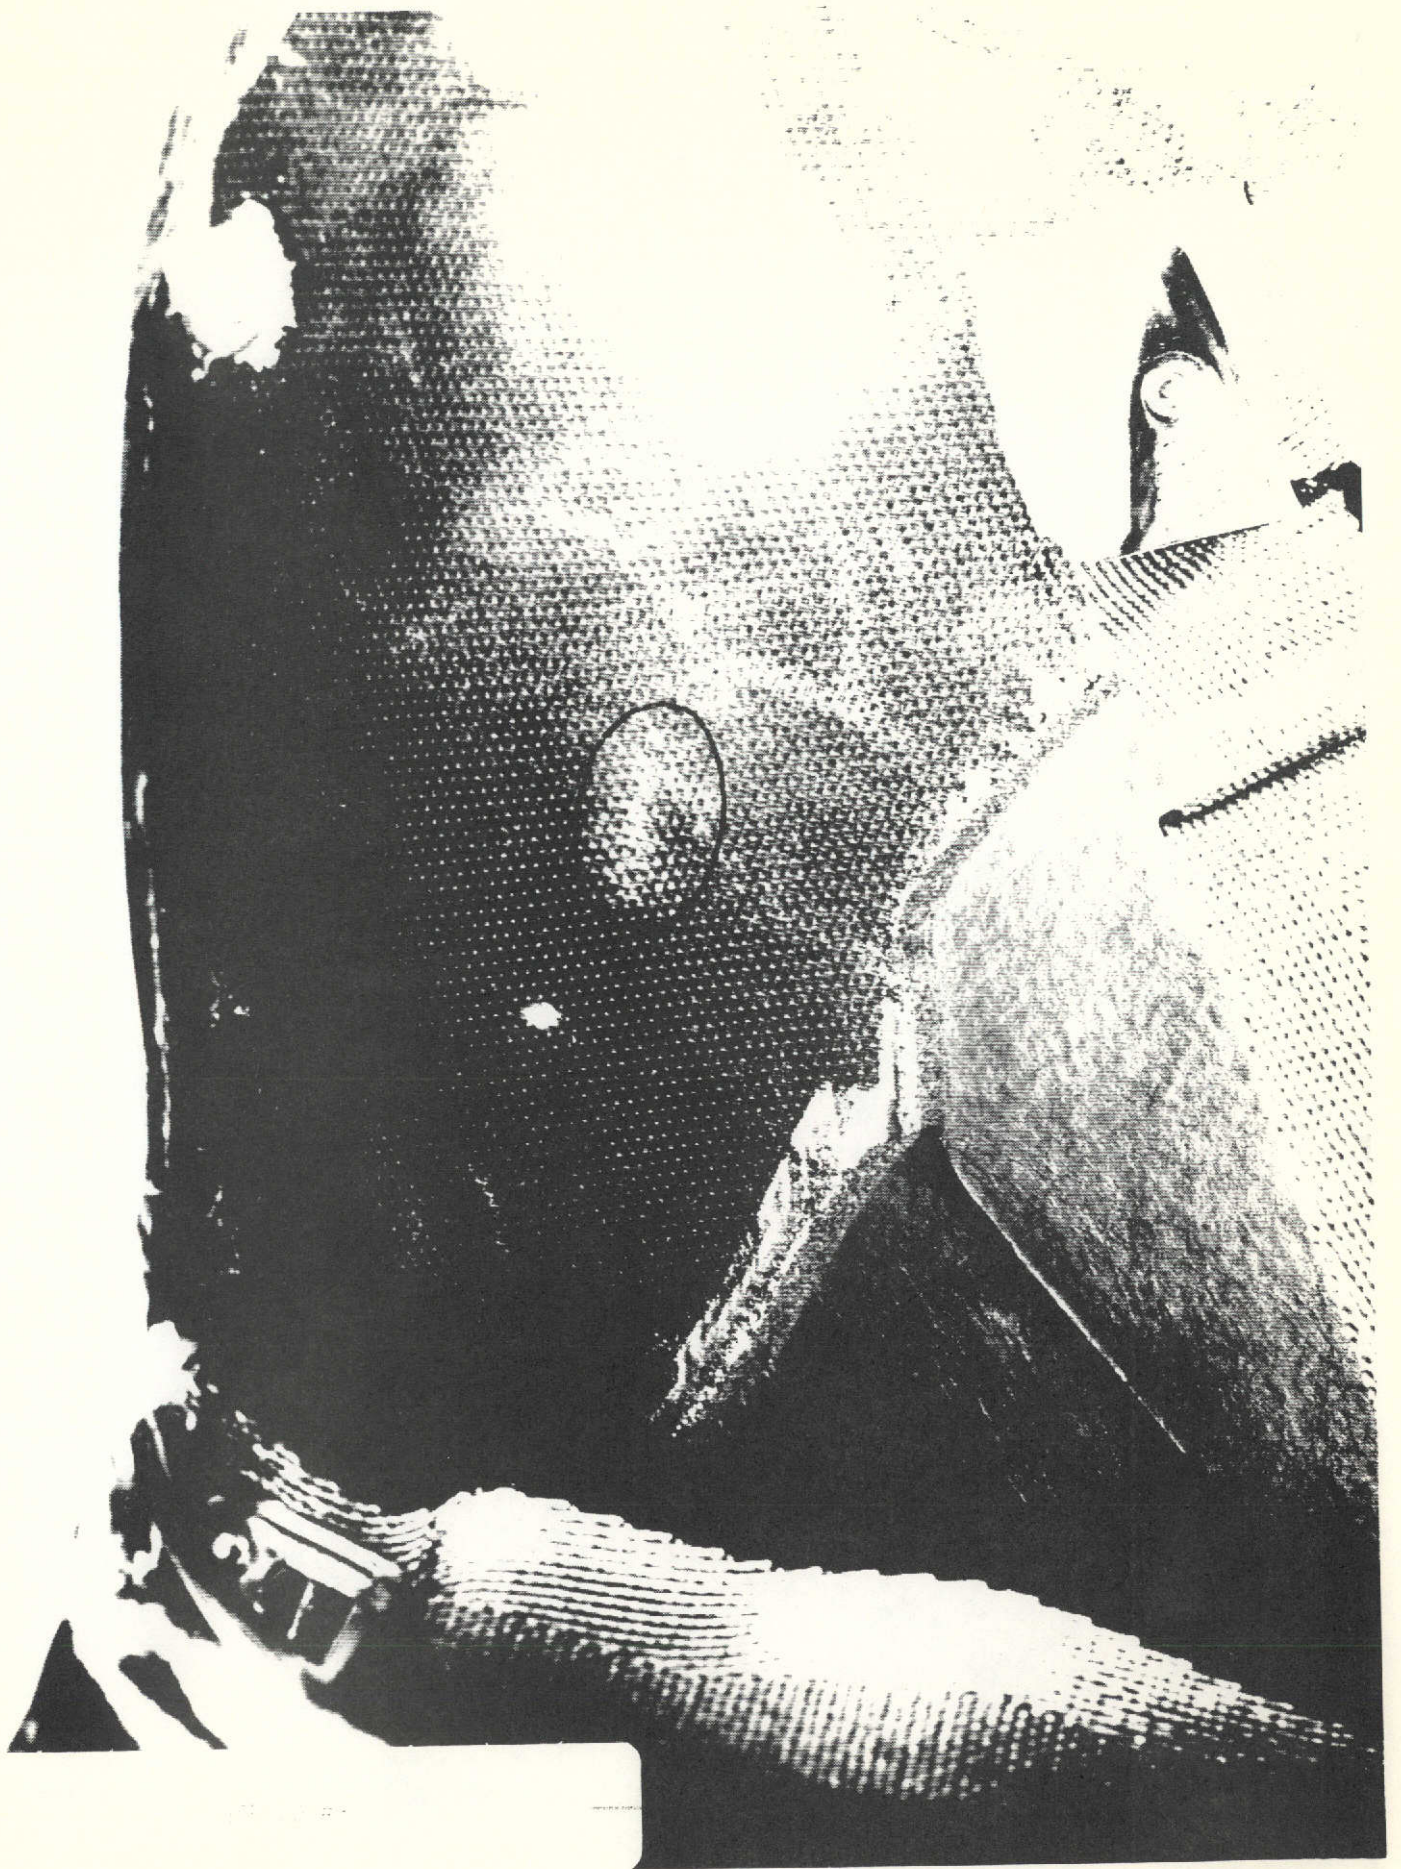
All three impacts caused stress cracks on the outside of the BPH. The side impact also caused stress cracks on the inside of the BPH. There were no stress cracks on the inside of the BPH for the top and front impacts. Analysis of the side impact cracks showed that the outside stress cracks were not the same as the inside cracks, hence, there was no penetration of the helmet. All cracks were acceptable according to the pass-fail criteria of QTP-72-1026.
