CHARACTERIZATION OF METALS MELTING DISCS
SKYLAB EXPERIMENT M551

By Robert E. Monroe
Battelle Columbus Laboratories
Columbus, Ohio 43201

January 1974

NASA-GEORGE C. MARSHALL SPACE FLIGHT CENTER
Marshall Space Flight Center, Alabama 35812

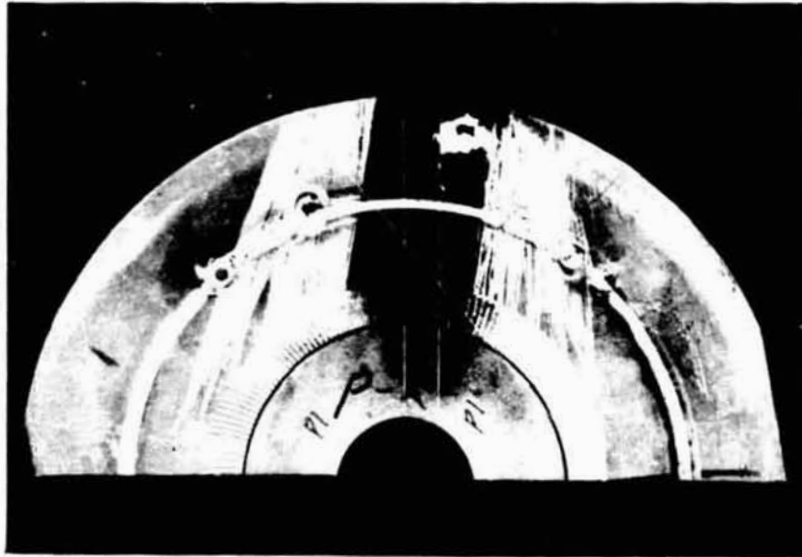
2G905-0.5X
FIGURE A-2. FRONT SURFACE OF P-1

No defects were noted in the radiograph except for cracks at the weld stops and dwells. Figure A-2 shows the appearance of this disc as received. The black area is a molybdenum spray coating used for a tracer. A section through the weld zone in the area of the tracer is shown in Figure A-3. No adverse effects of the tracer on the weld region were noted in this section.

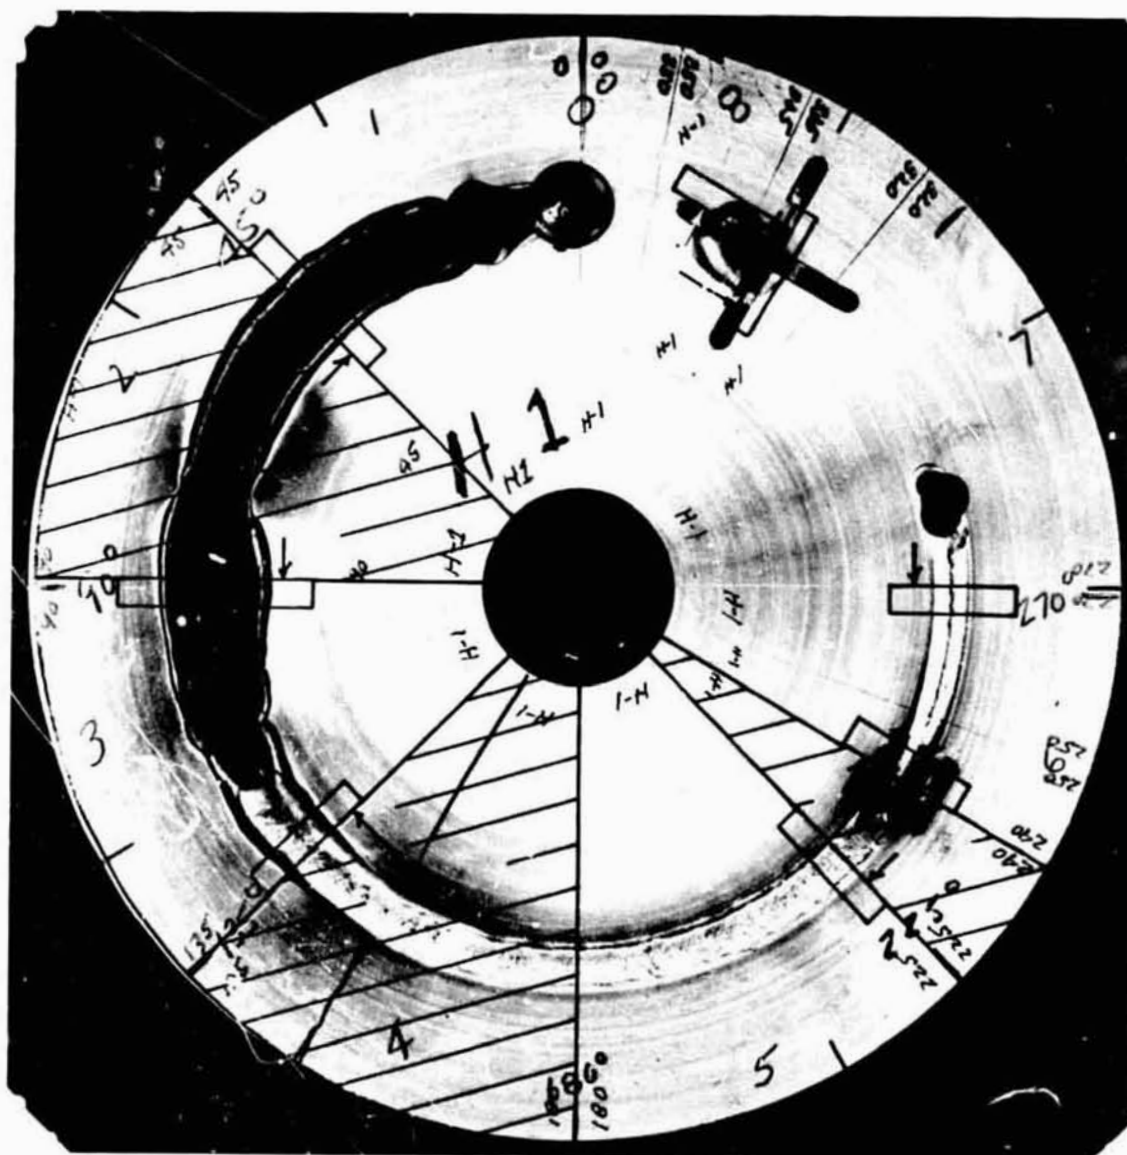
FIGURE A-4. FRONT SURFACE H-1

The radiograph showed longitudinal weld cracks near the weld start (125° to 135°), and near the molybdenum tracer (225° to 235°). Cracks in the dwell crater also were apparent. All of these cracks also were visible on the weld surface. Figure A-4 shows the front surface of Disc H-1. The rectangular cutouts were examined at Battelle. The cross hatch wedge sections were sent to MSFC for examination.

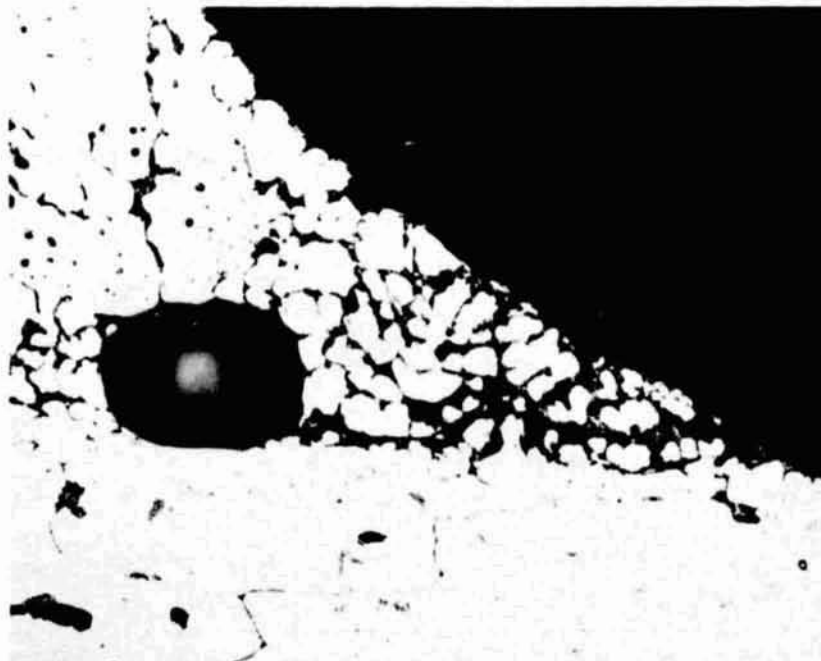
FIGURE A-13. PORE AT INSIDE EDGE OF WELD - H-1

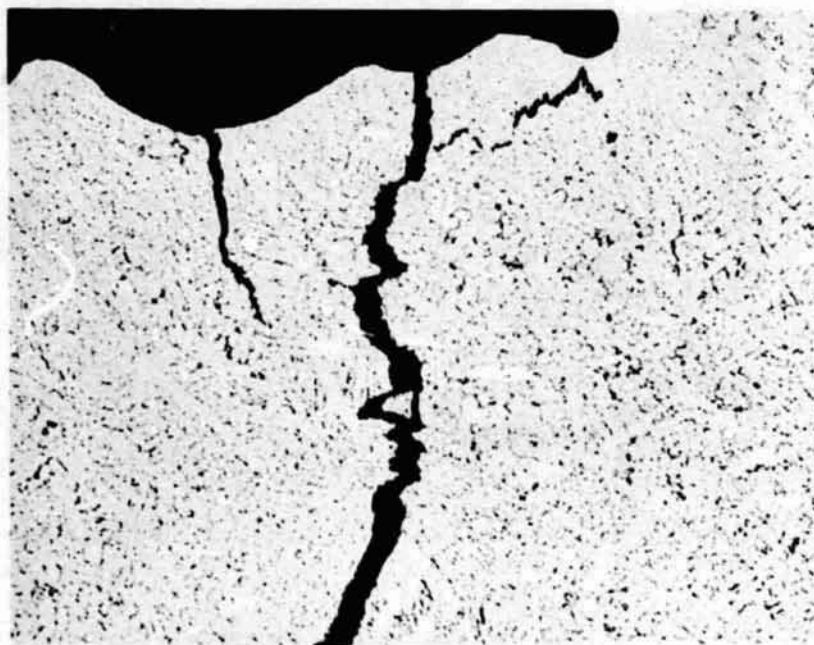
b. Main crack near center in Figure A-19

FIGURE A-20. CRACKS IN DWELL REGION- H-1

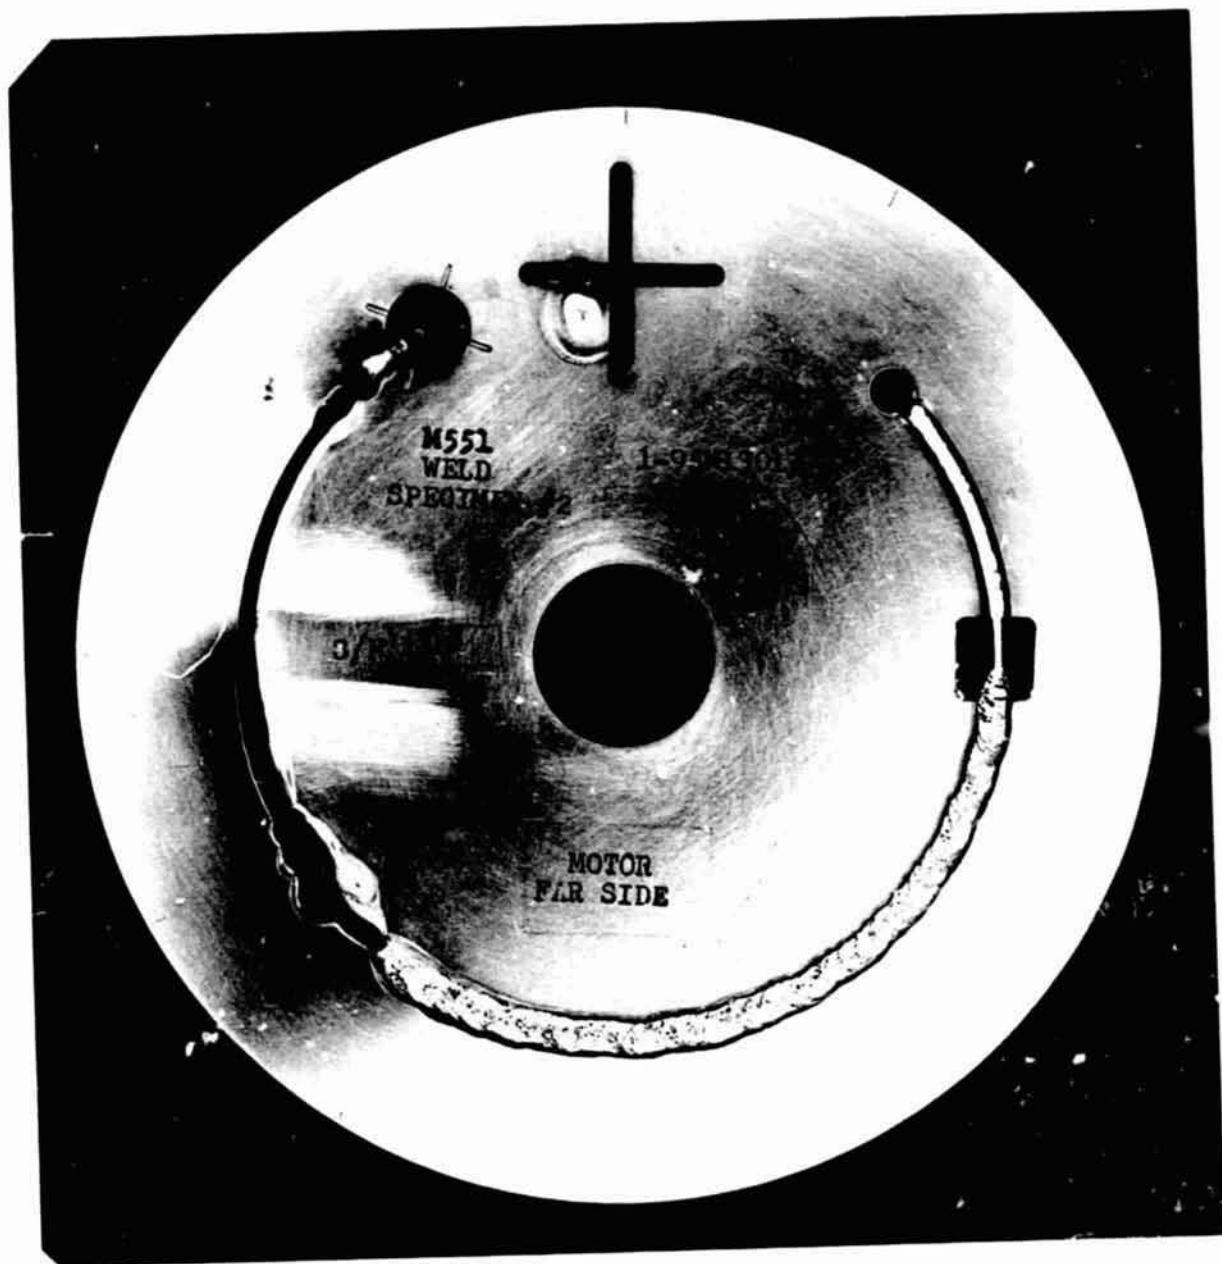
FIGURE B-1. FRONT SURFACE S/N 130

are believed to be transported from the back surface of the disc. Initially, both surfaces of the aluminum are covered with a thin film of aluminum oxide. The oxide on the front surface is removed from the weld center by impingement of the electron beam. Oxide on the back surface is not subject to the same conditions and is free to interact with the molten aluminum weld pool.

At 0 degrees, the target shows good positioning of the electron beam; almost exactly dead center. There is a short weld region on the tungsten which is not contaminated by aluminum which did flow back onto the outer edge of the target for a short distance. A short length of weld then exists up to the point where cutting starts. There is a shrinkage crack in the termination of this short length of weld. The initial width of the cut region is 6 millimeters. For most of the rest of the cut, the cut narrows to approximately 2 millimeters in width. Material from the cut region formed a bead on either side of the cut. This bead is much heavier on the inside edge of the cut. Several more massive accumulations of molten metal exist along the cut region. One at about 20 degrees, one at about 70 degrees, and one at 95 degrees. The region between about 80 and 100 degrees is very erratic in appearance with the cut width varying considerably and a very massive ball of molten material on the inside edge, as mentioned previously at 95 degrees. Welding starts at about 100 degrees with only a very slight indication of a starting crack. Weld ripples are fairly pronounced although the surface is quite molten with a brownish spot-type deposit in the center region with a dark appearance on the outer region of the weld. The weld continues fairly uniform in appearance until the molybdenum tracer region is reached. Initially, at that point, there is a depression in the weld surface and numerous small hairline cracks are apparent in this area. Once the weld passes by the tracer region, it again assumes a uniform appearance with clear surface ripples and very little evidence of the brown spotty material in the center. The center region for the remainder of the weld is basically bright and clean; the brown material appears to have remained along the edges of the weld. The weld terminates in the finish hole with some slight cracking in the weld center. The initial weld width is 8 mm; it then narrows to 6 mm (full penetration) then to 4 mm (partial penetration). The dwell region was focused slightly to the inside and beyond the intended 330 degrees. The bulk of the dwell which is basically circular in appearance, is completely outside of the two legs of the molybdenum target. The dwell extends

under these two legs but does not appear to have reacted with either leg very much. There are a number of shrinkage cracks in the center of the dwell region, which is depressed. In general, the dwell periphery is raised above the surface of the plate being approximately even with the surface at the top. The center of the dwell is quite bright with the outer fringes of the molten zone appearing with a light brownish surface coloring. The dwell measures 15 x 12 mm.

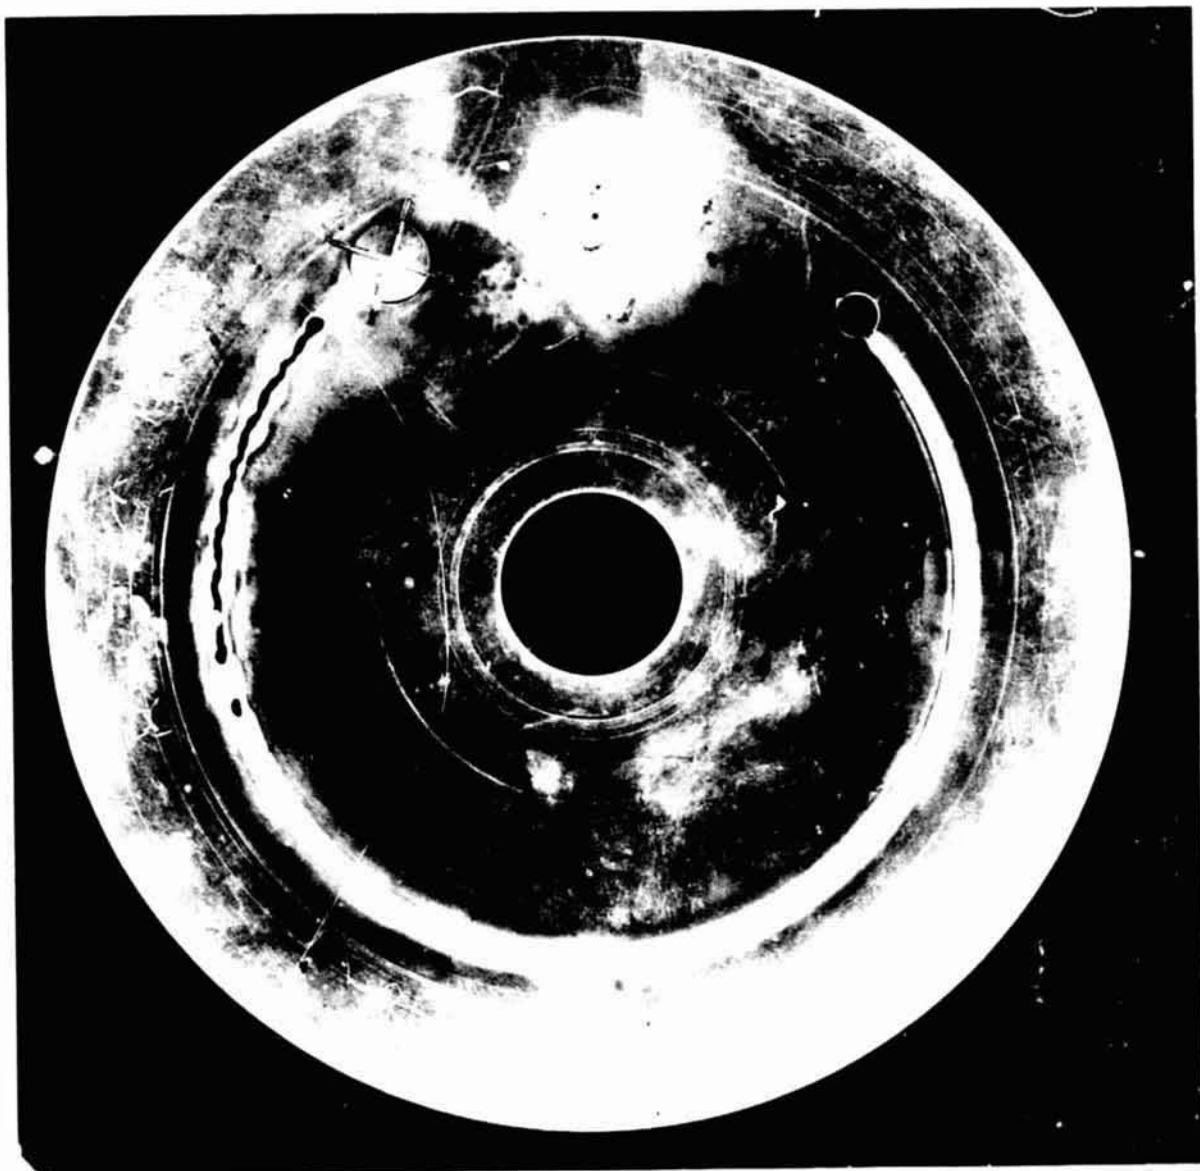
FIGURE B-17. FRONT SURFACE S/N 106

At zero degrees, the target shows evidence of having been used to locate the beam with a slight melted region almost exactly on the center. The flow back of the weld appears to extend all the way from the edge of the target back to the center. Another region on one of the grooves appears to contain molten stainless steel which has flowed back in almost a brazing-type flow. The surface of the tungsten shows evidence of having reacted with this stainless steel and also evidence of two cracks -- one on either side of the main weld deposit. A solid weld region extends from the target to the point where the thickness decreases and cutting commences. The appearance of the cut on stainless steel is quite different from that in aluminum. In the stainless steel, the molten metal from the cut region has accumulated periodically in essentially circular type balls. The first ball appears on the inside surface of the cut, followed by a large ball on the outside, another on the inside, and another on the outside. The width of the cut tends to vary considerably ranging between 1 and 2 millimeters. The pattern of the ball deposits being on the inner or outer cut surface is fairly uniform throughout the length of the cut region. At approximately 70 degrees, there is a complete bridge across the cut region. This is followed by one small hole and immediately followed by the start of the full penetration weld. As soon as the weld initiates, surface ripples which are very elongated, are immediately apparent. After an initial variation in the width, the weld is quite uniform in appearance until about 105 degrees. At that point, a rather severe undercut condition develops along the inside edge. This undercut appearance continues essentially unchanged for the remainder of the weld. There is no similar evidence of undercutting on the outside edge of the weld, and no significant variation in weld appearance from the initiation of the

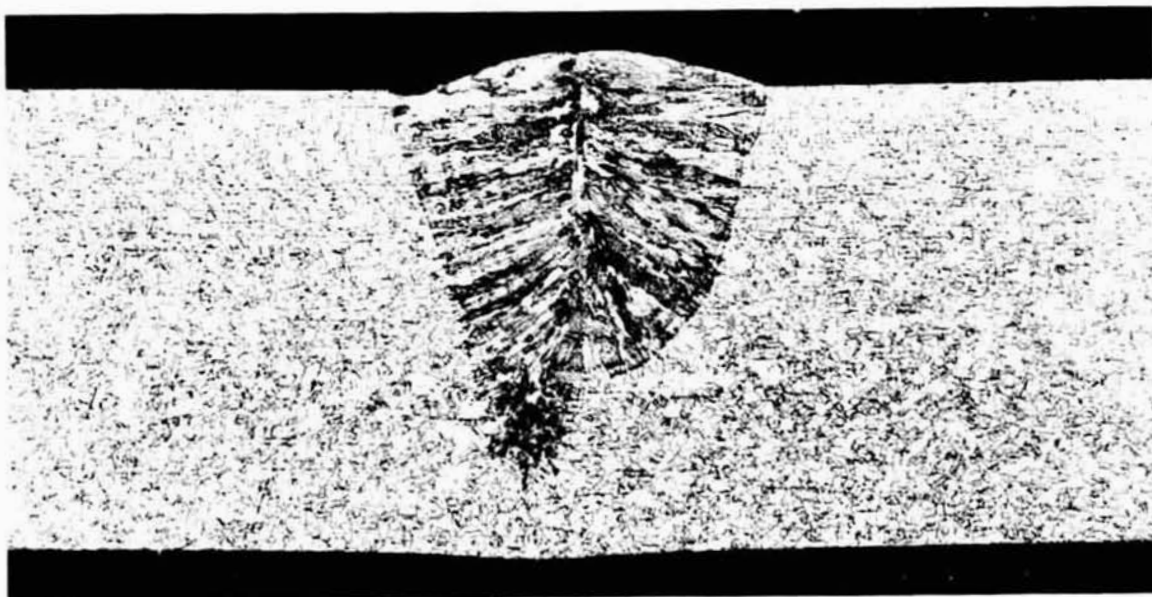
(a) The stainless steel welds exhibited the nail-head penetration shape commonly found in this material. However, the shape was asymmetrical in both welds (Figure B-24). Penetration was deeper on the ground sample than on the Skylab sample, but this probably reflects a slight difference in power density. The dwell regions (Figures B-17 and B-19) also indicated an effect of nonuniform power input. Normally, a circular melt zone would result from the spot heating in the dwell region. However, both discs exhibited an oblong melt zone about 18 x 10 mm in size. The melt shape indicates that the effective electron beam focal pattern was elongated.
