**SHUTTLE ACTIVE THERMAL CONTROL SYSTEM  
DEVELOPMENT TESTING**

**TUBE ANOMALY INVESTIGATION**

Report No. T169-28

5 April 1974

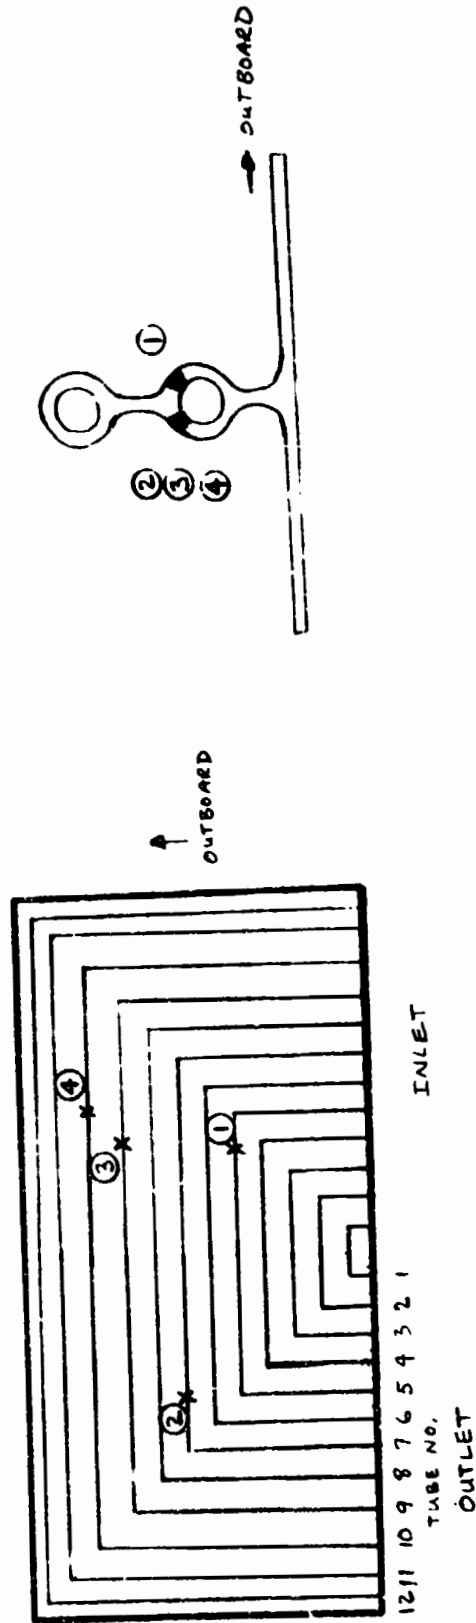
FIGURE 1  
ANOMALY DESCRIPTION

During the concluding phase of a six-month thermal-vacuum test ruptures occurred in the coolant tubes\* of the modular radiator panels containing Freon 21 (F-21)\*\*. Four tube ruptures on three panels (out of a total of seven panels in test) were noted during a thaw cycle following a two sided radiation condition (prime tube bypassed) to a liquid nitrogen sink temperature. The thermal up-ramp was 60°F/hour maximum. After a cold soak of some twelve hours with temperatures as low as -270°F measured, a recovery transient was started. Approximately 24 minutes into the thaw, tube 5 on panel 6 developed a leak. Tube 7 and possibly tube 9 of panel 5 began to leak some 34 minutes later. The thermal up-ramp was halted, but the thaw continued, causing tube 10 of panel 3 to rupture about 46 minutes after the initial leak was detected. The failure locations are diagrammed on the sketch in Figure 1. Note that all fractures occurred between the tube bends.

0 4 TUBES RUPTURED ON 3 DIFFERENT PANELS DURING RAPID WARM-UP FROM A COLD SOAK CONDITION

PANEL	TUBE	LOCATION
6	5	1
5	7 & 9	2 & 3
3	10	4

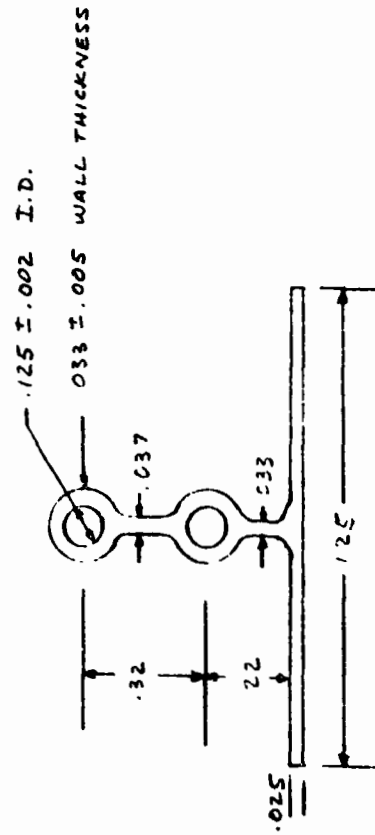
FIGURE 2  
COOLANT TUBE CONFIGURATION

Four coolant tubes from three modular radiator panels developed leaks during thermal-vacuum testing. The tubes were fabricated from as-extruded 6063-T42 aluminum alloy to the configuration shown in Figure 2. The four fracture locations and adjacent areas were sectioned from the panels and submitted for analysis.

- PROTOTYPE TV TEST ARTICLE OF MIN. WEIGHT DESIGN
- EXTRUSION VENDOR SELECTED FOR MIN. LEAD TIME
- WELDABLE 6063 AL AS EXTRUDED
- TUBES NOT ATTACHED AT TUBE BENDS

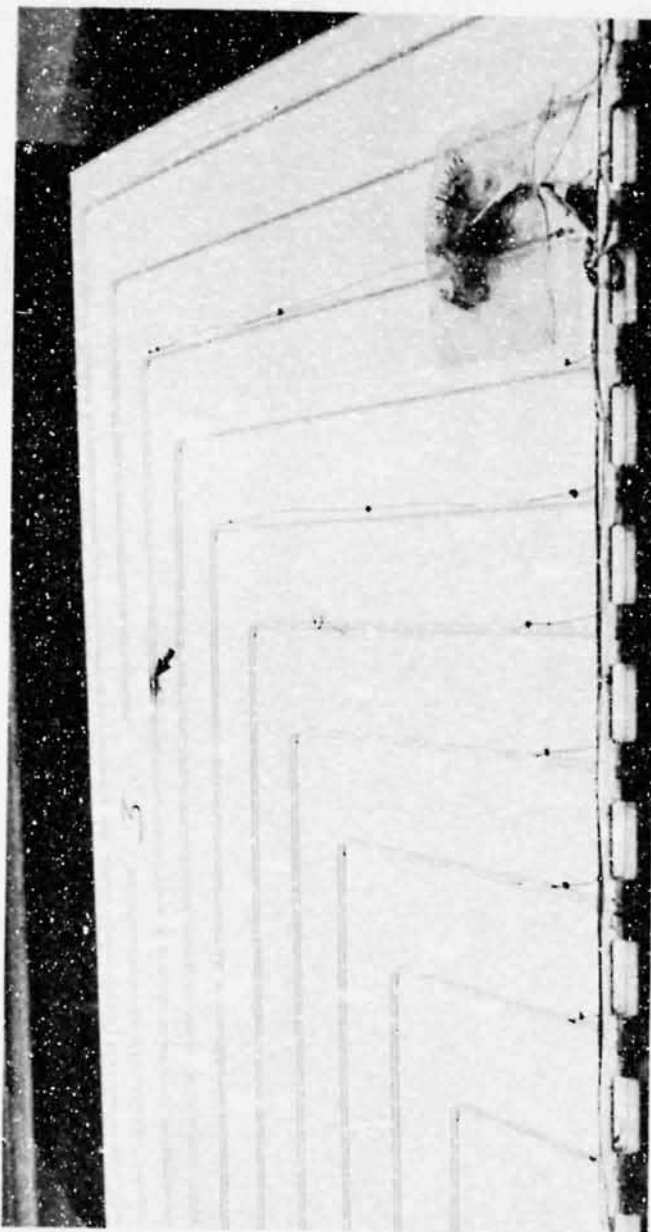
FIGURE 3

Location of the failures on radiator panels 3, 5 and 6 are shown in Figures 3, 4 and 5 respectively. The fracture locations were removed from the panels with surrounding metal intact as seen in Figure 6. A fractured and bulged area of tube 9, panel 5, with associated cracked and flaked paint is typical of each failure site, Figure 7.

LOCATION OF FAILED TUBE 10, PANE 3

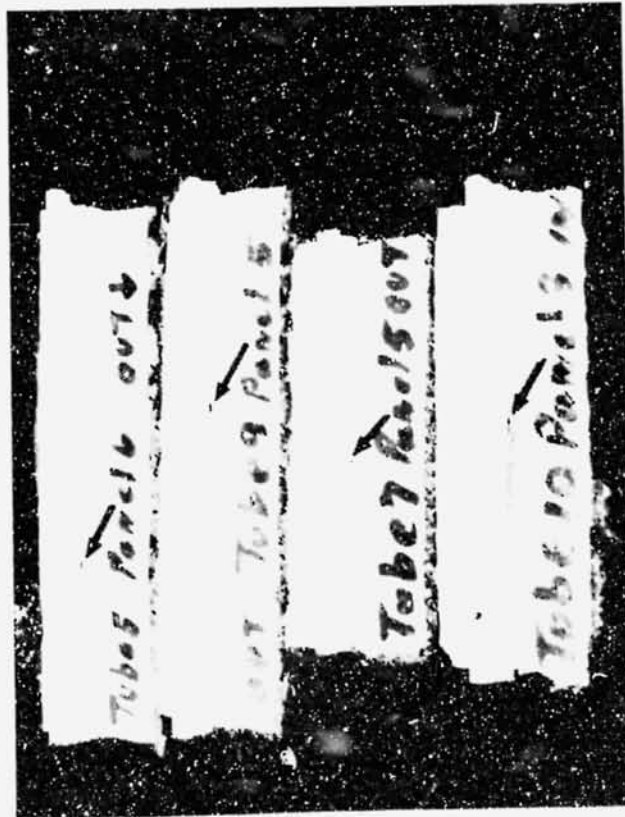
FIGURE 6

AS-RECEIVED COOLANT TUBES APPROXIMATELY 1/2X WITH  
FAILURE SITES DENOTED BY ARROWS

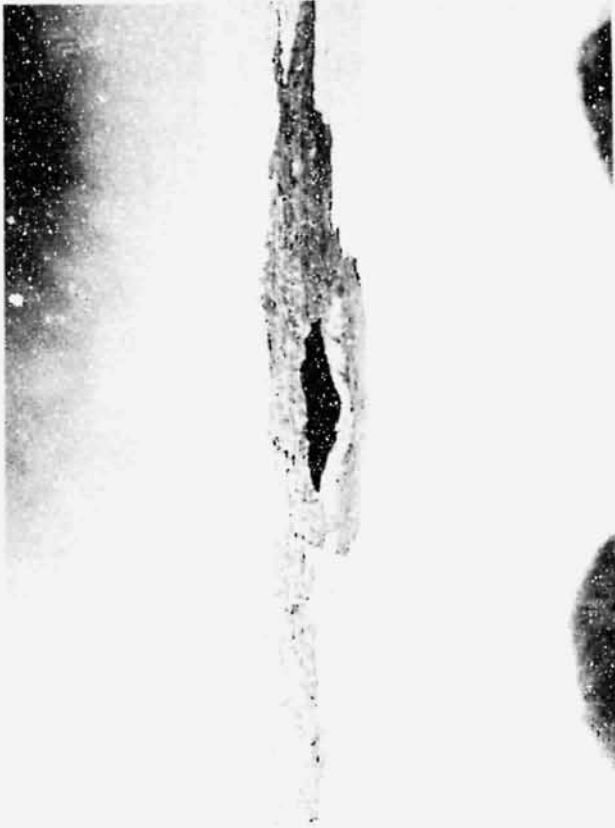
FIGURE 7

PHOTOMICROGRAPH OF THE FRACTURE  
SURFACE OF TUBE 9

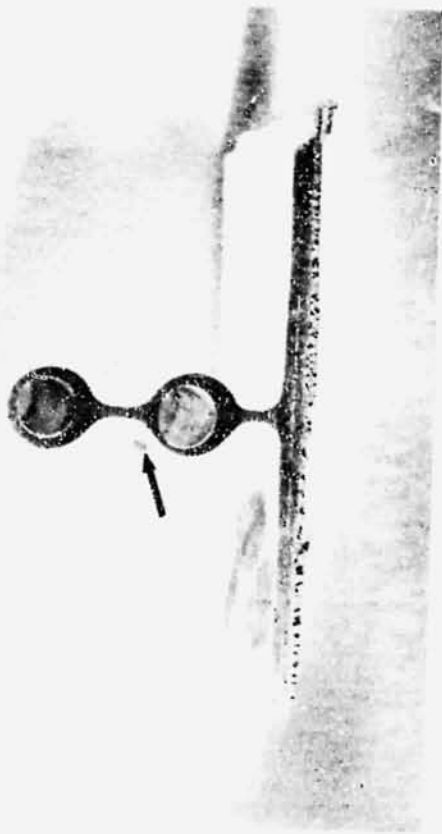
FIGURE 8

A transverse section showing the double bore shotgun extrusion is seen in Figure 8. The lower tube was typically off center as-manufactured. The fracture followed the thin walled area of the tube at each failure location.

PHOTOMICROGRAPH OF EXTRUDED COOLANT TUBE WITH YIELDED THIN WALL ADJACENT TO FAILURE SITE, ARROW, OF TUBE 5

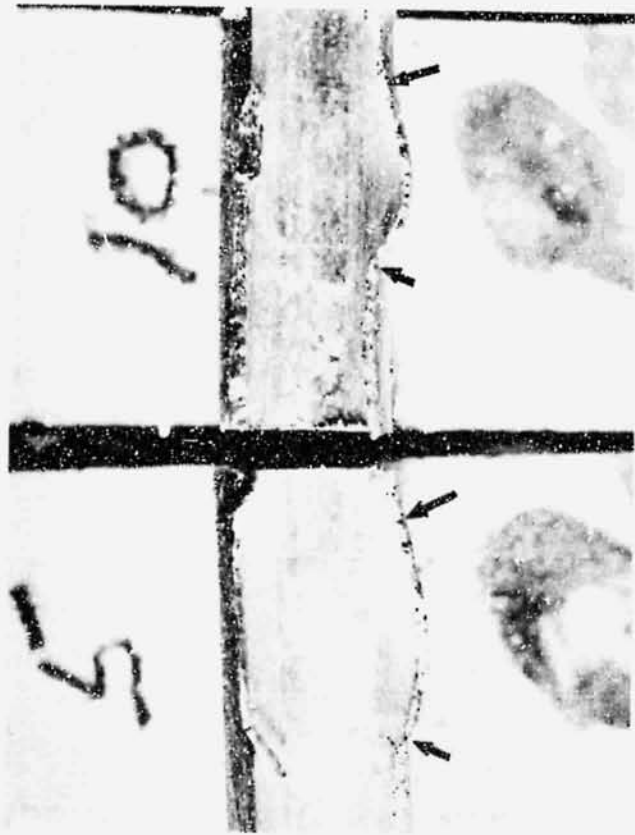
FIGURE 9

Considerable deformation at each of the failure sites was found; Figure 9 depicts the bulging noted in each tube. This indicates that catastrophic failure, i.e., leakage of F-21, was preceded by considerable yielding of the aluminum alloy tubing.

PHOTOMICROGRAPHS OF TUBES 5 AND 10 FRACTURE SURFACES AFTER OPENING  
CRACK ORIGINS APPEAR TO BE FROM INSIDE DIAMETER  
ARROWS DENOTE CRACK LOCATION

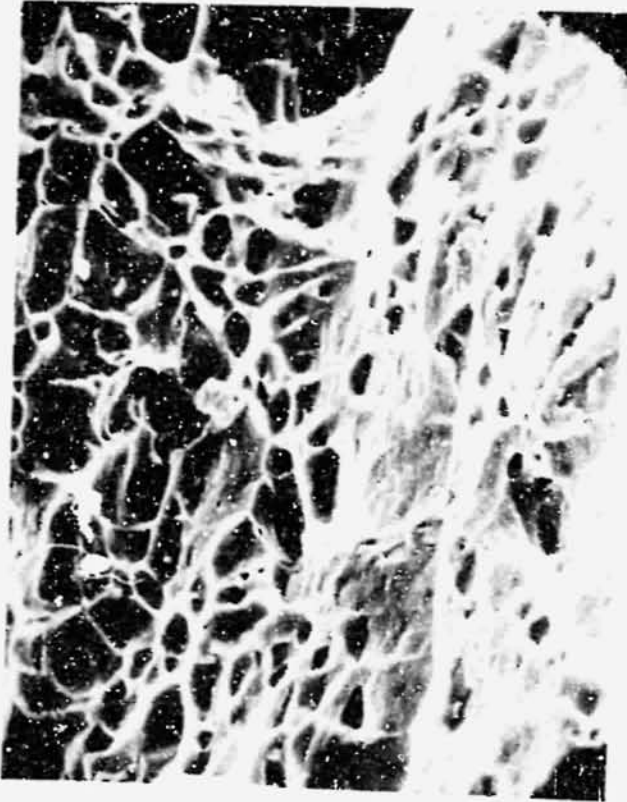
FIGURE 10

Fractographic examination with the scanning electron microscope (SEM) on each of the failure sites revealed a ductile tension mode of failure in every case. The primary topographic feature present was elongated dimples, see Figure 10, which indicates a tensile/shear mode of crack propagation. Indications of possible fatigue cracks originating on the inside diameter of tubes 7 and 9, panel 5 and tube 10, panel 3 were found during the SEM examination. A typical fractograph of an area containing the parallel striations associated with metal fatigue is illustrated in Figure 11. Such areas were patchy and scattered over the fracture surface, indicating that a dual crack propagation mode of fatigue - ductile tension was operative.

SEM FRACTOGRAPH SHOWING DIMPLE TENSION FAILURE  
SCAN FROM INSIDE DIAMETER OF BULGED AREA OF TUBE 5

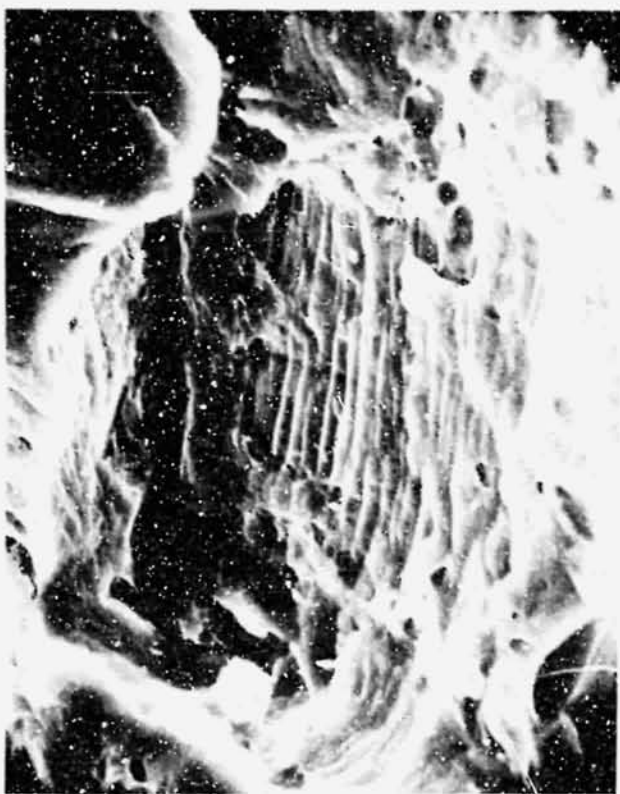
FIGURE 11

SEM FRACTOGRAPH OF FATIGUE STRIATION AREA FROM INSIDE DIAMETER OF TUBE 9

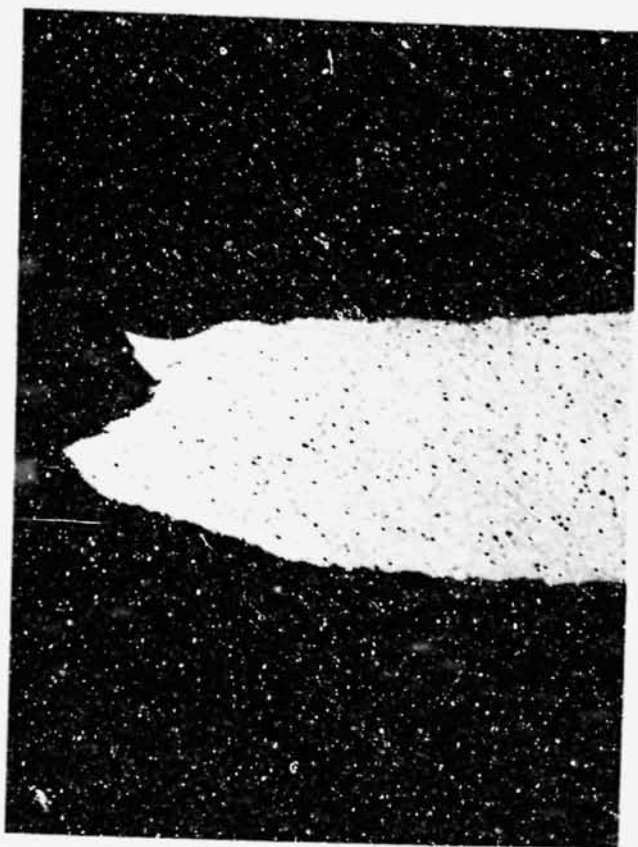
FIGURE 12

The microstructure of the extruded tubing appeared normal for 6063-T42 alloy in both failed and unfailed areas from each panel. The photomicrograph shown in Figure 12 was typical of all sites studied. The extrusion weld line was not related to the fracture locations as shown in Figure 13. No evidence of metallurgical defects was found during metallographic examination of the various specimens.

PHOTOMICROGRAPH OF SECTION THROUGH FAILURE ORIGIN OF TUBE 9 SHOWS NORMAL MICROSTRUCTURE  
INSIDE DIAMETER AT RIGHT

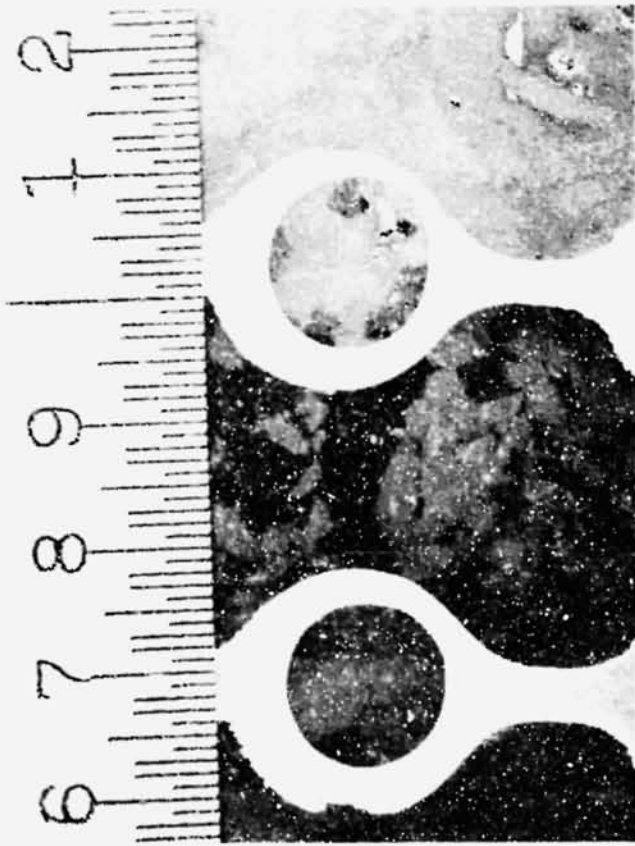
FIGURE 16

Wall thickness in the coolant tubes was below the drawing requirement of  $0.033 \pm 0.005$ ". A typical thickness in tube 5, see Figure 16, was 0.0165" in the thin wall area, decreasing to 0.013" adjacent to the fracture. The thick wall section of the tube measured between 0.023" - 0.024". As-received extrusions varied in wall thickness from 0.021" in the thin area to 0.029" on the opposite thick wall. This implies that yielding of the tube wall occurred remote from the fracture locations.

PHOTOMICROGRAPH OF TUBE 5, PANEL 6 ON INLET MANIFOLD SIDE,  
LEFT, AND ADJACENT TO FRACTURE, RIGHT

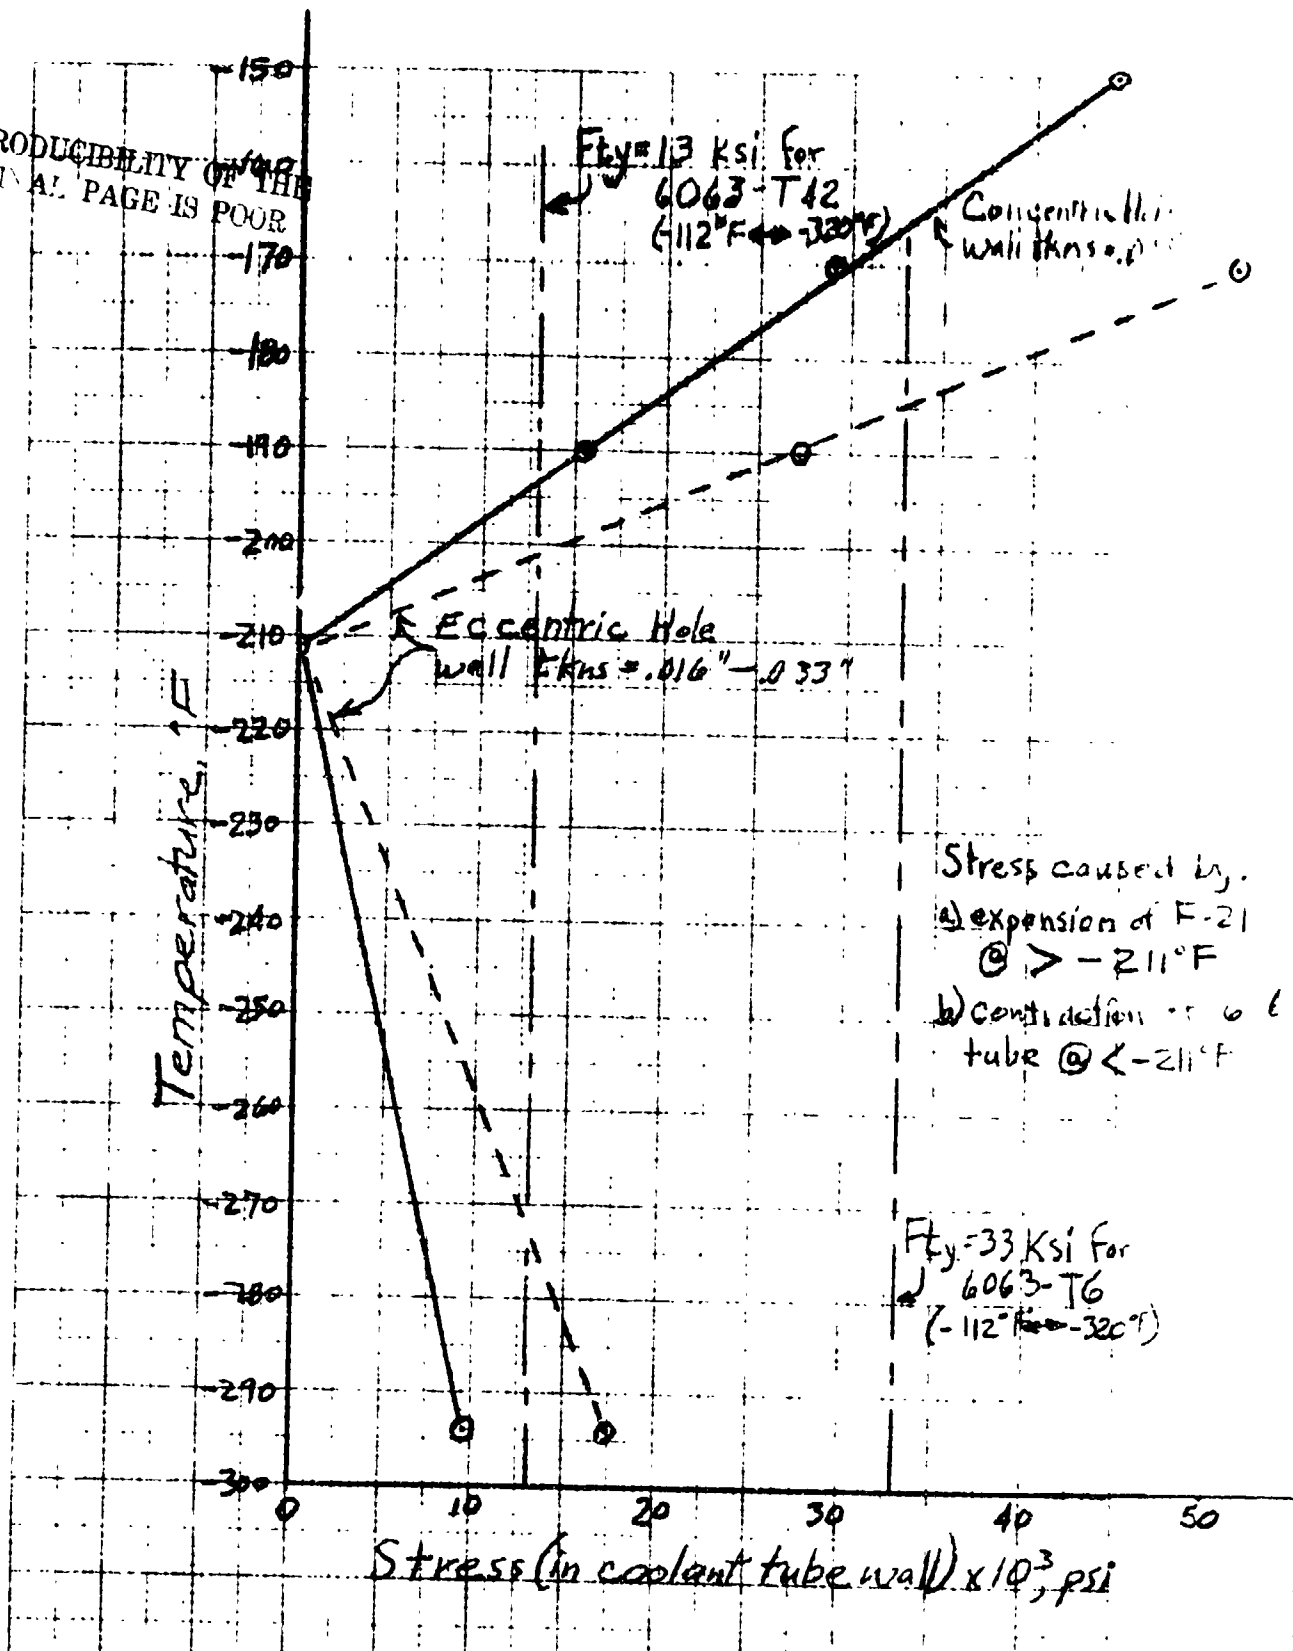
FIGURE 17

The data plotted in Figure 17 show that concentric walls in the coolant tubes cause considerably lower stress levels to be developed at a given temperature of Freon 21. In addition the heat treatment of 6063 to the -T6 condition raises the yield strength to the 33 - 36 ksi range at cryogenic temperatures. Maximum temperature differences of 35°F were measured between frozen corners and thawed tubes at mid-points. Assuming a concentric tube and a delta of 35°F from -211°F to -176°F, a stress of 26 ksi would be induced in the coolant tube by expansion of the F-21. This is below the yield strength of ca.33 ksi for 6063-T6, allowing a thaw under these conditions to leave the tube undamaged.

Analysis indicates that concentric extrusion holes and heat treatment of the tubes to the -T6 condition would have prevented the test anomaly. Thermal analysis indicates that attaching the tube corners to the radiator fin could eliminate the fluid trapping.

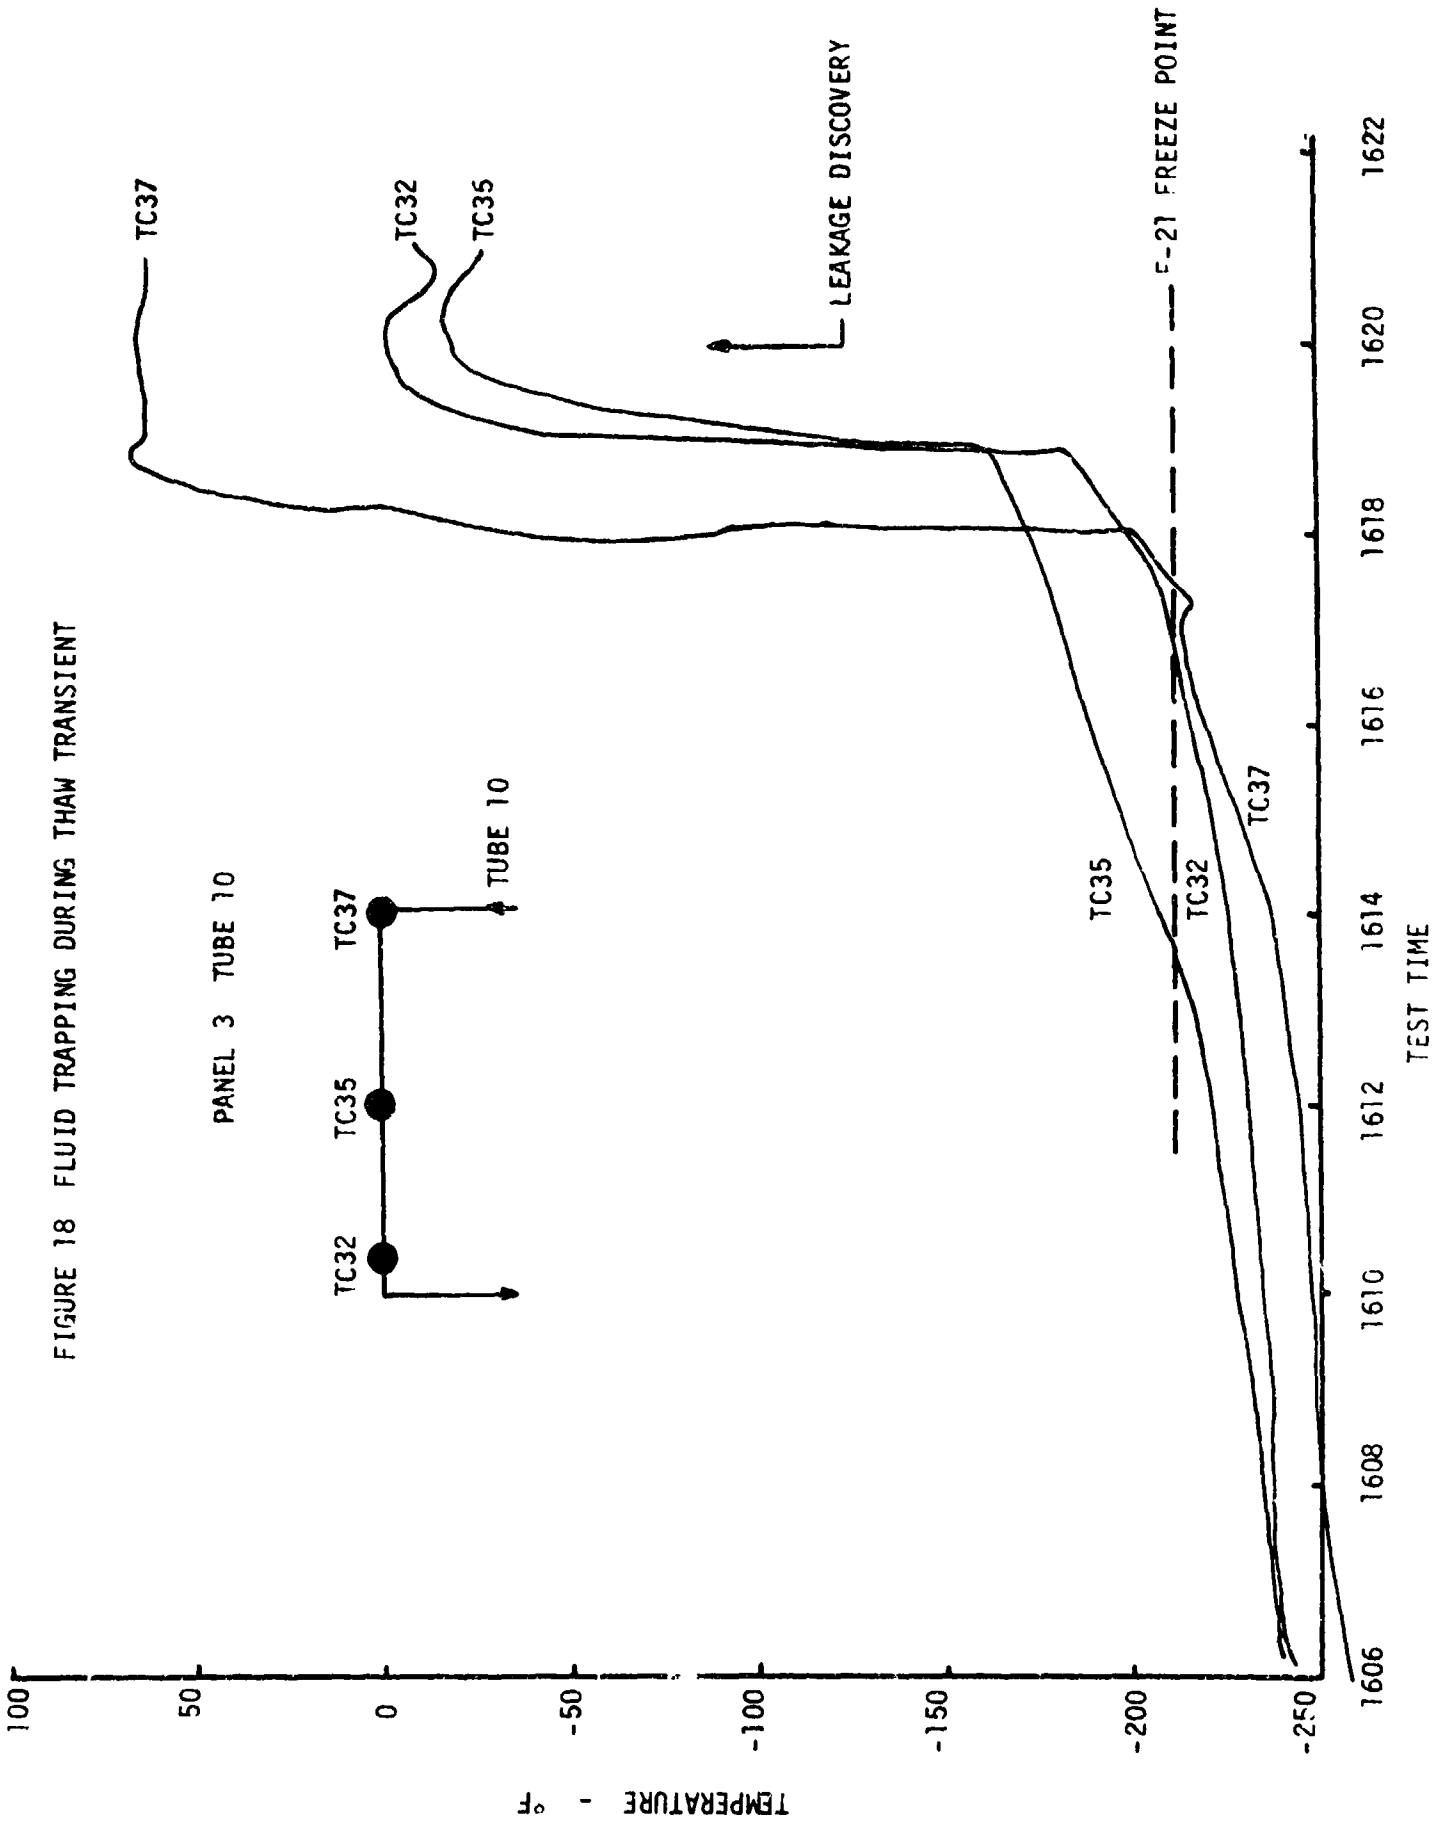
FIGURE 18 FLUID TRAPPING DURING THAW TRANSIENT

Figure 18 presents measured temperature data during the last freeze-thaw cycle in which the tube failed. This data indicates that the section between the tube corners thawed approximately 3 minutes before the corners. The fluid in this section thus underwent thermal expansion while constrained by the frozen corners. The trapped fluid was heated to approximately -180°F before the tube corners thawed and allowed the tube to flow. This demonstrates the postulated failure mechanism and indicates that thermally attaching the tube corners to the radiator fin to provide uniform heating of a frozen tube would prevent or reduce the snapping.
