NASA TECHNICAL NOTE

NASA TN D-7775

LIGHTNING DAMAGE TO A GENERAL AVIATION AIRCRAFT - DESCRIPTION AND ANALYSIS

by Paul T. Hacker

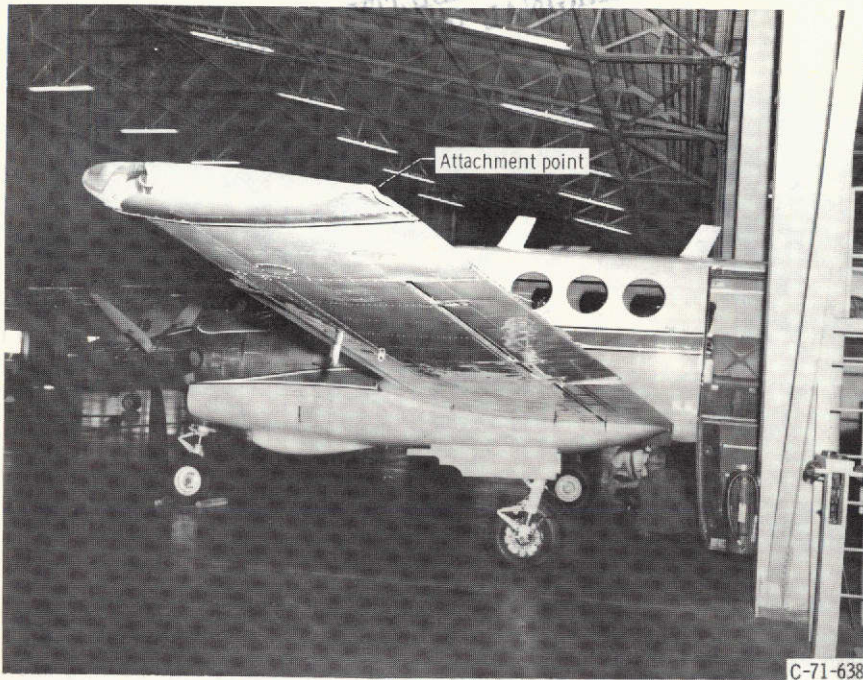
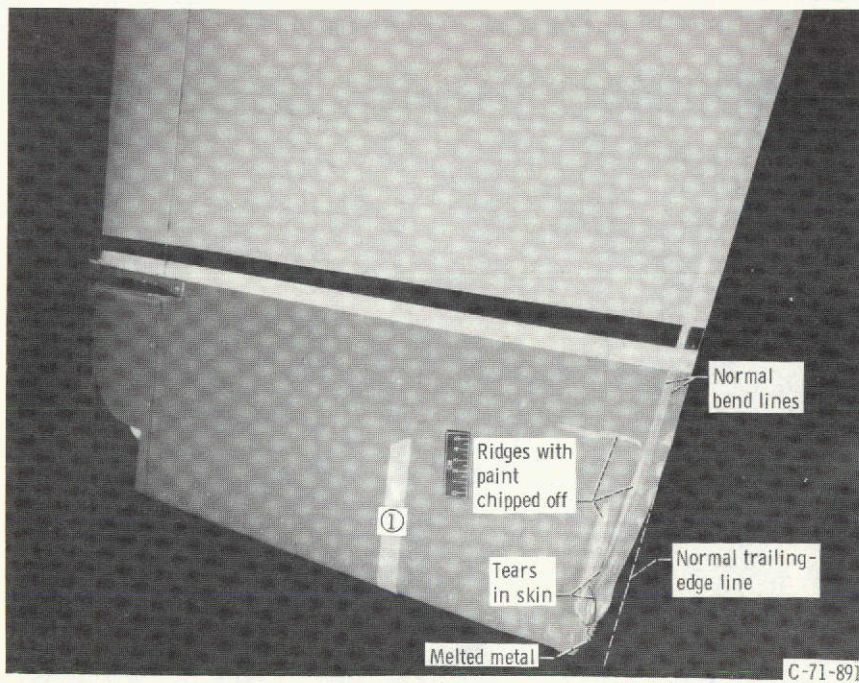
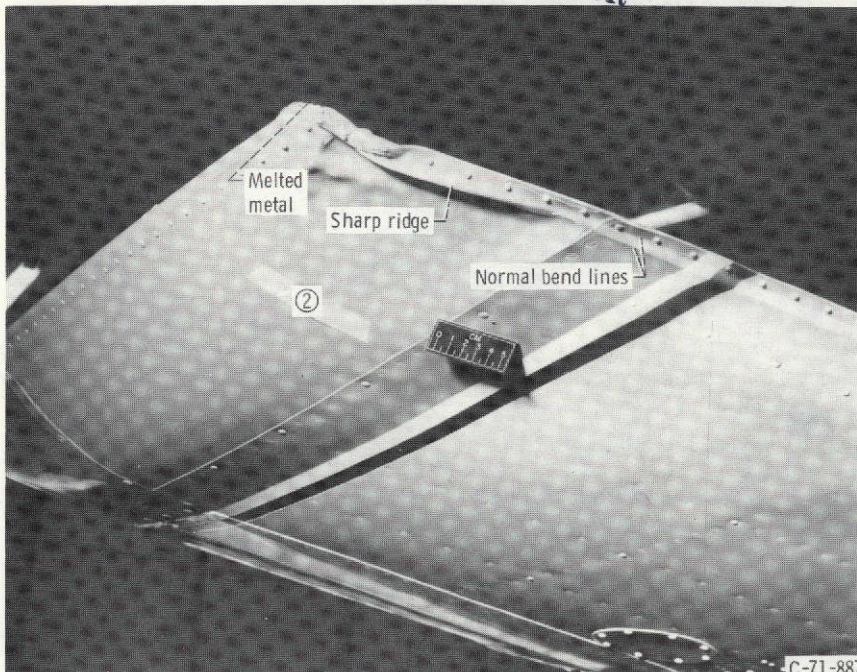
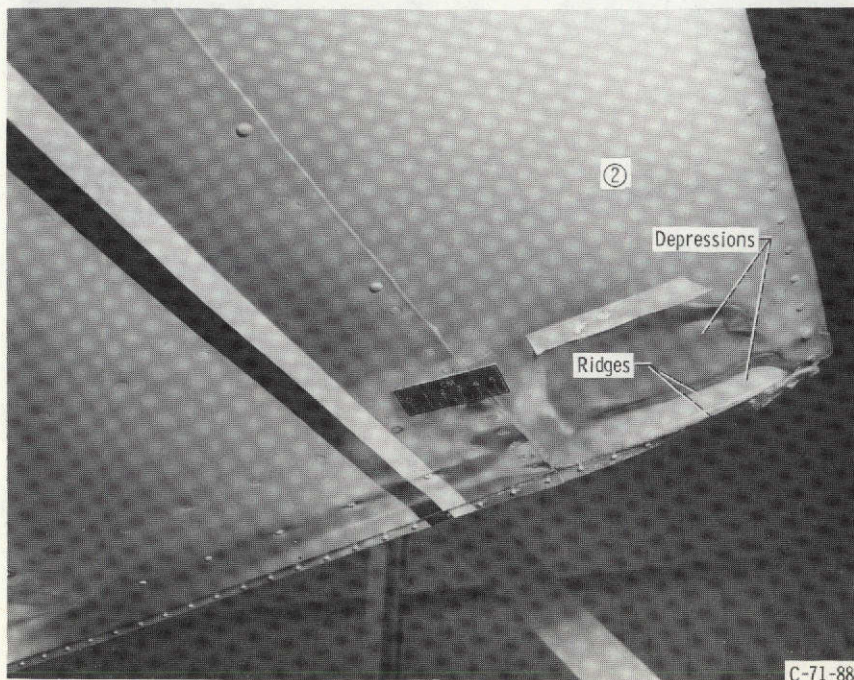
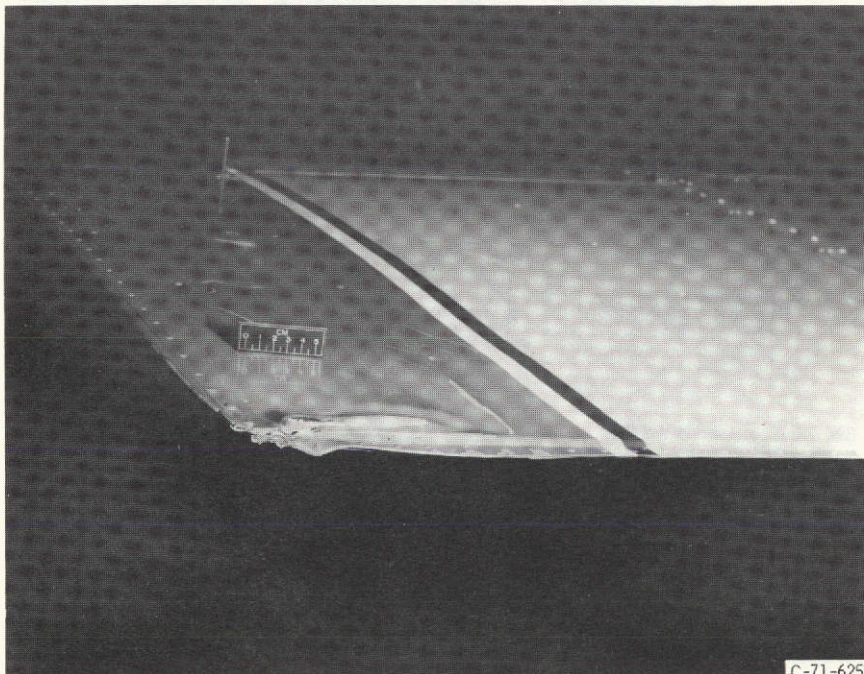
Figure 2. - Damage at lightning attachment point on trailing edge of left wingtip.

Left wingtip. - One attachment point of the lightning strike was at the trailing edge of the left wingtip. The damage at this point is shown in figure 2. Besides the metal being melted (figs. 2(b) and (g)), which is typical lightning discharge damage, the trailing edge has been pushed forward (fig. 2(b)). This forward motion of the trailing edge created two pronounced ridges in both the upper and lower surfaces of the wing which were approximately parallel to the trailing edge. The rearmost ridge coincided with a normal bend line in the wing and was so sharp that the metal was torn (figs. 2(b) and (g)). Forward of the ridges, both surfaces of the wing skin were pushed inward. This crumpling damage is probably due to electromotive forces created by the interaction of magnetic fields generated by the lightning electrical currents flowing in the upper and lower surfaces of the wing. This phenomenon is commonly called the "magnetic pinch effect." An analysis and an estimation of the magnetic forces involved in the magnetic pinch effect are presented in a later section.

The crumpling-type damage sustained at the lightning attachment point on the trailing edge of the left wingtip (fig. 2) appears to have been caused by an impact on the trailing edge since the trailing edge has been pushed downward and forward. The approximate geometry of a chordwise cross section of the wingtip trailing edge before and after the lightning strike is shown in figure 30. In the analysis that follows, it will be shown that the damage probably resulted from magnetically induced forces created by the lightning current as it flowed through the aircraft wing skin.

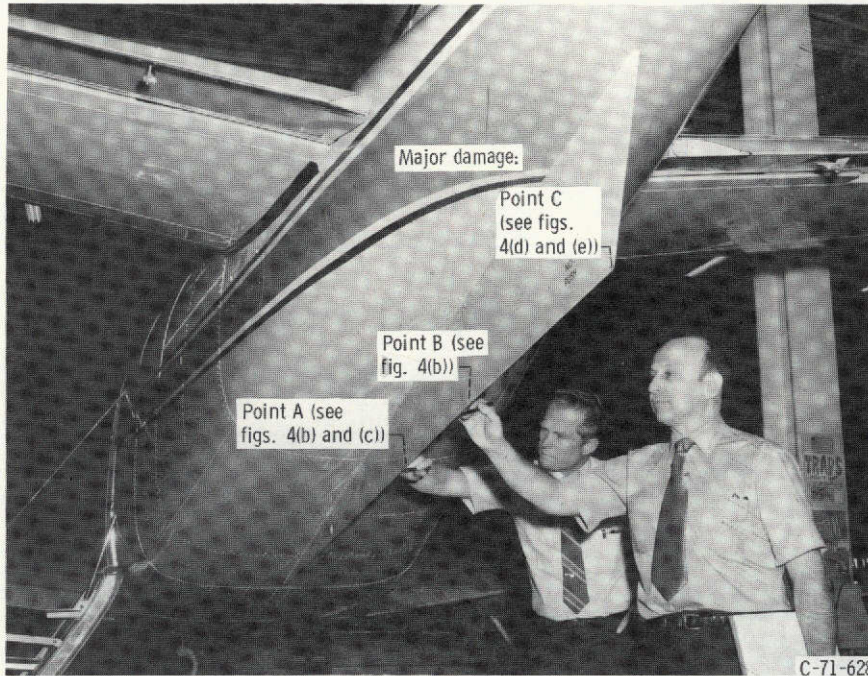
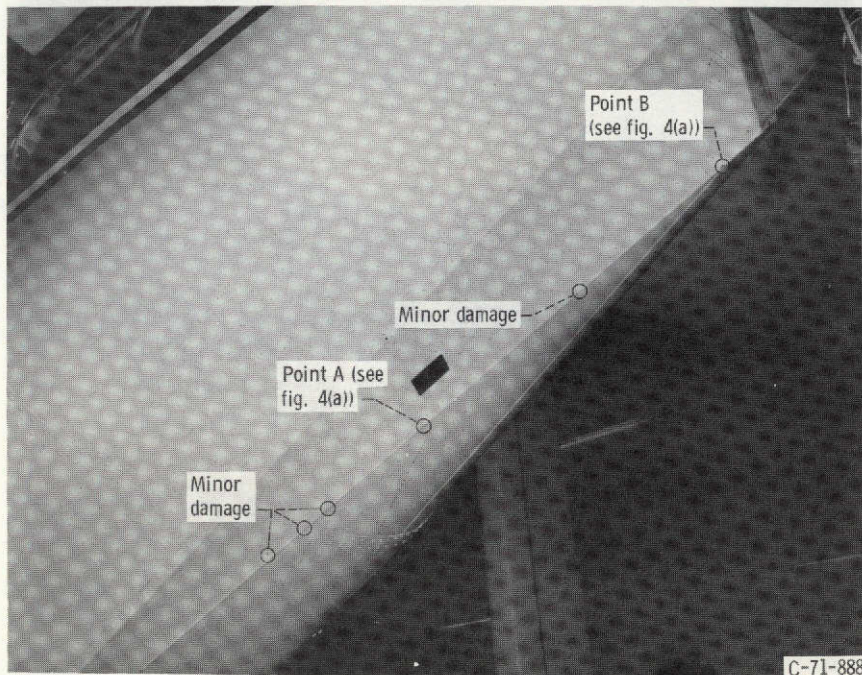
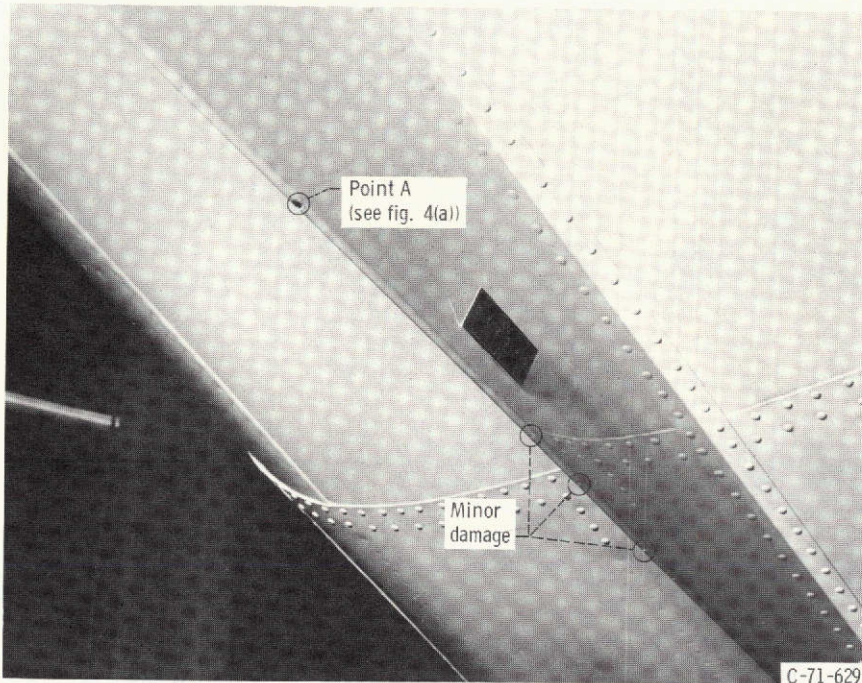
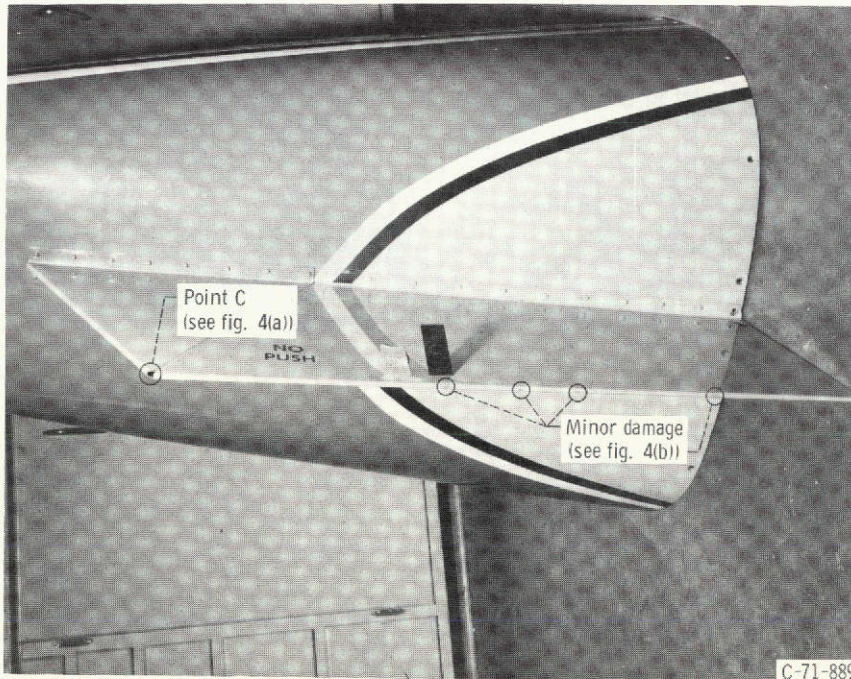
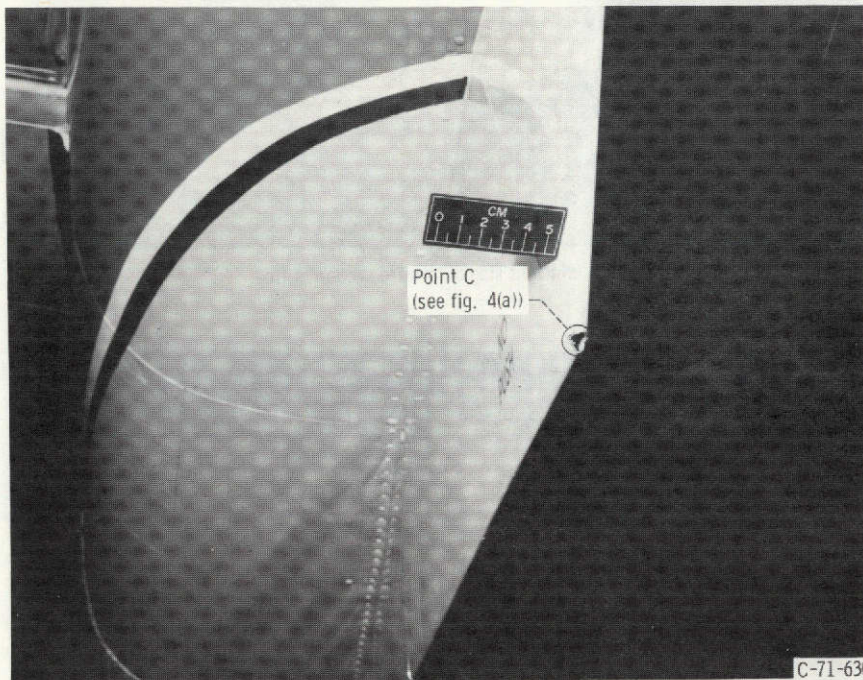
Figure 4. - Lightning attachment points on ventral fin.

Ventral fin. - Another area of lightning attachment was the bottom edge of the ventral fin. These damage points are shown in figure 4. The lightning attachment on the fin is typical of what is generally referred to as a "swept stroke." The stroke first attached itself at a forward position on the fin. Then, because of the motion of the aircraft relative to the nearly stationary lightning discharge path, the attachment point moved rearward along the fin, creating damage that ranged from small pitmarks to relatively large holes.

The lightning attachment point did move to the lower edge of the ventral fin and became what is generally referred to as a swept stroke, as shown in figure 4. The swept stroke left a series of damaged areas that ranged from scorched paint with small pits in the metal to large holes through the sheet metal. The positions of the damaged areas along the ventral fin are shown in figure 28. The relative magnitude of the damage at each position is qualitatively indicated by the length of the line marking the position. Altogether there were 12 damaged areas, with six of these more pronounced than the others. The spacing of these pronounced damaged areas along the fin was fairly uniform, 35.6 to 43.2 centimeters (14 to 17 in.), except the one at the aft end which was 20.3 centimeters (8.0 in.) from the preceding area. The average spacing, not including the 20.3 centimeters (8.0 in.), was 39.7 centimeters (15.6 in.). At the time of the lightning strike, the aircraft speed was 82.3 m/sec (160 knots). The time required for the aircraft to move 39.7 centimeters (15.6 in.) was 4.8 milliseconds. This is very close to the 4.5 milliseconds calculated earlier for the time between the high-amperage strokes of the discharge. This suggests that the change in attachment point for a swept stroke is triggered by the high-amperage strokes. After attachment, the continuing current flow caused the melting-type damage. The amount of current flow required to melt aircraft structural materials is discussed in reference 5. Meanwhile, because of the motion of the aircraft, the lightning discharge path near the aircraft was stretched and bent with respect to the original path which was relatively fixed in space. When the next stroke occurred, the large magnetic field created around the path ruptured the discharge path at the bend, causing a new attachment at a point on the aircraft near the original discharge path. The minor damage occurring between the major damage positions (fig. 28) could have been caused either by momentary contact between the discharge path and the structure as the attachment point was carried forward with the aircraft or by momentary contact as the attachment point changed position.

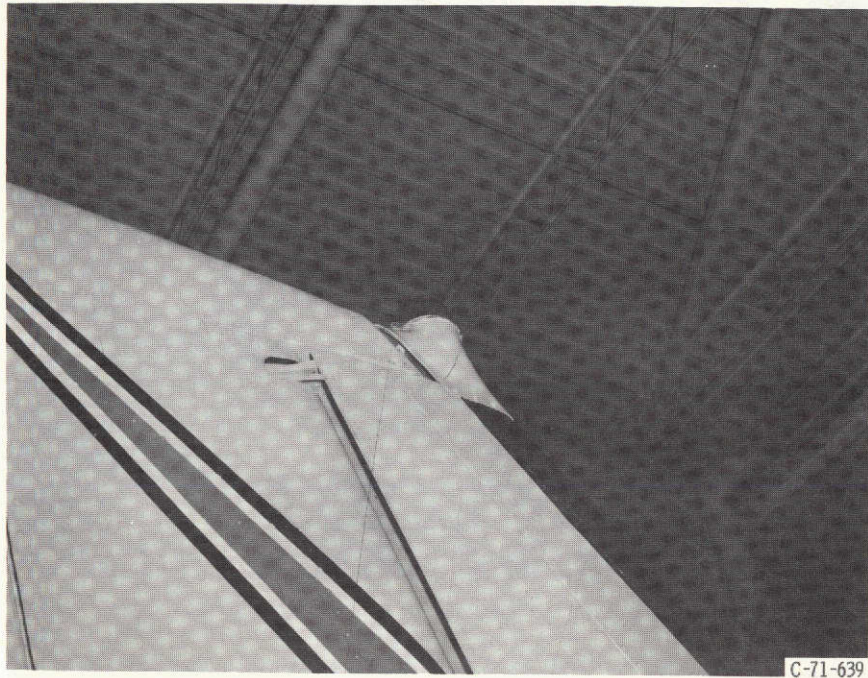
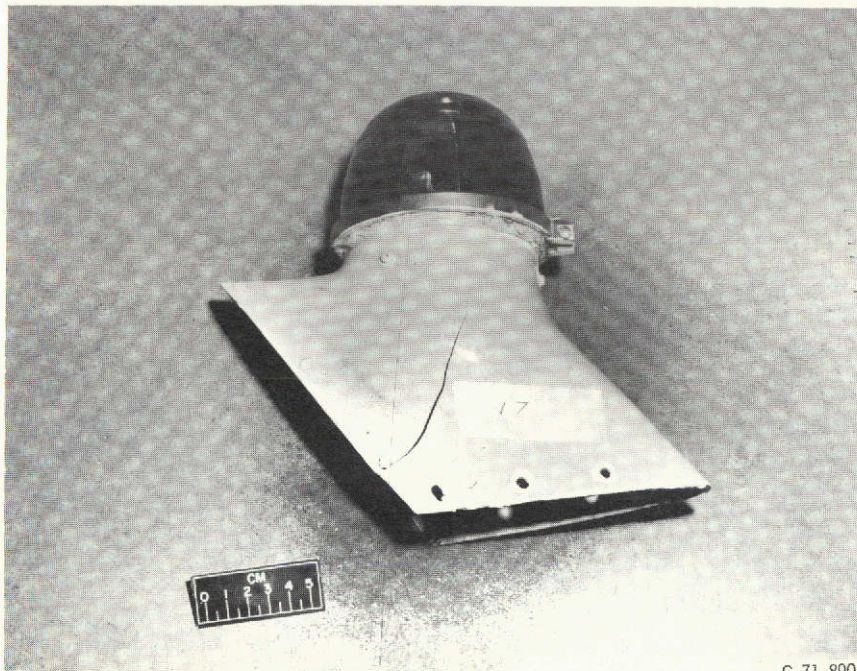
Vertical stabilizer. - Another possible lightning attachment point was the navigation light on the top of the vertical stabilizer. There was no evidence of burning or melting, but the plastic mounting for the light was cracked, as can be seen in figure 5.

The crack in the plastic mounting for the navigation light on the top of the vertical stabilizer (fig. 5) is typical of damage produced when lightning strikes an electrical insulating or dielectric material. When the lightning attaches to the exterior of the plastic housing, the insulating plastic is in the current path and an electric field is generated across the material. When the electric field exceeds the dielectric strength or breakdown potential of the dielectric material, the material is punctured or cracked. The dielectric strength of most insulating materials ranges from 10^3 to 10^7 volts per centimeter. Potential gradients of this order of magnitude are easily obtained when the dielectric material is a part of a lightning discharge path. Dielectric material can be protected by use of electrical conductive paints or metallic strips bonded on the exterior surfaces and connected electrically to the metal aircraft.

Figure 5. - Crack in plastic mount for navigation light located on top front of vertical stabilizer.

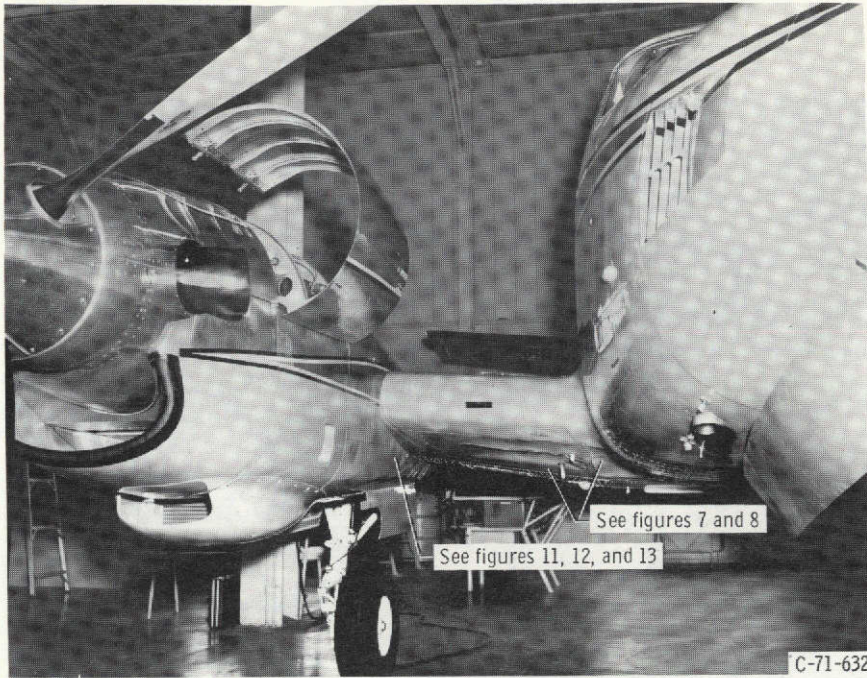
Figure 6 is a general view of the damage to the lower surface of wing and the inboard side of the engine nacelle. The major damage on the wing occurred to two skin panels: the hatch cover for the battery compartment and a wing root fairing. Closeup views of the implosion-type damage to these panels are shown in figures 7 and 8. The inward force on the fairing panel was sufficient to pull the skin over the rivet heads. The fairing panel had no internal stiffeners, but the hatch cover had a stiffener as is evidenced by the rows of weld spots visible in figure 7. All the damaged skin panels were aluminum alloy. Typical thicknesses of damaged skin panels are given in table I. In addition to the implosion-type damage, the paint in an area containing a part of the hatch cover, the wing root fairing, and a section of the fuselage was discolored as though it had been exposed to high temperature. This area of discoloration is shown in figures 8 and 9. Most of the discoloration was slight, except on the fuselage, where it was moderate. The longitudinal black streak on the bottom of fuselage (fig. 9) is not paint discoloration but exhaust deposits from the cabin heater.

Figure 6. - General view of damage to lower surface of wing and inboard side of engine nacelle.

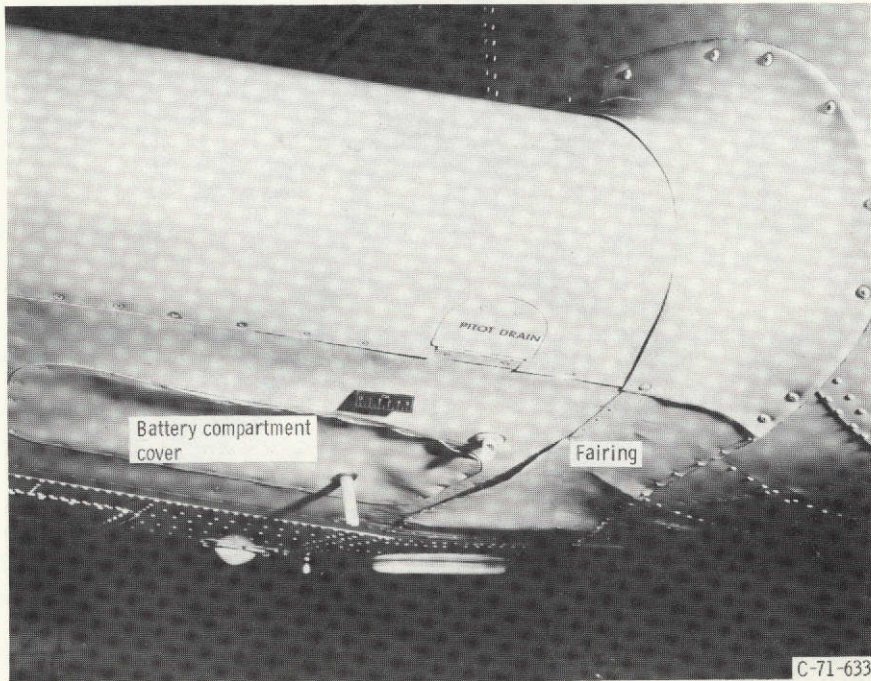
Figure 7. - Damage to battery compartment cover and wing-to-fuselage fairing.

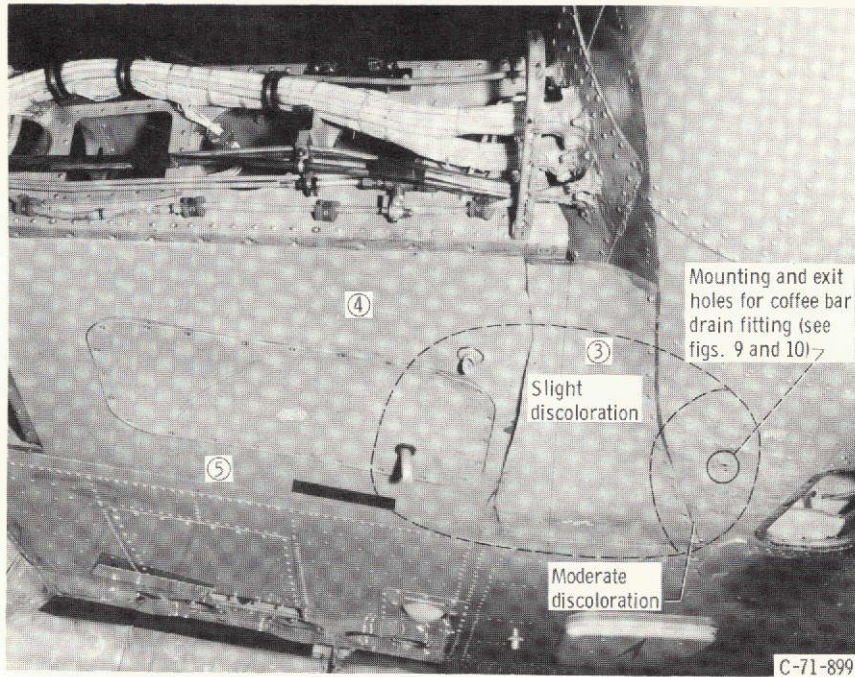
A drain fitting for a cabin coffee bar was located in the area of moderate paint discoloration. The mounting holes for this fitting are shown in figures 8 and 9. The fitting is shown in figure 10. The fitting flange was mounted on the internal surface of the skin with five rivets. The fitting was found inside the fuselage skin and completely separated from it.

Figure 8. - Area of paint discoloration on wing and fuselage.

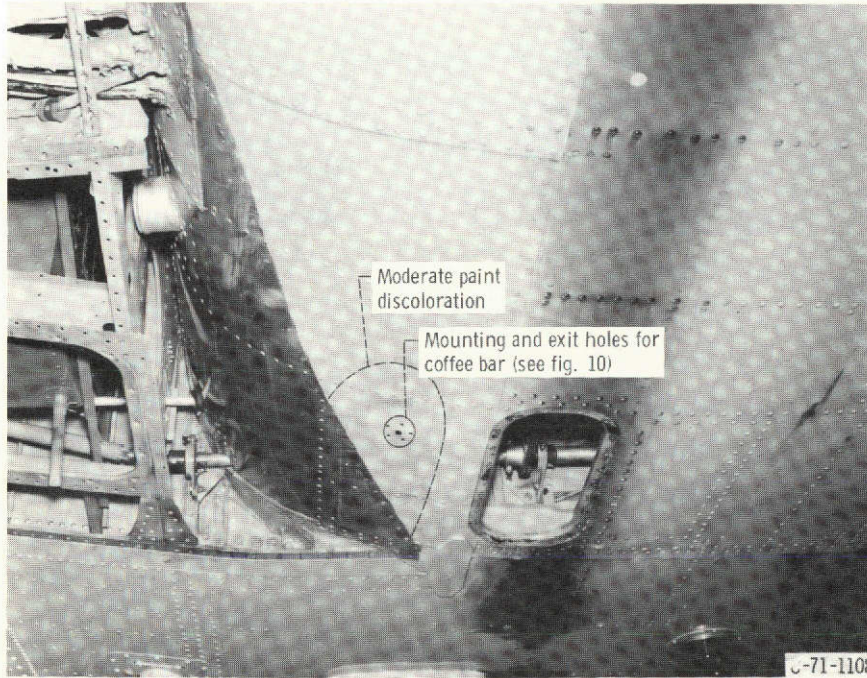
Figure 9. - Area of moderate paint discoloration around mounting and exit holes for coffee bar drain fitting on bottom of fuselage.

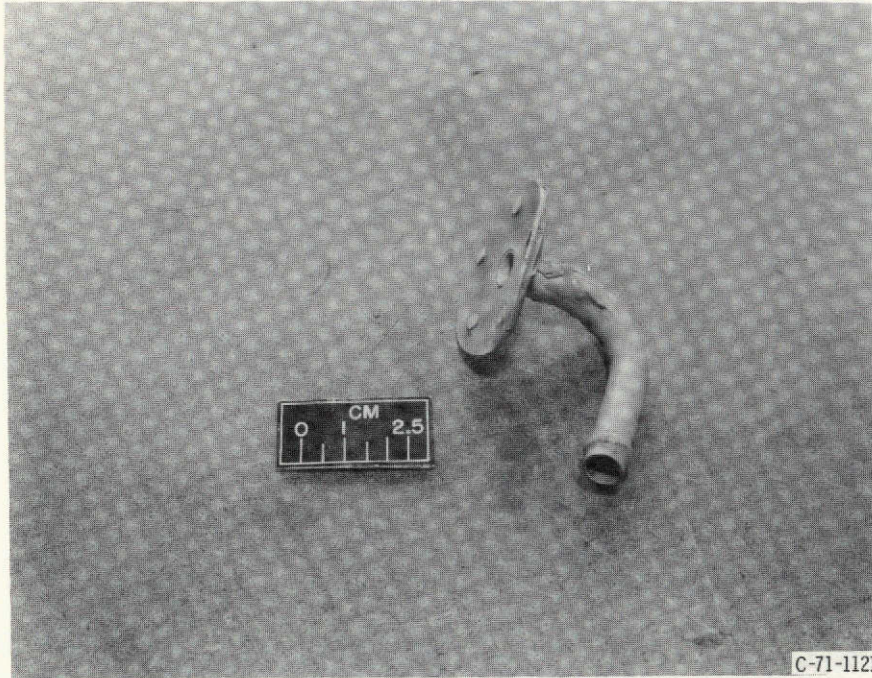
Figure 10. - Coffee bar drain fitting. (See fig. 9 for location on bottom of fuselage.)

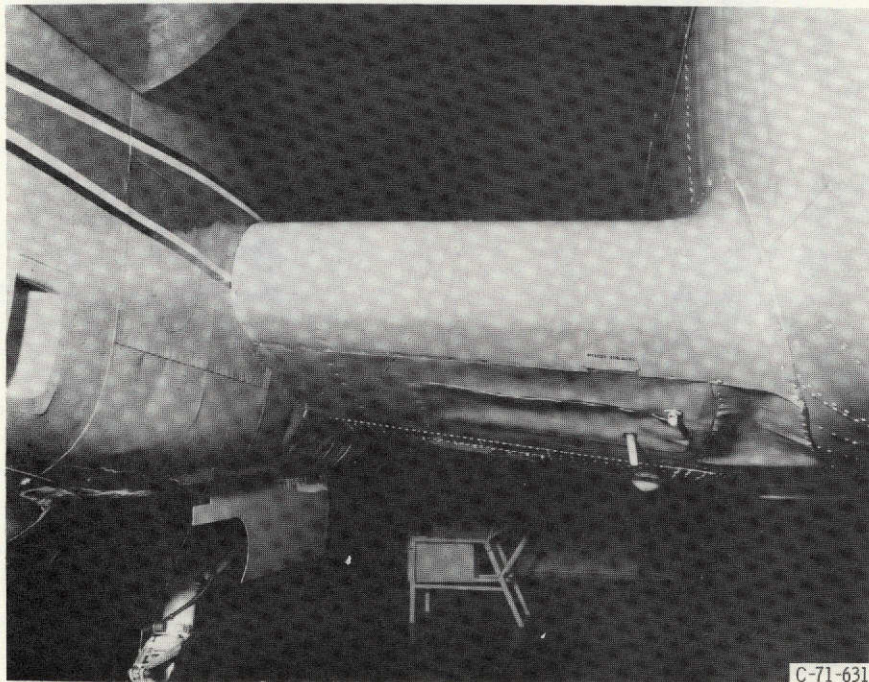
Damage to the lower inboard side of the right engine nacelle is shown in figures 11 to 13. The damaged area was below the wing chord line and extended from about 35 centimeters (13.8 in.) in front of the wing leading edge to the aft end of the nacelle (fig. 12). The severity of the damage increased markedly in the aft direction. The forward panels showed some wrinkling and sharp creases at an internal structural member. The aft skin panels were severely buckled. The landing gear doors showed no evidence of damage. However, the bottom of the nacelle aft of the landing gear doors was damaged, as is shown in figure 13.

Figure 11. - Damage to lower inboard side of right engine nacelle and wing.

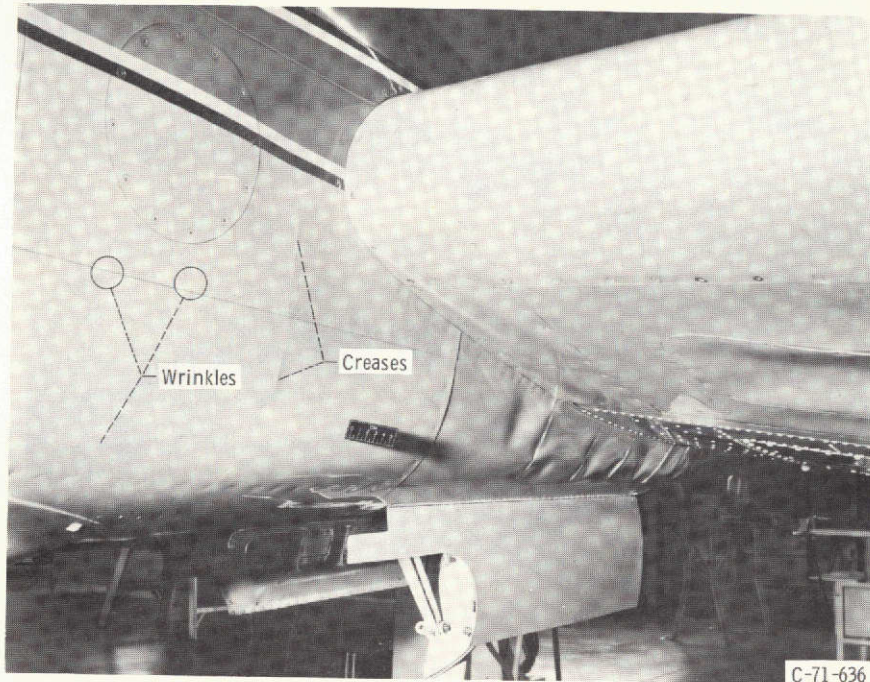
Figure 12. - Damage to lower inboard side of right engine nacelle.

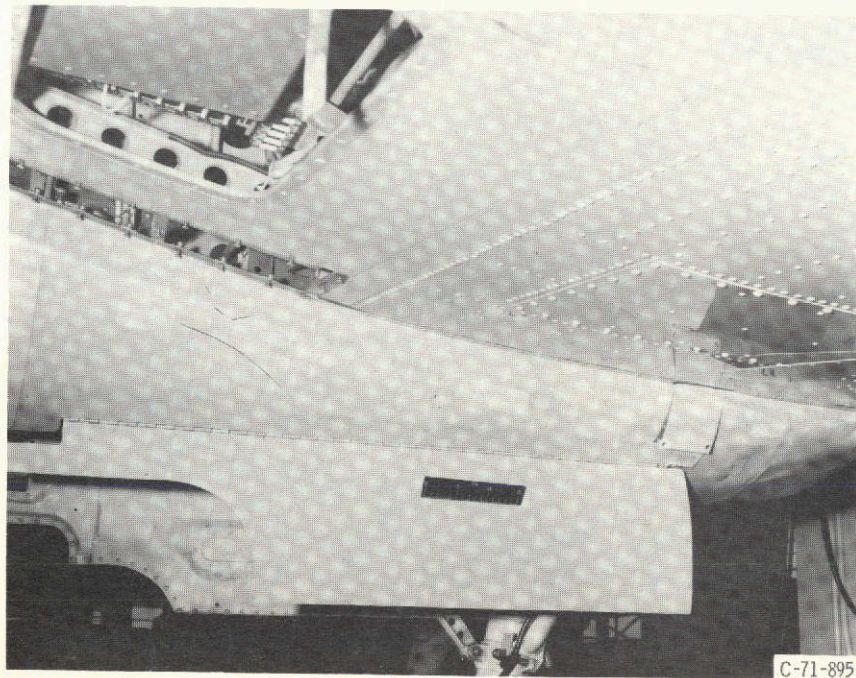
Figure 13. - Inboard view of damage at aft bottom of right engine nacelle. (See also figs. 15 and 16.)

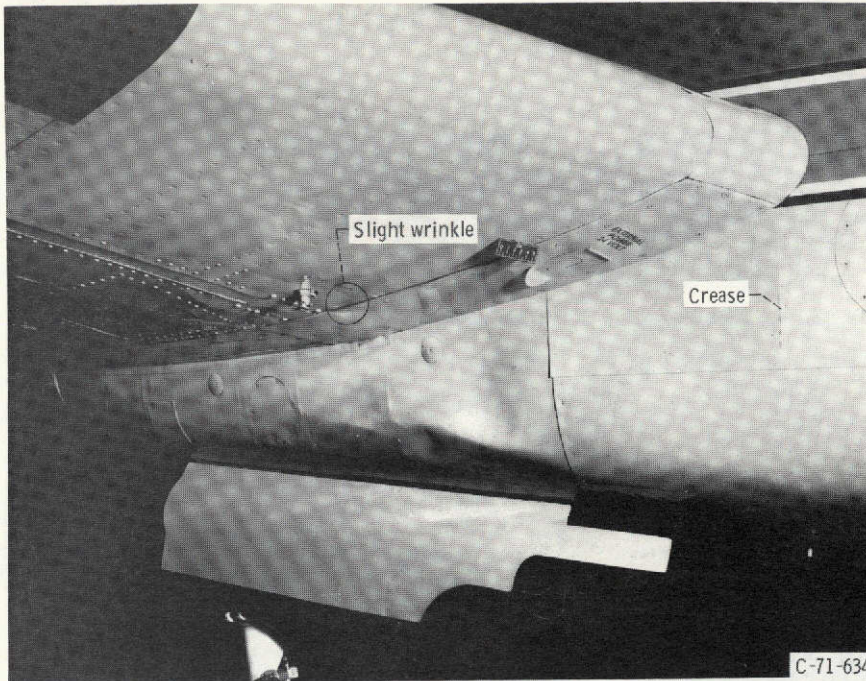
The damage to the outboard bottom side of the right engine nacelle is shown in figures 14 and 15. The area of damage is almost identical to that on the inboard side of

the nacelle. The magnitude of the damage also increased in the aft direction but overall was not as severe as that on the inboard side. Damage to the lower wing surface on the outboard side of the engine was minor, as shown in figure 14. Figure 15 presents another view (see fig. 13) of the damage to the aft bottom of the nacelle.

Figure 14. - Damage to outboard bottom side of right engine nacelle and lower wing surface.

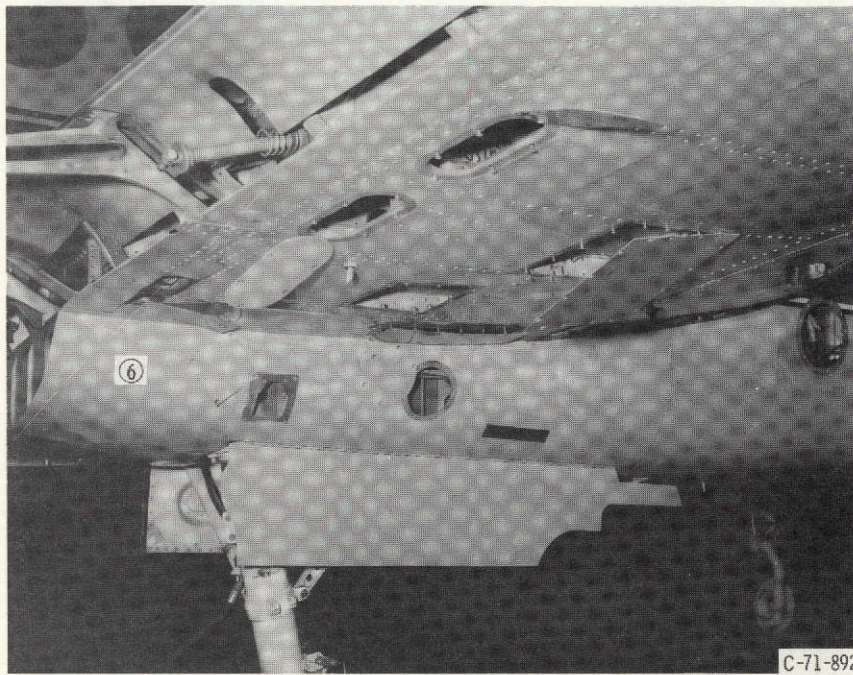
Figure 15. - Outboard view of damage at aft bottom of right engine nacelle. (See also figs. 13 and 16.)

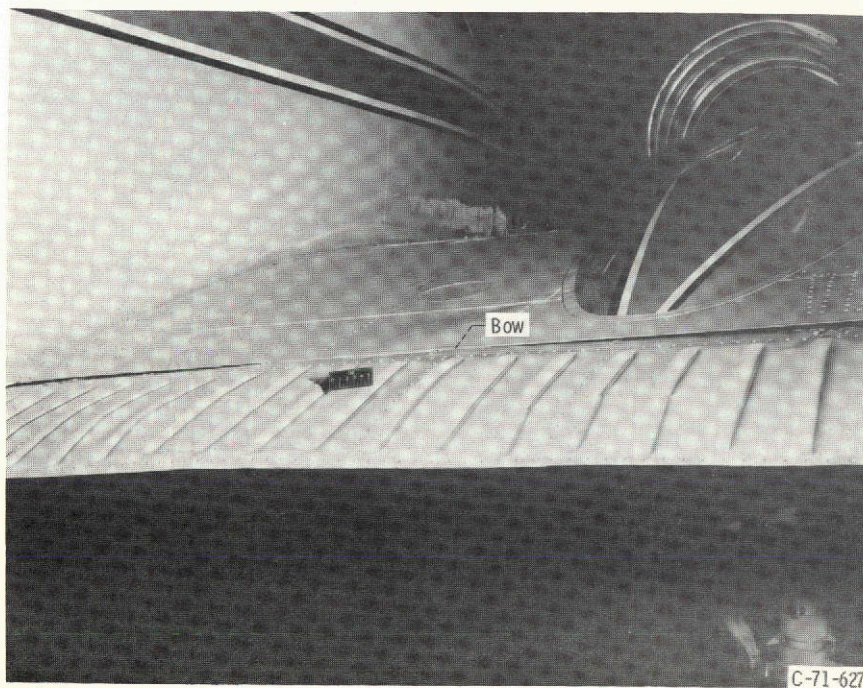
As might be expected from the damage shown in previous photographs of the wing and nacelle, the inboard flap received the greatest damage. In general, the inboard flap was bowed upward, as can easily be seen in figures 16 and 17. The centerline of the bow appears to be oriented in approximately the chordwise direction and located about 13 centimeters (5.1 in.) from the inboard side of the engine nacelle fairing that is attached to the flap (figs. 16 and 18). In addition to the bowing, both upper and lower surfaces sustained extensive damage in the form of buckling and dents. The severest buckling occurred at the leading edge of the flap near the centerline of the bow. Both the lower surface (point A, fig. 18) and the upper surface (point A, fig. 19) were sharply creased inward. The creasing was sufficient to tear the metal on the leading edge. A depression in the metal at the inboard end of the inboard flap at the leading edge (point B, fig. 18) was sufficient to create a sharp crease in the metal on the leading edge. There was a similar depression in the lower-surface leading edge of the inboard flap at the outboard end (point C, fig. 20). The trailing edge of the inboard flap near the midsection was sharply bent downward, as can be seen in figures 16 and 17. The skins of the flaps, especially on the upper surface at the aft end of the flap attachment fittings, were distorted (figs. 19 and 21). The metal on each side of the engine nacelle fairing adjacent to the lower flap surface was dented inward (figs. 16 and 20).

Figure 17. - Damage to top surface of right inboard flap.

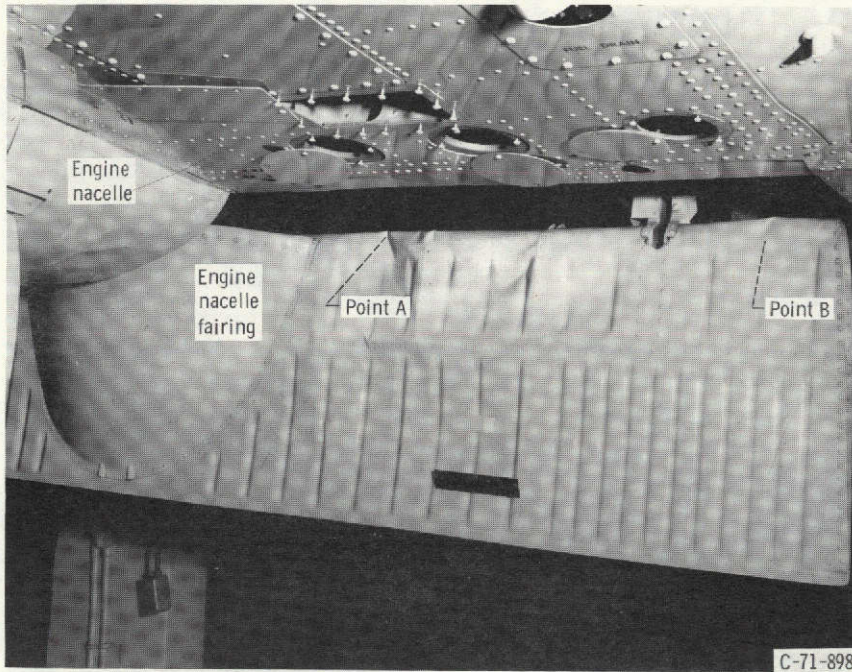
Figure 18. - Rearward view of damage to lower surface of right inboard flap and aft end of engine nacelle. Flap control rod disconnected with flap hanging from flap track. (See fig. 19.)

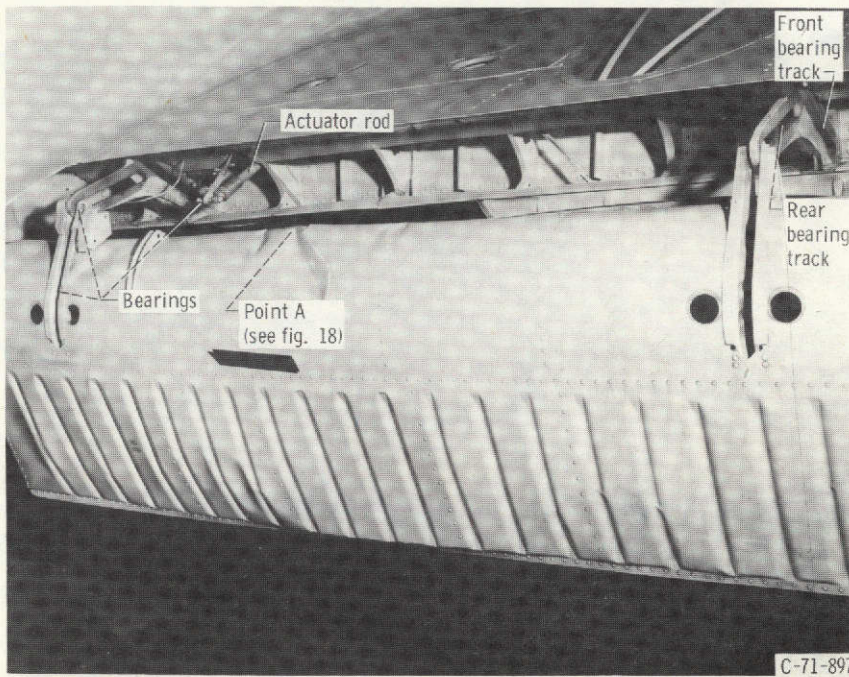
Figure 19. - Damage to top surface and leading edge of right inboard flap. Flap control rod disconnected with flap bearing normally in forward track supporting flap in rear track.

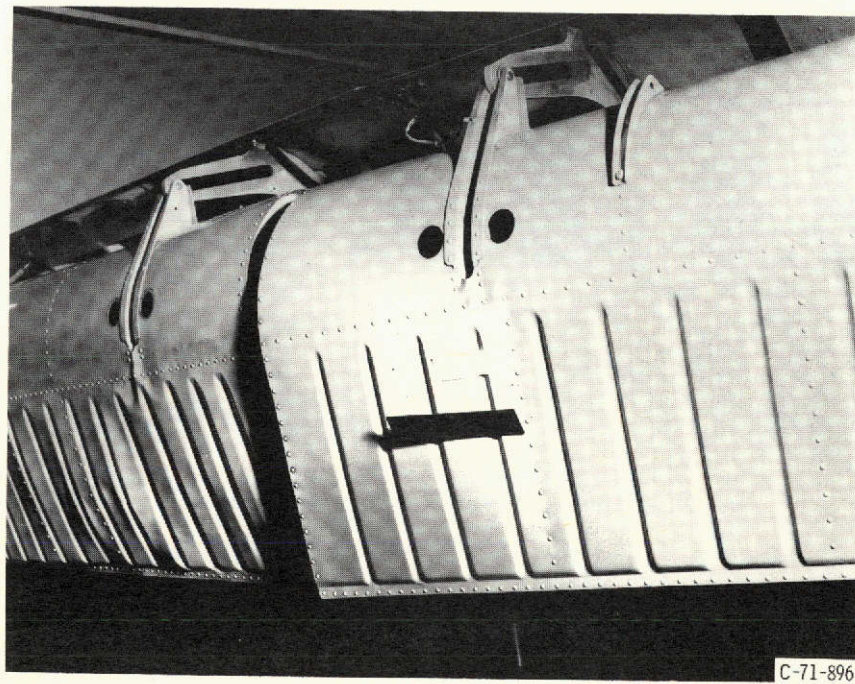
Damage to the outboard flap was minor compared with that to the inboard flap. There was no evidence of general bowing or widespread buckling. The lower surface near the leading edge was dented inward in three areas. These are shown at points D, E, and F in figure 22. Point D is also shown in figure 20. There was also some distortion of the upper surface flap skin at the aft end of the flap attachment fitting on the inboard side (fig. 21).

Figure 21. - Damage to upper surfaces of right inboard and outboard wing flaps. Flap control rods disconnected with flaps hanging from flap tracks.

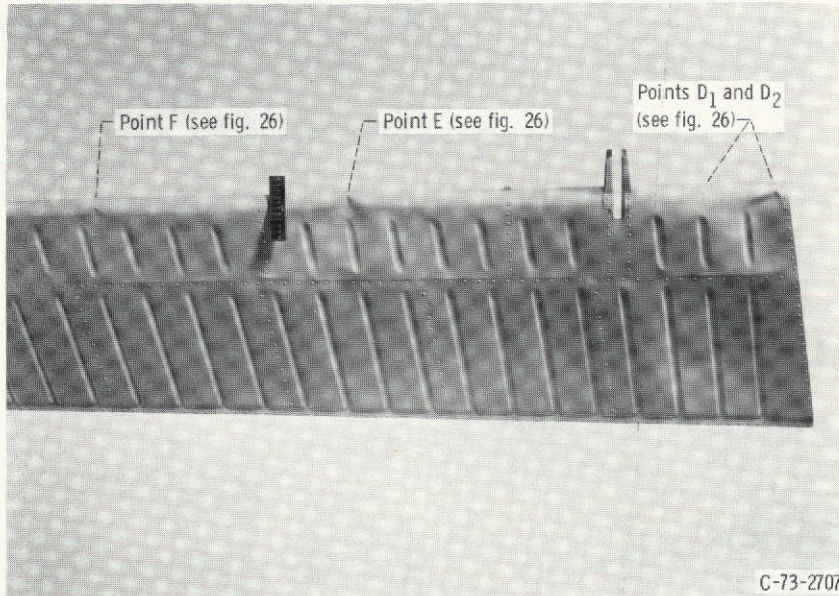
Figure 22. - Damage to lower-surface leading edge of right outboard flap.

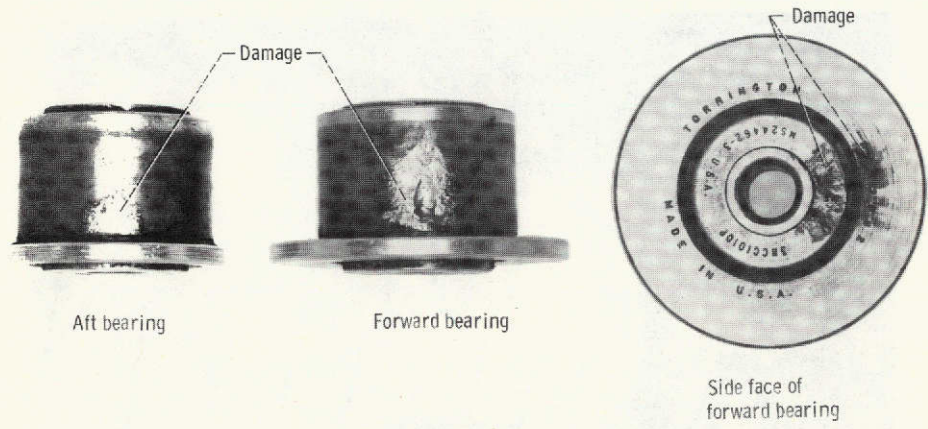
The pitting of the left wing-flap bearings (figs. 23 and 24) by electrical arcing is typical of damage that can occur on mating surfaces which are not adequately electrically bonded. Bonding in this case is difficult because the flaps have to be free to move with respect to the wing. The bonding provided on the aircraft consisted of flexible cables, one for each of the four flap support and attachment points (two per flap). These cables were about 0.5 centimeter (3/16 in.) in diameter and 25 centimeters (10 in.) long and were connected to the main wing structure near the flap support structure and to the sheet metal structure to which the flap bearings were attached, as shown in figures 33 and 20. The flap actuators (fig. 19) also provided, through the bearing surfaces, a connection between the flaps and the main wing structure.

Figure 23. - Damage to outboard pair of bearings on left outboard flap.

Although bonding cables were provided around each of the flap bearing assemblies, they were obviously inadequate for the lightning strike encountered. Electrical arc pitting damage of mating surfaces on movable components may not immediately create a serious problem but with time may lead to a serious problem unless the damage is detected and repaired. Detection of arcing on internal or hidden components such as these bearings may be a time-consuming task. Arcing inside integral fuel tanks is a hazard to be avoided. Thus, not only is good electrical bonding required in the design and fabrication of an aircraft, but periodic inspection and maintenance of bonds should also be made.
