PHASE B REPORT

MATERIALS PROCESSING IN SPACE M512

CONTRACT NAS 8-28725

July 15, 1973

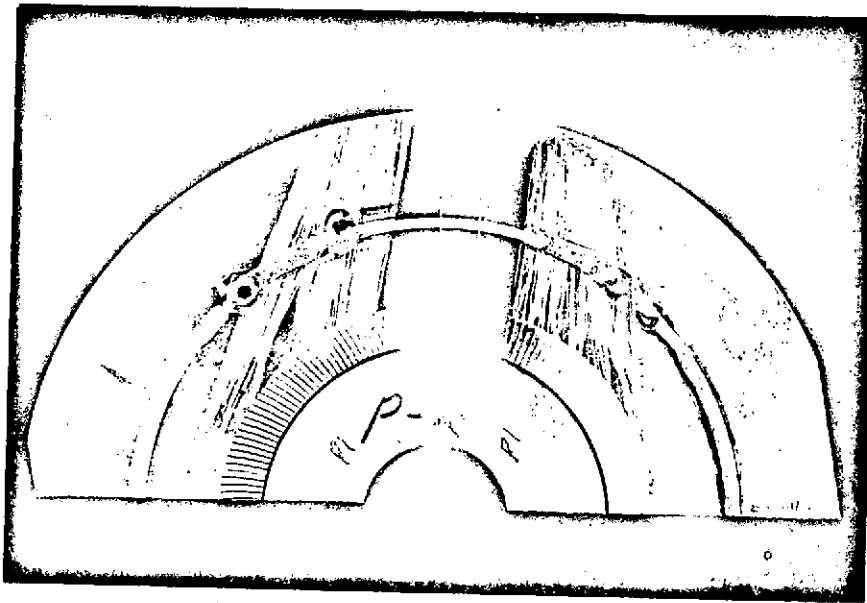
No defects were noted in the radiograph except crater cracks at the weld stops and dwells. Figure A-2 shows the appearance of this disc as received. The black area is a molybdenum spray coating used for a tracer. A section through the weld zone in the area of the tracer is shown in Figure A-3. No adverse effects of the tracer on the weld region were noted in this section.

FIGURE A-2. FRONT SURFACE OF P-1

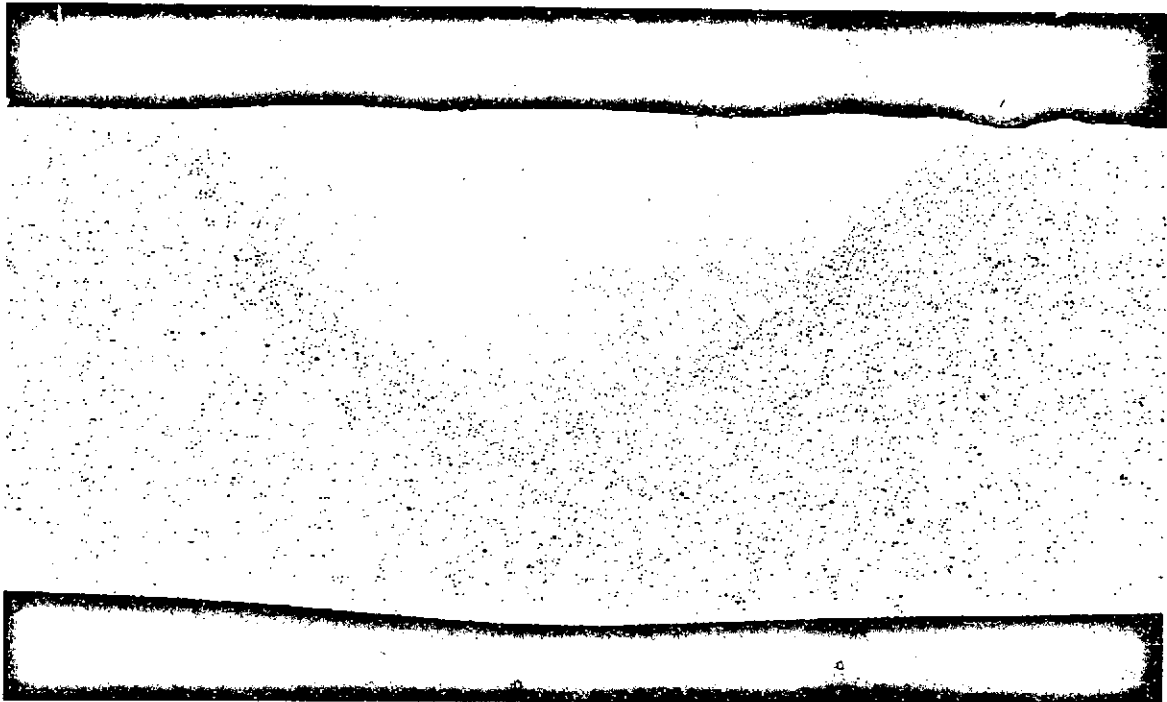
FIGURE A-3. SECTION P-1 AT TRACER REGION

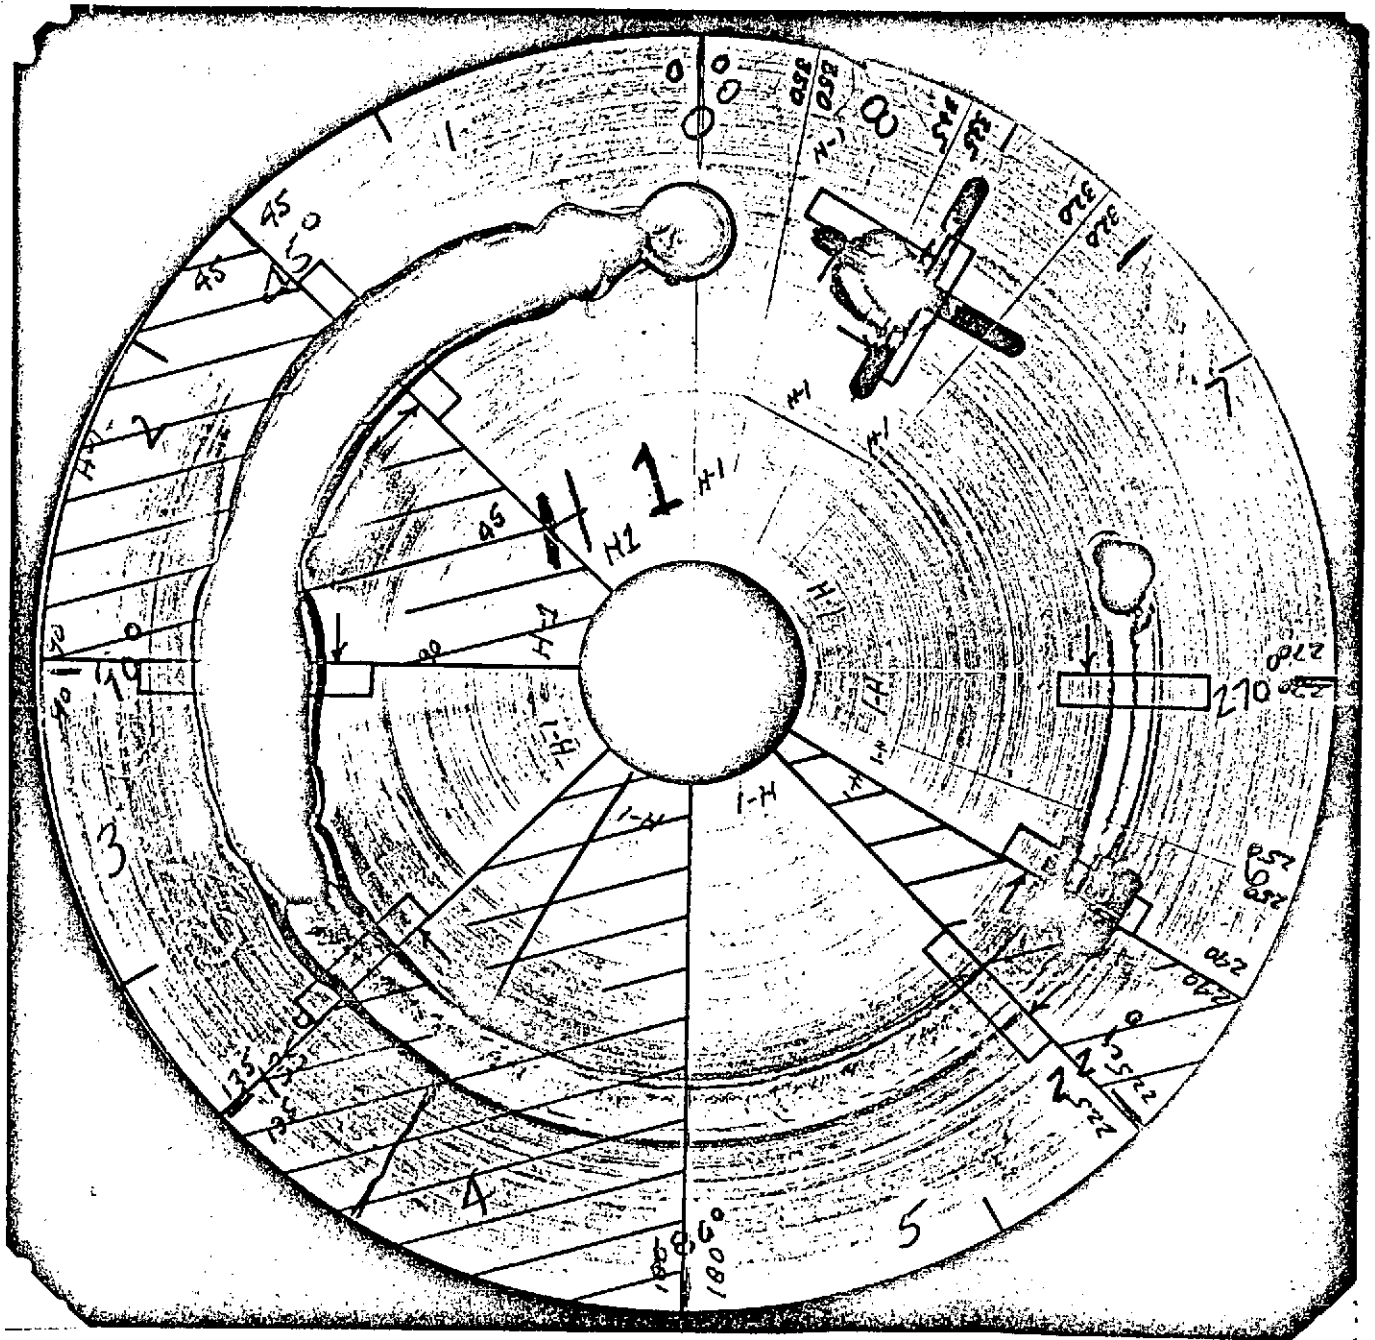
The radiograph showed longitudinal weld cracks near the weld start ( $125^{\circ}$  to  $135^{\circ}$ ), and near the molybdenum tracer ( $225^{\circ}$  to  $235^{\circ}$ ). Cracks in the dwell crater also were apparent. All of these cracks also were visible on the weld surface. Figure A-4 shows the front surface of Disc H-1.

FIGURE A-4. FRONT SURFACE H-1

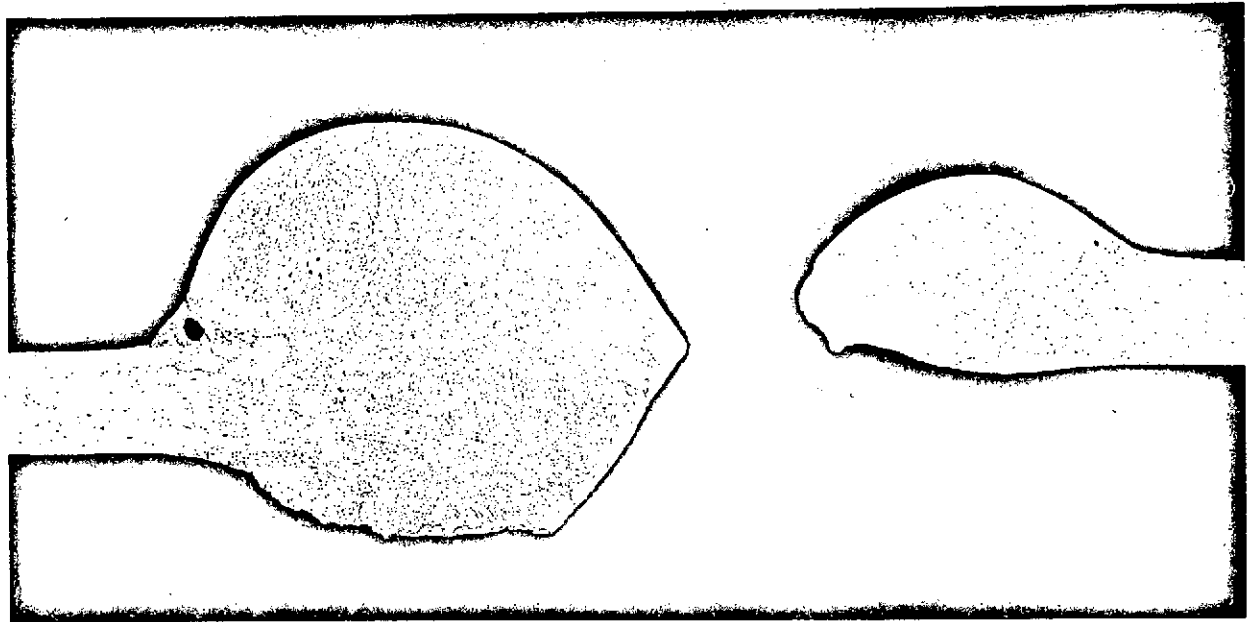
Figures A-5 through A-10 show the appearance and microstructural details in the cut region. Several areas on the cut surfaces indicate the presence of a contaminant or reaction zone. This has probably come from material vaporized from the surface under the weld disc. The very wide cut that resulted in this disc is indicative of an electron-beam power level favoring excessive penetration.

FIGURE A-5. SECTION THROUGH CUT REGION -H-1

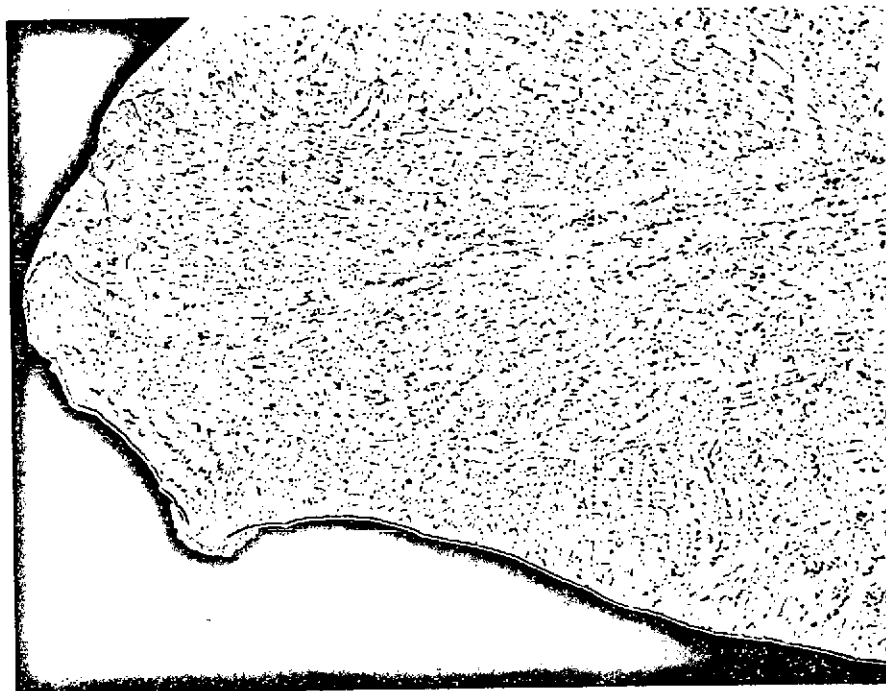
FIGURE A-6. SURFACE OF CUT ON INSIDE -H-1

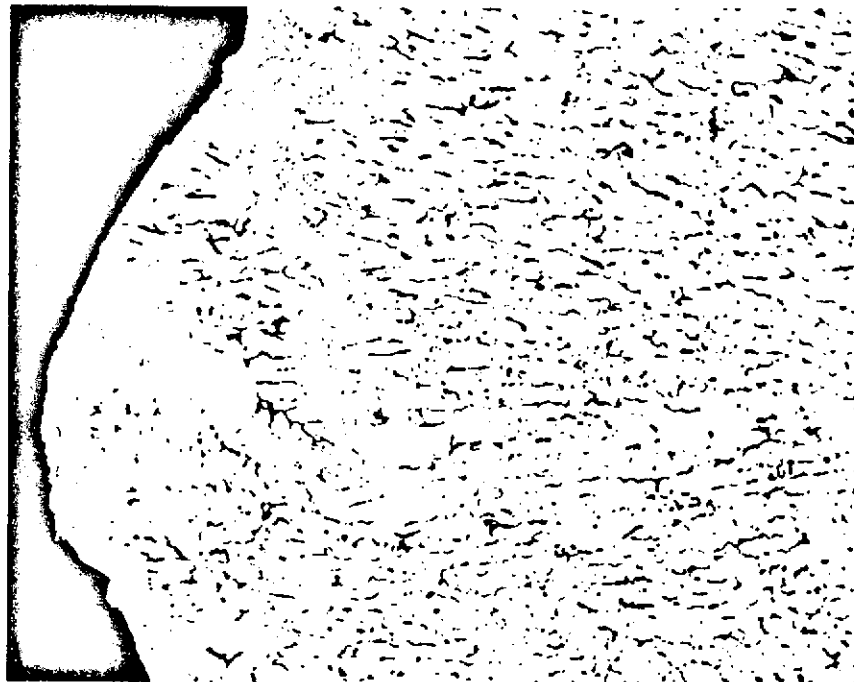
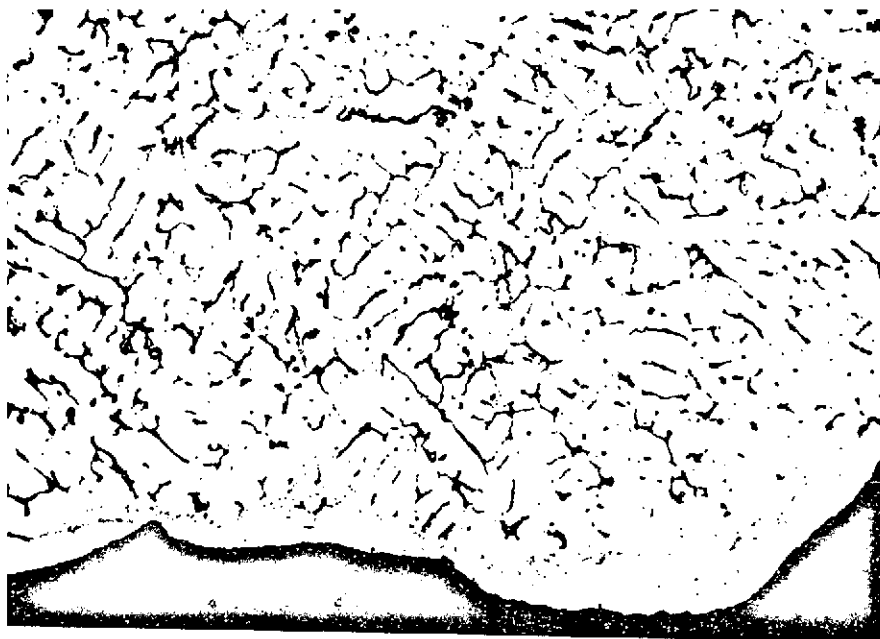
a. Enlarged area of Figure A-6

b. Bottom surface of cut on outside

FIGURE A-7. SURFACE OF CUT -H-1

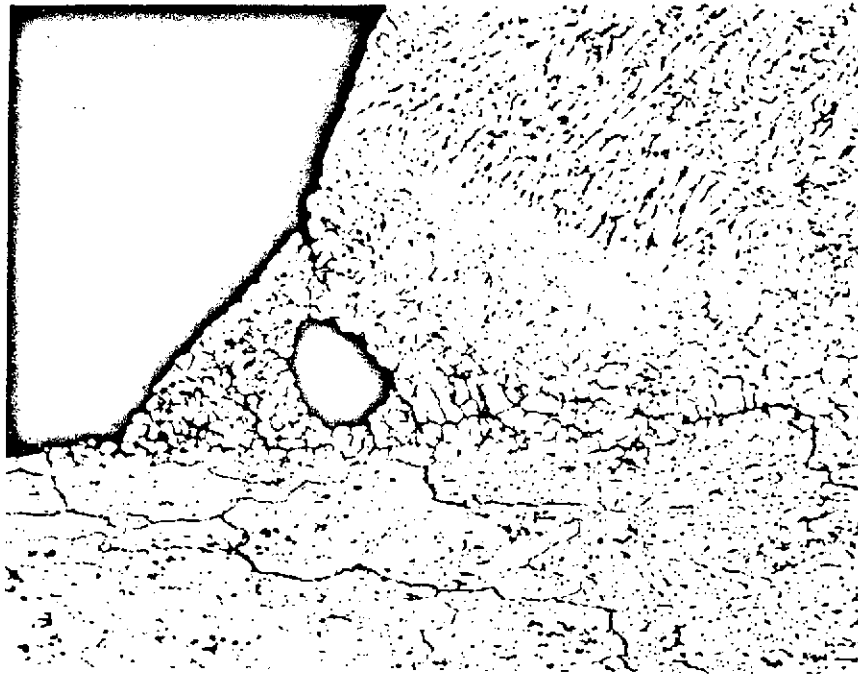
FIGURE A-8. PORE IN SECTION AT BASE METAL INTERFACE  
H-1

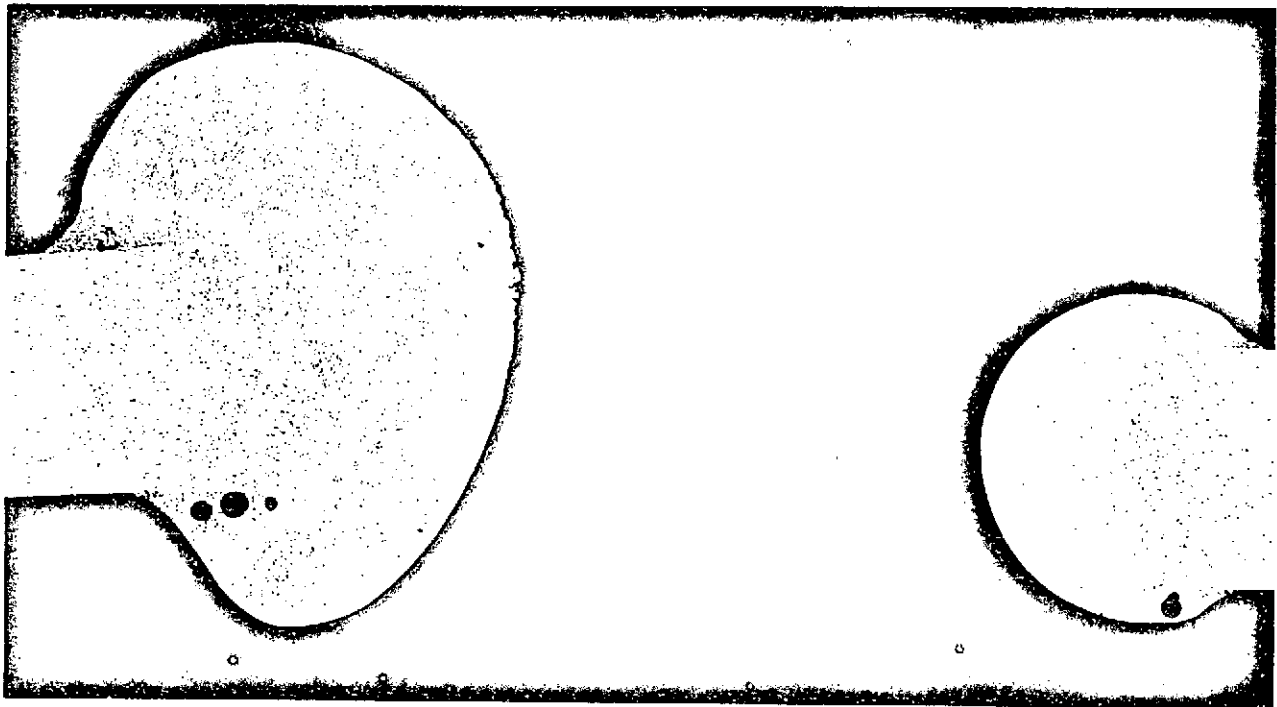
FIGURE A-9. SECTION THROUGH RAMP REGION -H-1

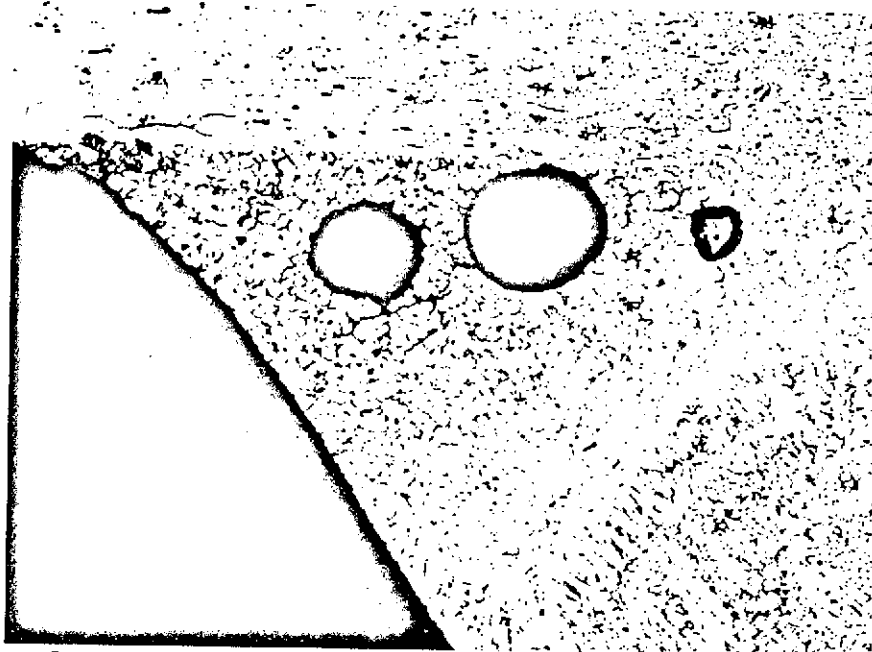
FIGURE A-10. PORES IN RAMP SECTION -H-1

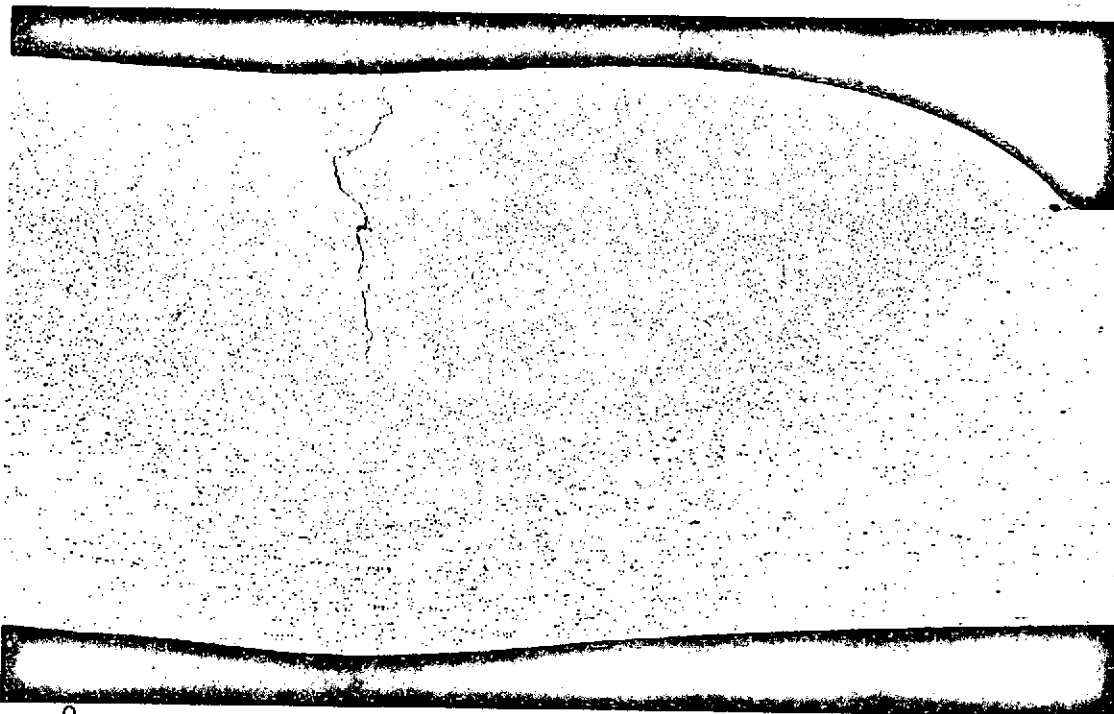
FIGURE A-11. SECTION THROUGH CRACK NEAR WELD START

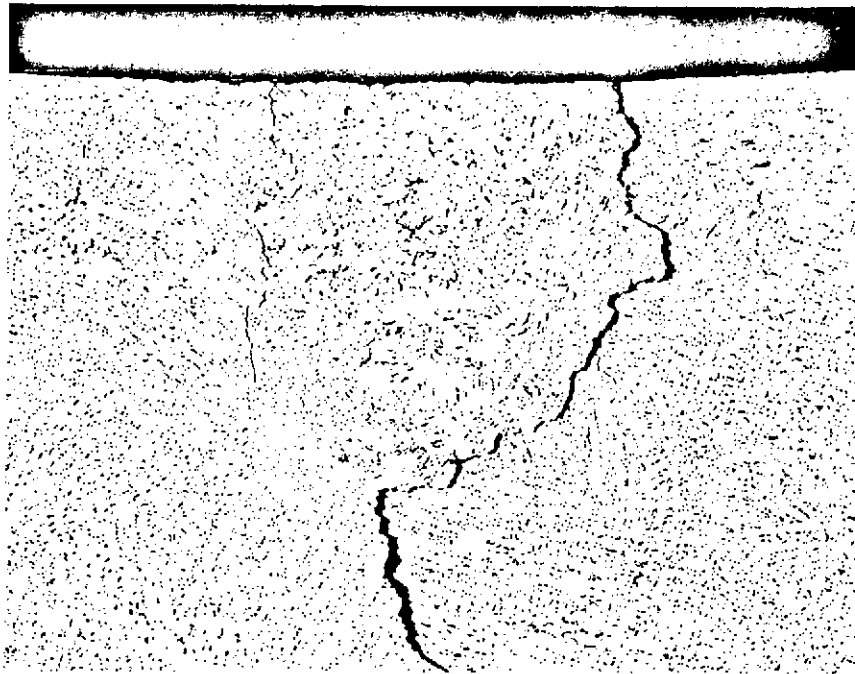
FIGURE A-12. ENLARGEMENT OF LONGITUDINAL CRACK  
AT WELD START - H-1

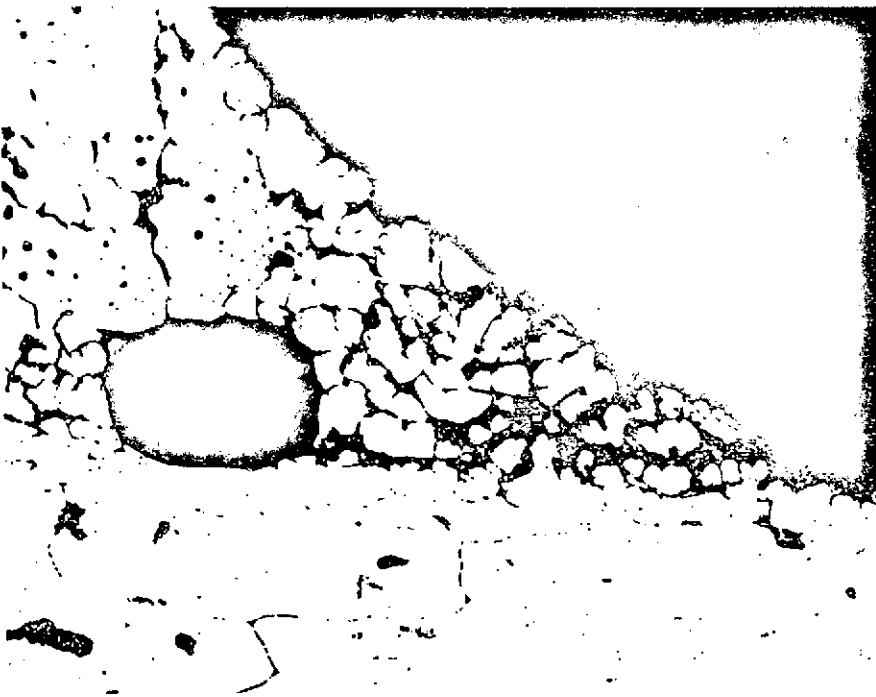
FIGURE A-13. PORE AT INSIDE EDGE OF WELD - H-1

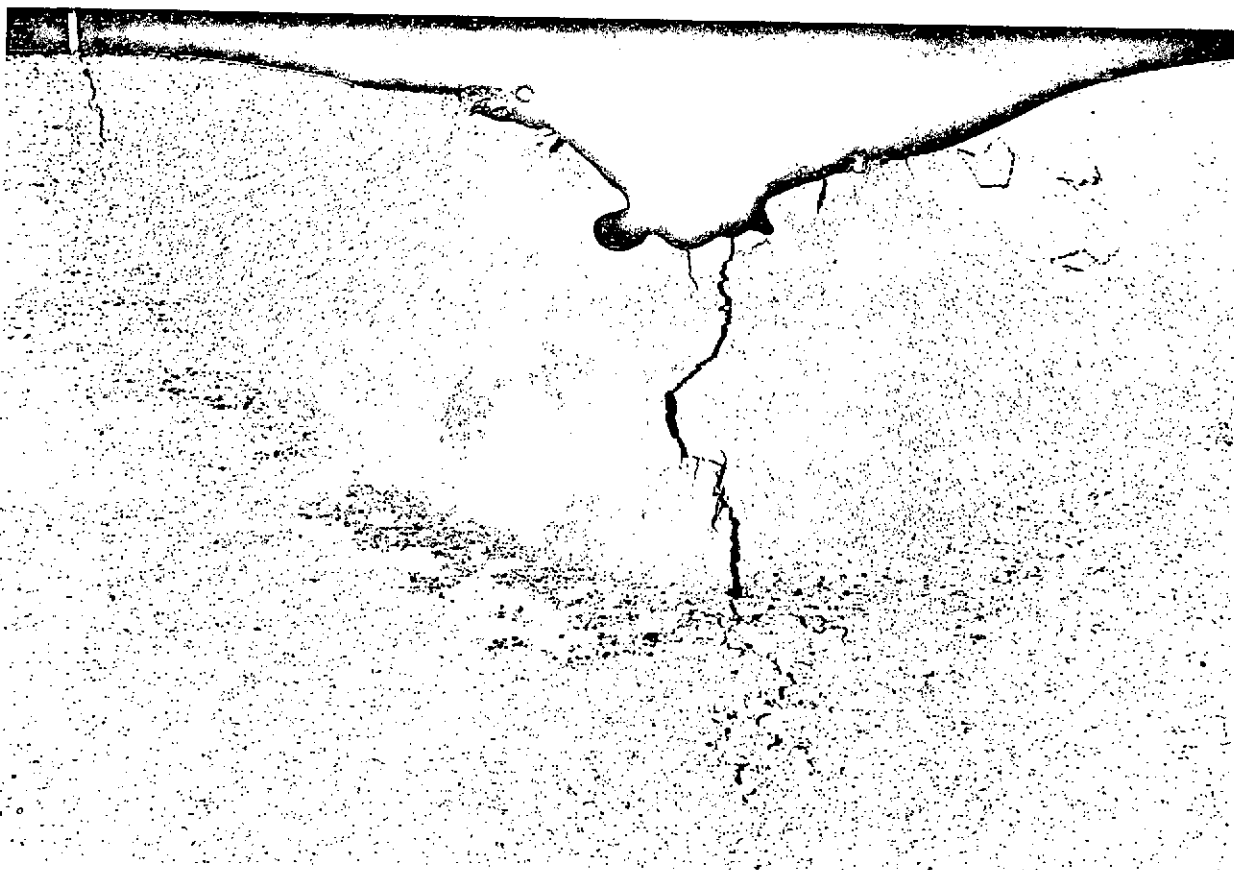
FIGURE A-19. SECTION THROUGH DWELL REGION - H-1

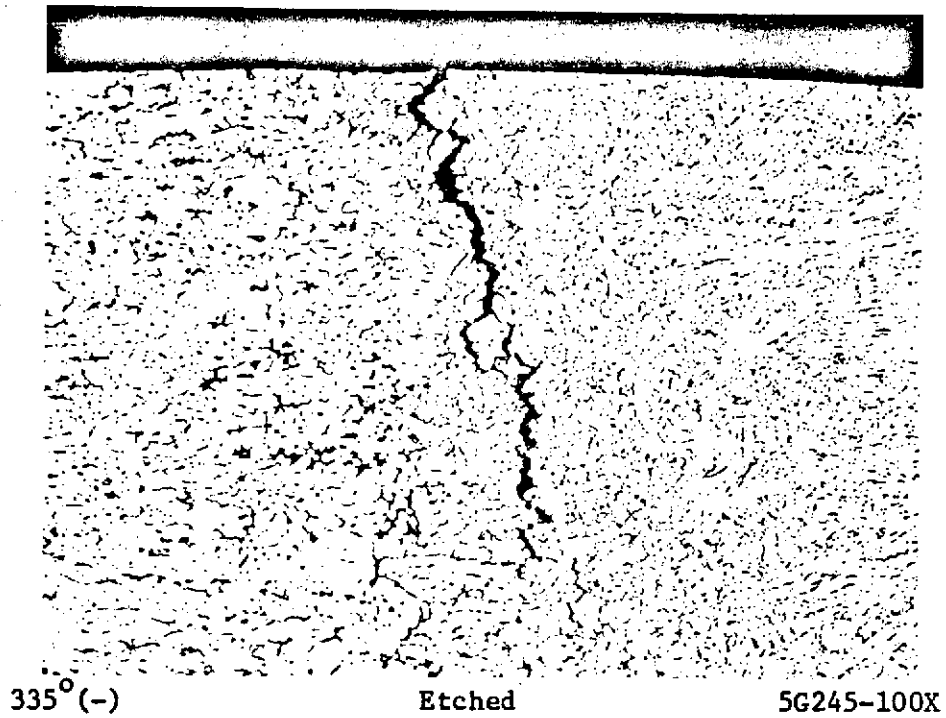
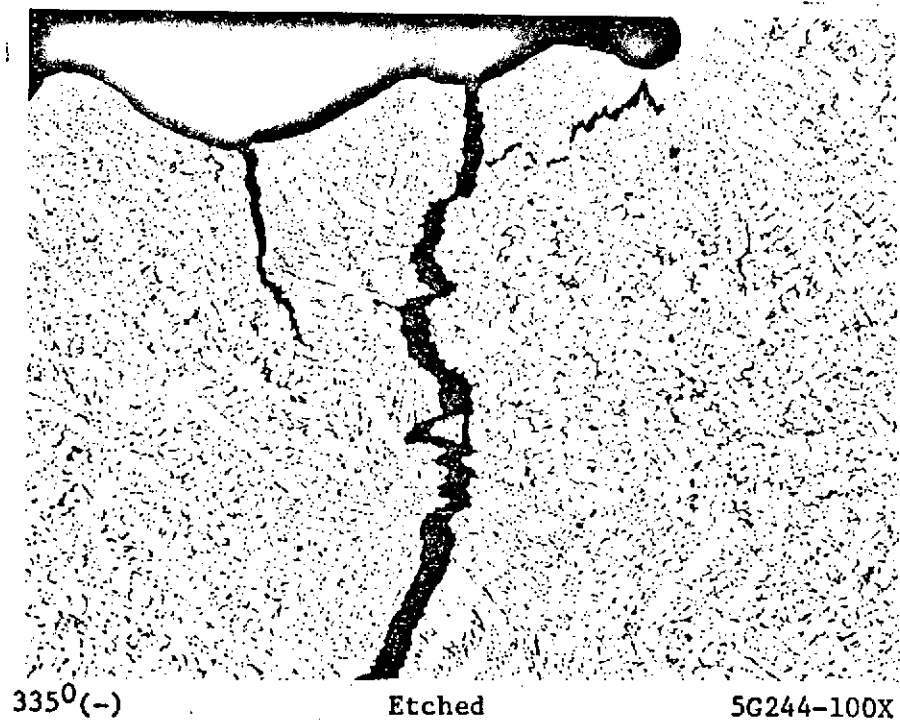
a. Crack near left edge in Figure A-19

b. Main crack near center in Figure A-19

FIGURE A-20. CRACKS IN DWELL REGION- H-1

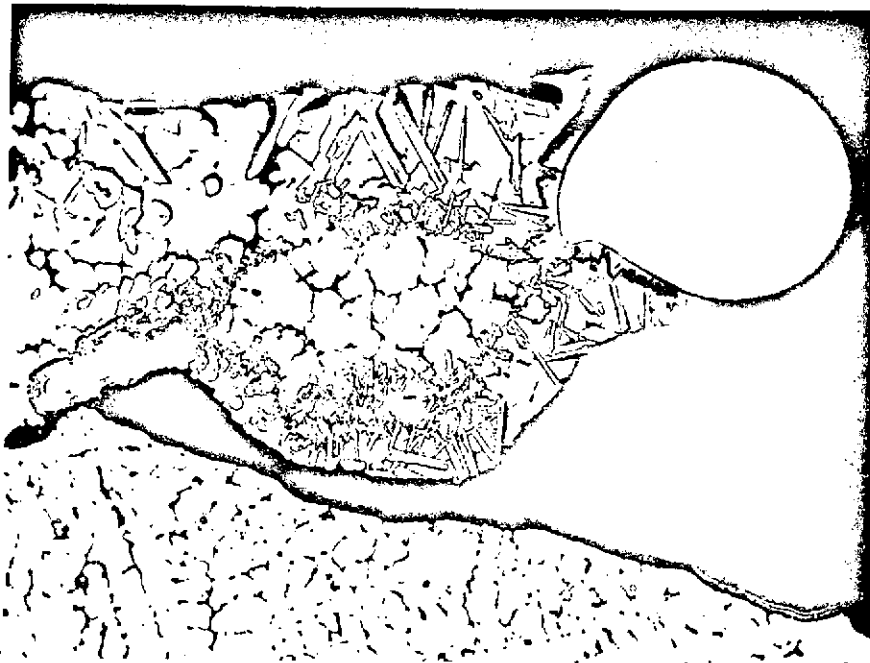
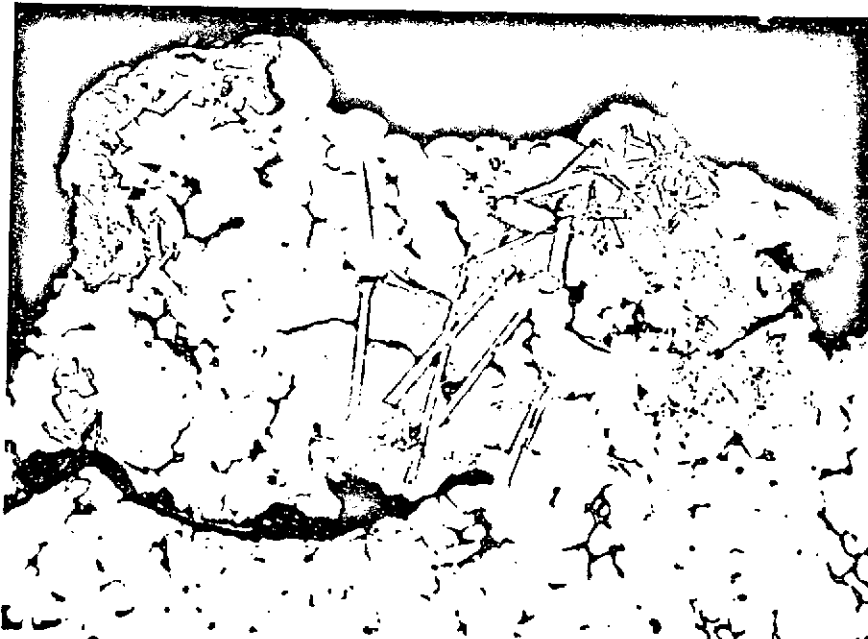
a. Near Left center in Figure A-19

b. Near right center in Figure A-19

FIGURE A-21. MOLYBDENUM TRACES ON SURFACES OF DWELL REGION- H-1

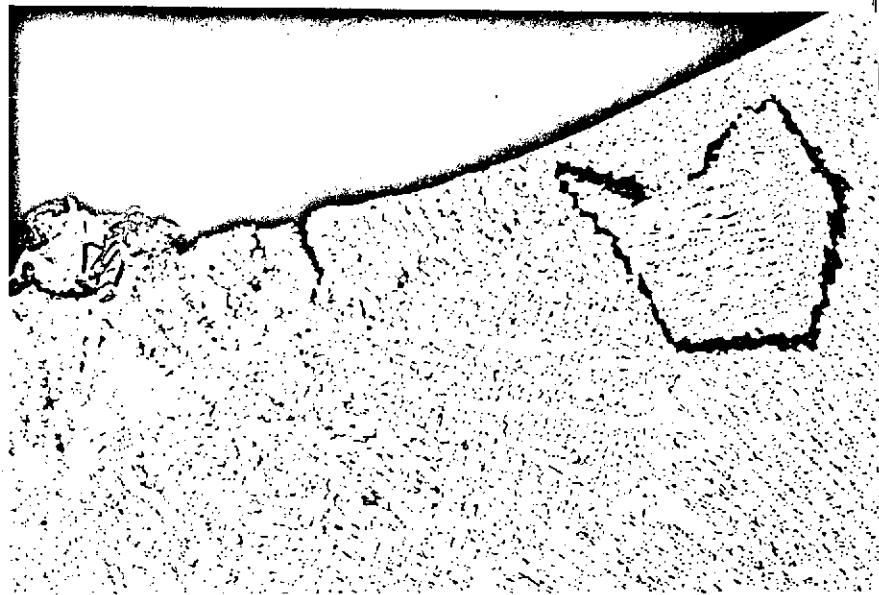
FIGURE A-22. CRACKS NEAR TOP OF DWELL REGION- H-1

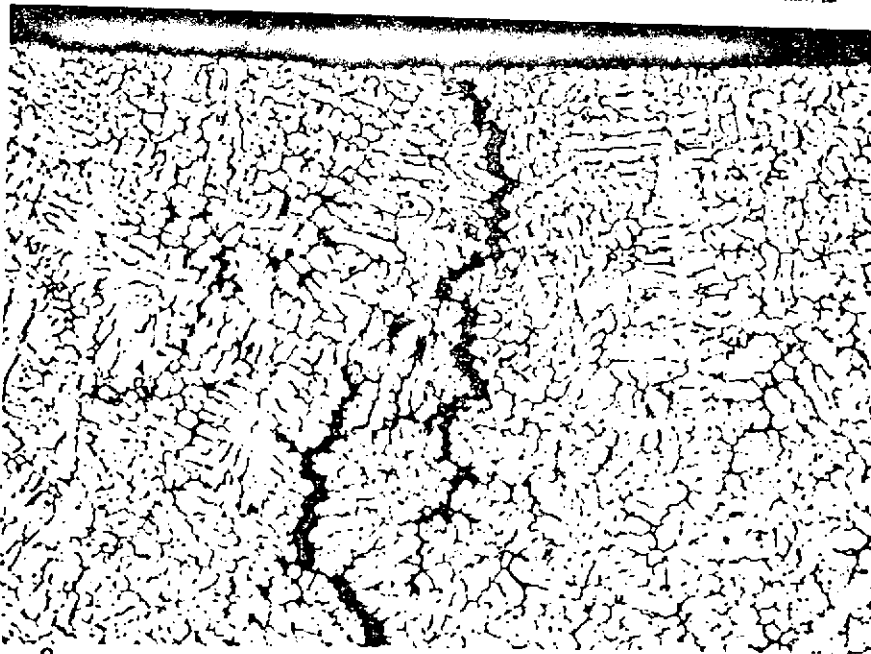
FIGURE A-30. SECTION THROUGH CRACK  
IN DWELL REGION - S/N-124
