NASA TECHNICAL
MEMORANDUM

NASA TM X-64819

MSFC SKYLAB INSTRUMENTATION AND COMMUNICATION
SYSTEM MISSION EVALUATION

Skylab Program Office

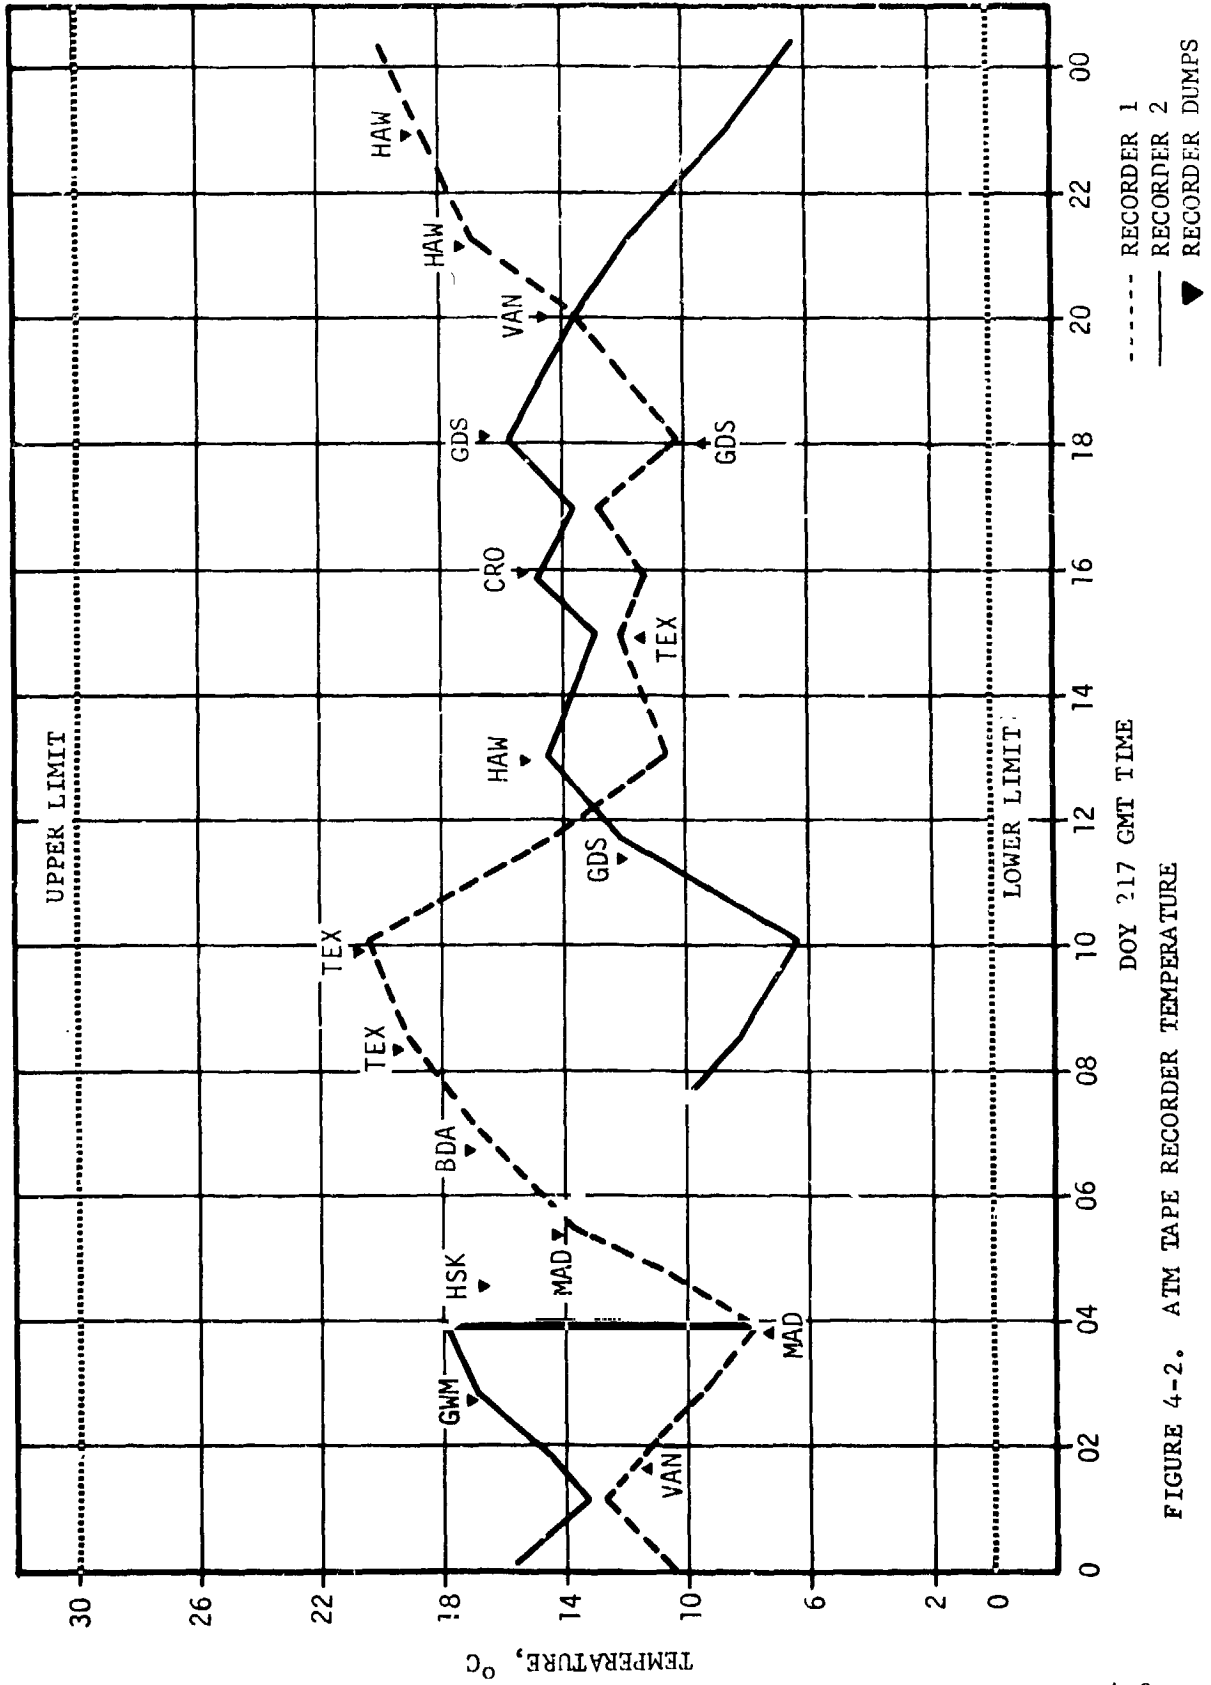
FIGURE 4-2. ATM TAPE RECORDER TEMPERATURE

The loss of the meteoroid shield shortly after launch altered the original plan to run the primary tape recorder continuously during the mission, using the secondary tape recorder as a backup. Thermal stresses on Skylab prompted plotting recorder temperature. It was immediately apparent that continuous operation of a single recorder would cause an over-temperature condition. The management plan was then changed to allow alternate operation of the primary and secondary recorders to maintain recorder operation within the design thermal limits at all times. This plan was in effect throughout the mission. A temperature plot for the typical 24-hour period is shown in Figure 4-2.

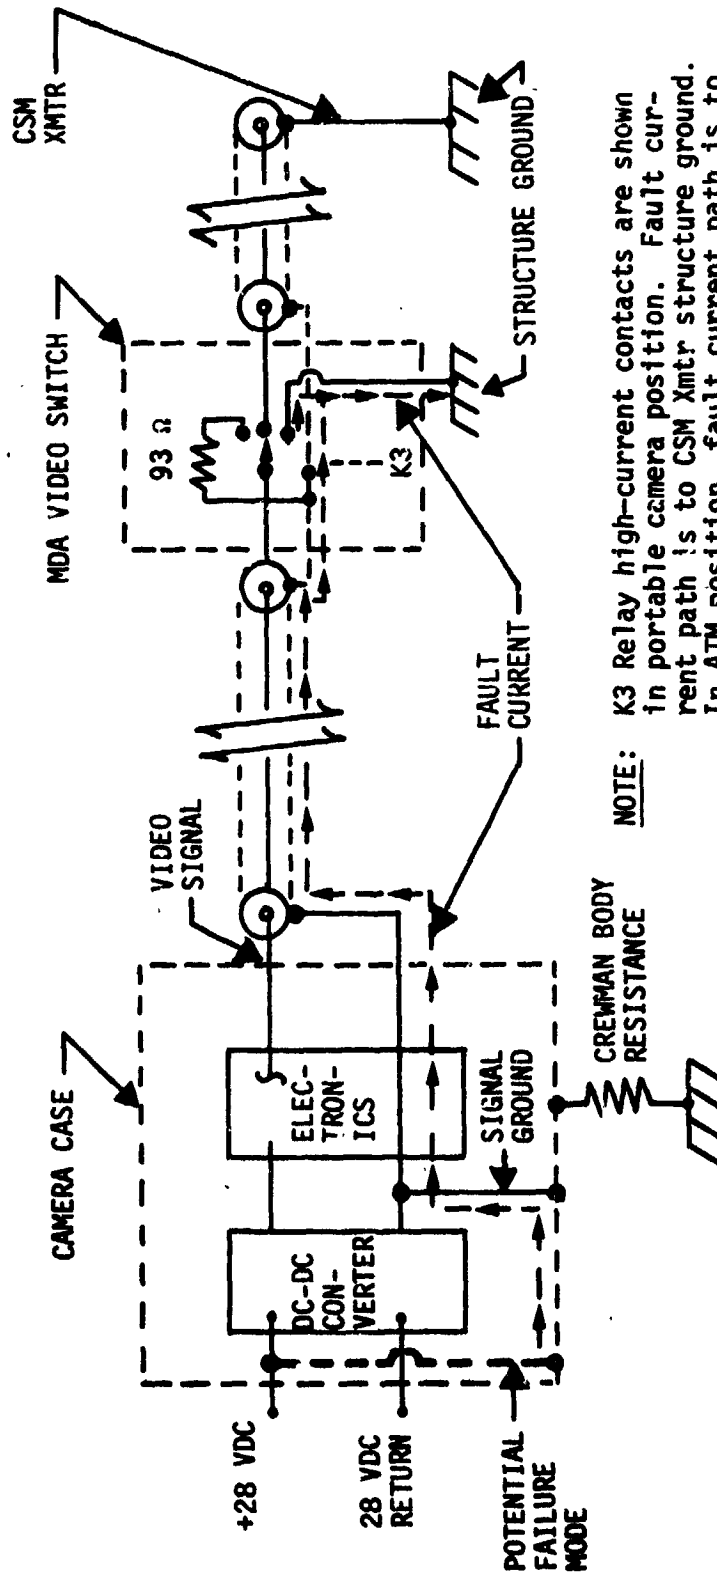
Another discrepancy affecting the operation, but not part of the ATM Data System, was the failure on DOY 216 of TV No. 2 Bus during SL-3 activation. A short circuit apparently caused the circuit to burn open. Operation continued on TV Bus No. 1 for the duration of the mission. An investigation of the performance of the ATM system showed that no ATM I&C components were damaged by the short.

NOTE: K3 Relay high-current contacts are shown in portable camera position. Fault current path is to CSM Xmtr structure ground. In ATM position, fault current path is to structure ground as shown.

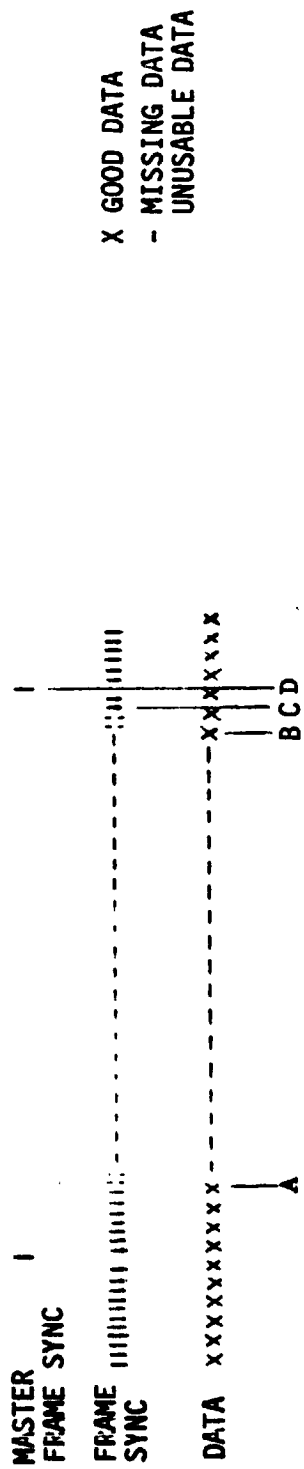
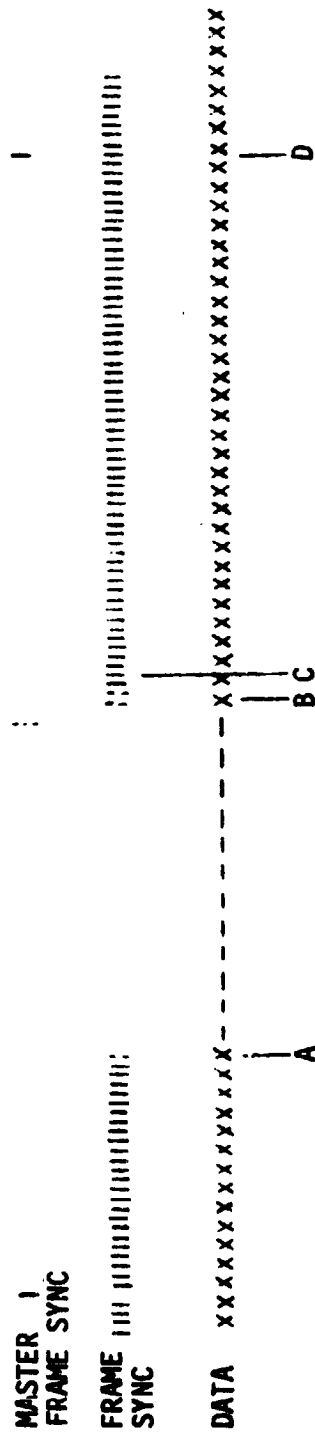
FIGURE B-2. DECOMMUTATION DATA LOSS.

X GOOD DATA
 - MISSING DATA
 UNUSABLE DATA
