REVIEW OF HYDROGEN ACCIDENTS AND INCIDENTS IN NASA OPERATIONS

by Paul M. Ordin

Lewis Research Center

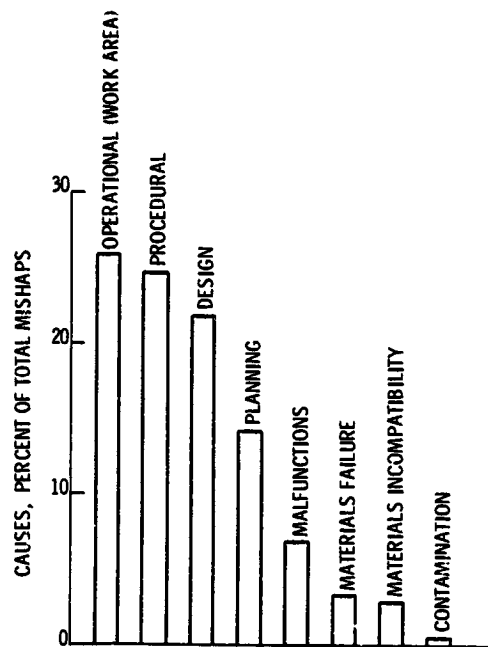
The largest number of mishaps (26 percent) was considered to be caused by work area deficiencies. Procedural deficiencies accounted for 25 percent. Design deficiencies were responsible for 22 percent. Planning deficiencies followed next with 14 percent. These four categories, which are basic to an overview of safety requirements for any type of engineering system, were responsible for 87 percent of the mishaps reviewed. Malfunctions were involved in about 8 percent of the accidents, while problems concerned with materials failures and materials incompatibilities were each factors in about 3 percent of the mishaps.

Figure 1. - General distribution of causes of mishaps with hydrogen - (more than one cause factor is involved with most mishaps).

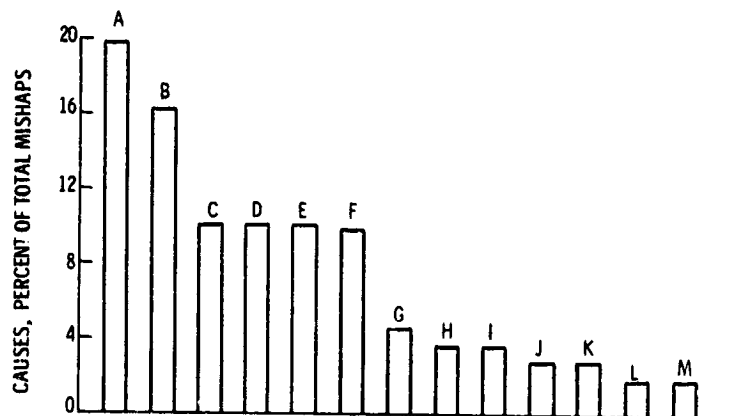
Valve malfunctions and/or valve leaks were considered as being responsible for 20 percent of the mishaps. These valve malfunctions and leaks, as well as a number of the other specific causes of mishaps, were due primarily to operational (work area), procedural, and design deficiencies. For example, valve malfunctions and valve leaks were caused by

On several occasions, the valve design or the materials used in construction caused the malfunction or leak. Leaking connections and/or fittings were identified as being separate from valve leaks and caused about 16 percent of the mishaps. Items such as loose flange connections caused shrinkage of the "O" rings and/or gaskets because of the low temperature and resulted in leaks that caused mishaps. Fittings not installed properly also resulted in leaks that caused accidents. To a large extent, not following established procedures, or the lack of specific instructions were responsible for the leaking connections.

Safety disk failures, materials failures, and high venting rates were each identified as responsible for about 11 percent of the mishaps. Safety disk failures in tank and piping installations and in over-the-road tanker trailers caused leaks which were responsible for some of the accidents. A number of the disk failures were considered as malfunctions; however, in several instances, improper installation and failure to follow established planning for the replacement of ruptured disks caused the failure. In most instances, the disk performed as designed and ruptured when the design pressure was attained. The rupture did, however, release hydrogen and, in some instances, caused an accident.

Figure 2. - Detail distribution of causes of mishaps in which hydrogen was released (more than one cause factor is involved with some mishaps).

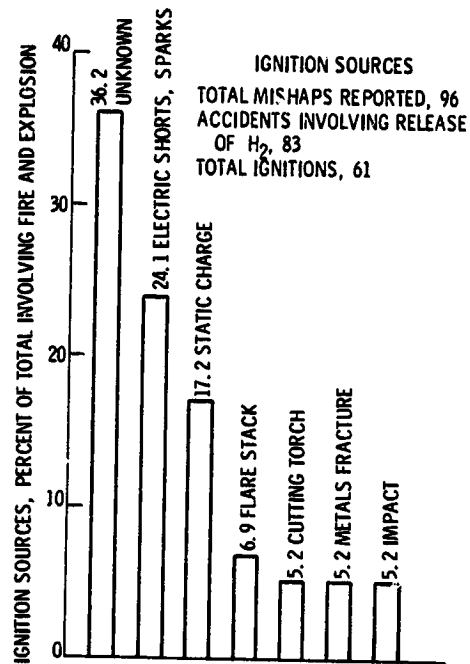
each considered to be responsible for about 5 percent of the ignitions. Ignition of hydrogen-air mixtures attributed to metal fracture involved tensile testing mishaps in which the fracturing of the specimens provided the ignition source. Also included are mishaps in which the cause of ignition was considered to be burst safety disks or metal failures. The specific ignition source was probably the static charges or hot spots that developed during material rupture. Ignitions attributed to impact include those considered to be caused by high-velocity fragments.

Figure 3. - Ignition sources - mishaps involving release of hydrogen.

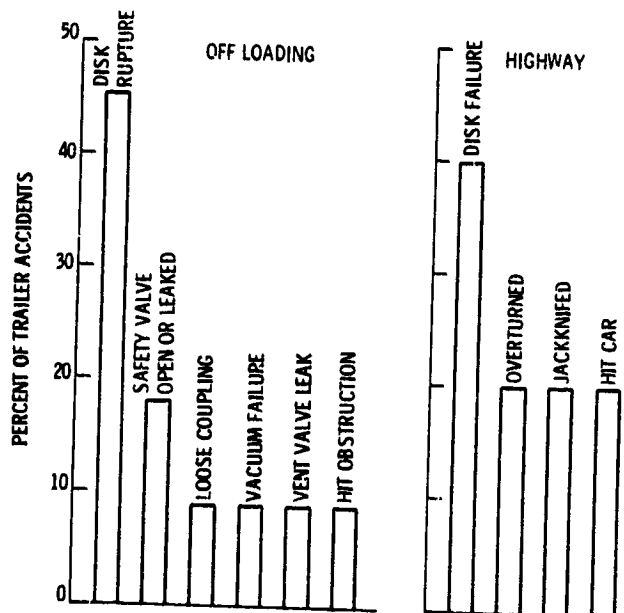
The causes of hydrogen tanker trailer mishaps are summarized in figure 4. Seventeen tanker trailer mishaps were included in the study with 71 percent (12) associated with off-loading operations (usually at the test facility) and 29 percent (5) occurring on the highway. In about 92 percent of the off-loading accidents (11), hydrogen was released, but in only 27 percent (3) did ignition take place. With respect to highway mishaps, 60 percent (3) involved a release of hydrogen, but no ignitions occurred. For both the off-loading and highway mishaps, disk rupture was the principal cause; other causes included open or leaking safety valves (18 percent), loose couplings, vacuum failures, and vent valve leaks. In several instances, positioning the trailer in preparation for connecting lines resulted in the driver hitting parts of the facility.

The safety record of over-the-road transportation of liquid hydrogen is quite evident in that only five tanker trailer highway accidents are included. These reports involved NASA operations. In three of these accidents the tractor was heavily damaged, but the trailer remained substantially sound. There was no damage in the other two highway accidents. In only one case was liquid hydrogen spilled on the ground, and there was no ignition of the hydrogen-air mixture.

Figure 4. - Liquid hydrogen trailer accidents.
