NASA TM X-58141  
June 1974

FULL-SCALE AIRCRAFT CABIN FLAMMABILITY TESTS  
OF IMPROVED FIRE-RESISTANT MATERIALS

Robert N. Stuckey, Daniel E. Supkis, and L. James Price  
Lyndon B. Johnson Space Center  
Houston, Texas 77058

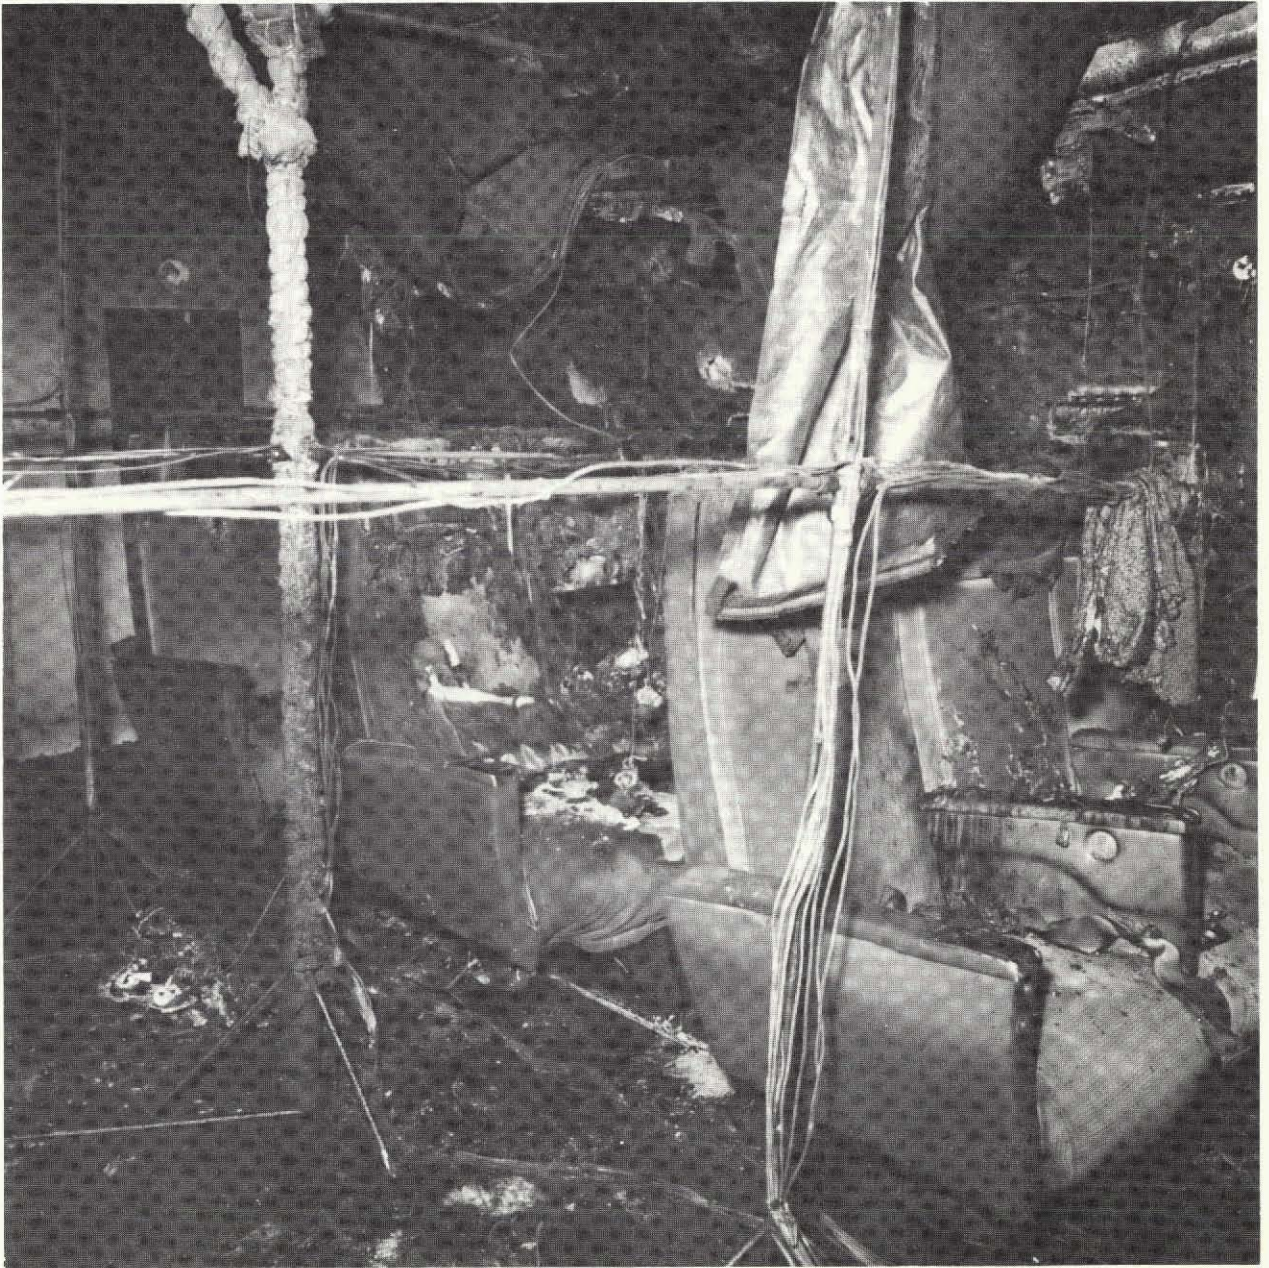
Figure 16.- Fire damage for test 1 using pre-1968 materials, front view.

(fig. 8) followed by oxygen depletion to a concentration of less than 5 percent (fig. 9). In addition, the concentration of nonhydrolyzable products of combustion - carbon dioxide, carbon monoxide, methane, and ethylene - increased rapidly as the oxygen was depleted (figs. 10 to 13). Data for hydrolyzable products of combustion - chlorides, fluorides, and cyanides - are not available for test 1 because of an error in analyzing the gas samples. Thermocouple (TC) data indicate that the flash fire originated beneath the hatrack, spread to the ceiling and to the seats, and propagated beneath the hatrack for the full length of the test section. The propagation path along the forward end of the test section cabin walls was downward from the hatrack, as illustrated by a post-test photograph (fig. 14). The damage to the seats other than the one directly above the ignition source was more severe at the top of the seats. This damage indicated heating and burning from above and is further evidence of a flash fire. The damage is shown in figures 15 and 16.

1. Seats: The seat above the fire ignition source was almost completely consumed. Some of the aluminum structure had melted. The adjacent seat was also severely damaged; approximately 70 percent of the materials were consumed, and a small percentage of the metal seat structure had melted. The remaining seats were scorched; some of the cushion fabric (nylon-wool-rayon combination) and the seat-back covering (supported vinyl) was burned. The damage was most severe at the top of the seat backs. All of the nylon seatbelts were scorched and partly burned.

3. Hatrack: Except for a small amount of foam on the hatrack bullnose, all the vinyl and foam padding had burned away from the honeycomb panels. The paper-core, fiberglass-covered honeycomb above the fuel pan location also burned; only the brittle remains of the fiberglass cloth were left.

4. Ceiling panels: All the vinyl covering and the paper core of the honeycomb ceiling panels had burned away. Only the brittle fiberglass cloth, which fell onto the hatrack and TC trees, remained.

5. Passenger service units: All three passenger service units burned, melted, and fell to the seats and floor below them. All of the metal structure of the center unit (above the fuel pan location), 80 percent of the back unit, and 50 percent of the front unit were melted and destroyed.

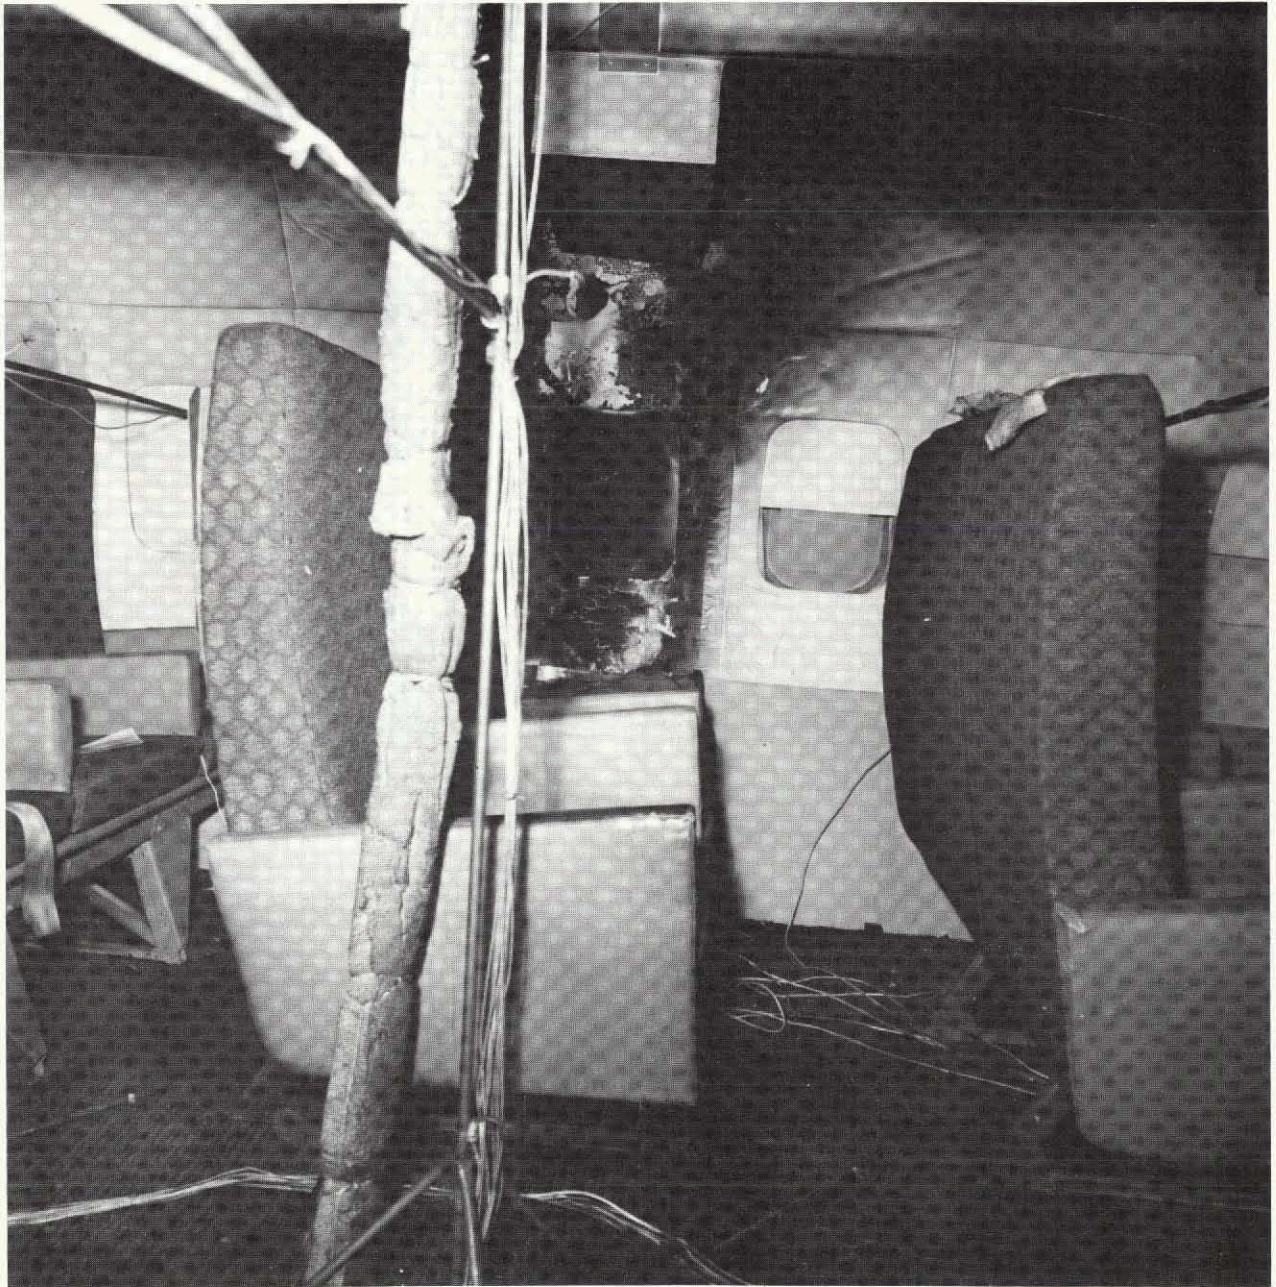
Figure 20.- Fire damage for test 2 using new materials, side view.

Figures 20 to 24 show clearly that flames did not propagate, and damage was confined to the seat above the fire and the adjacent sidewall. The ceiling was severely damaged (fig. 21), but, because of inadequate insulation behind panels adjacent to the ignition source, flames melted through the sidewall and spread between the sidewall and insulation to the unprotected back side of the ceiling panels, which had a flammable paper honeycomb core. The flames then melted through the aluminum skin above the ceiling panels, and the test was terminated after 280 seconds to prevent destruction of the fuselage. The paper honeycomb ceiling panels were not intended for involvement in the fire since they were known to be flammable and are to be evaluated in subsequent tests using fire-resistant materials.

2. Sidewall: A 61-centimeter (2 foot) wide section of the sidewall covering (Kel-F and Fluorel on Durette) adjacent to the fuel pan was charred from the floor to the hatrack, and the aluminum panels were partly melted. The sidewall extending outward from each side of the charred area was scorched and blistered (fig. 20).

Comparison with other tests.- Far less material damage occurred in test 2 than in test 1, and propagation of the fire was limited (figs. 15 and 20). A comparison of ceiling temperatures (fig. 25) indicated a maximum temperature of 505 K (450° F) for test 2, whereas, during test 1, the

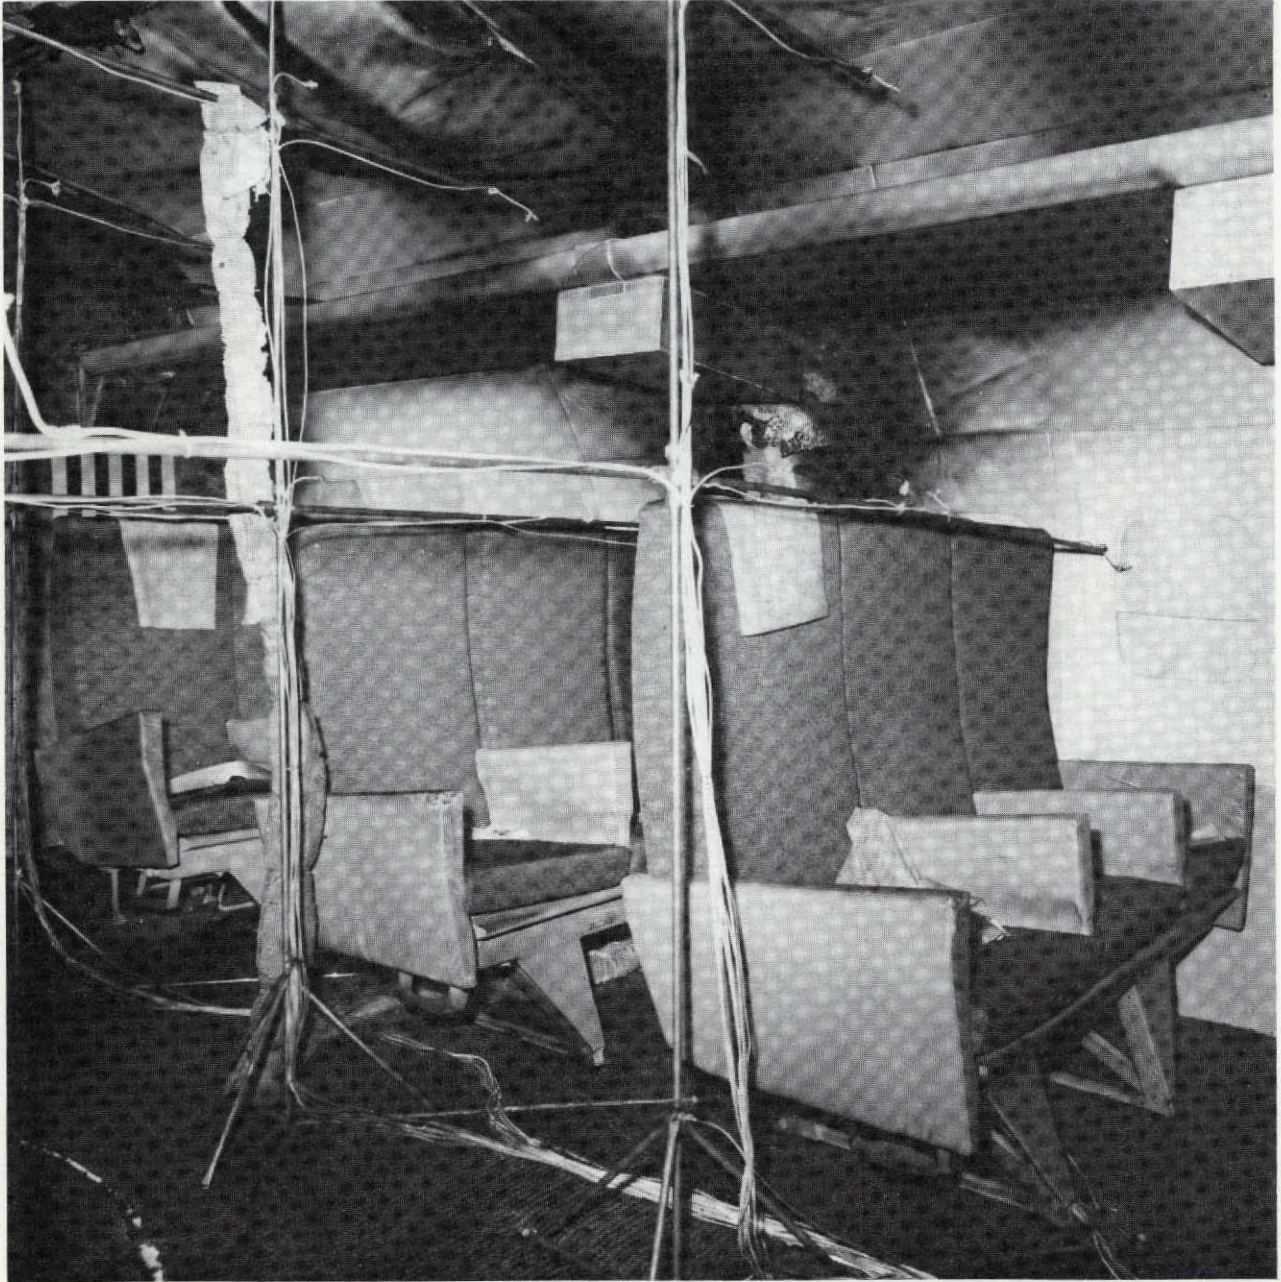
Figure 21.- Fire damage for test 2 using new materials, front view.

4. Ceiling panels: The ceiling panels were heavily charred where they joined at the middle of the test section (fig. 21). Close examination revealed that the panels had burned from the back side, which had not been covered with the fiberglass cloth overcoated with Kel-F and Fluorel. (The same type of ceiling panel used in test 1 was covered on one side only with the Kel-F/Fluorel/fiberglass-cloth composite for use in test 2.) The back side had been ignited by flames that melted the sidewall and spread between the sidewall and insulation up to the back side of the ceiling panels. The remaining interior side of the ceiling was slightly scorched.

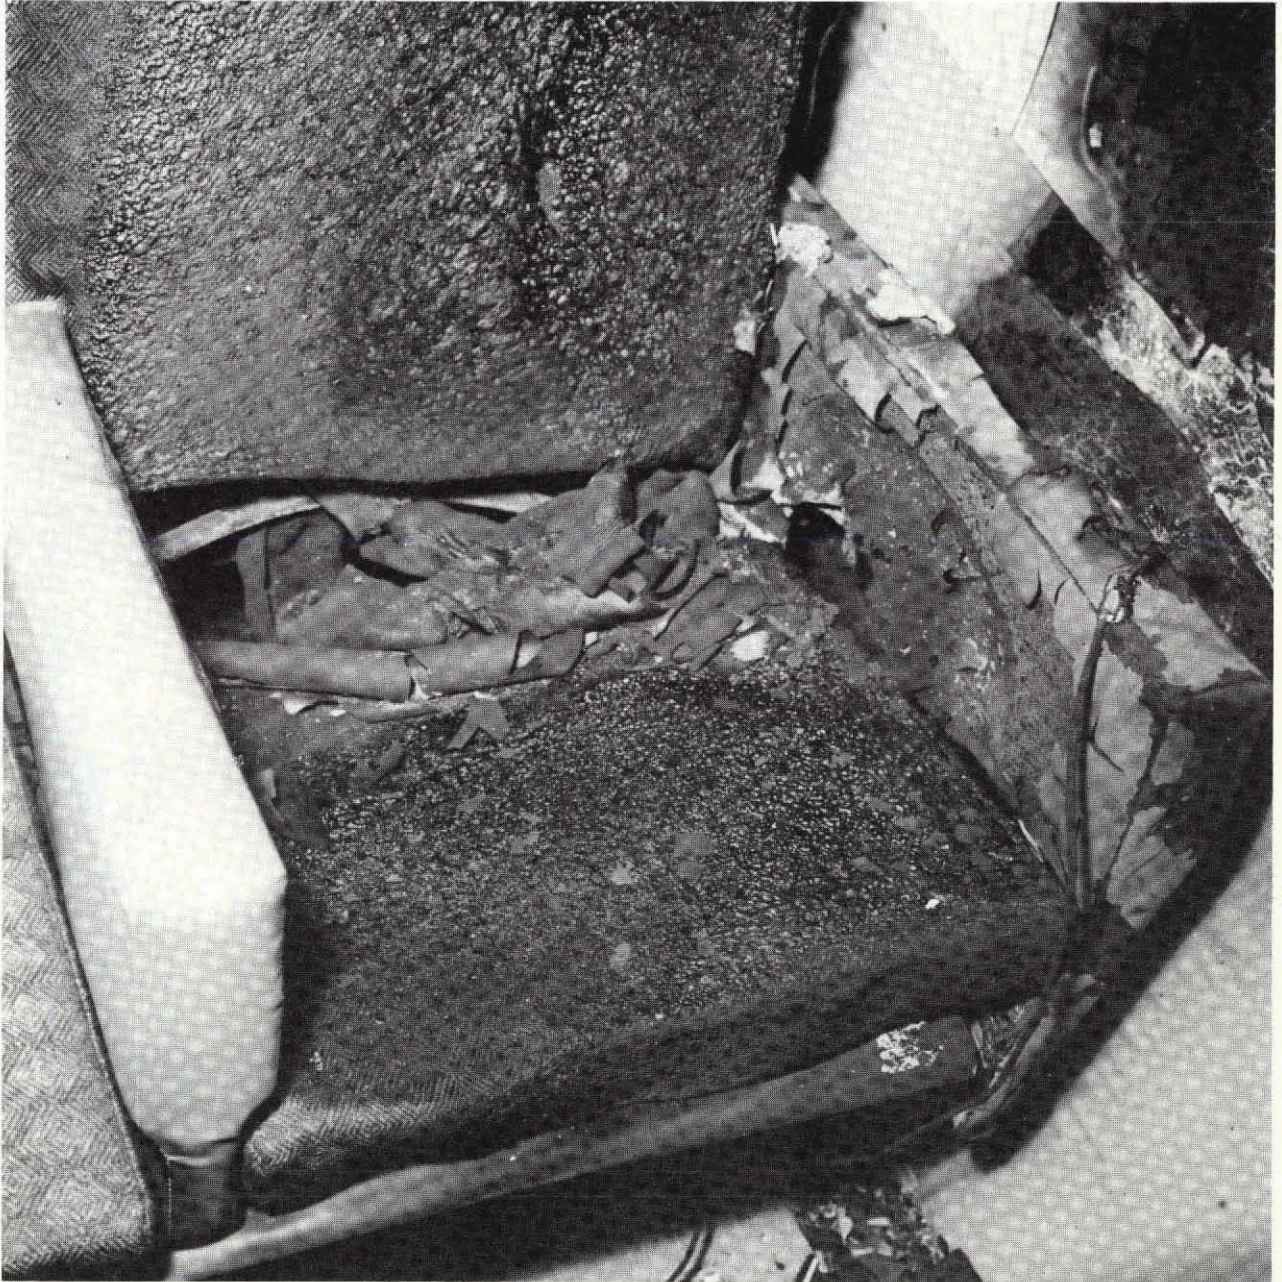
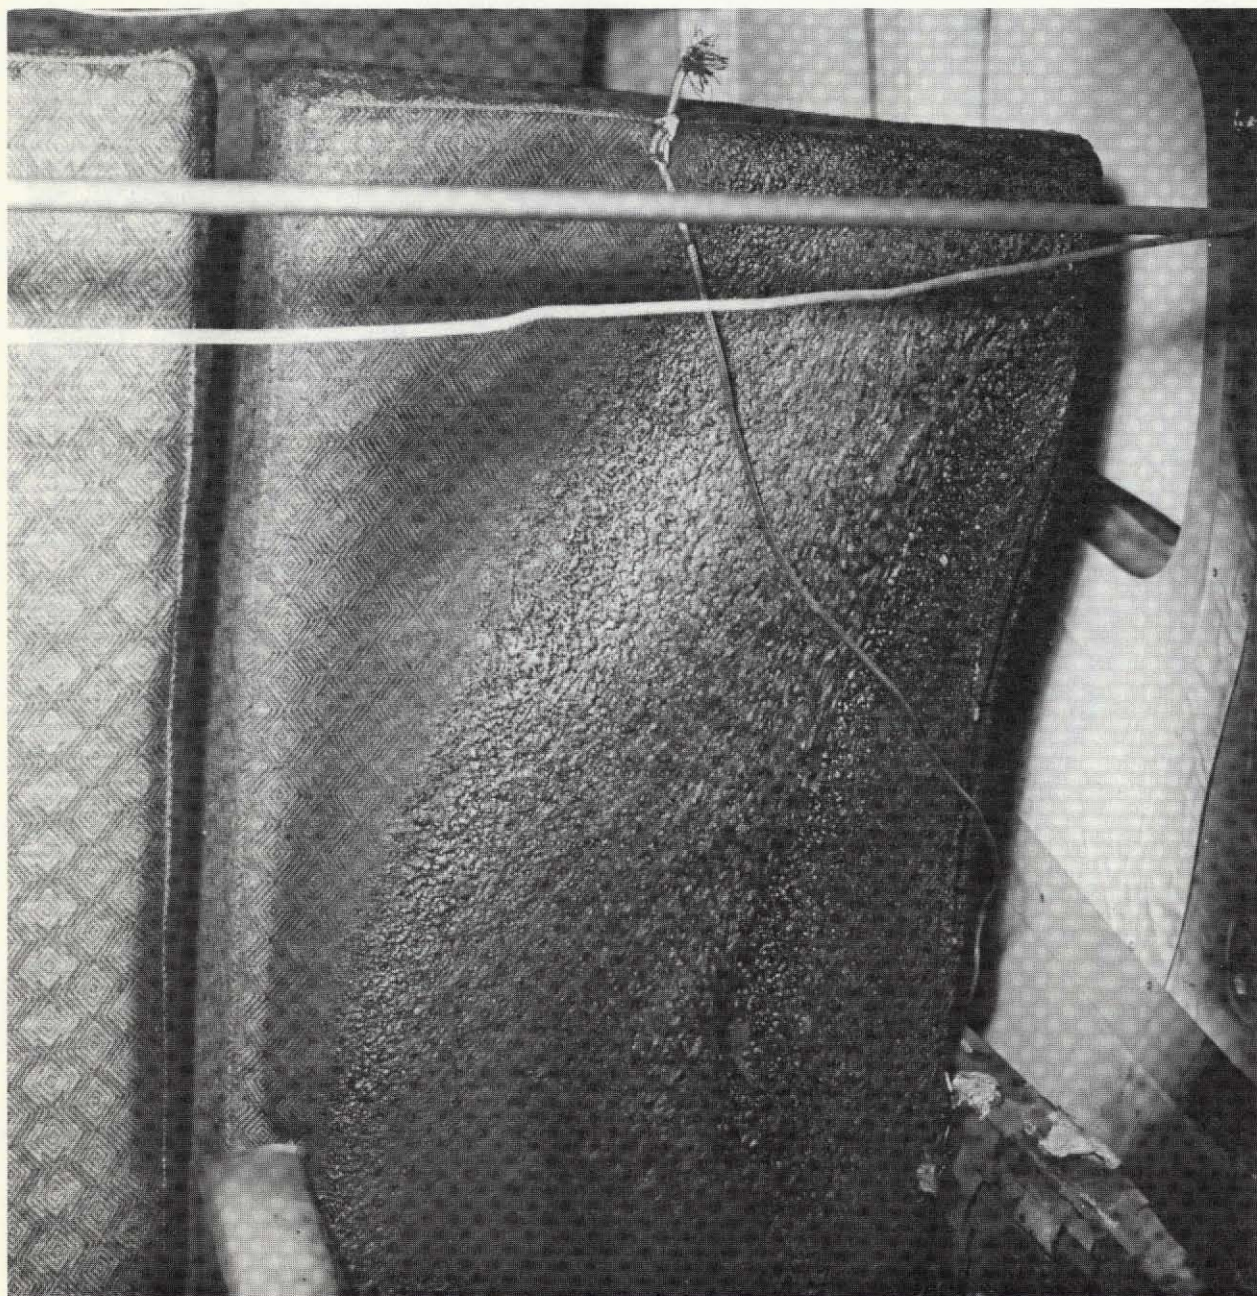
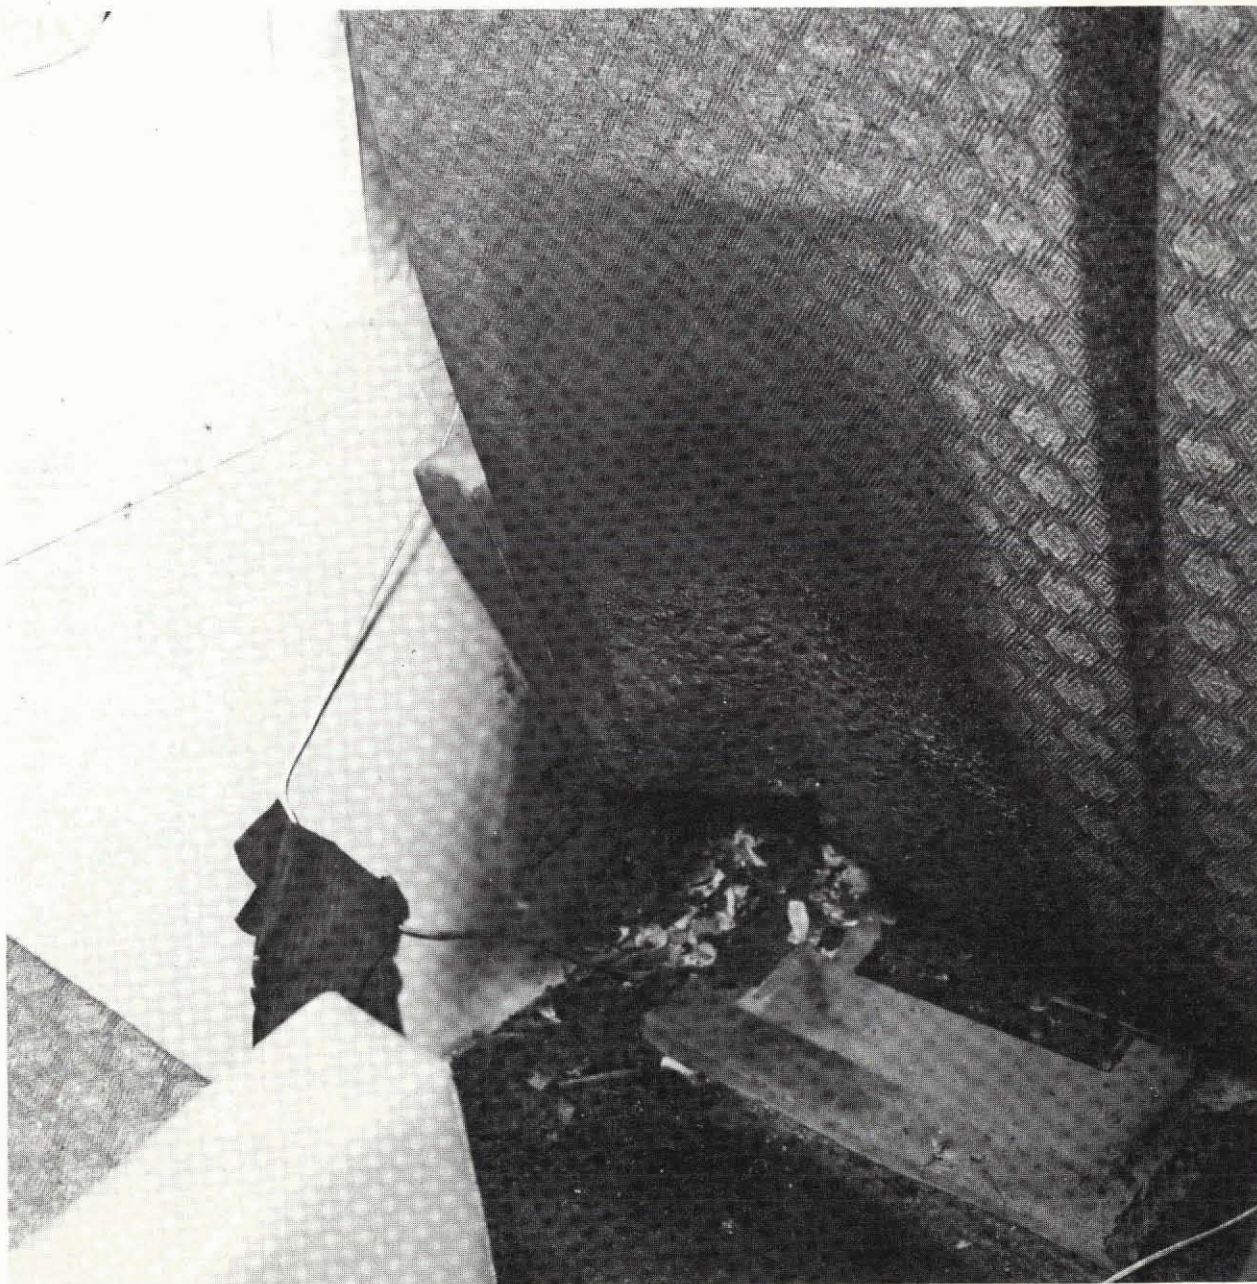
1. Seats: The seat above the fire was partly consumed by the fire, and some of the metal structure had melted away

(figs. 22 to 24). Approximately 95 percent of the bottom seat cushion upholstery was charred, and approximately 50 percent of the fire-retardant foam padding was consumed. The front of the seat-back upholstery was 70 percent charred, the back side was 25 percent charred and 30 percent scorched, and the foam padding was damaged only slightly. The Nomex seatbelt was almost completely charred. The other seats were not damaged except for slight scorching of the seat adjacent to the damaged seat. Fire-resistant, disposable headrest napkins had also been included for evaluation; however, most of the napkins were blown from the seats when the carbon dioxide extinguisher was activated. The napkins that remained in place were not damaged.

Figure 22.- Seat bottom fire damage for test 2 using new materials.

Figure 23.- Seat top fire damage for test 2 using new materials.

Figure 24.- Seat back fire damage for test 2 using new materials.
