# THE IMPACT RESISTANCE OF CURRENT DESIGN COMPOSITE FAN BLADES TESTED UNDER SHORT-HAUL OPERATING CONDITIONS

## INTERIM REPORT

GENERAL ELECTRIC COMPANY  
Advanced Engineering and Technology  
Programs Department

NASA Lewis Research Center  
Contract NAS3-16777

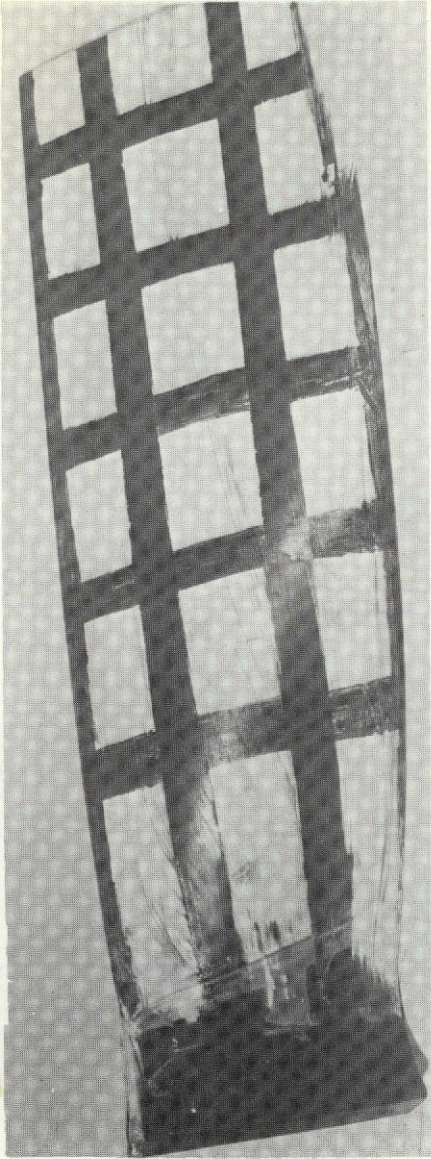
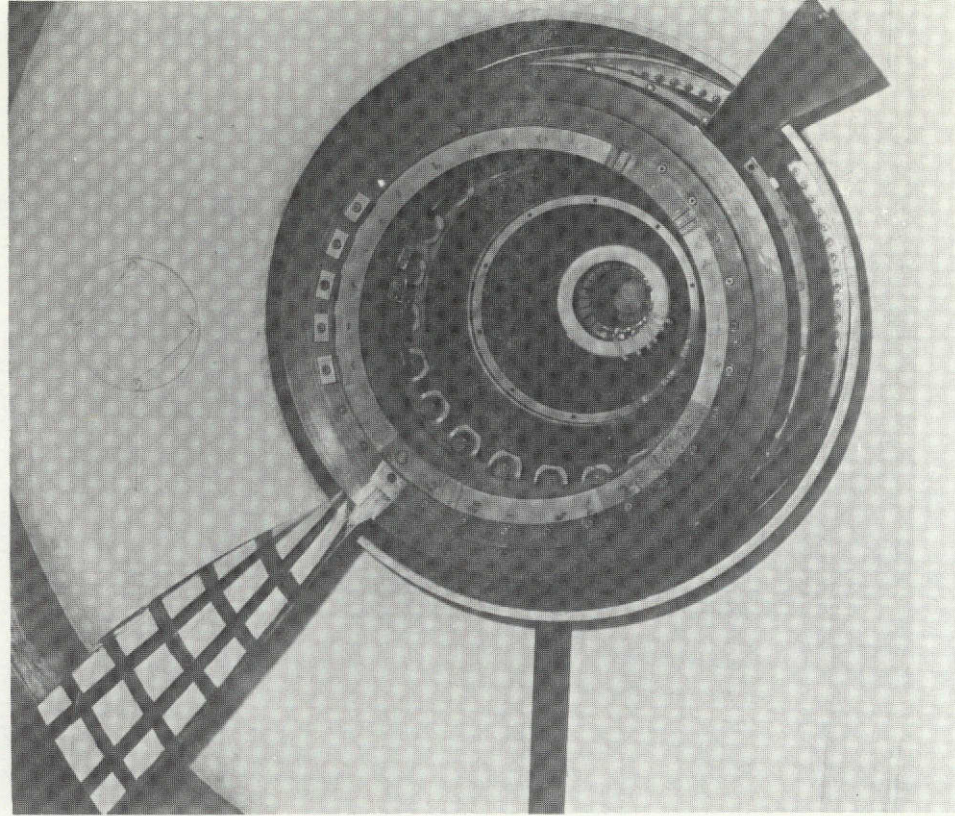
Figure 6. Blade S/N-NG1 after Impact.

NASA-FOD Impact Resistance Test  
Blade S/N NG1  
Graphite/Epoxy  
Tip Speed: 800 ft/sec  
12 oz RTV Bird  
6 oz Slice  
22° Incidence Angle

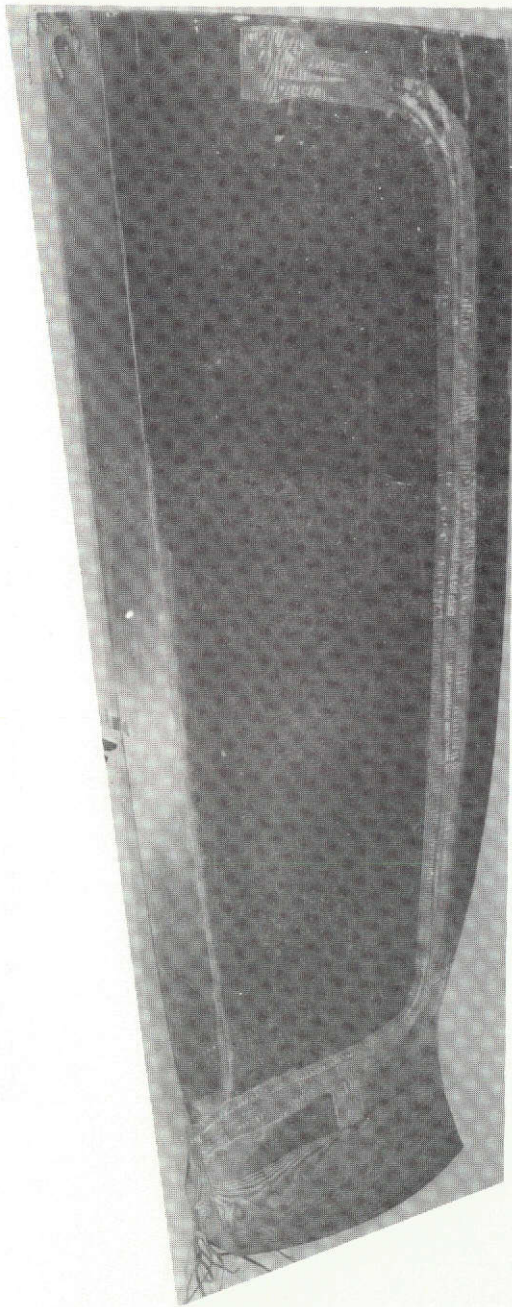
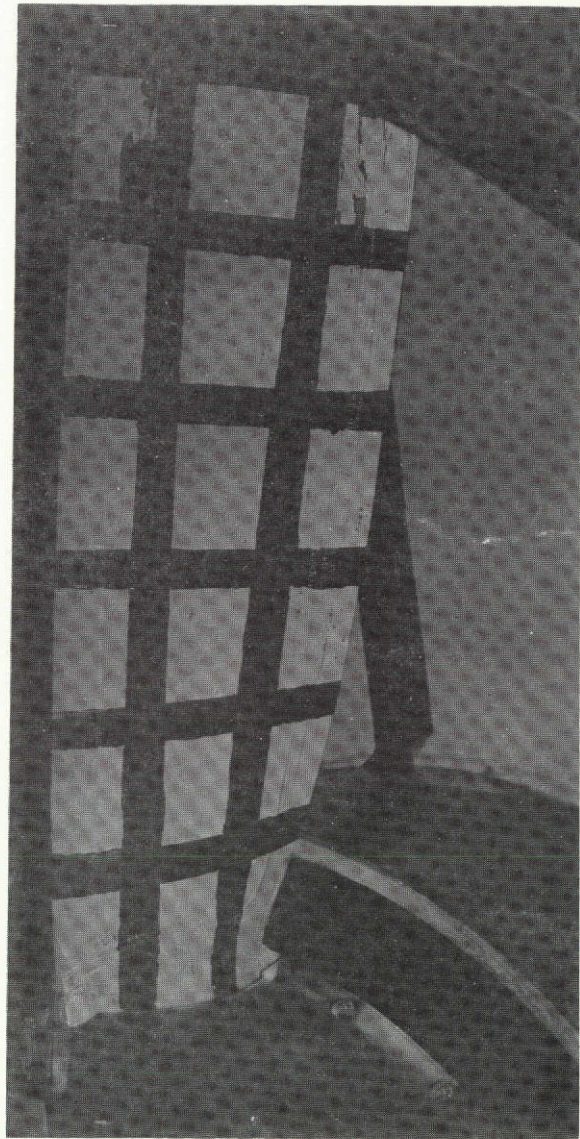
Figure 7. Blade S/N-NB2 after Impact.

NASA-FOD Impact Resistance Test  
Blade S/N NB2  
Boron/Epoxy  
Tip Speed: 800 ft/sec  
12 oz RTV Bird  
6 oz Slice  
22° Incidence Angle

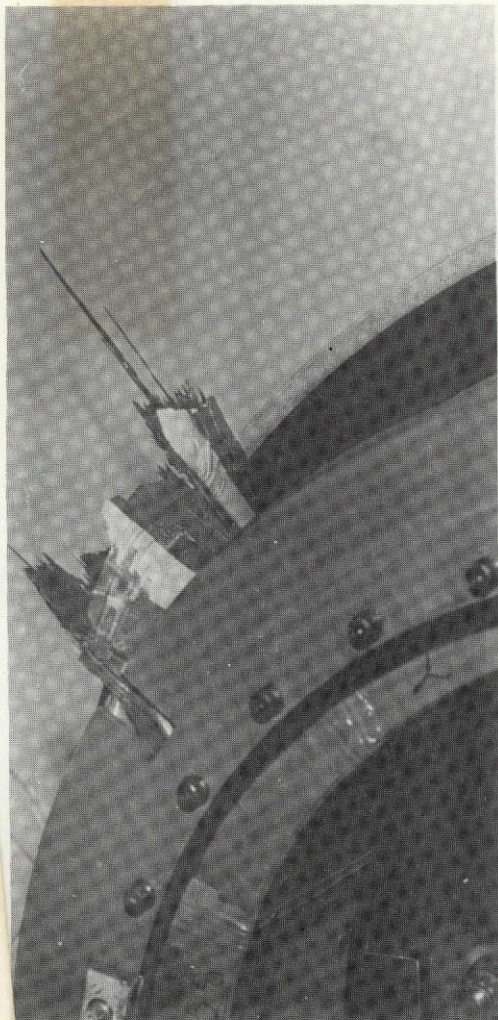
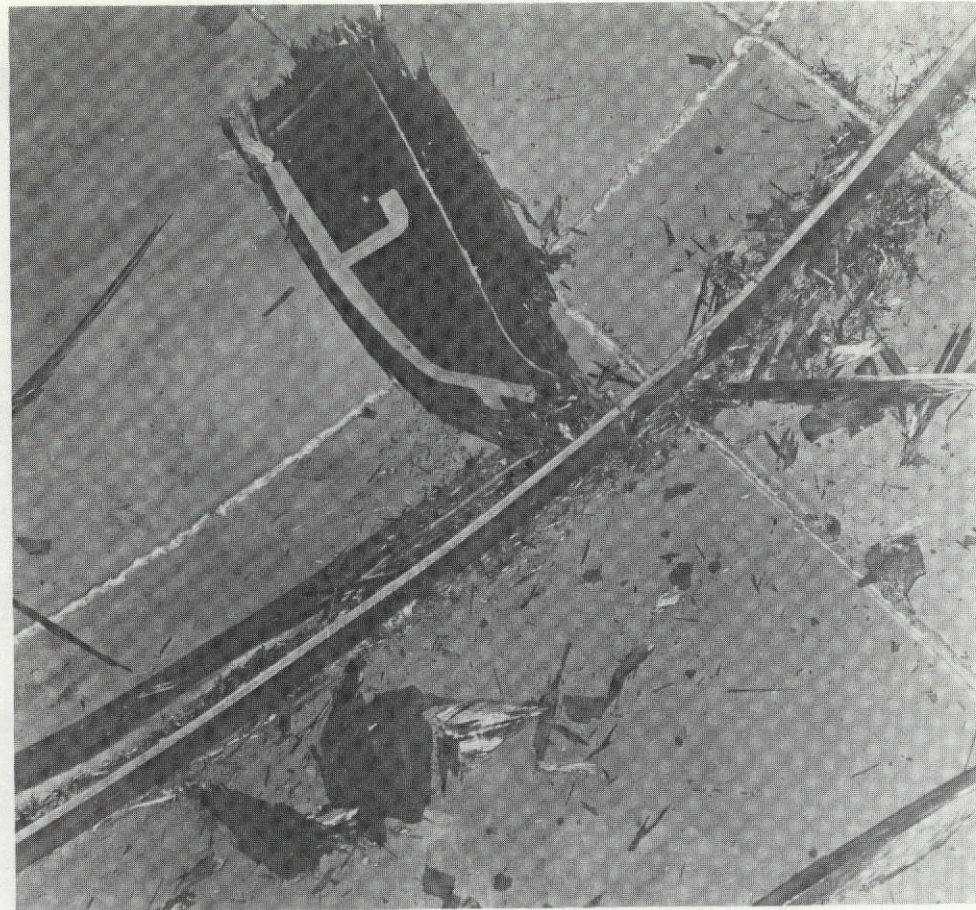
Figure 8. Blade S/N-NG3 after Impact.

NASA-FOD Impact Resistance Test  
Blade S/N NG3  
Graphite/Epoxy  
Tip Speed: 800 ft/sec  
26 oz RTV Bird  
12 oz Slice  
22° Incidence Angle

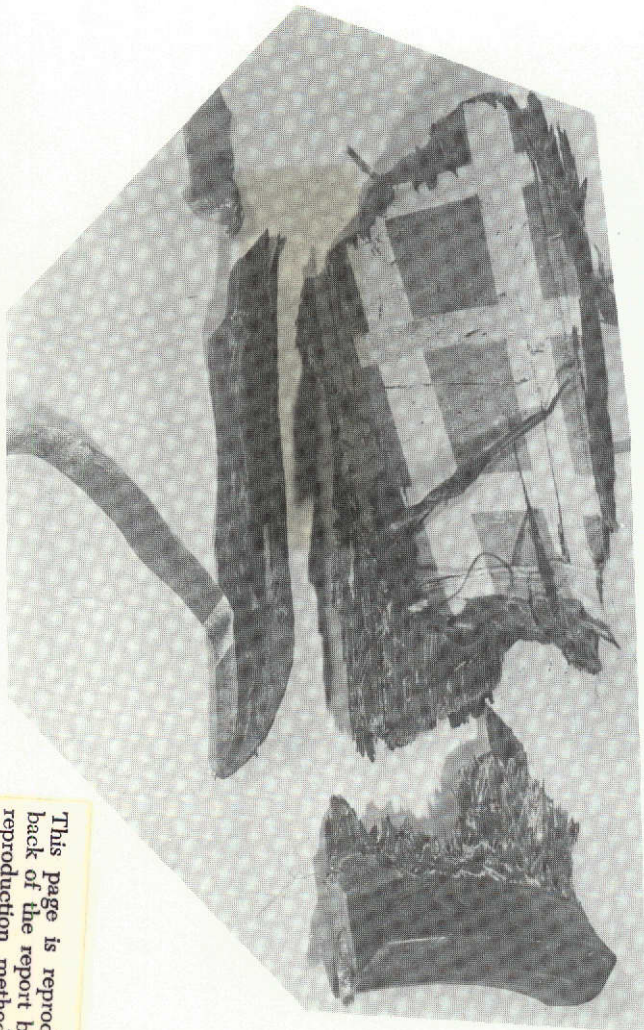
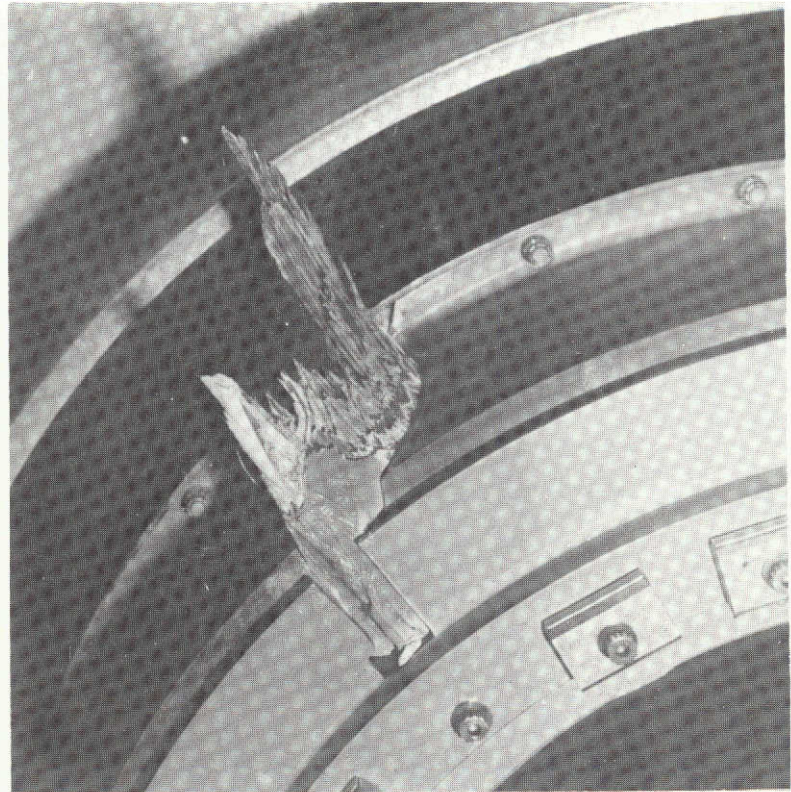
Figure 9. Blade S/N-NB4 after Impact.

NASA-FOD Impact Resistance Test  
Blade S/N NB4  
Boron/Epoxy  
Tip Speed: 800 ft/sec  
26 oz RTV Bird  
12 oz Slice  
22° Incidence Angle

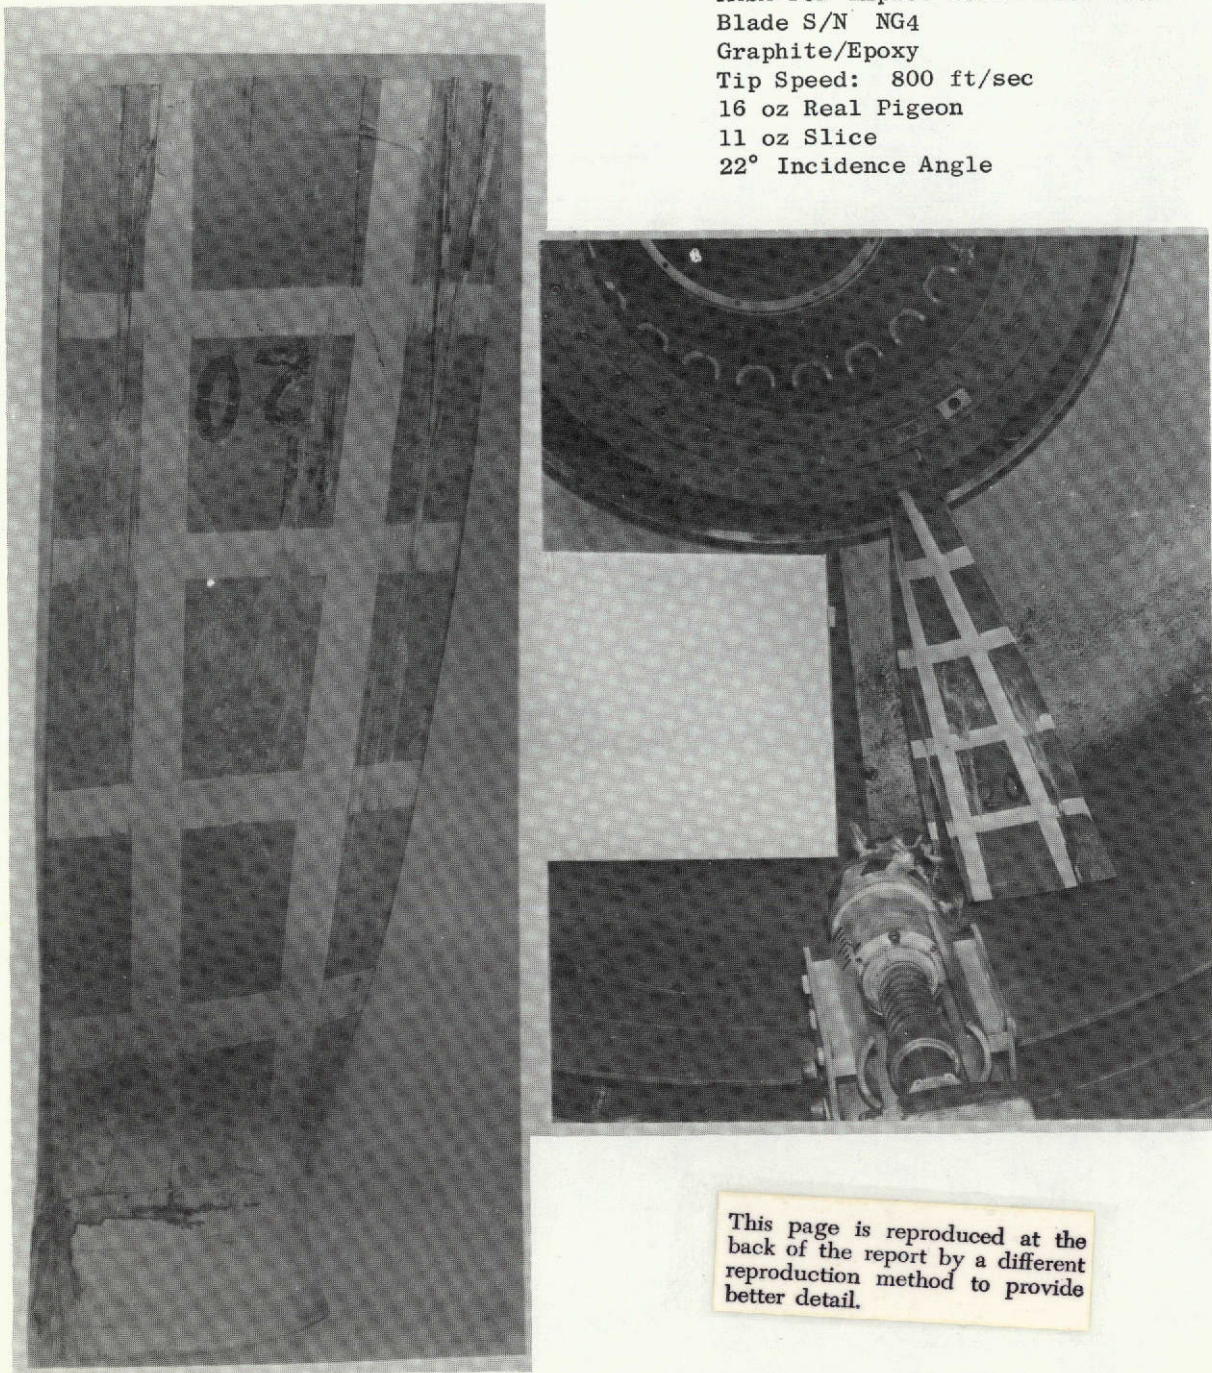
Figure 10. Blade S/N-NG4 after Impact.

- Bench Frequency Check - The bench frequencies for the first three modes of all blades are shown in Table I. In addition, the after test frequencies for the first flex only are presented due to the extent of damage. These data show that for the most part, 1F frequencies remain the same. The biggest change in frequency occurred on graphite blade NG4 which was impacted with an 11 oz slice of a 16 oz pigeon.

NASA-FOD Impact Resistance Test  
Blade S/N NG4  
Graphite/Epoxy  
Tip Speed: 800 ft/sec  
16 oz Real Pigeon  
11 oz Slice  
22° Incidence Angle

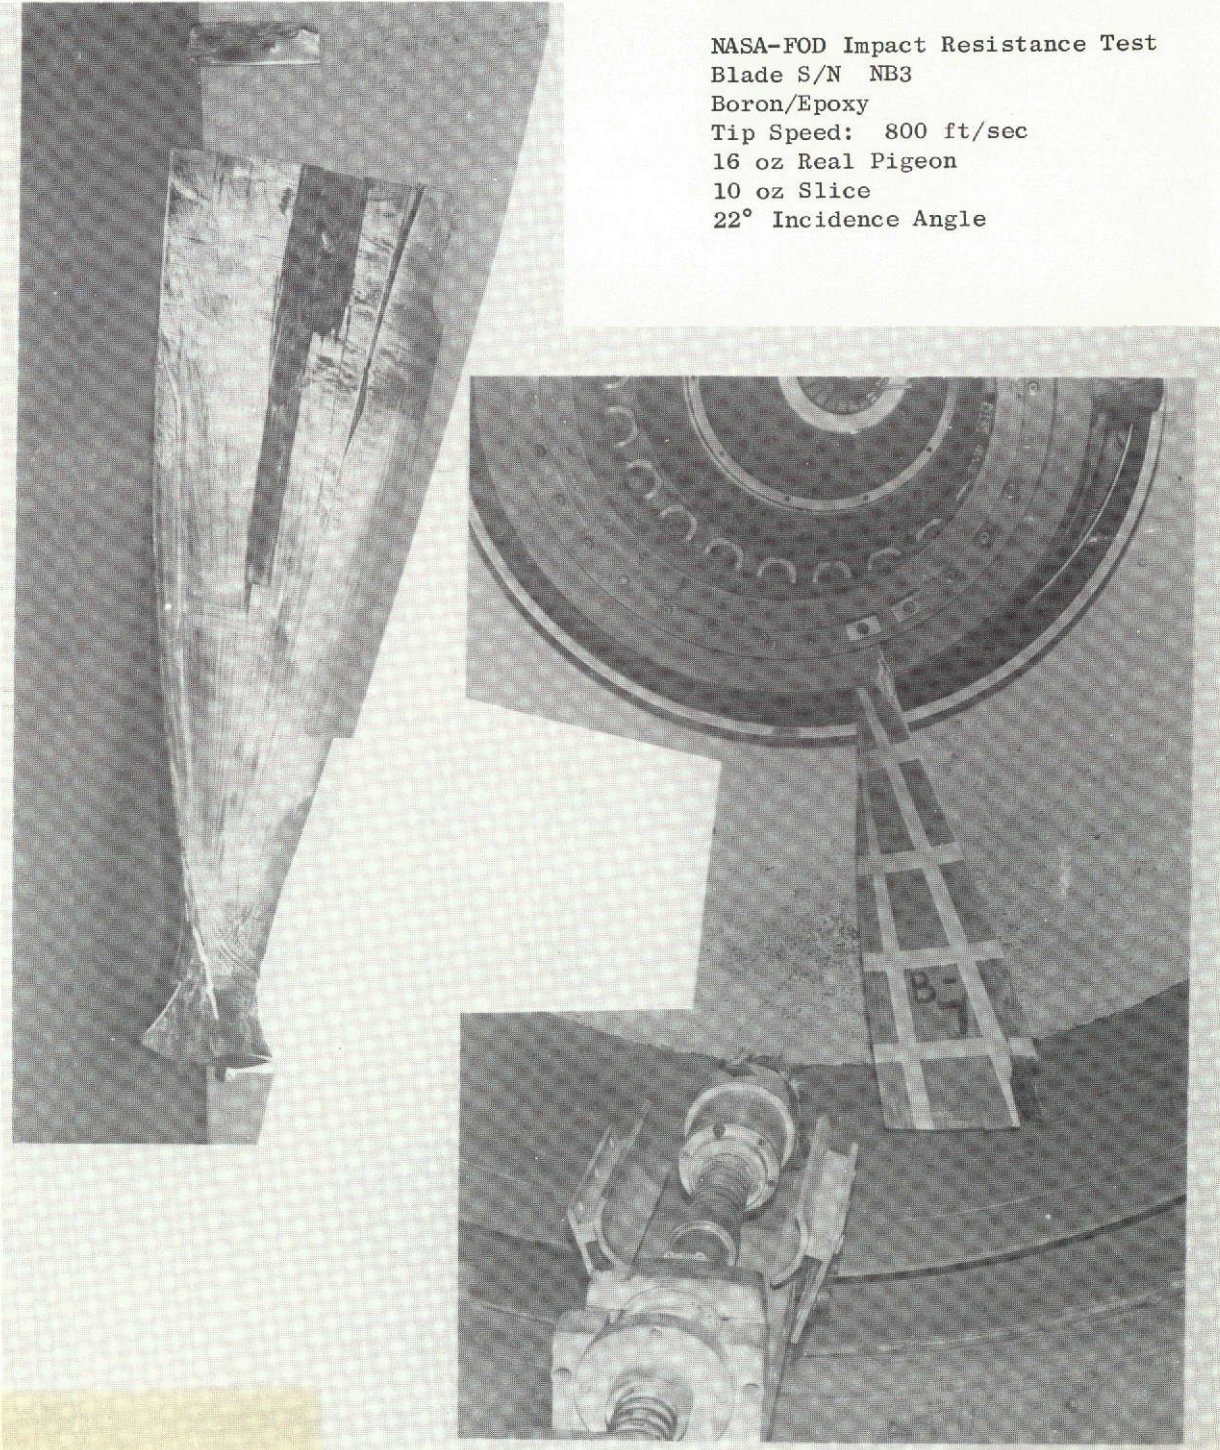
Figure 11. Blade S/N-NB3 after Impact.

NASA-FOD Impact Resistance Test  
Blade S/N NB3  
Boron/Epoxy  
Tip Speed: 800 ft/sec  
16 oz Real Pigeon  
10 oz Slice  
22° Incidence Angle

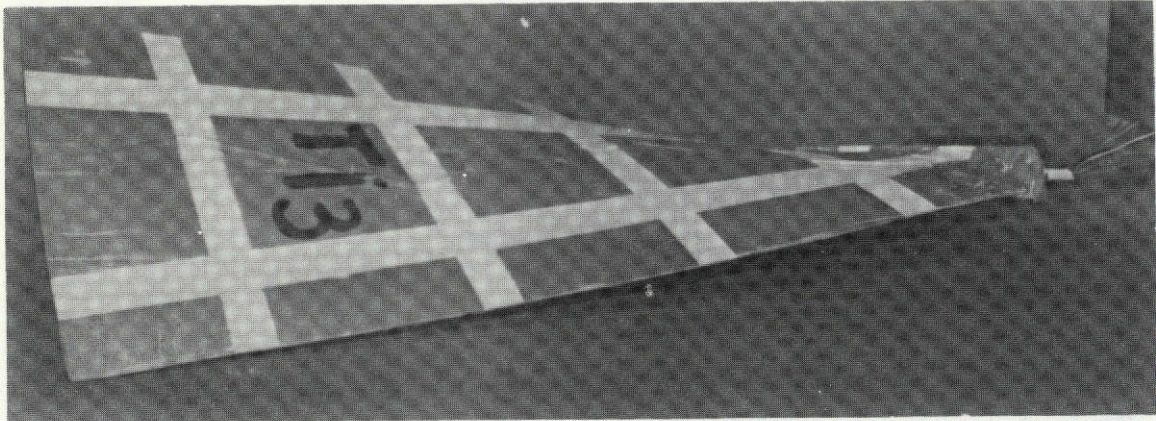
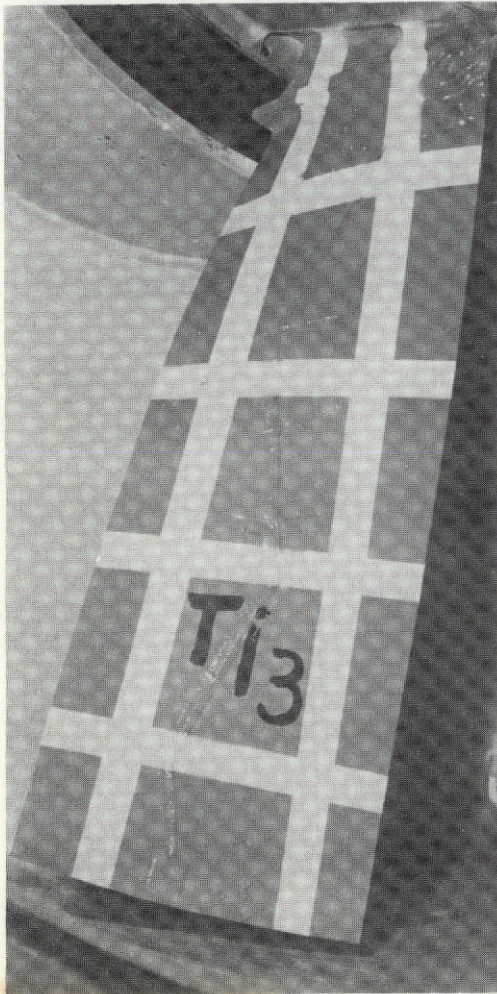
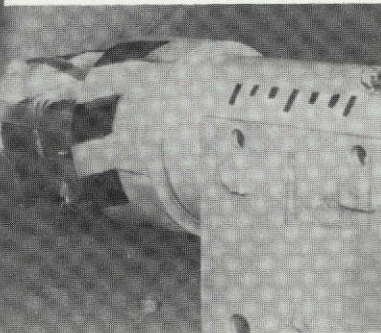
There was no visible damage to the titanium blade when impacted with an 8 oz bite from a 16 oz pigeon. There was considerable deflection.

NASA-FOD Impact Resistance Test  
Blade S/N Ti3  
Titanium  
Tip Speed: 800 ft/sec  
16 oz Real Pigeon  
8 oz Slice  
22° Incidence Angle

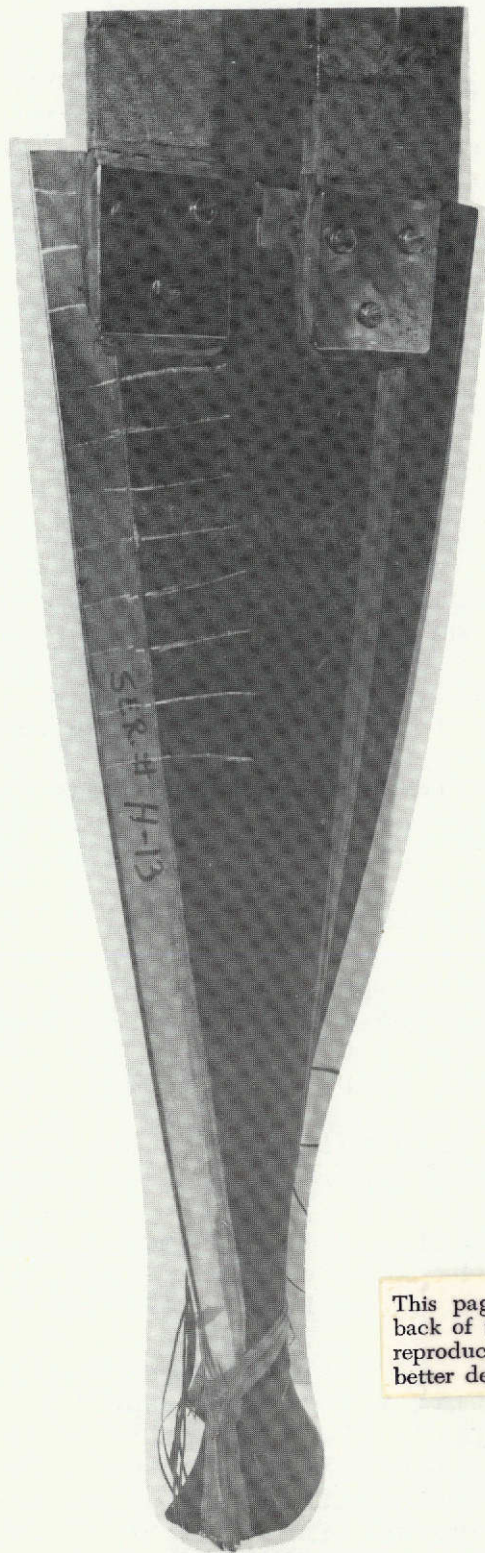
Figure 19. NG5 Graphite/Epoxy Blade after Impact (Convex Surface), Test No. STOL 1.

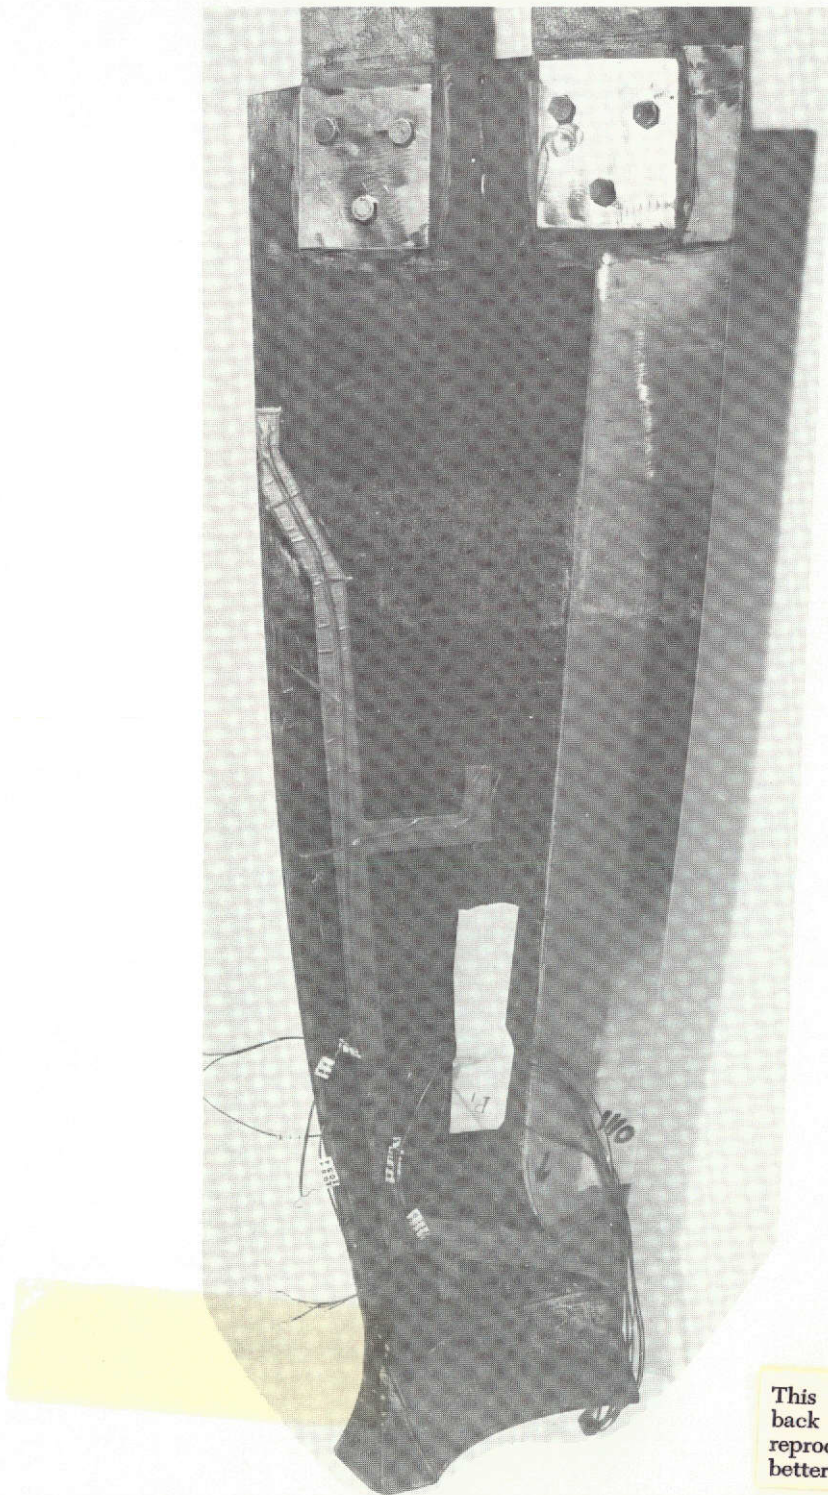
Figure 20. NG5 Graphite/Epoxy Blade after Impact (Concave Surface), Test No. STOL 1.

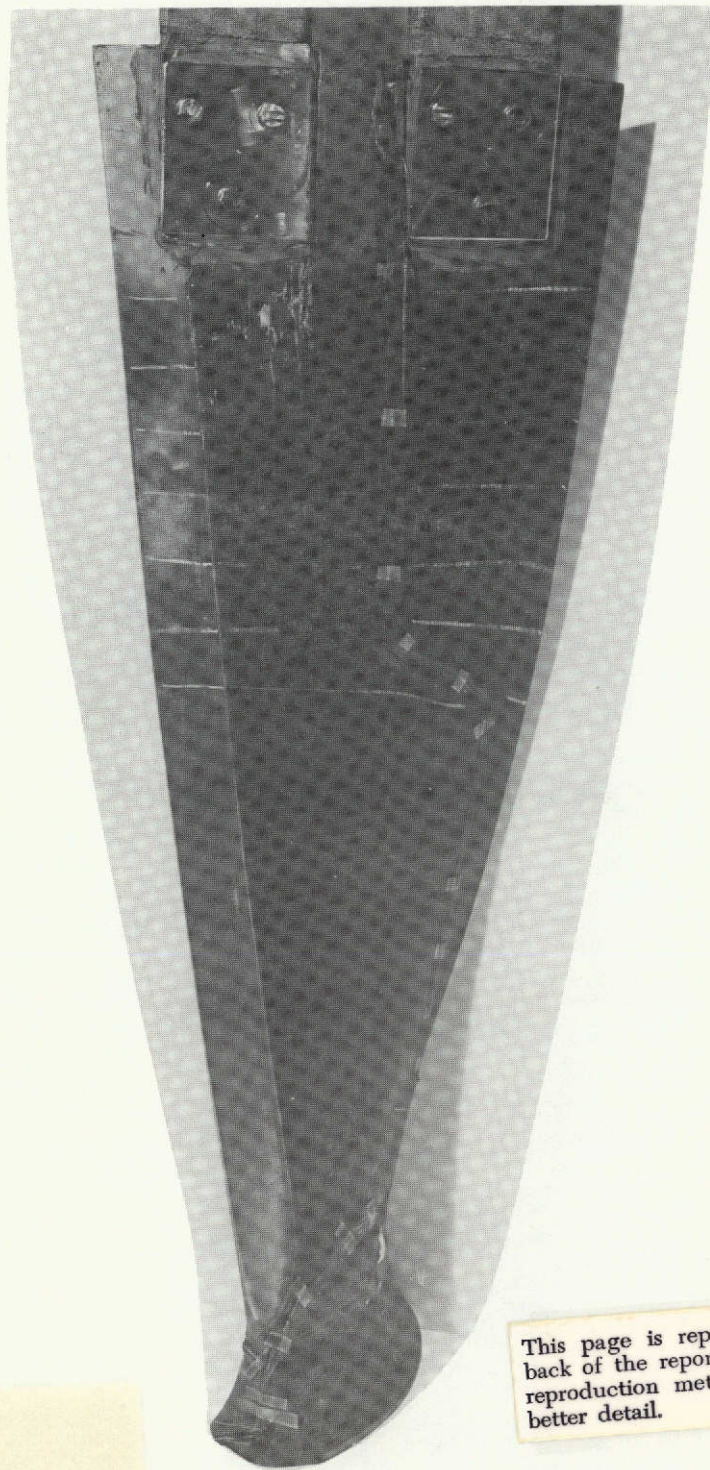
Figure 21. NB5 Boron/Epoxy Blade after Impact (Convex Surface), Test No. STOL 2.

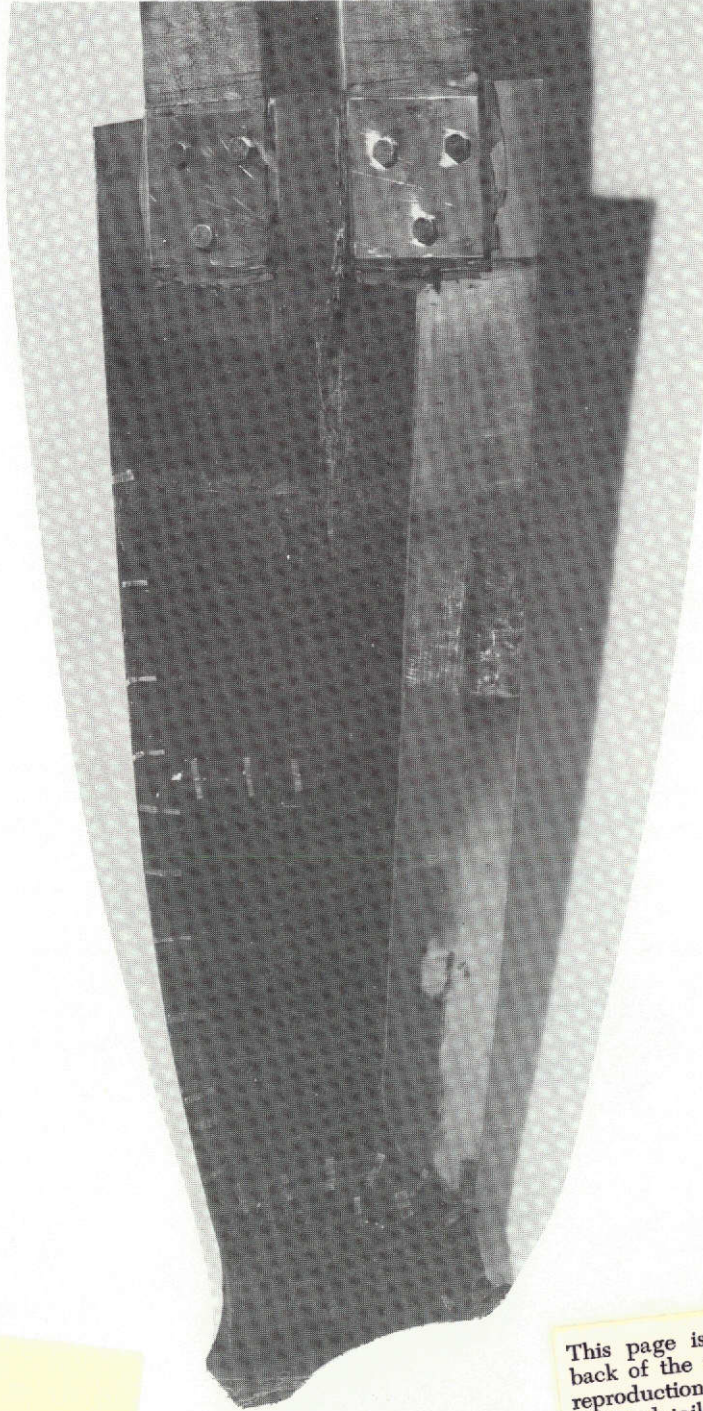
Figure 22. NB5 Boron/Epoxy Blade after Impact (Concave Surface), Test No. STOL 2.

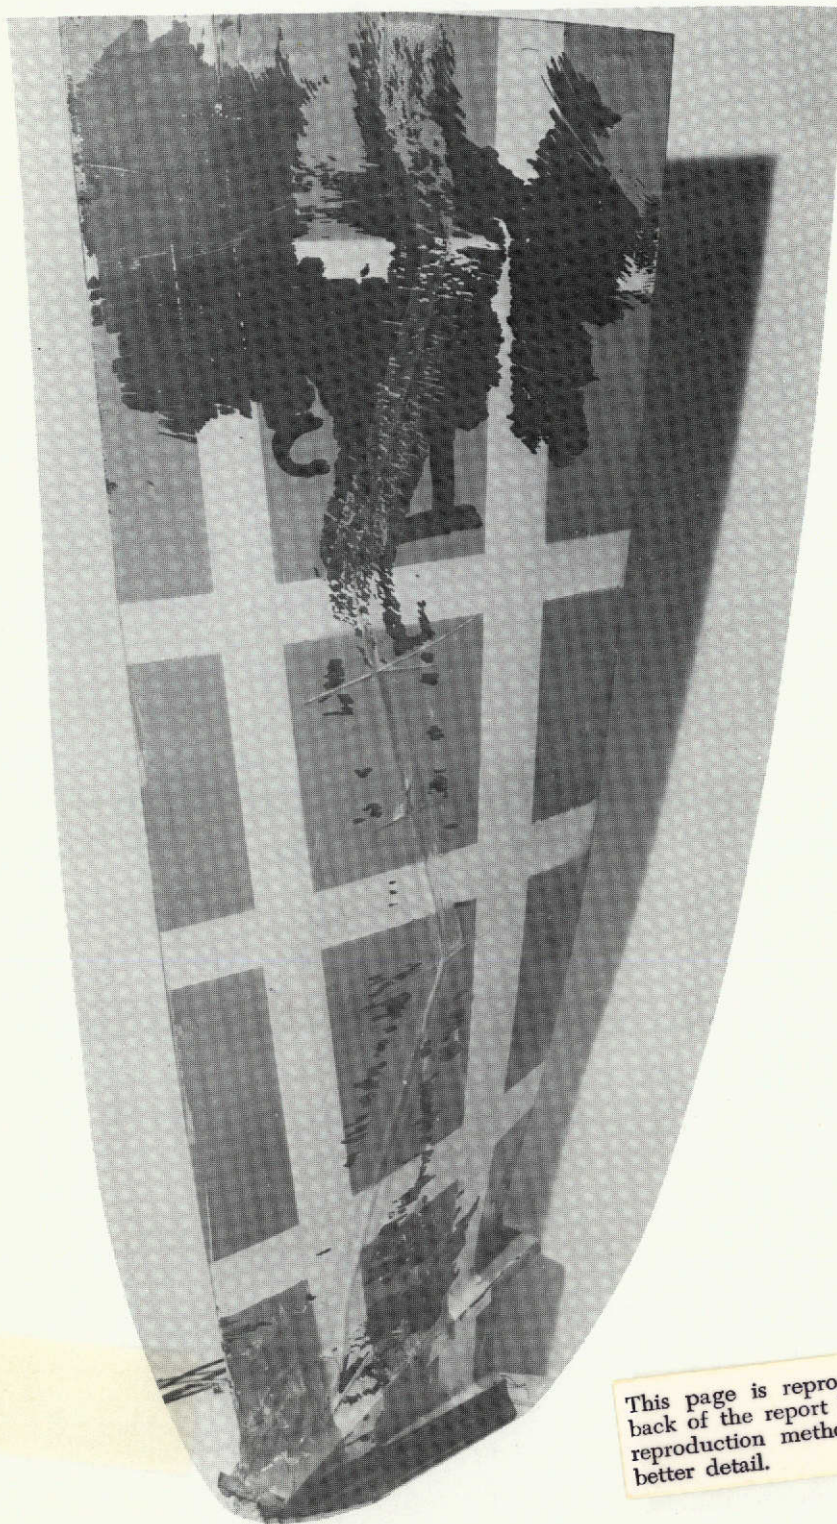
Figure 23. Titanium Blade after Impact (Convex Surface), Test No. STOL 3.

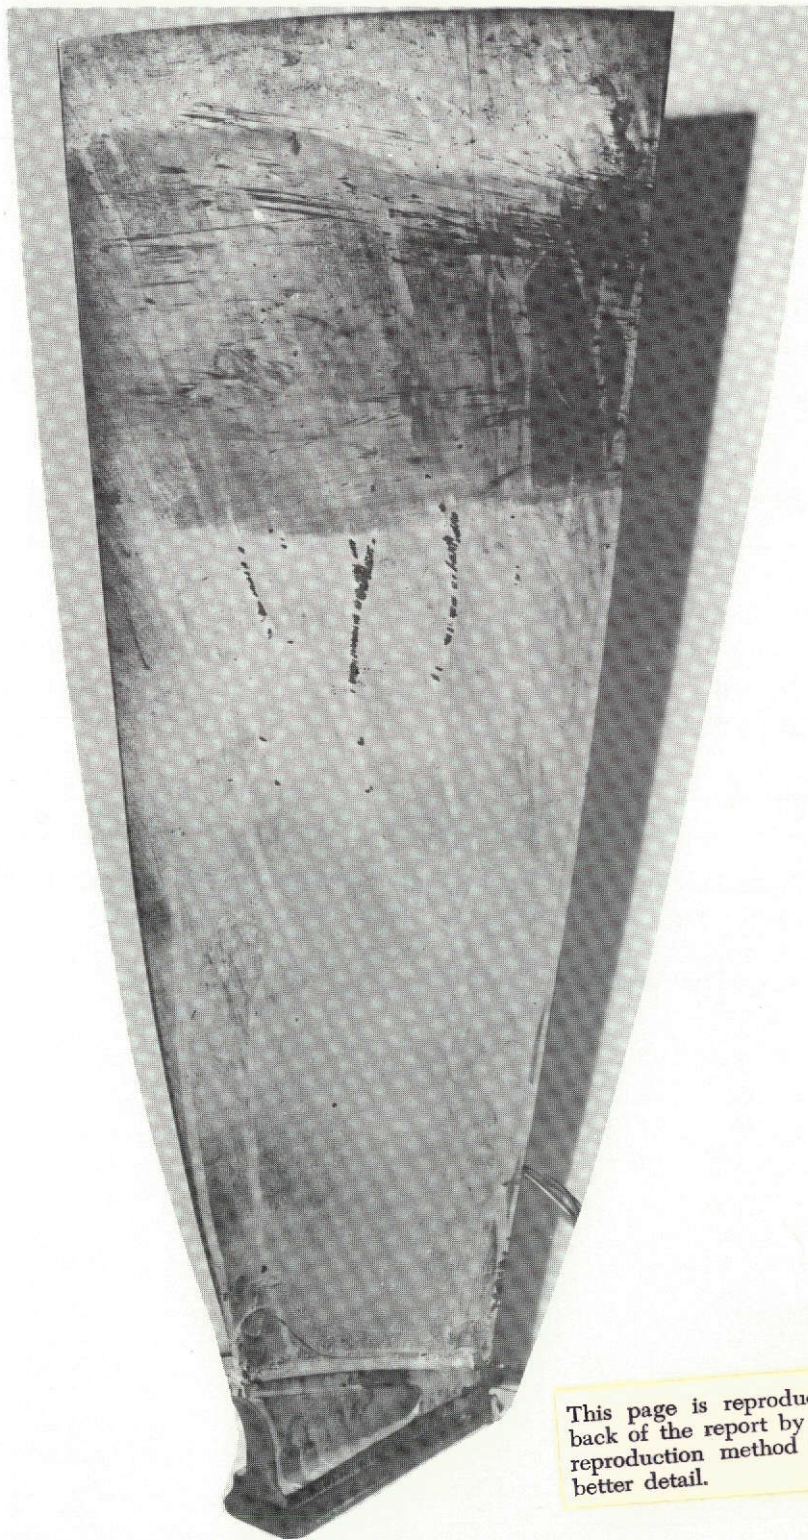
Figure 24. Titanium Blade after Impact  
(Concave Surface), Test No.  
STOL 3.
