NASA CR-WRL 10822-1-T

# ENGINEERING EVALUATION OF 24-CHANNEL MULTISPECTRAL SCANNER

Subject: Engineering Evaluation of 24-Channel Multispectral Scanner

### PERFORMANCE OF MSDS AS OF 2 AND 4 JUNE 1972

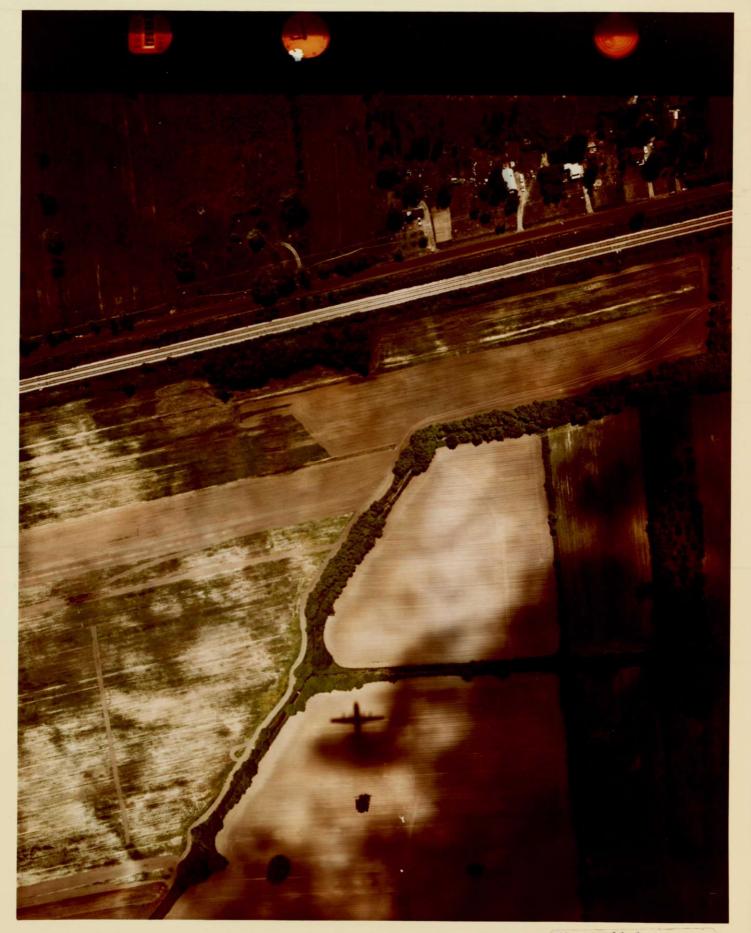
Figure 11.1 Cloud shadow 1.5K ft. 6/4/72

Note the differences between Figures 11.1 and 11.2 in the location of various portions of the cloud shadow, indicating that the cloud was both moving and changing shape. Since the cloud was more or less following the path of the aircraft but at a slower speed, the outline of the cloud depicted in Figure 11.2 is elongated slightly in the flight direction relative to what appears in Figure 11.1. This indicates that the RC-8 film should not always be trusted to indicate the precise shape and location of a cloud shadow in the scanner data.

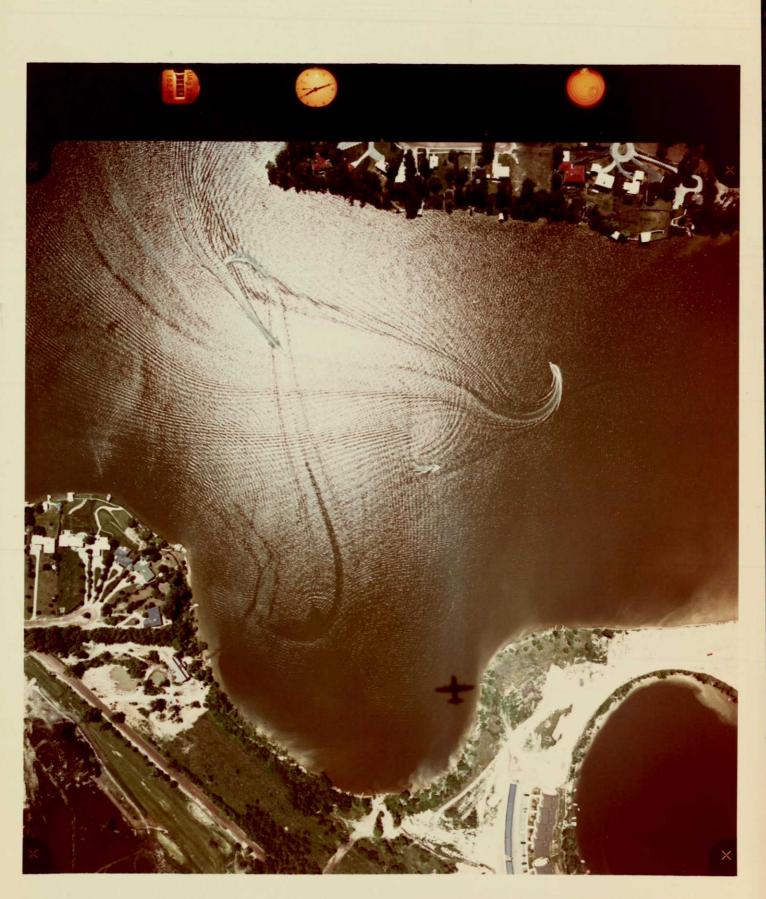
Figure 12.1	
1.7K ft.	over lake
6/4/72	(clear)

Note the lack of evidence for clipping or ringing in this film recorder output for channel 3. Earlier in this same run clipping and ringing were noted in the digitized data for this channel (see Section 6 and Figure 6.21). This indicates that the abnormalities in channel 3 occur downstream from the connection for input to the film recorder in this channel.

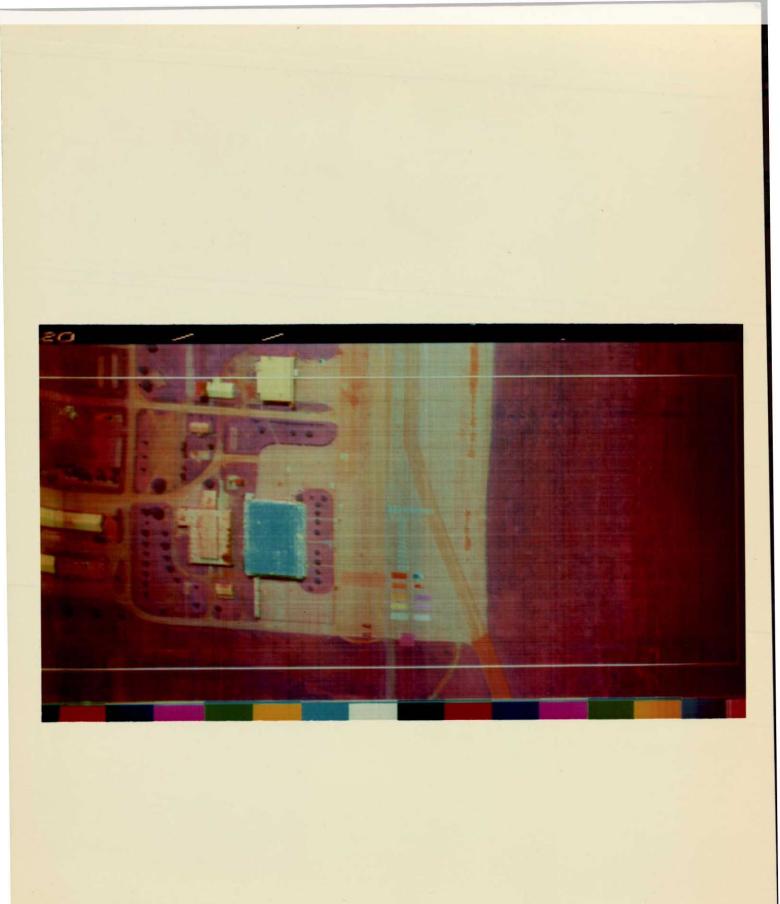
Figure 13.4 DAS Film, Run 18 1.5K ft. 6/4/72 19-R 2-G 11-B

For Figures 13.1-13.5 channel 19 was used for the red gun, channel 2 for the green, and channel 11 for blue. In Figure 13.4 note that the seven tar paper strips can be seen separately (whenever the moire pattern present does not obscure them) even though the resolution element size in that figure is nearly identical to the width of these strips (3 feet). In Figure 13.5, edit 44, note that these strips cannot be seen separately even though they do appear separated in the graymap from the corresponding tape edit shown in Figure 10.4. This apparent lack of resolution appears partly due to the presence of vertical streaks in the DAS film, partly due to the reduced signal contrast over these strips resulting from the reduced scanner response along the scan relative to across the scan lines together with the effect of the overcast conditions for that day, and partly due to the lack of signal registration among the three channels chosen for this edit at its V/H of .16 which leads to a different moire pattern effect in each channel.

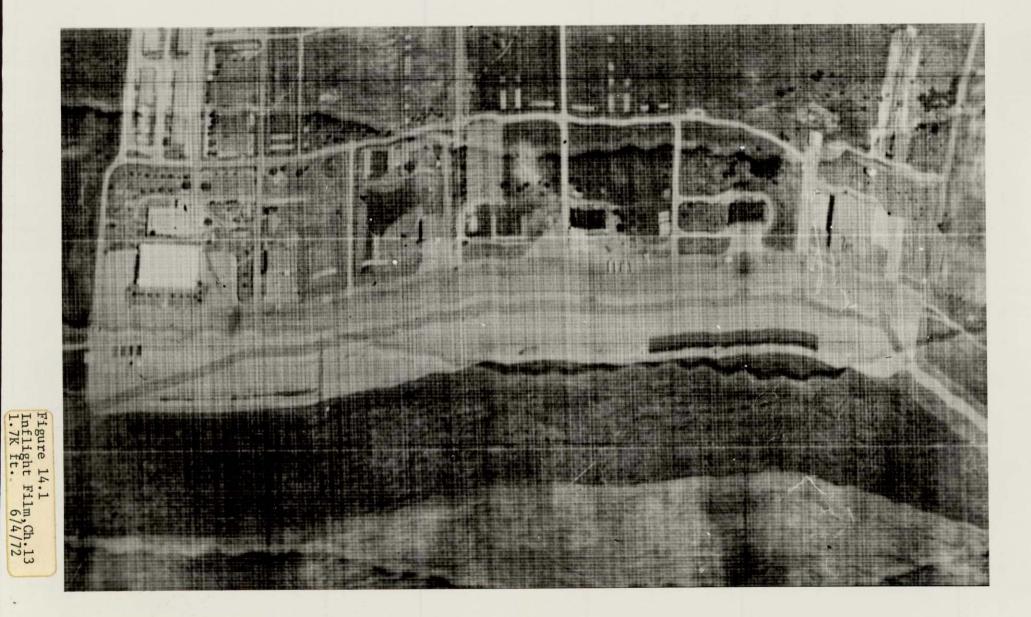
Roll compensation was not working properly for the scanner data, as indicated in Figure 14.1, an enlargement from the inflight film recorder output for channel 13 (a noisy channel with motor spikes) during run 20 on 4 June. During this portion of the run the aircraft was deliberately rolled 5° right, then 5° left to test the system for roll compensation.
