# 1           **Subsidence damage assessment of a gothic church using** 2                           **Differential Interferometry and field data**

3           R. Tomás<sup>1</sup>, J. García-Barba<sup>1</sup>, M. Cano<sup>1</sup>, S. Ivorra<sup>1</sup>, M.P. Sanabria<sup>2</sup>, J. Duro<sup>3</sup>, G. Herrera<sup>2</sup>

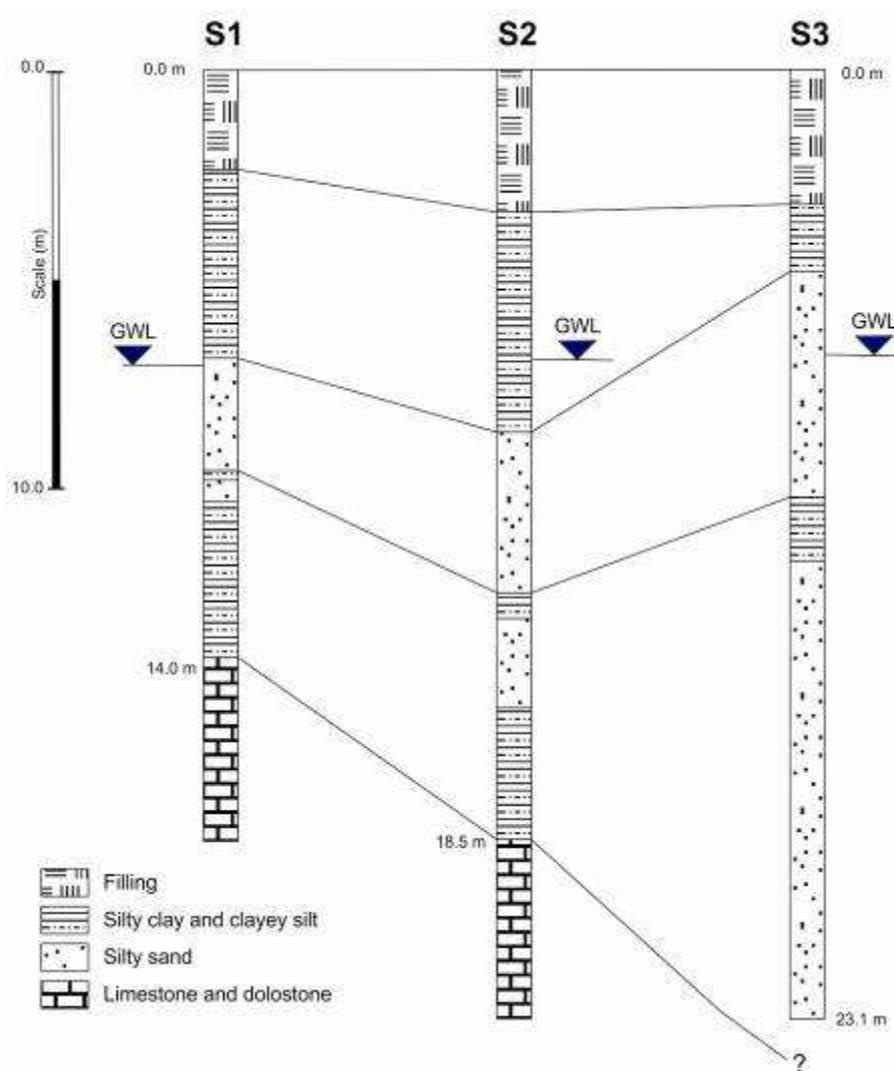
153 Figure 4. Geotechnical boreholes performed in the Santos Justa and Rufina gothic church.

156 Three geotechnical boreholes have been drilled in the proximities of the church (Figure 4) in  
157 order to better know the substrate properties and the geometry under the church. Four different  
158 lithologies have been recognized (from top to bottom): a) Fillings; b) Silty clays and clayey silts;  
159 c) Silty sand; and d) Limestones and dolostones.

160 The fillings have up to 2 m depth and present a low relative density with standard penetration  
161 test results lower than 5 blow counts. Next layer is composed by silty clays and clayey silts that  
162 present a slight improvement of the properties (standard penetration test up to 6 blow counts).  
163 The penetration values of this lithology increase notably with depth, reaching maximum values  
164 up to 15 blow counts on standard penetration test. Silty sands are intercalated among  
165 previously described layer. These sands have a higher penetration resistance than fillings and  
166 more surficial silty clays layer (11 blow counts). The geotechnical substrate is constituted by  
167 carbonatic rocks (Figure 4), limestones and dolostones with refusal values on standard  
168 penetration test and uniaxial compressive strength higher than 30 MPa. This layer appears at a  
169 depth higher than 16.0 m and is usually used for founding deep foundations due to the

170 considerable improvement of its geotechnical properties. Notice that the depth of this layer  
171 changes in a few meters with slopes higher than 0.19 m per meter ( $>11^\circ$ ) in the church area.

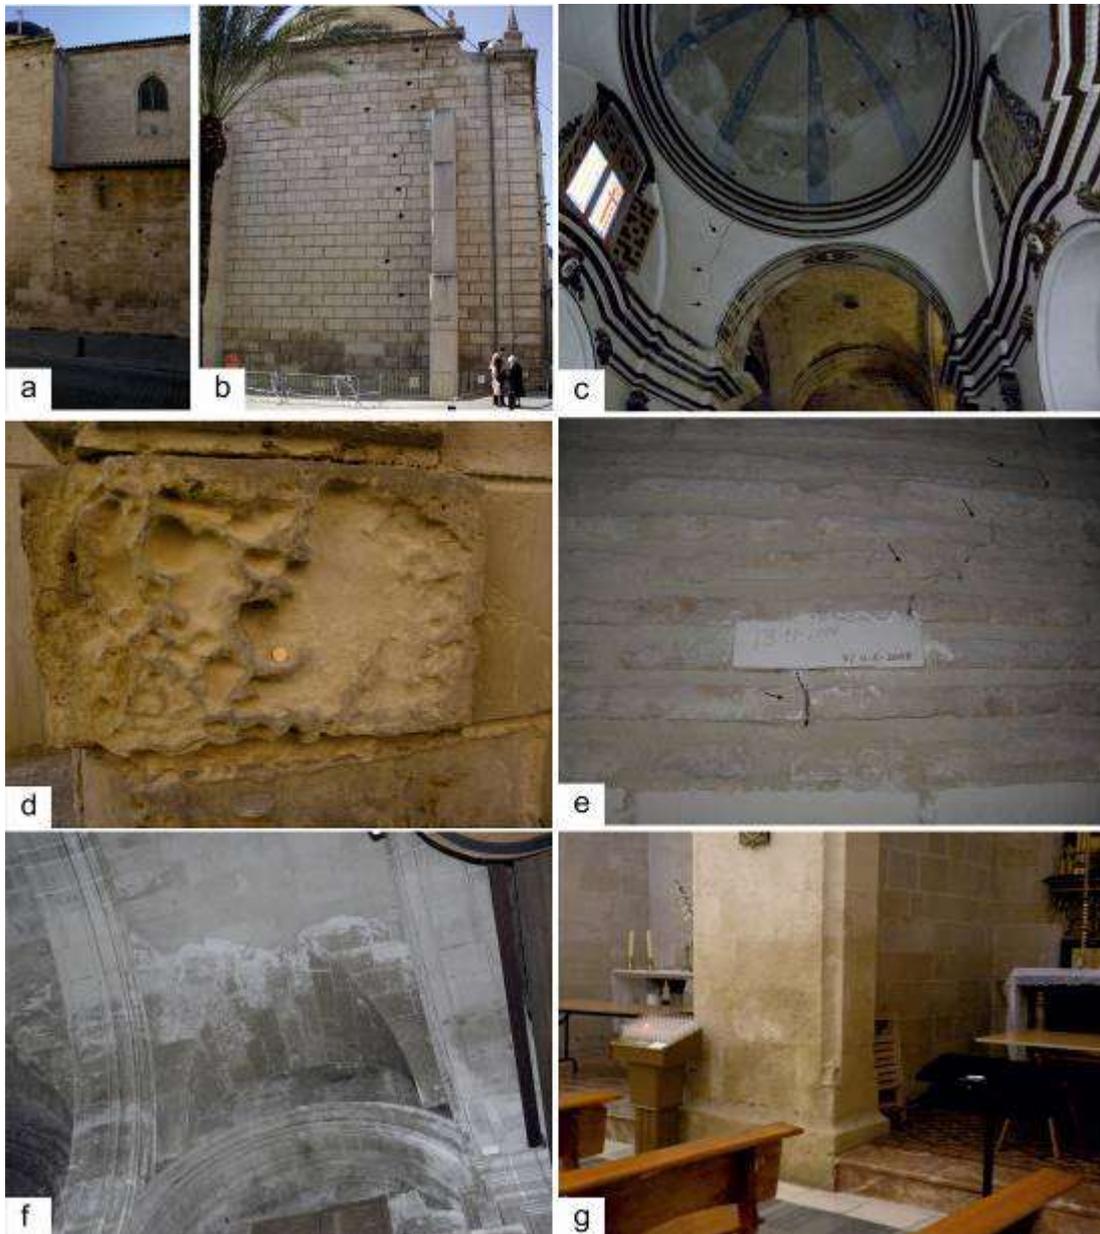
180 Rock alveolization is observed in sandstones blocks of several elements of the church causing  
181 cluster of small cavities and an evident loss of resistance (Figure 5d). These holes can be the  
182 result of the stonework (stacking), biological activity (pits) or the action of salt in the irregular  
183 porous network of the marble (alveoli) (Chabas and Jeannette, 2001). The salts form  
184 efflorescence growing on rock surface (Figure 5c and f) composed of small crystals that can  
185 influence both weathering and disintegration (alveolization) of the rocks. Microorganisms (fungi,  
186 moho, lichens, etc.) and other organisms (birds, plants, etc.) can cause a wide range of  
187 pathologies that are out of the scope of this work. Due to the high water level and the proximity  
188 to the Segura River, capillarity ascent affects the lower part of the elements that are in contact  
189 with soil although humidity can affect higher elements (cupules, columns heads, etc.) when rain

190 access through preexisting cracks (Figure 5f). Salts from ground water can be transported by

191 capillarity through the rock pore system causing salt crystallization, which is the origin of the  
192 previously mentioned efflorescence and alveolization processes.

195 Figure 5. Pathologies observed in the Santos Justa y Rufina church: a) vertical cracks related  
196 with a rigidity change; b) cracks due to local effects of counterfort; c) cupola cracks due to  
197 differential movements of the base; d) Cluster of small cavities (alveoli); e) masonry cracks  
198 induced by differential movements. Notice, the installed plaster markers for crack monitoring f)  
199 Efflorescences due to rain infiltration; g) Capillary ascent of water.

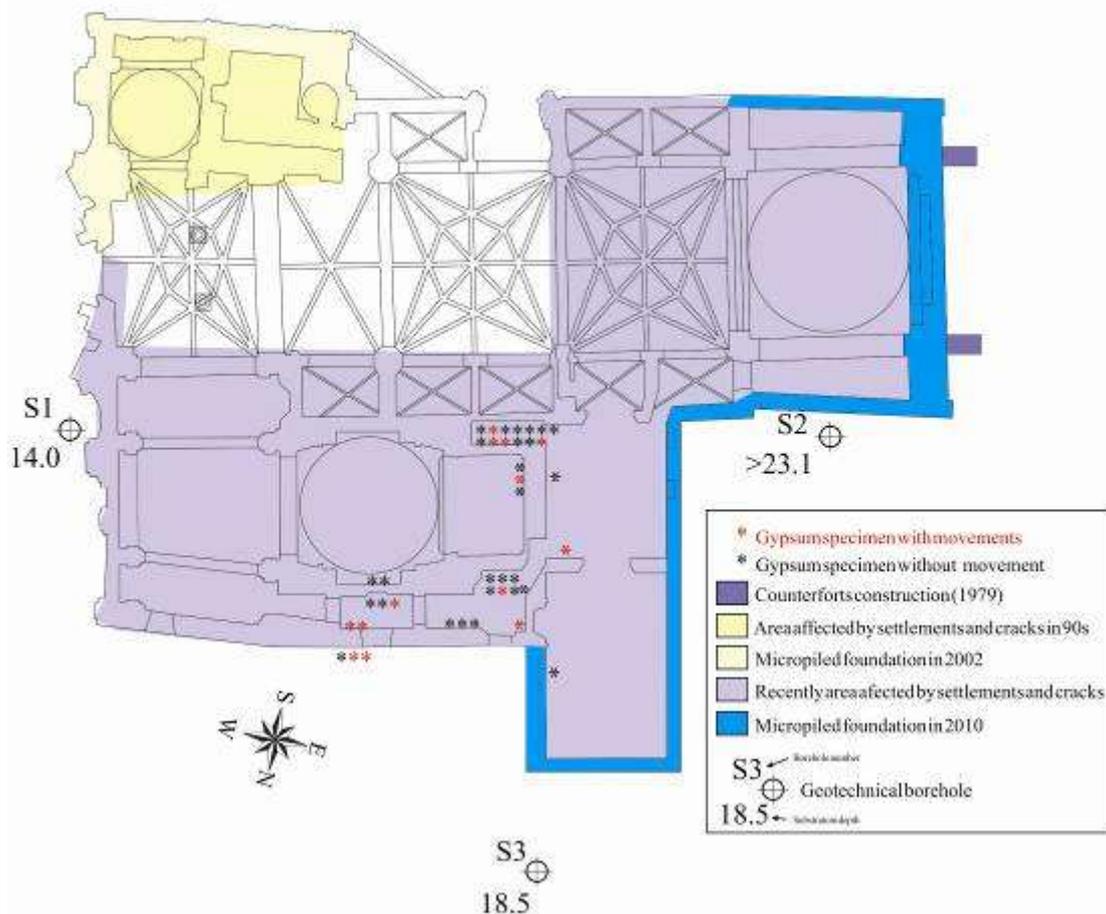
208  
209 Figure 6. Gypsum plaster markers, geotechnical boreholes location and structural improvement  
210 actions performed on the church. Notice that the plaster markers control period was November  
211 2006-June 2008. See geotechnical boreholes lithological description on Figure 4.

212  
213 The eastern wall that closes the principal chapel suffered an important tilt in 70s decade. The  
214 problem was solved by means of the construction of two reinforced concrete counterforts  
215 (Figures 5b a 6). After that, deformations affecting the church have occurred in two different  
216 phases. In the ninety decade of the last century, important settlements affected the San José  
217 chapel zone (Southwest area of the church, Figure 6). Unfortunately no in situ observations are

218 available for this period. As a consequence, the foundation was reinforced in 2002 with  
219 micropiles. On a second stage (first decade of present century), deformations affected the  
220 whole north zone of the church and the principal chapel area. Ground settlements were visible  
221 at the floor of the antesacristy, the sacristy and La Comunción chapel. Multiple cracks where  
222 identified in the north, west and east walls, affecting as well La Comunción cupola (Figures 5b, c  
223 and e), the sacristy and the antesacristy. Several plaster markers were placed in the cracks in  
224 2006 and controlled in 2008 coinciding with the higher piezometric level fall never known in the  
225 Vega Baja of the Segura River basin (Figure 7). Figure 6 shows that multiple cracks grew up for  
226 this period as a consequence of the sinking of the walls foundation caused by ground  
227 subsidence. This affected zone of the church has been recently repaired in 2010 using

228 micropiles (Figure 6).

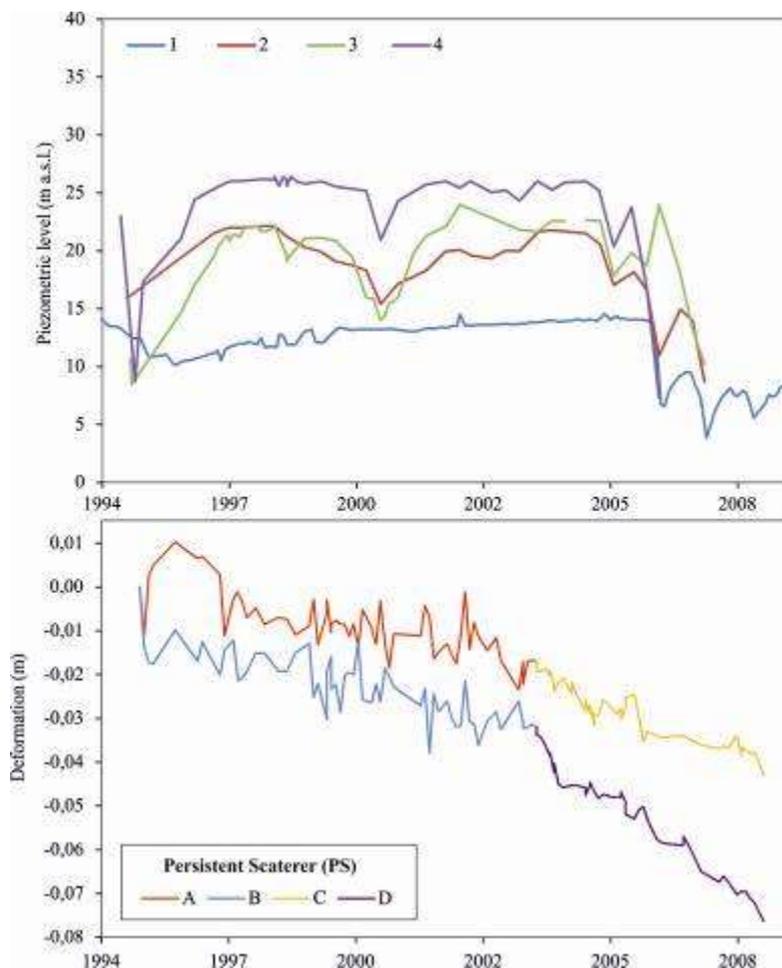
232 Figure 7. Piezometric level evolution of several piezometers located in the Vega Baja of the  
233 Segura river superposed to DInSAR deformation time series of 2 PSs located in the vicinity of  
234 the Santos Justa and Rufina church (see A, B, C and D PSs location in Figure 9 and 1, 2, 3 and

235 4 piezometers location in Figure 3). Notice that PS time series of both DInSAR processed  
236 periods has been jointed for neighborhood PSs in order to have complete temporal series for  
237 1995-2008.

320 been proved to be closely related with piezometric level changes (Figure 7) suffering an  
321 important acceleration when the piezometric level dropped drastically from 2004 to 2008.  
322 Although no PSs are available for the Santas Justa and Rufina church due to the loss of  
323 coherence derived from the maintenance works performed in its cover, subsidence rate values  
324 up to -21 and -95 mm per year have been measured for 1995-2006 and 2004-2008 periods,  
325 respectively, in the nearby areas of the church (Figures 7 and 9). Computed differential  
326 settlements using interpolated maps provide maximum differential settlements affecting the  
327 church of 12.5 and 24.5 mm for 1995-2006 and 2004-2008 periods, respectively. As it can be  
328 notice, these values are lower than the general rule of 25.4 mm (equals to 1"; Terzaghi et al.,  
329 1996) of acceptable maximum differential settlement, although during the second period

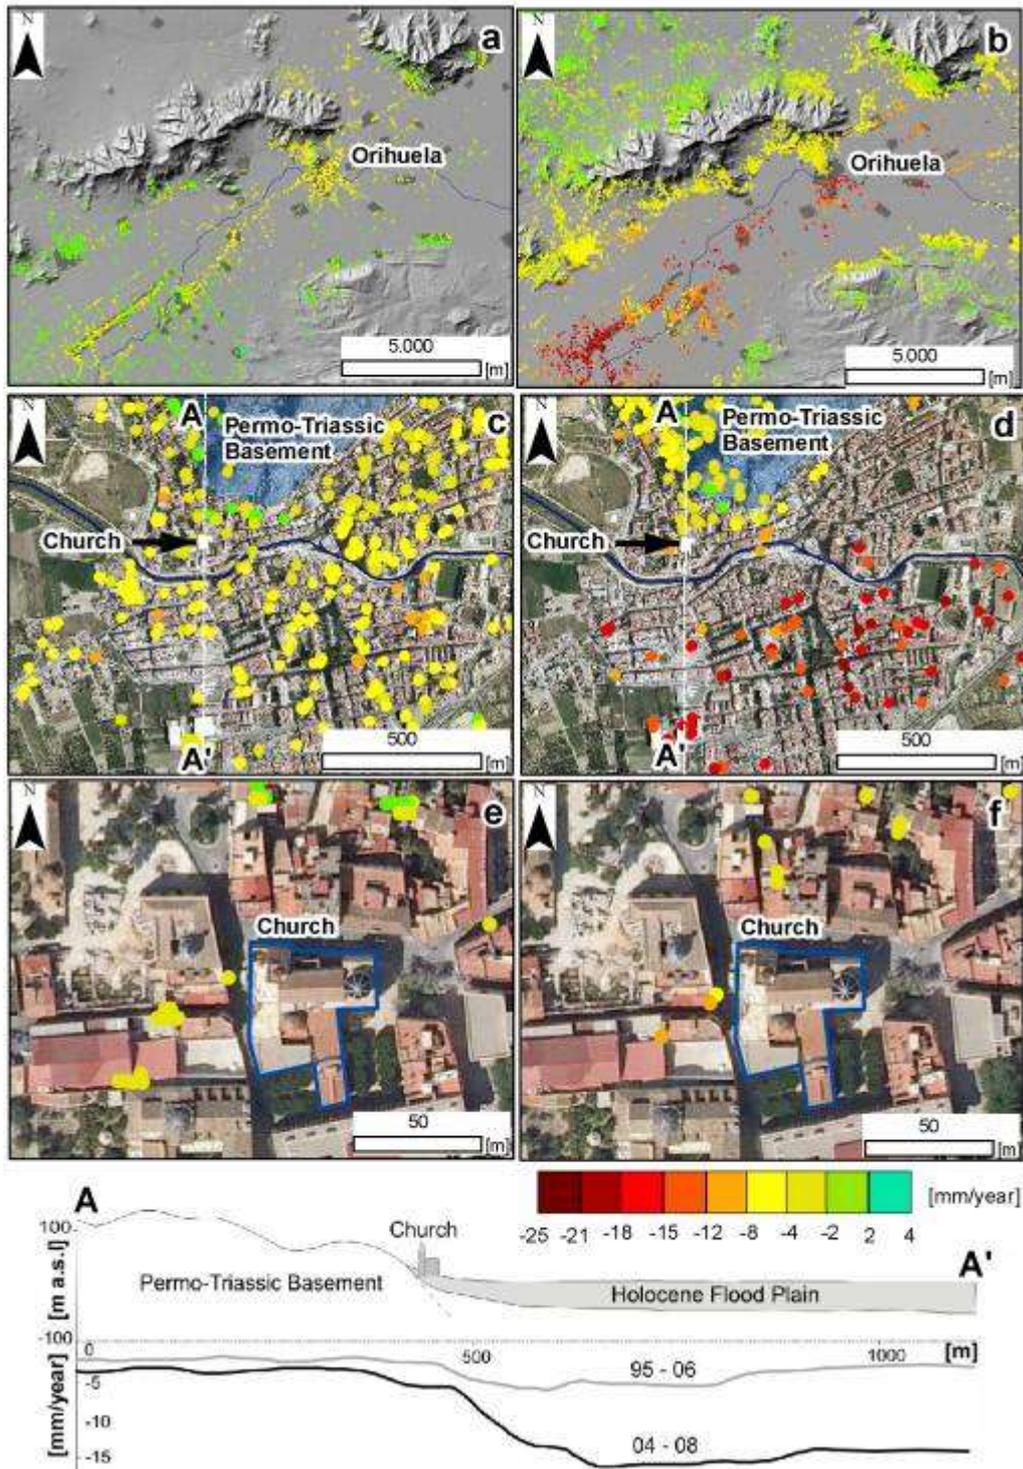
265 Results of subsidence in the city of Orihuela for both periods (1995-2005 and 2004-2008) are  
266 shown in Figure 8. As it can be seen in figure 8a and b, the higher density of PSs corresponds  
267 to the urban area of Orihuela. In the Santas Justa y Rufina church neighborhood deformation  
268 rates up to -2.1 and -9.5 mm/year for 1995-2005 and 2004-2008 periods respectively have been  
269 measured by means of DInSAR (Figure 8a to 8d). Notice that subsidence measured for 2004-  
270 2008 period in the vicinity of the church is higher than the measured deformation for the

277 Figure 8g represents N-S cross section of the study area. As it can be noticed, Holocene  
278 sediments from the flood plain of the Segura River increase their thickness from the north  
279 towards south (from the Sierra de Orihuela relief towards the center of the basin). Subsidence  
280 follows a similar trend. The Santas Justa and Rufina church is just located near the Sierra de  
281 Orihuela that is composed of carbonatic rocks (dolostones and limestones). This relief deepens  
282 under Holocene sediments with high slopes causing important changes in substratum depth as  
283 it has been observed in the available boreholes performed in the church perimeter (Figure 4).  
284 These substratum changes favor differential settlements occurrence. Differential settlements  
285 affecting the church have been computed interpolating the available data for both study periods  
286 (Figure 9). The maximum differential settlements have been calculated considering the highest

287 and the lowest subsidence values contained in an area composed by the church and a buffer  
288 ring of 14 m providing 12.5 and 24.46 mm for 95-06 and 04-08 periods respectively. The  
289 angular distortion has been obtained dividing differential settlement by the distance between the  
290 two points that provides the maximum and minimum subsidence value. Computed distortion  
291 values for both periods are  $1.5 \times 10^{-4}$  m/m and  $3.4 \times 10^{-4}$  m/m.

294 Figure 8. Subsidence measured by means of DInSAR for 1995–2005 and 2004–2008 periods:

295 a) and b) for the whole study area; c) and d) in Orihuela city; e) and f) in the vicinity of the

296 church; g) Geological simplified and subsidence N-S cross section along Orihuela city.

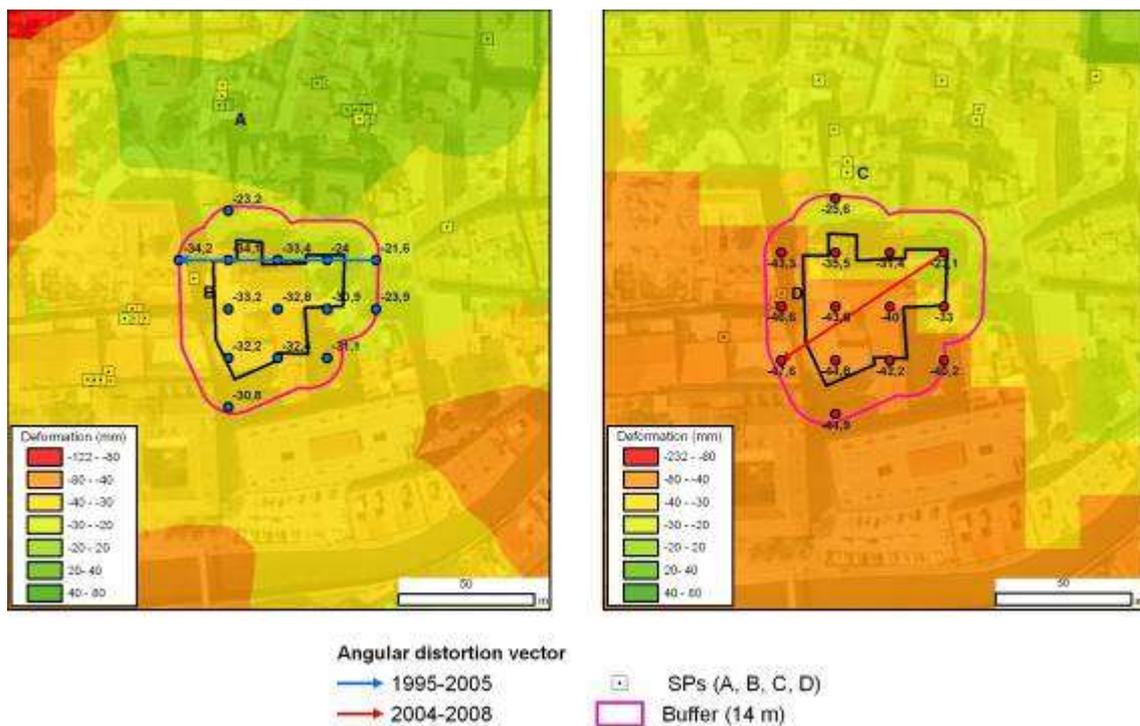
313 Figure 9. Interpolated DInSAR subsidence in the vicinity of the Santas Justa and Rufina church  
314 and computation of differential settlements and maximum deformation gradients for 1995-2006  
315 and 2004-08 periods. Notice that the arrow indicates the direction of maximum deformation  
316 gradient.

333 The interpolated subsidence values of subsidence also allow interpreting the deformational  
334 evolution of the church. As it was explained in section 5, in the ninety decade, high settlements  
335 affected the San José chapel zone. Figure 9a shows that the maximum settlements for 1995-  
336 2006 period were concentrated on the NW corner of the church, just coinciding with the  
337 mentioned area. Also notice that the computed angular distortion (blue arrow) is oriented from E  
338 towards W coinciding with the San José chapel zone. The foundation was repaired in 2002  
339 using micropiles. More recent damages are concentrated in the SE zones (La Comunción  
340 chapel, antesacristy and sacristy; Figures 6). As it was explained in section 5 field work has  
341 been performed in order to identify the damages affecting this area. Observed damages consist  
342 principally on floor settlements (pavement irregularities are easily recognized) and wall cracks

343 that can affect other elements. Figure 9b shows that maximum interpolated settlements for the  
344 2004-2008 period are concentrated on the SW corner of the church with a maximum angular  
345 distortion direction NE-SW (the church has undergone a tilt towards the SW) in agreement with  
346 field observations.
