Building monitoring during the partial implosion stage

J. Garcés¹, J.C. Botero¹, D. Murià-Vila²

(1) Universidad EAFIT - Colombia, (2) Instituto de Ingeniería- UNAM – México

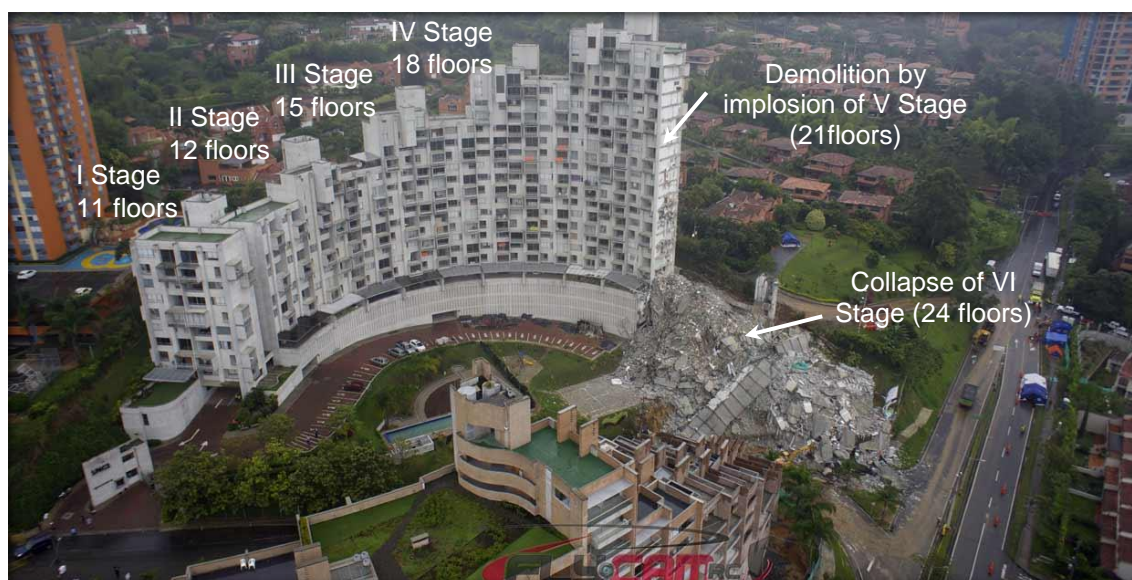
On October 12, 2013 the SPACE building located in Medellin city, Colombia, suffered a partial collapse of the VI stage that caused damages in the rest of the building (Figure 1). Those damages affected notably the stage V; therefore its demolition was necessary and was done on Thursday February 27 2014 at 13:52 UTC hours, through an implosion process. EAFIT University performed the monitoring survey of the remaining four (4) towers in order to register their behavior and to obtain the dynamic properties of the structure through a period of thirty (30) days after the implosion.

Figure 1. SPACE building after collapse of VI stage

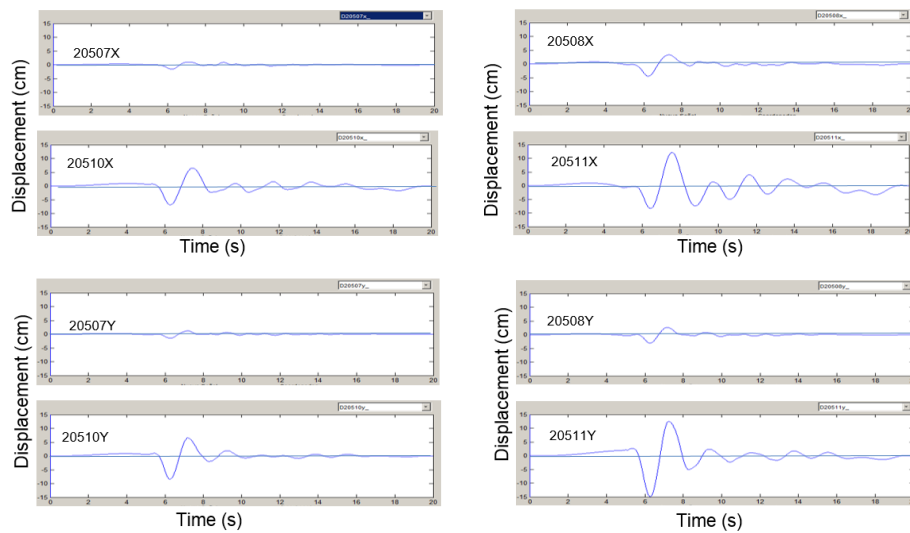
In Figure 4 the historical relative displacements to the structure base, produced by the implosion are shown. It is noteworthy that some initial displacements are seen before the implosion, which are the result of the signals numerical integration process and also suggests a possible rotation of the building at the base due to the implosion.

Figure 4. Relative displacements registered obtained for the X and Y axes on the implosion event (VF01)

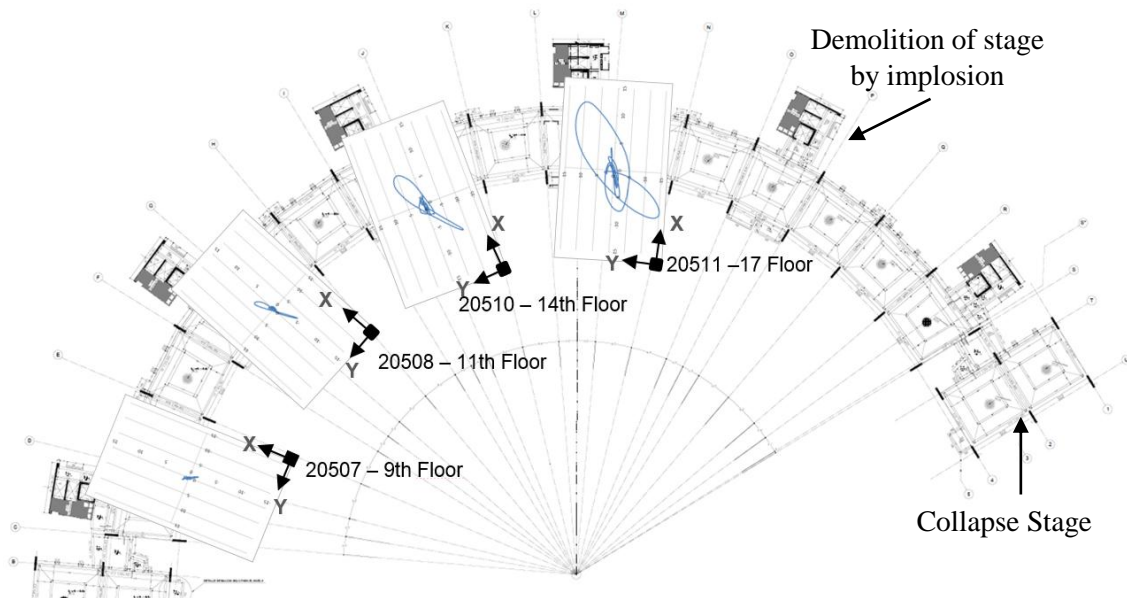
Figure 5 shows the trajectories of movement in the horizontal plane made by each point of the structure where the sensors are placed, making it possible to display the horizontal movements of the building after the implosion of stage V. It can be noted that the movement sensor 20511 located on the 17th floor and close to the implosion area, presents an elliptical motion which happens to be about 10 times higher than that recorded by the sensor 20507 in the 9th floor for both X and Y directions .

Figure 5. Horizontal path journeys made by the spots where sensors were placed

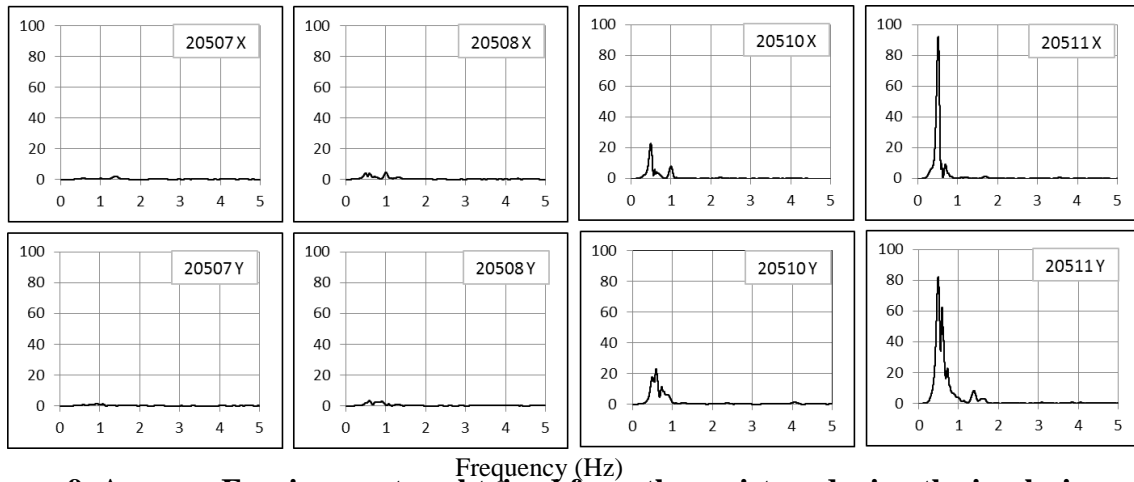
Figure 9 shows Fourier spectra associated with the implosion of stage V. In this case it was observed that the frequencies associated with the first mode were equal to 0.51 and 0.69 Hz, for the X and Y directions respectively. Values of 1.00 and 1.40 Hz for the second mode were obtained for the X and Y directions respectively. The variation of these frequencies compared to previous cases obeys to nonlinear changes occurred due to the loss of mass and stiffness at the implosion and due to the increased levels of acceleration. Similar results have been reported by (Murià-Vila, 2007).

Figure 9. Average Fourier spectra obtained from the registers during the implosion VF01

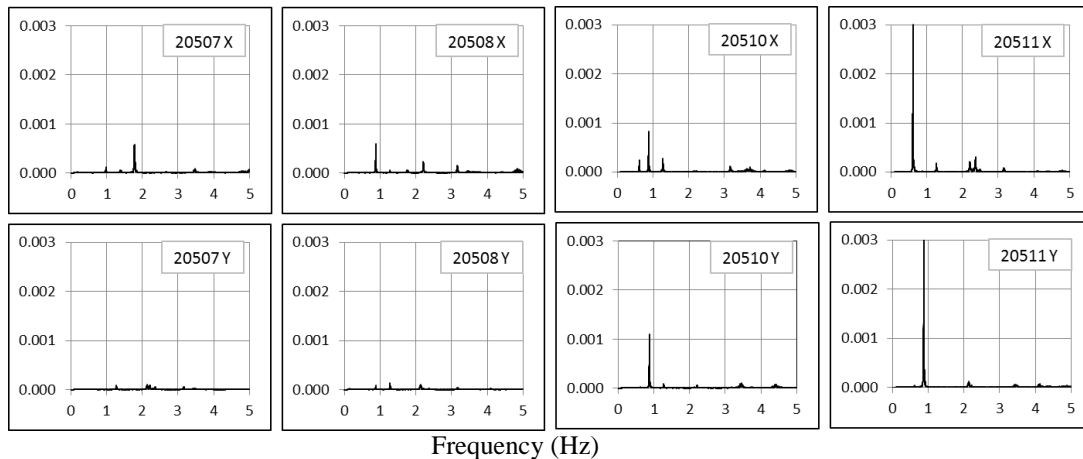
After the implosion an ambient vibration test (VA03) was performed. For this new structure frequencies associated with the first mode close to 0.74 and 0.99 Hz, for the X and Y directions respectively were obtained. For the second mode frequencies for the X and Y directions respectively were close to 1.40 and 1.79 Hz.

Figure 10. Average Fourier spectra from the ambient vibration test VA0

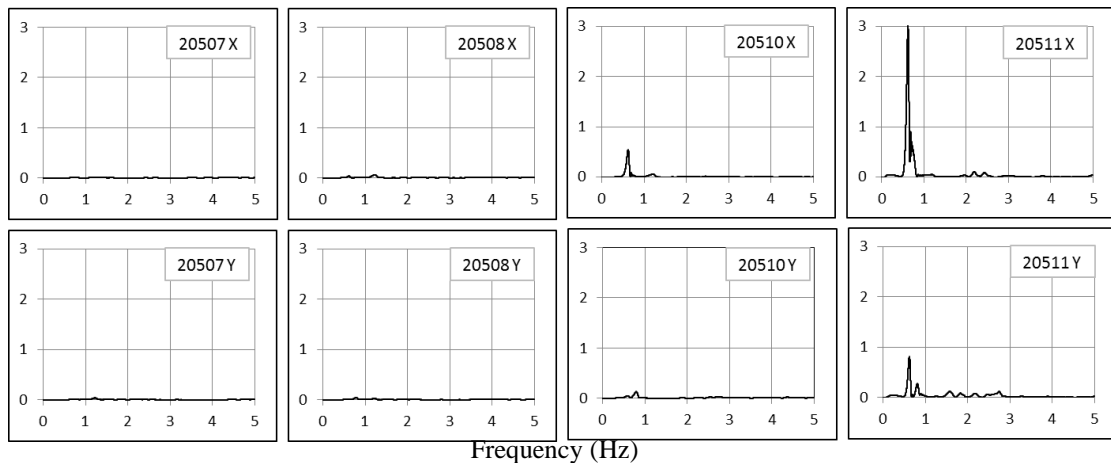
Forced vibration test associated to the controlled demolition of the slabs that were hanging after the implosion (VF02) shows variations in the frequency due to the explosive charges and to the collapse of stage V. For this case frequencies associated to the first mode were obtained equal to 0.63 and 0.82 Hz, for the X and Y directions respectively. For the second mode the obtained frequencies were close to 1.23 and 1.59 Hz, for X and Y directions respectively.

Figure 11. Average Fourier spectra calculated from the registers obtained during the demolition of the slabs attached in the IV Stage IV VF02

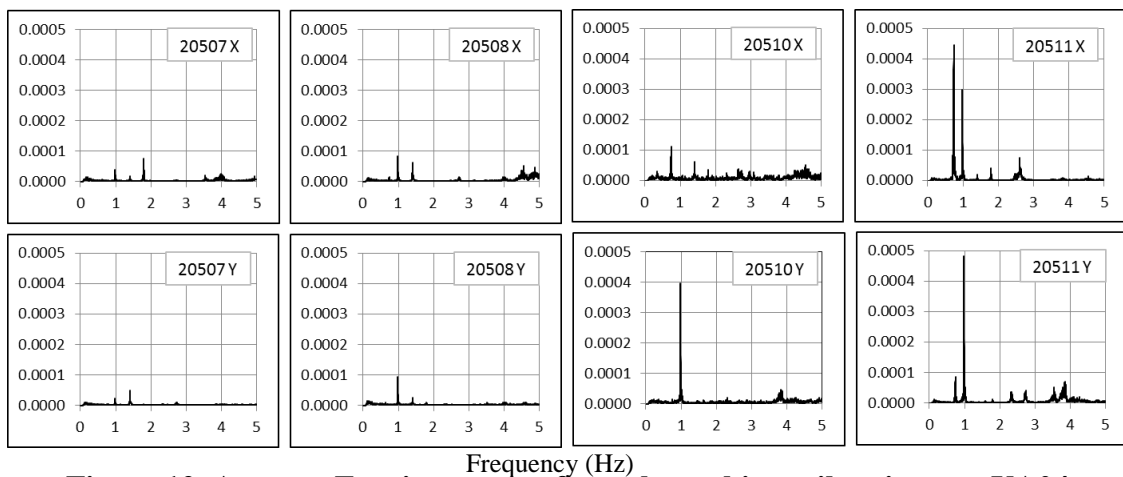
Figure 12. Average Fourier spectra from the ambient vibration test VA04

The final ambient vibration test (VA04) was performed after the controlled demolition and the same frequencies reported in the case VA03 were obtained.

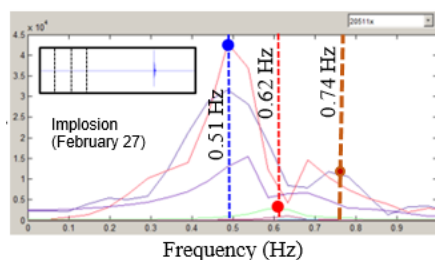
An important aspect that was observed during implosion corresponds to the variation of the fundamental frequency in the X direction. Before the implosion, the first mode frequency had a value of 0.62 Hz. During the implosion this value decreased to 0.51 Hz and after the implosion the frequency stepped to 0.74 Hz. This change is shown in Figure 13 where Fourier spectrums are illustrated in sections. A record of 30 minutes was taken and windows of 20 s, approximately were generated. This allowed seeing the frequency evolution during the implosion of stage V.

Figure 13. Average Fourier spectra by tranches during the process of implosion and demolition
