Fatigue initiation and crack growth behaviour in GLARE from the Airbus MegaLiner Barrel test

Teardown fractography of a GLARE window panel (F4) from the Airbus MegaLiner Barrel (MLB) fatigue test.

NLR-TP-2006-276

May 2006

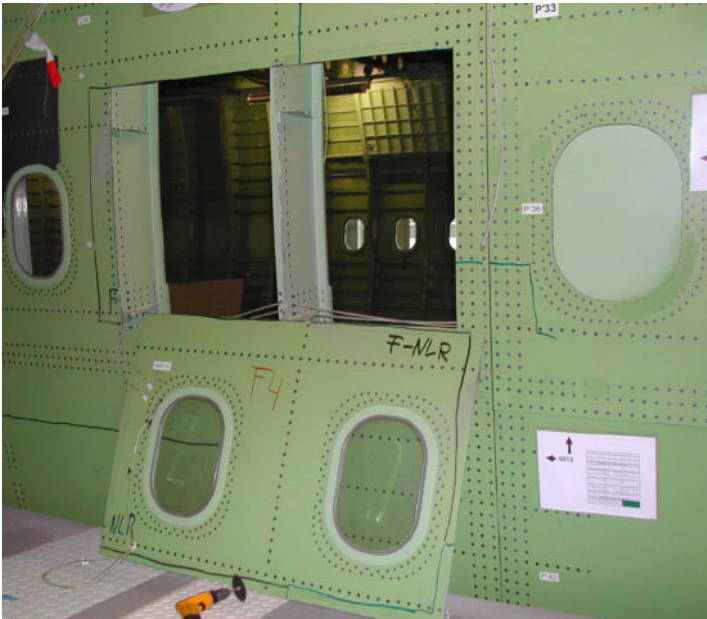
Fig. 1 GLARE window area cut from the MLB

Figure 1 shows the GLARE window area after its removal from the MLB. The windows are A340 shape rather than the A380 elliptical ones. This difference is unimportant for the present work. This window area was in the lower row of starboard windows, midway along the MLB. The basic structure is a GLARE 3-7/6-0.3/0.4 skin fastened to die forged 7175-T73 aluminium window frames by press fit 3/16" (4.76mm) Hi-Loks. The GLARE code means seven 2024-T3 aluminium layers 0.3mm thick (five inner layers) or 0.4mm thick (two outer layers), interleaved with six glass fibre layers.

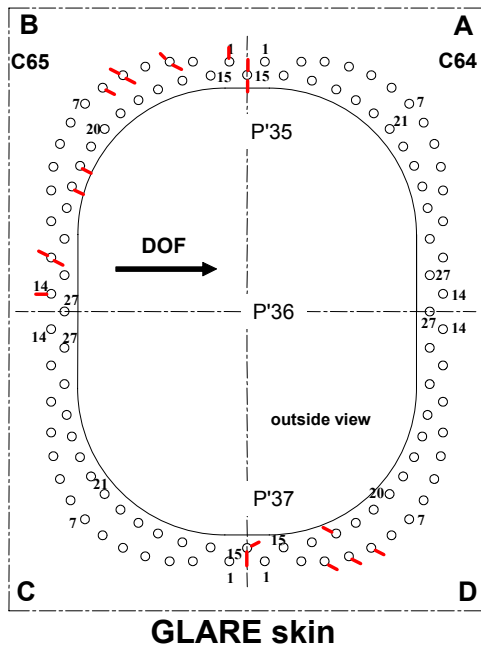
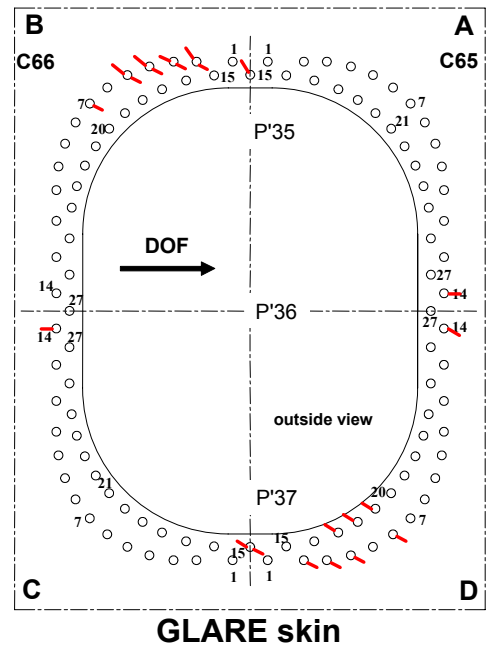
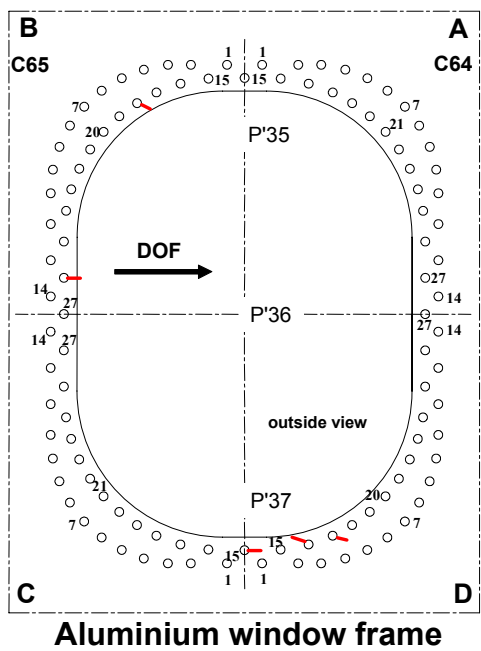
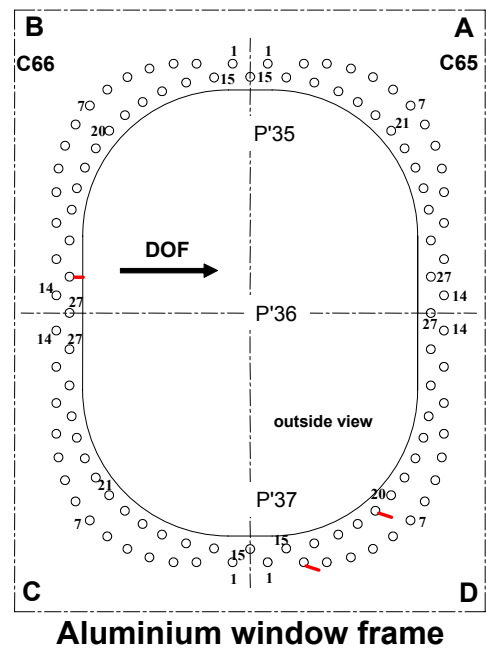
Fig. 2. Overviews of the crack indications from NDI of the fully disassembled GLARE skin and aluminium window frames. *DOF* = Direction Of (simulated) Flight

Figure 2 gives an overview of the NDI results after fastener removal and separation of the GLARE skin and aluminium window frame. These results were obtained from eddy current pencil probe rotor inspections of the fastener hole bores. The GLARE contained many more crack indications than the window frames, mostly in the **B** and **D** quadrants. These were the quadrants largely subjected to shear loads during the MLB fatigue test.

The largest crack in the aluminium window frames was at fastener hole D19 in window area C65-C66, see figure 2. This crack was quarter-elliptical with length 1.68mm normal to the fastener hole bore. This direction was selected for fractographic analysis.

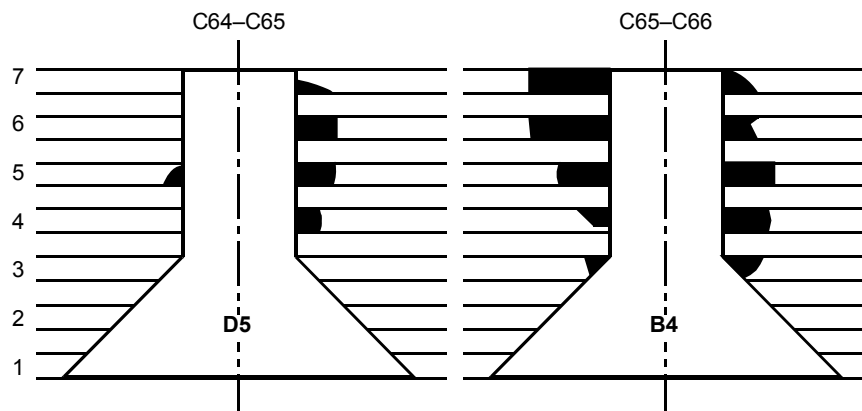
Fig. 4 Examples of GLARE cracking

Figure 4 gives representative examples of the cracking patterns in the aluminium layers of the GLARE skin. Most cracks were in the fastener hole bores, the largest mainly in layer 5. Only a few cracks grew from the countersinks, and only in layer 3.

The R.H. example in figure 4 shows the fastener hole (B4, C65-C66) with the largest GLARE cracks. These were 0.91 and 0.95mm long. The crack in layer 6 was selected for detailed fractography.

The smaller cracks in figure 4 show that they began from one or both corners of an aluminium layer. This was also the case for all the other cracked fastener holes in the GLARE skin. Thus the most likely causes of fatigue crack initiation, besides the severity of the applied fatigue load spectrum, are the stress concentrations provided by these corners.

However, this does not explain why many more cracks began in the fastener hole bores (layers 4 – 7) rather than in the countersinks (layers 1 – 3), where there are so-called “knife edges”. It is possible that local secondary bending favoured fatigue initiation in the fastener hole bores. Support for this possibility comes from the window frame cracks. These were all corner cracks with maximum dimensions along the fastener hole bores.

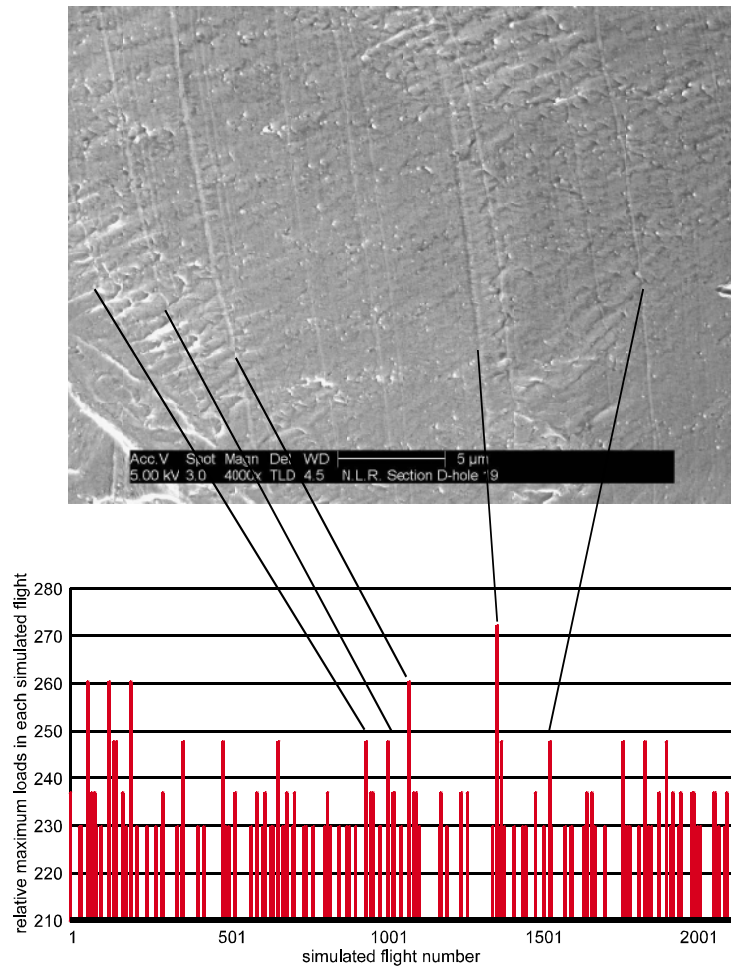
Fig. 5 Example identification of severe flights from crack front markings by peak loads

FEG-SEM fractography showed that fatigue fracture was a mixture of faceted and mainly continuum-mode areas. The latter contained evident crack front markings due to the peak loads in severe simulated. flights.

Figure 5 gives an example of identifying the severe simulated flights, notably flight types A, B and C. The crack front markings from these flights were mostly sufficient for tracing fatigue crack growth back to a small crack length. However, the fainter crack front markings from D type flights helped in checking the numbering of B and C type flights. In general, the fractographic “readability” was excellent.

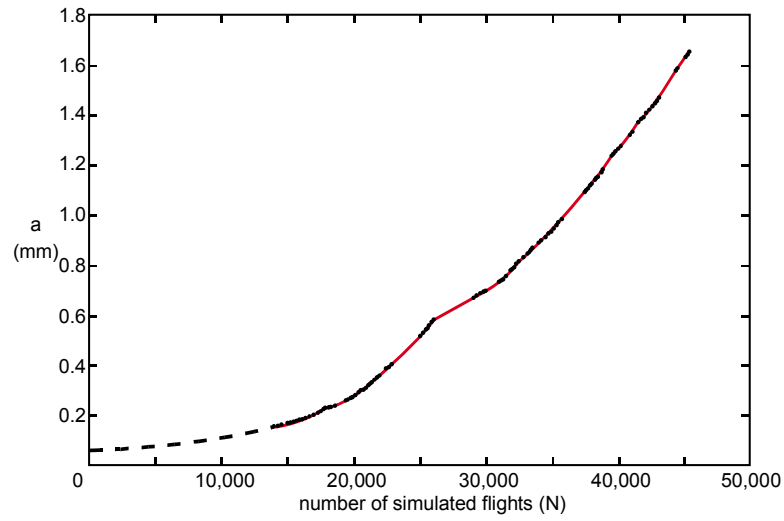
(a) Crack length *versus* number of simulated flights

Figures 6a and 6b show the curves of a versus N and da/dN versus a^* , respectively. Both show the effects of severe simulated flights, pointed out explicitly in figure 6b. Most of these effects appeared to be transient. However, beginning at a crack length of about 0.6mm there was a persistent retardation of fatigue crack growth. This could be due to termination of the “short crack effect”. This effect is well known, and is generally attributed to no fatigue crack closure in cracks smaller than about 0.5mm. Thus once the window frame crack grew beyond 0.5mm, closure-induced retardation due to peak loads in severe simulated flights would have become possible.

The a versus N curve in figure 6a suggests that the fatigue “initiation” life was zero, and that there was an initial crack size of about 0.06mm. In fact, the crack initiated from a fretting scar due to fastener movement against the bore of the fastener hole [2]. This explains the effectively zero fatigue “initiation” life [3] and also the indication of an initial crack size, which was most likely due to the fretting scar.

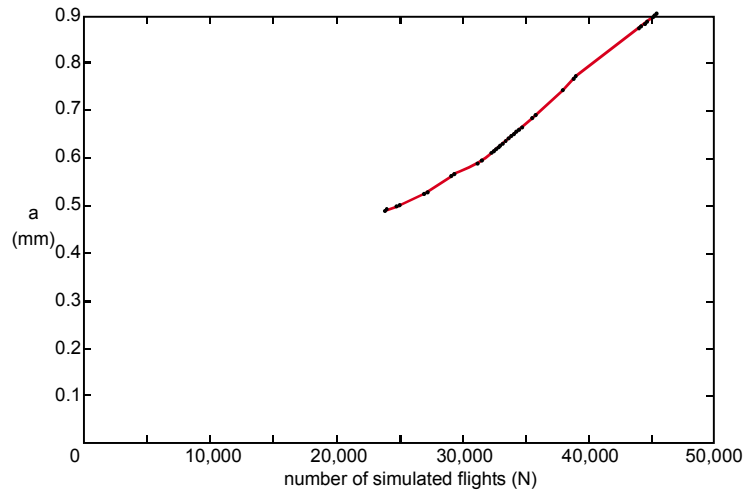
(a) Crack length *versus* number of simulated flights

As stated in subsection 4.2, the selected crack was in aluminium layer 6 of fastener hole B4 in window area C65-C66. Figure 7 presents the same types of crack growth curves as those for the window frame crack. The data are limited, but enough to show a growth rate “plateau” at about 50% of that for the aluminium window frame.

Back-extrapolation of the a versus N curve in figure 7a is unfeasible, owing to the limited data. The crack could not be traced back to less than 0.45mm, owing to too closely-spaced crack front markers. Hence an estimation of the fatigue “initiation” life is not possible.
