NLR-TP-2003-441

Fatigue of air supply manifold support rods in military jet engines

This report is based on an article submitted to the journal "Practical Failure Analysis".

Bending fatigue failure occurred in a support rod linking the bleed air supply manifold to the diffuser case in a military jet engine. Other rods were subsequently found cracked. The rods were wrought Inconel 718, operating at about 550 °C. The bending was caused by relative movements of two expansion sleeves held together by the rods, whereby accommodatory swivelling of the spherically-rounded ends of the rods in the mating seatings of the inner sleeves was prevented by contact pressure, fretting and binding. The main reason for binding would have been decomposition of the anti-galling compound applied to the contact surfaces. Fractographic analysis and oxidation interference colours enabled interpreting the cracking history of the broken rod. Elementary stress and fracture mechanics calculations indicated that the maximum fatigue stress would have been below the stress needed to "unlock" the spherically-rounded rod end from its seating.

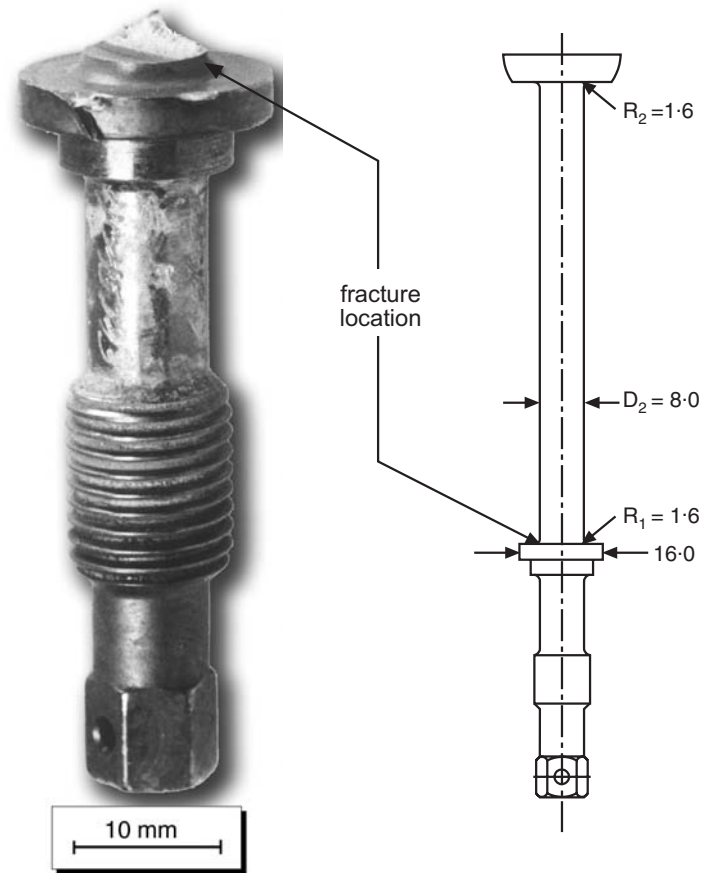
An in-flight fire warning occurred in a military jet aircraft. Post-flight inspection showed that a bleed air supply manifold support rod had broken, see figure 1. This rod had held together two expansion sleeves linking the compressor bleed air supply manifold to the turbine diffuser, see figure 2. Fracture of the rod allowed separation of the expansion sleeves and hot (550 °C) bleed air to impinge on the surrounding airframe.

Fig. 1 Broken rod, and sketch of intact rod, showing spherically-rounded end. Indicated dimensions are nominal (mm)

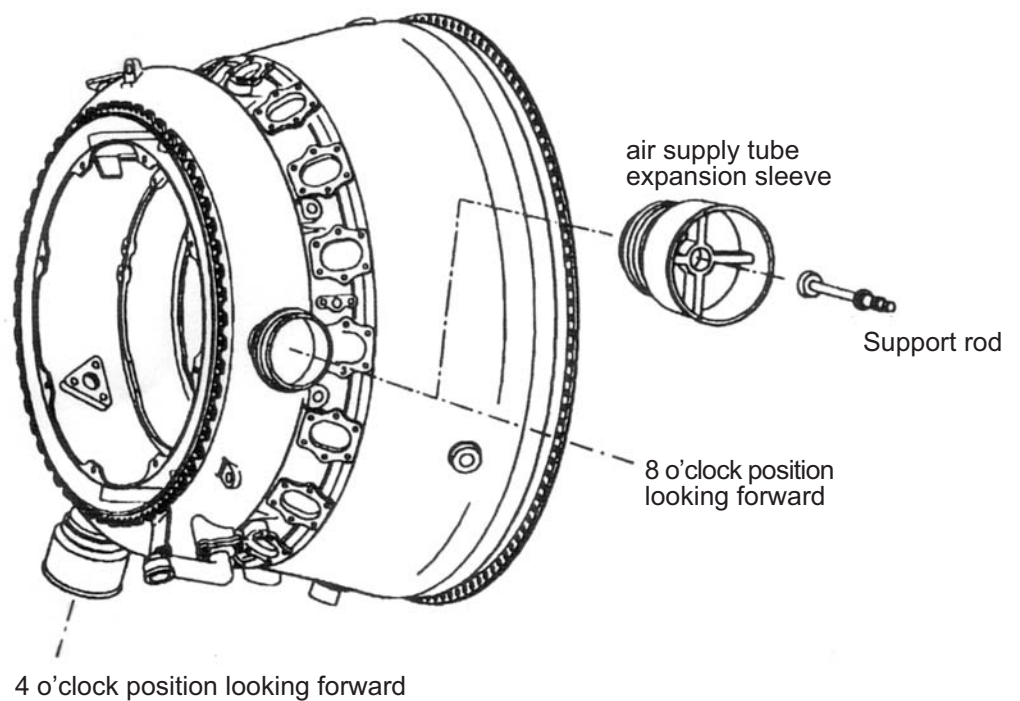
Fig. 2 Diffuser case and one air supply tube expansion sleeve and a support rod (broken in the incident engine)

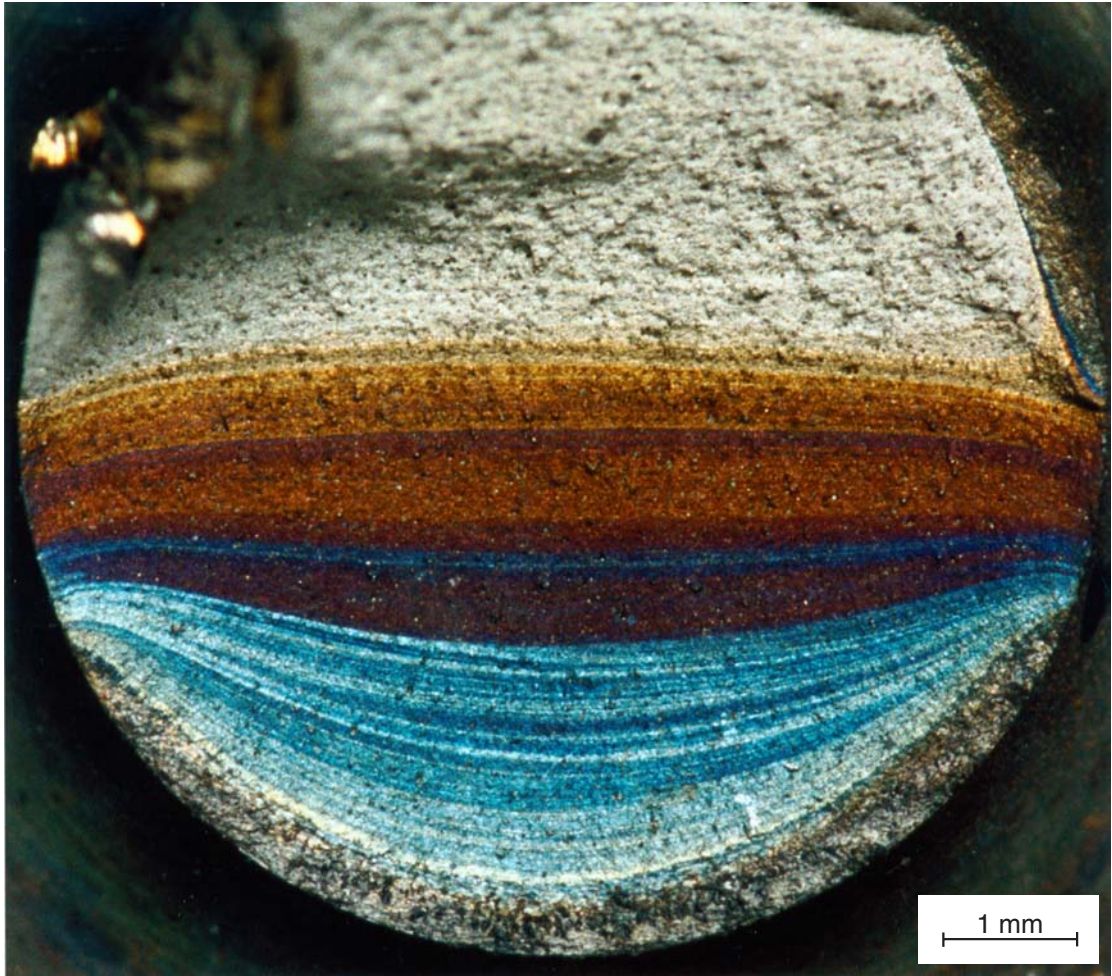
Figures 3 and 4 show the actual and schematic fracture surfaces of the broken rod. There were two locations of fatigue initiation and crack growth. The older fatigue area shows both 1st and 2nd order interference colours (discussed later) and is centered on the 2 o'clock position in figures 3 and 4. The more recent main fatigue crack shows 1st order interference colours and is centered on the 6 o'clock position. The shapes of the early fatigue crack fronts are diagnostic for

The actual and schematic fracture surfaces are shown in figures 3 and 4. The minor fatigue crack at the 2 o'clock position showed 2nd order interference colours down to blue at the circumference of the rod. Under the influence of the main fatigue crack, this older minor crack began to grow again from 2nd order yellow through silver (the silvery hiatus) to the 1st order colours blue, brown and finally yellow.

Figure 8 shows that silver became dominant after furnace oxidation for 370 hours, but figure 3 shows that Stage II fatigue began in the light blue region, with some Stage I fatigue also in the light blue region. Thus Stage II fatigue in the broken rod probably took considerably less than 370 hours. This is returned to in the discussion section of this paper.

Furthermore, these calculations indicate a dominating contribution of bending stress. The shapes of the early fatigue crack fronts in the broken and cracked rods, for example figure 3, are consistent with stresses primarily due to bending.

Fig. 3 Macro photograph of the fracture surface of the broken rod

This investigation led to two obvious recommendations. First, all the other air supply manifold support rods in service should be inspected for cracks. This would be a regular addition to the normal maintenance T.O. Second, the MoS₂ + binder anti-galling compound should be replaced by a compound with temperature capability well above 600 °C. Both recommendations were implemented.

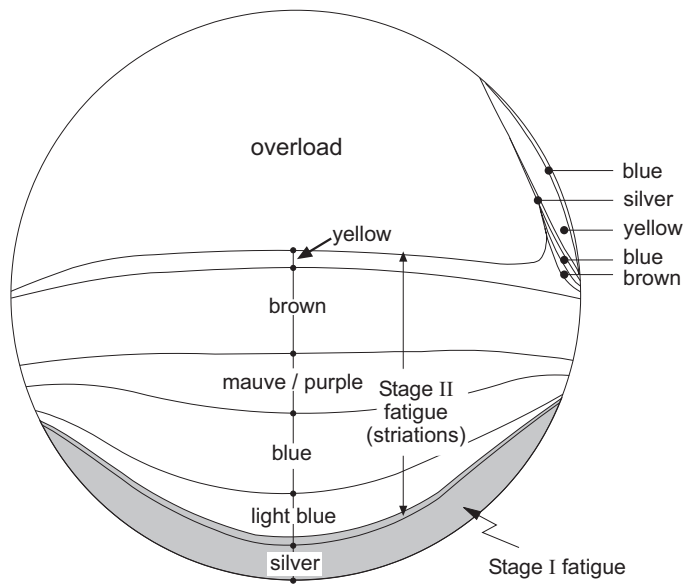
Figure 4 indicates that the main fatigue fracture surface of the broken rod consisted of Stage I and Stage II fatigue. This was inferred from changes in fracture topography, figure 5, and similar topographical changes on less-oxidised fatigue fracture surfaces from a cracked rod and low-cycle fatigue (LCF) specimens from a test programme^[1]. Stage I fatigue is common in precipitation - strengthened nickel-base superalloys, like Inconel 718, and occurs in both LCF and high-cycle fatigue^[2].

The predominance of fatigue striations on the Stage II fracture surface of the main crack in the broken rod prompted striation and "beach marking" counts. Numerous measurements of striation spacings resulted in an estimate of 14,500 cycles for the entire Stage II region, see figure 4. This is LCF.

Now consider the main crack shown in figures 3 and 4. At the transition from Stage I to Stage II fatigue the crack shape is approximated by a partly annular surface flaw with a depth-to-length ratio of 0.06. For this geometry, with a crack depth of 0.54 mm in an 8 mm diameter rod, the NASA/FLAGRO SC09 stress intensity factor solution for a crack in bending^[12] gives $K/\sigma = 0.048 \sqrt{m}$. Substituting $K_{\max} = 11.7 \text{ MPa} \sqrt{m}$, and writing σ_{\max} for σ , gives $\sigma_{\max} = 244 \text{ MPa}$.

Fig. 4 Schematic of the fracture surface of the broken rod, listing fracture characteristics and oxidation interference colours

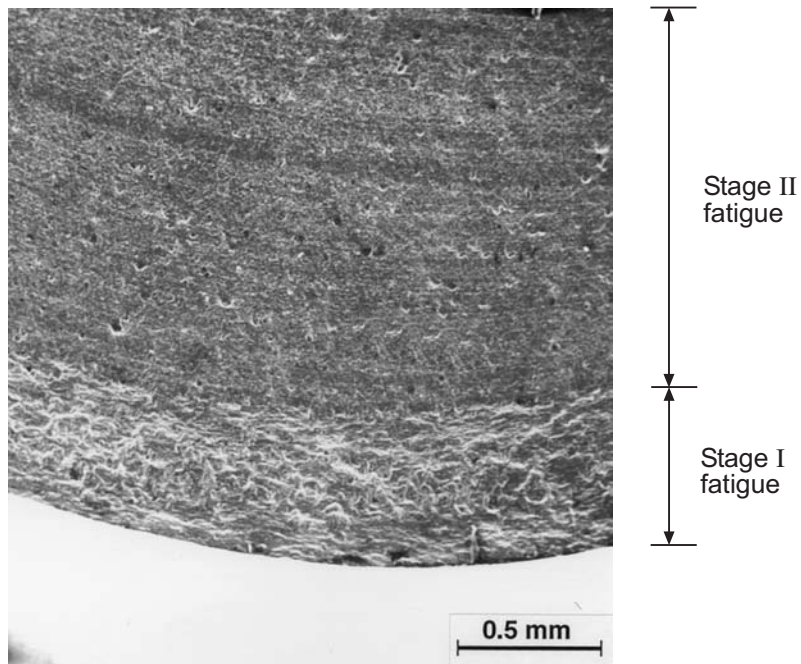
Besides a change in fatigue fracture topography, figure 5 shows numerous "beach markings" representing positions of the Stage II fatigue crack front. Figure 6 is a detail of the Stage II fracture surface, showing virtually complete coverage by fatigue striations. This was also the case for the Stage II fracture surfaces of the broken-open cracks.

At a crack depth of 0.54 mm the main crack in the broken rod made a transition from Stage I to Stage II fatigue, see figure 5. According to Runkle and Pelloux^[2] such transitions depend on the crack tip cyclic plastic zone size becoming larger than the grain size. Under nominally plane strain conditions the cyclic plastic zone has a "butterfly-wing" shape, with its longest dimension, r_y^c , roughly normal to the path of the fatigue crack. From Wanhill and Looije^[10]:

Fig. 5 SEM mesofractograph of Stage I → Stage II fatigue transition for the main crack in the broken rod: see figure 4 also

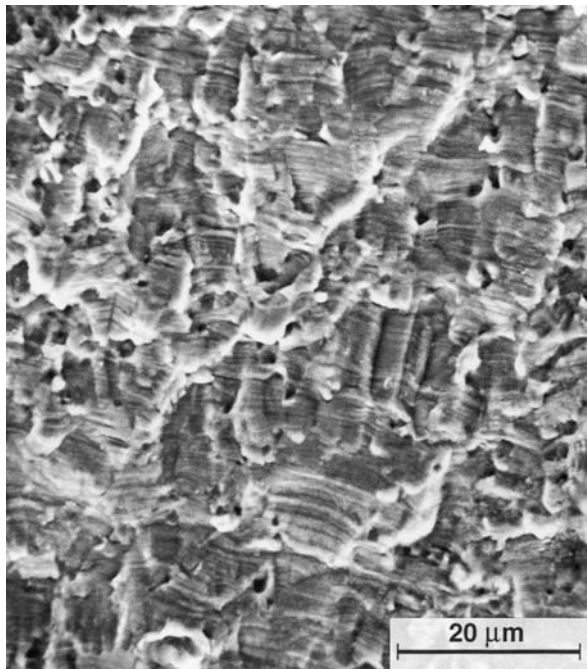
Fig. 6 Detail of figure 5 in the Stage II region, showing fatigue striations

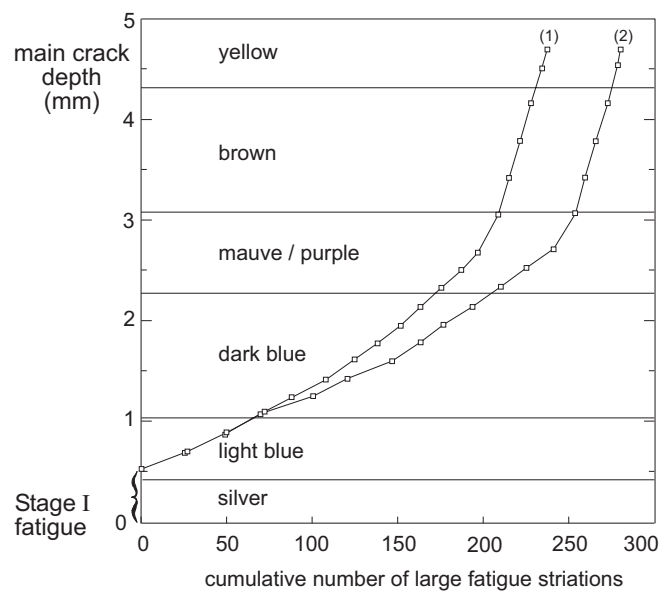
magnification of 200X, with details at up to 1000X. The mapping revealed periodic large fatigue striations. These were counted by two independent investigators. Figure 7 shows the results related to the main crack depth and the broad divisions of oxidation interference colours. If the large striations were to correspond to starting the engine, then figure 7 would indicate a Stage II fatigue life of about 250 flights. However, as argued in the discussion section of this paper, it is most likely that the large striations represent peak load excursions that occurred more than once per flight.

Fig. 7 Cumulative number of large striations for the Stage II fatigue region of the main crack in the broken rod: (1) and (2) are independent measurements by two fractographers

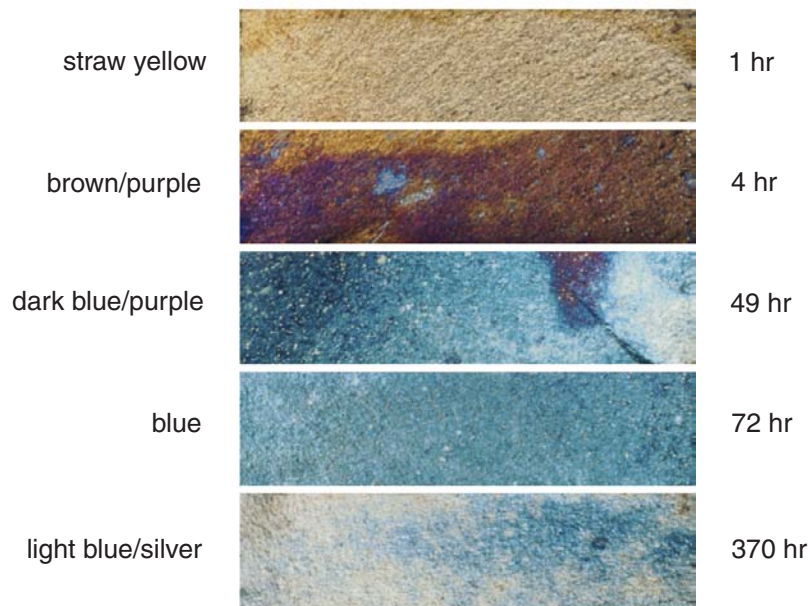
surfaces were sliced in the crack growth direction and furnace oxidised for different times in air at 550 °C. Figure 8 shows a selection of the results. Within 1 hour the initially metallic grey fracture surfaces became straw yellow. Within 4 hours a mauve/purple colour became dominant. Thereafter, the rate of colour change decreased considerably, as would be expected from the kinetics of oxidation and film thickening^[5], but it was evident that only blue colours were present after about 50 hours oxidation, and that the silvery hiatus was becoming dominant at 370 hours.

Fig. 8 Furnace oxidation of Inconel 718 Stage II fatigue fracture surfaces at 550 °C

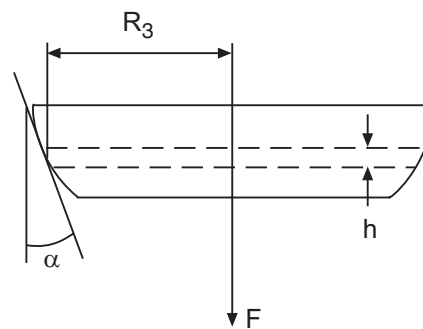
2. *Contact stress from pressure on the spherically-rounded end.* Figure 9 is a diagram of the situation, with definitions of force and contact stress. Assuming D₂ = 8 mm, $\sigma_{ut} = 183$ MPa, $\alpha = 27^\circ$, average R₃ = 10.25 mm, and h ~1 mm, the maximum contact stress is $\sigma_{c,max} = 315$ MPa. This contact stress is substantial and could prevent swivelling, depending on the friction between the rod end and the mating seating of the expansion sleeve.

3. *Swivelling moment on the spherically-rounded end.* Since the spherically-rounded end experiences a substantial contact stress, a moment is required to swivel it. The swivelling moment M towards the rod axis is defined in figure 9. Assuming the above values of D₂, σ_{ut} , α and R₃, and a low value of the coefficient of friction, $\eta = 0.2$, then M = 23.56 N.m.

Fig. 9 Force, contact stress and swivelling moment for a spherically-rounded rod end; η is the coefficient of friction; D_2 is the rod diameter, see figure 1. See text for quantification of the formulae

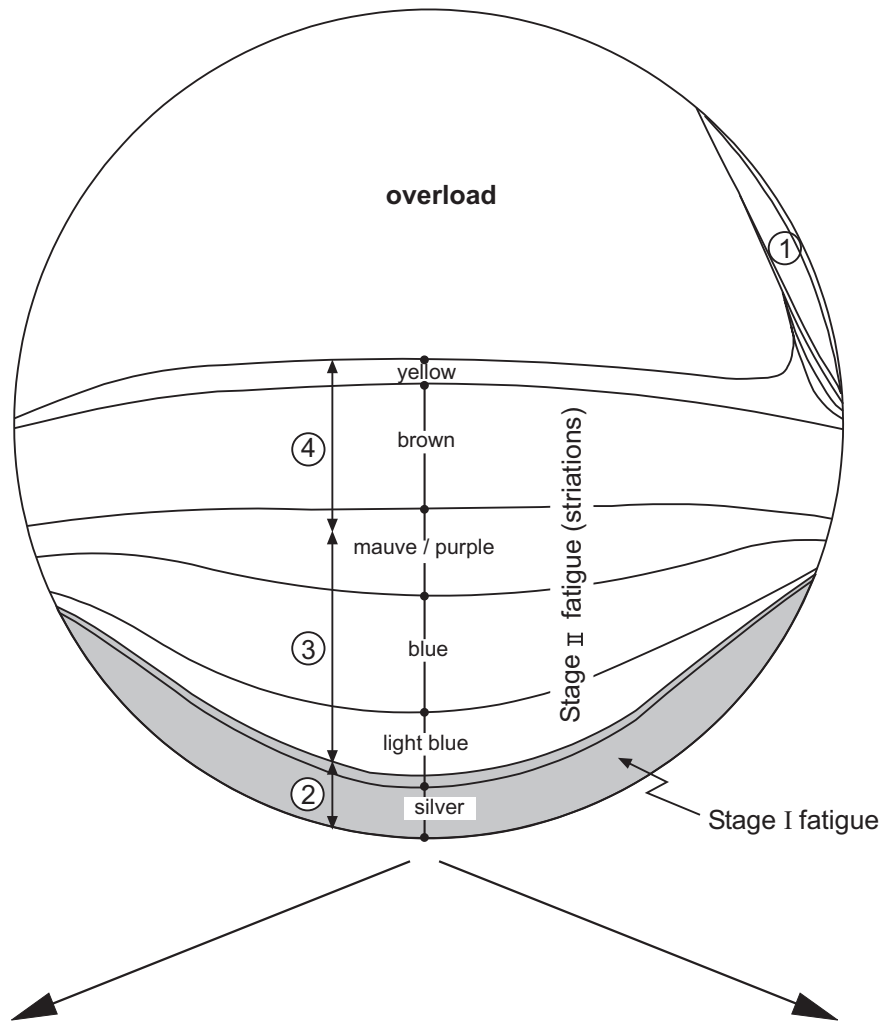
Figure 10 is a summary linking the broken rod fracture surface details with the engine operating history. The secondary crack ① was the first to occur, by bending fatigue. As a result of the first maintenance, the rod was re-installed with an axial rotation such that further growth of the secondary crack was inhibited. Bending fatigue then initiated the main crack by Stage I fatigue ② .

The table in figure 10 gives the most probable history of formation of the main crack fatigue fracture surface. An essential point is that the 2nd maintenance resulted in the rod being in a similar orientation to that between the 1st and 2nd maintenances. Although this might seem unlikely, the alternative would be that the entire main crack grew to failure during the short period between 2nd maintenance and failure. This is incompatible with the interference colour evidence, since a fully completed silvery hiatus would require several hundred hours, see figure 8.

The most probable history of the main fatigue crack is that most – or all – of the fatigue fracture area ② formed during the period between 1st and 2nd maintenance. This leaves the period from 2nd maintenance to failure, 143.5 engine operating hours, as the maximum amount of time to form the fatigue fracture areas ③ and ④. This rationale is compatible with the interference colours on the fracture surface. Furthermore, there were about 55-60 of the submacroscopic interference colour bands on areas ③ and ④. This number agrees well with the number of flights, 57, from 2nd maintenance to failure, and is likely to be no coincidence. Instead, these submacroscopic bands could represent oxidation effects from flight-by-flight heating and cooling, which was not possible in the furnace oxidation tests.

Fig. 10 Interpretation of the relation between fatigue fracture areas and engine operating history for the broken rod
