NLR-TP-2002-294

Patch repair of cracks in the upper longeron of an F-16 aircraft of the Royal Netherlands Air Force (RNLAF)

W.G.J. 't Hart and J.A.M. Boogers

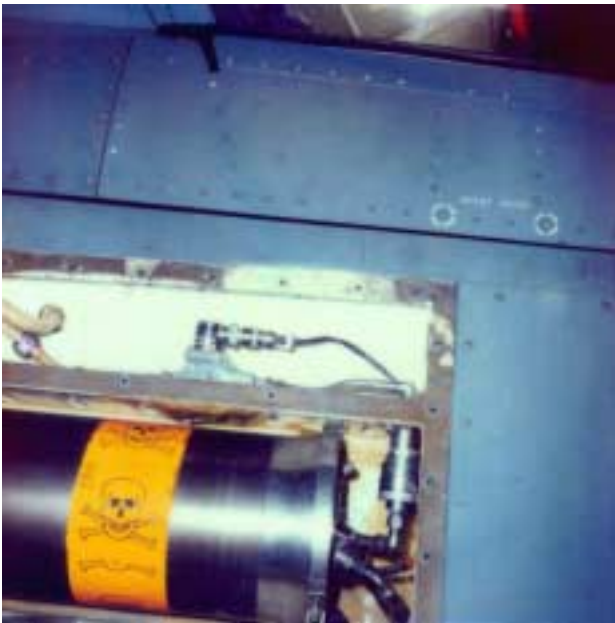
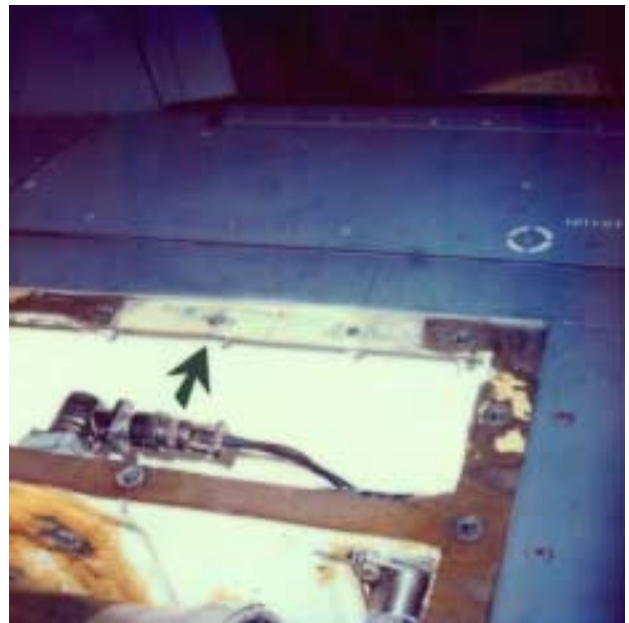
Fig. 1 Cracks in longeron 16B1111 at third fastener hole from the right (see arrow)

During a phase inspection of the RNLAf F-16, cracks were detected in the upper right longeron 16B1111-21, FS 186.90 – FS 247.89. The cracks occurred in the longeron flange for fixing the access panel 2408, at the location of the third fastener hole from the right of the panel, see figure 1. There are two cracks: one in longitudinal direction (outside the hole) and one transverse crack through the hole, see figure 2. The longitudinal crack length is about 70 mm and the transverse crack about 22 mm.

Arrow indicates location of cracks

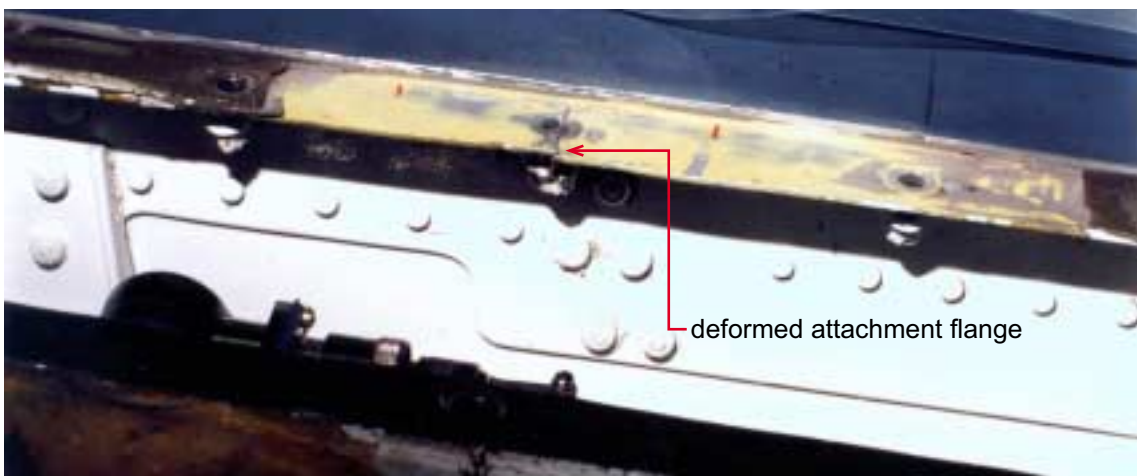
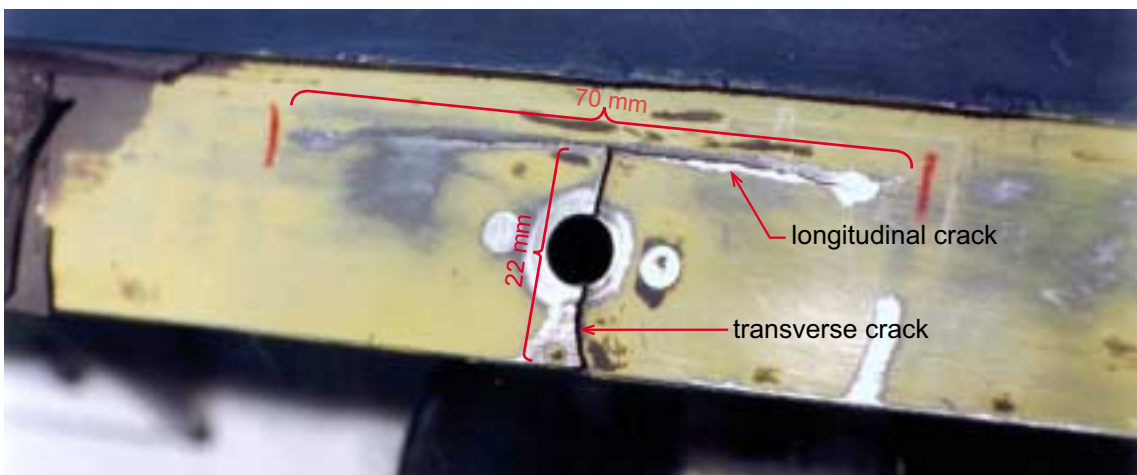
Fig. 2 Details of cracks in longeron

Figure 2 shows the main cracks that were found in the upper attachment flange. In the upper view it is seen that the flange is somewhat deformed and the upper surface shows signs of rubbing. Further, it was observed that the nut riveted to the flange lower side had an oblique orientation. These discrepancies indicated a bad fit of the panel on the longeron flange.

Operational aircraft loads in combination with assembly-induced bending stresses most probably caused the longitudinal crack first. Subsequently, the transverse crack initiated

deformed attachment flange

longitudinal crack

transverse crack

The patch repair concentrated on restoration of the longeron strength in the longitudinal direction. However, a bonded patch does not remove the longitudinal crack. In order to prevent possible further growth of the longitudinal crack, stop drilling at the tips of the longitudinal crack was recommended.

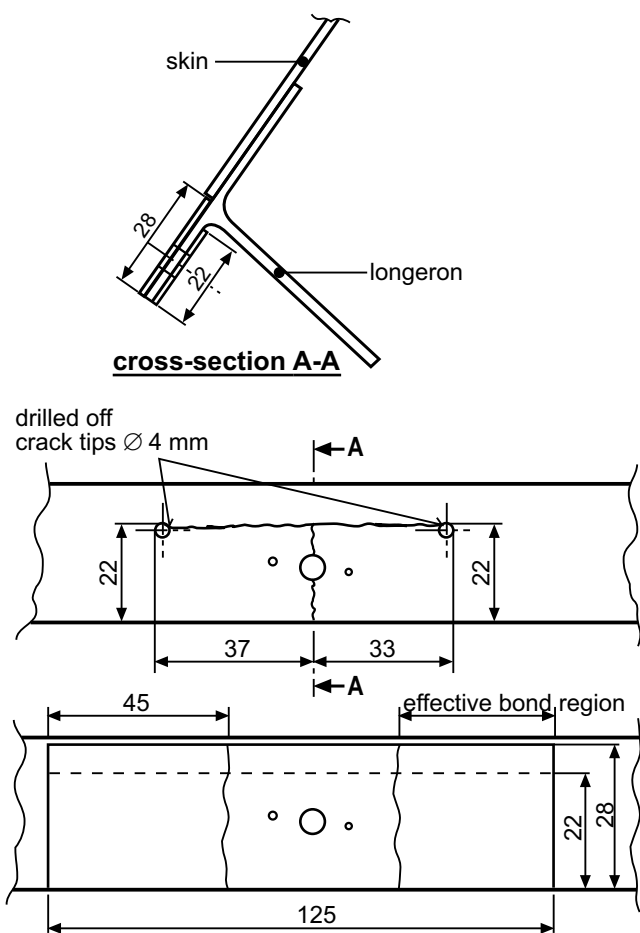
Fig. 4 Repair concept for cracked longeron

- Titanium 6Al4V annealed sheet with a thickness of 0.5 mm was selected for the patch. The thinner the patch, the lower the mis-match upon re-assembling the access panel 2408. Further, Titanium 6Al4V has outstanding strength, stiffness and corrosion properties.

Figure 4 shows the proposed repair concept with a Titanium patch on both sides of the

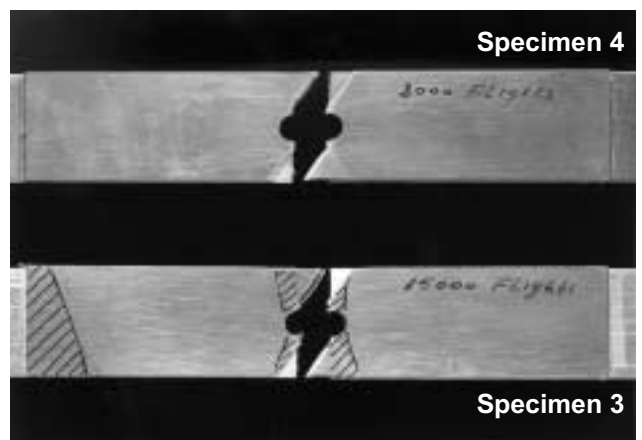
Titanium patches despite local fatigue induced delamination for specimen 3.

Fig. 8 Residual strength tested specimens after fatigue testing for 3000 and 15000 flight hours.(delamination after fatigue testing was only found for the specimen tested for 15000 flights)

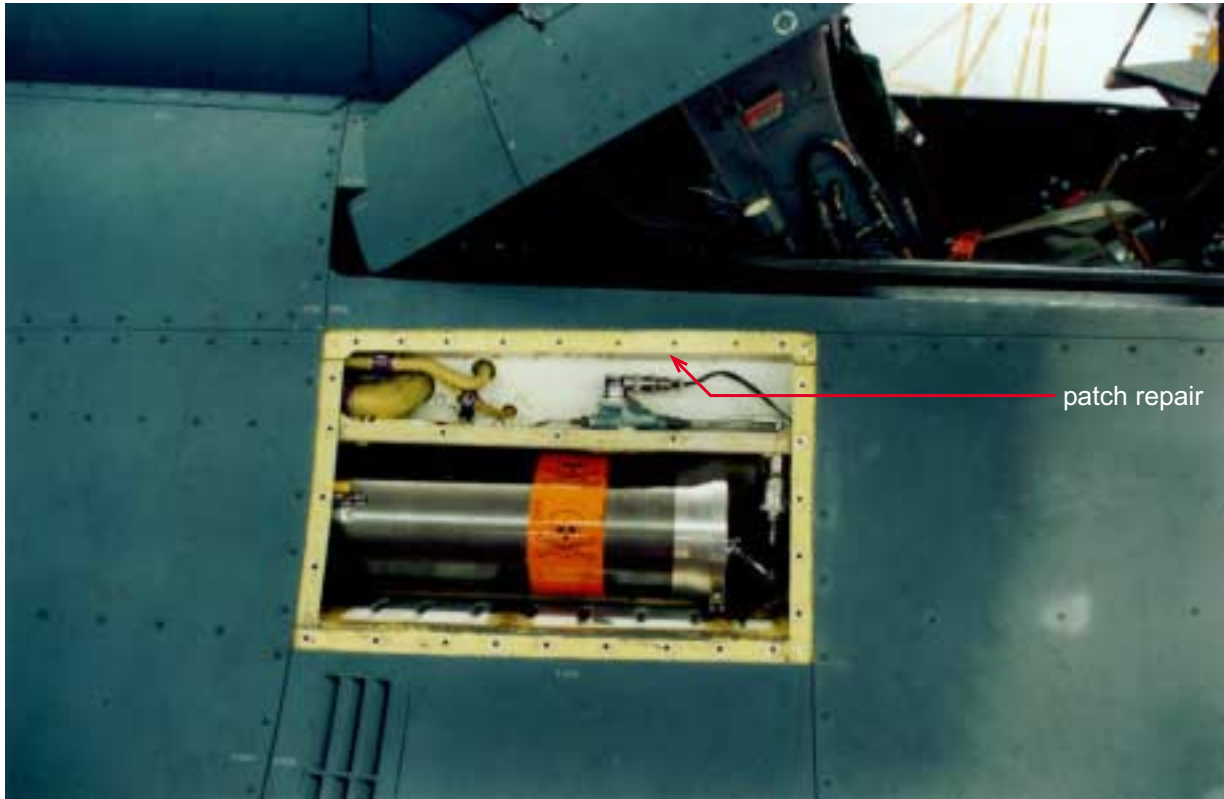
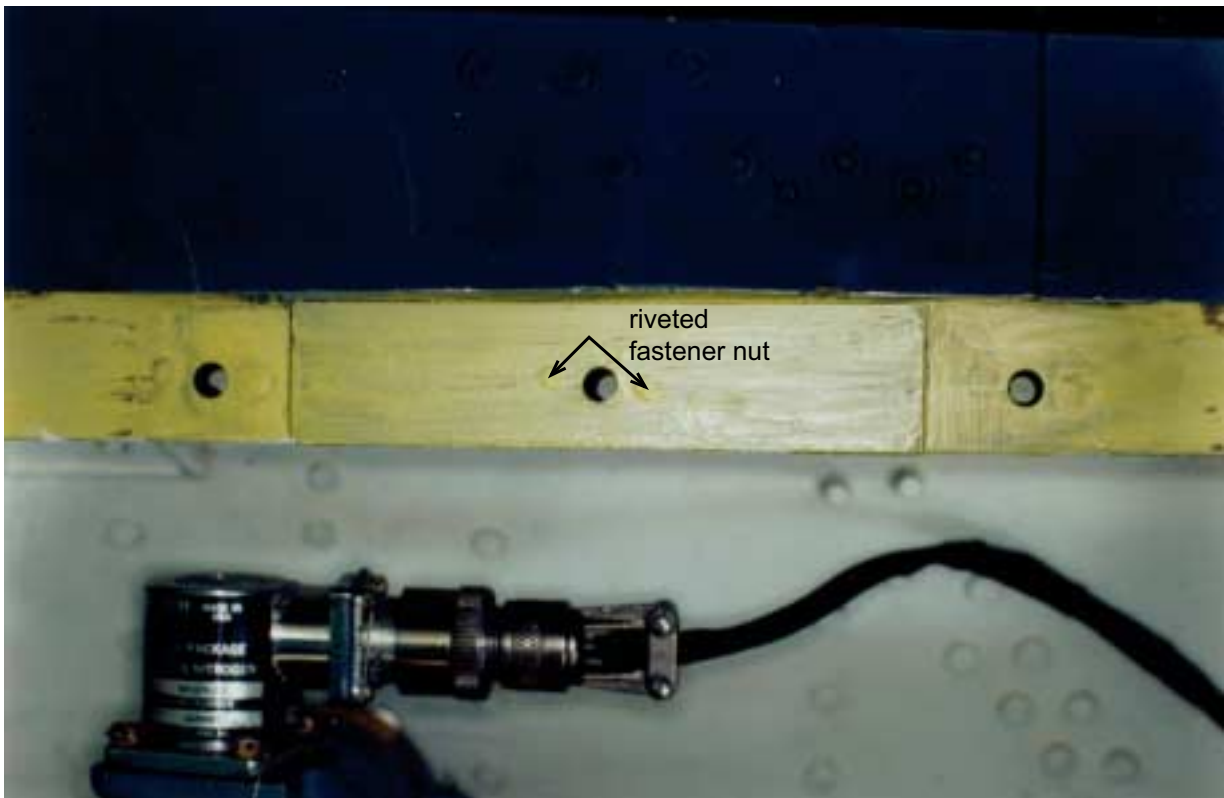
Fig. 9 Repaired longeron

Location of the repaired attachment flange

Detail of bonded patch repair

In March 1997 the cracked longeron was repaired. Before the Titanium patches were applied the deformed attachment flange was straightened to guarantee good contact between patch and flange. The surface pre-treatment consisted of abrasive blasting (Al_2O_3) of the Titanium patches and sanding of the aluminium flange. After bonding, the repair region was provided with the F-16 primer, FMS-3035, figure 9. A spare access panel was fixed to the structure using liquid shimming to compensate for the patch thickness.

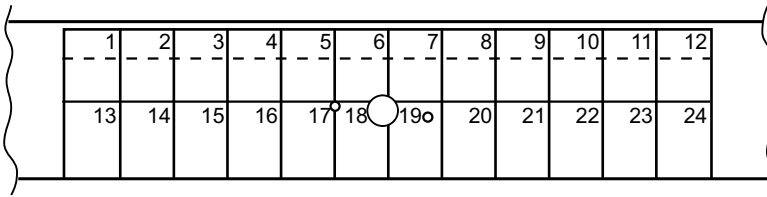
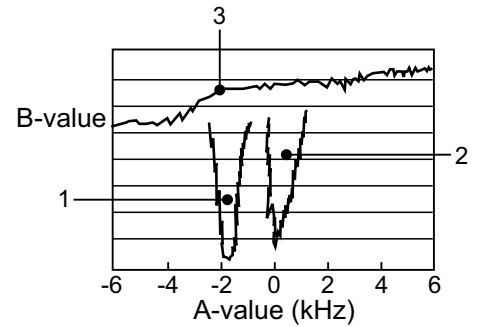
Fig. 10 Inspection set-up for Fokker Bondtester inspection

For checking on debonding the Fokker Bondtester Model 70 was used with transducer 1414 and coupling fluid. The patch surface was divided into areas of about 1 cm^2 , figure 10. The possible Fokker Bondtester responses are indicated in the same figure and were used as calibration signals during the periodic inspections.

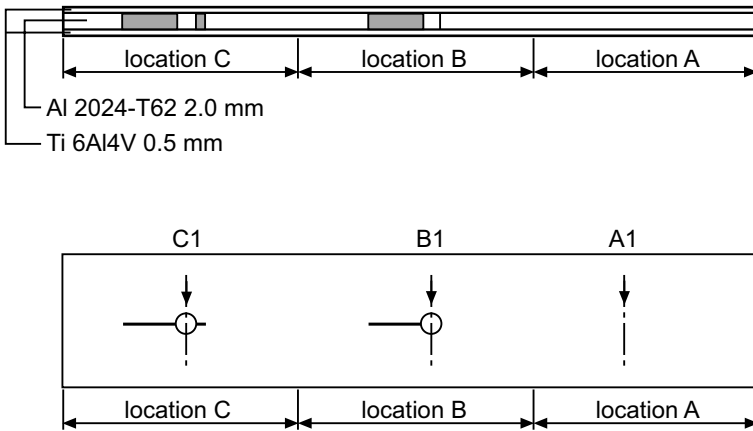
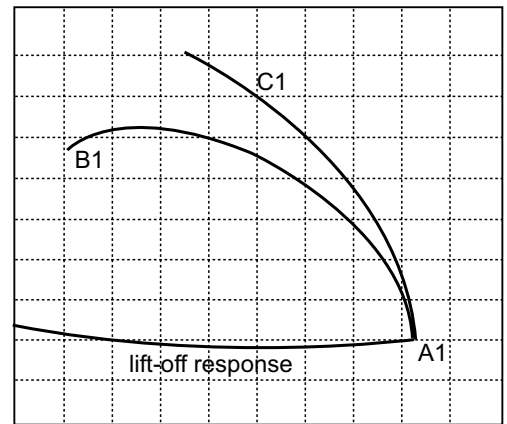
Fig. 11 Calibration standard for Eddy Current detection of crack growth from the drilled-off hole at the tip of the longitudinal crack

For crack detection the Nortec-19e^{II} Eddy Current scope was used with a Nortec PR/1 kHz – 100 kHz/A pencil probe. The test frequency was 15 kHz. A calibration standard was made to monitor possible crack propagation from the stop-drilled holes. The reference signals are shown in figure 11.
