Assessment, diagnosis and strengthening of Outeiro Church, Portugal

P.B. Lourenço *

Department of Civil Engineering, School of Engineering, University of Minho, Azurém, P – 4800-058 Guimarães, Portugal

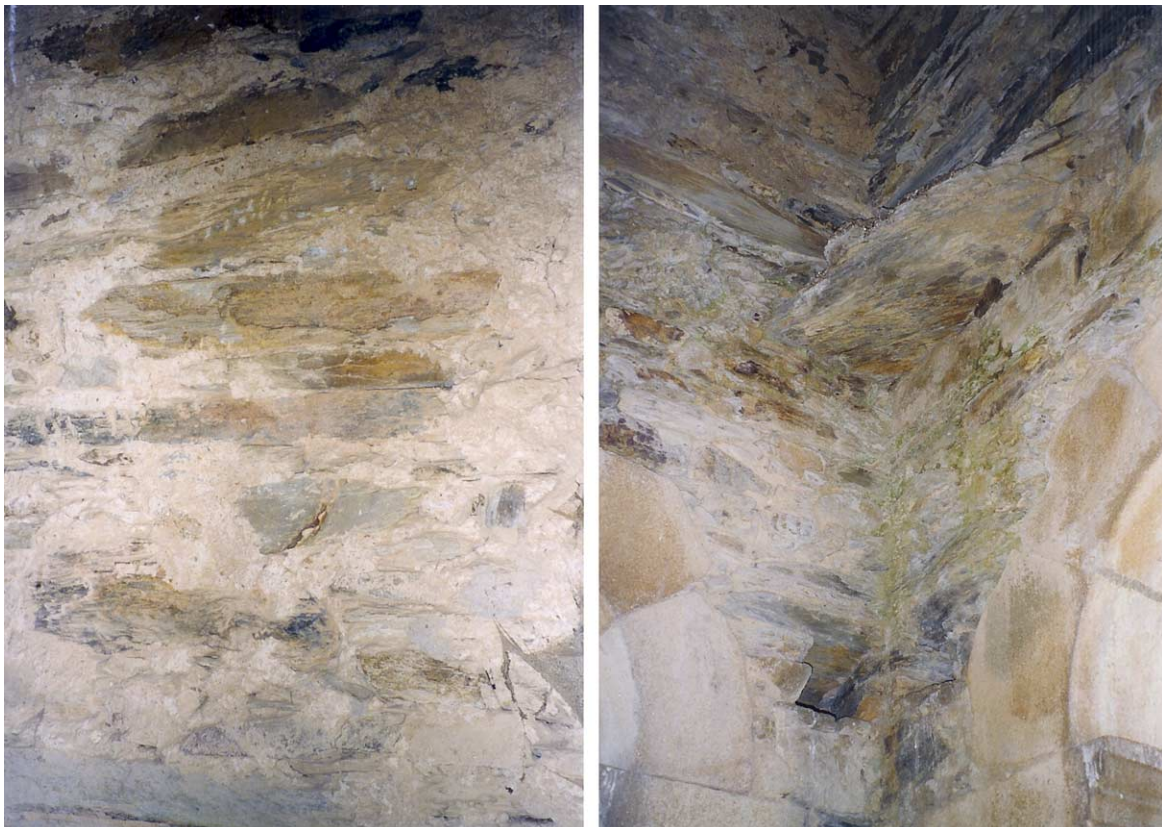
Fig. 1. Aspects of the irregular masonry in non-plastered areas, including ashlar around window openings.

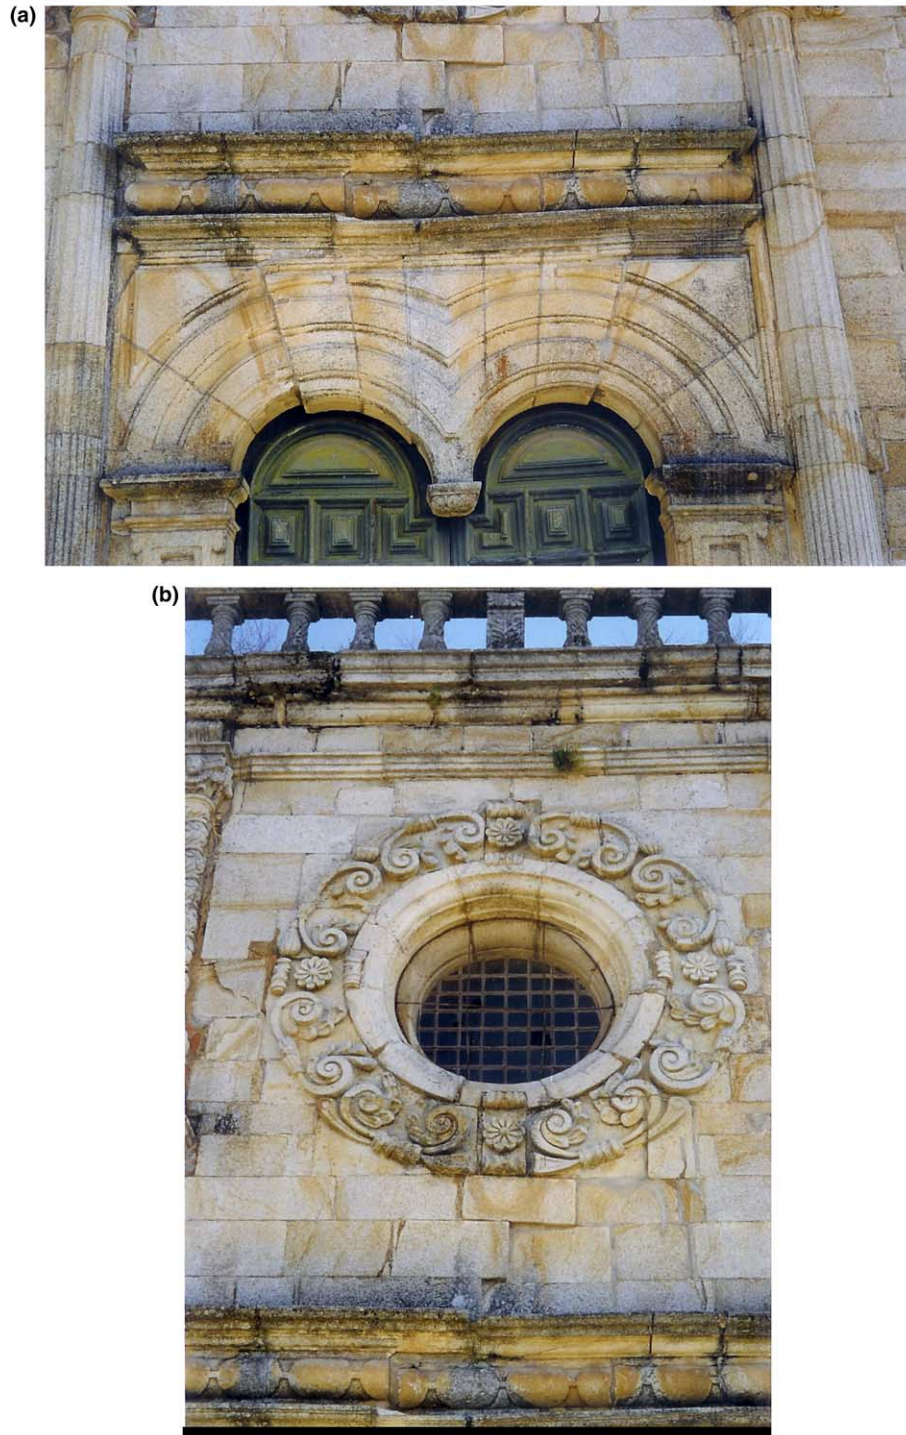
Damage of the structure is localized in the main façade and in the choir. Additional minor cracking at very few locations, of no concern for stability purposes, is visible in other parts of the structure. The façade features large displacement, downwards vertically, in the vicinity of the twin arch, and horizontally, towards the outside, around the central opening and at the top central part of the façade, see Fig. 3. The interior face of the wall is straight and, with the help of a boroscopic camera (HSW Henke-Sass Wolf – PRZ06-0550-VAR-50, equipped with a rod of 0.50 m, a vision angle between 60° and 120° , and a zooming range of 10–20 times), it was possible to check that the wall is made of two leaves,

Fig. 3. Damage in the façade: (a) twin arch and (b) opening.

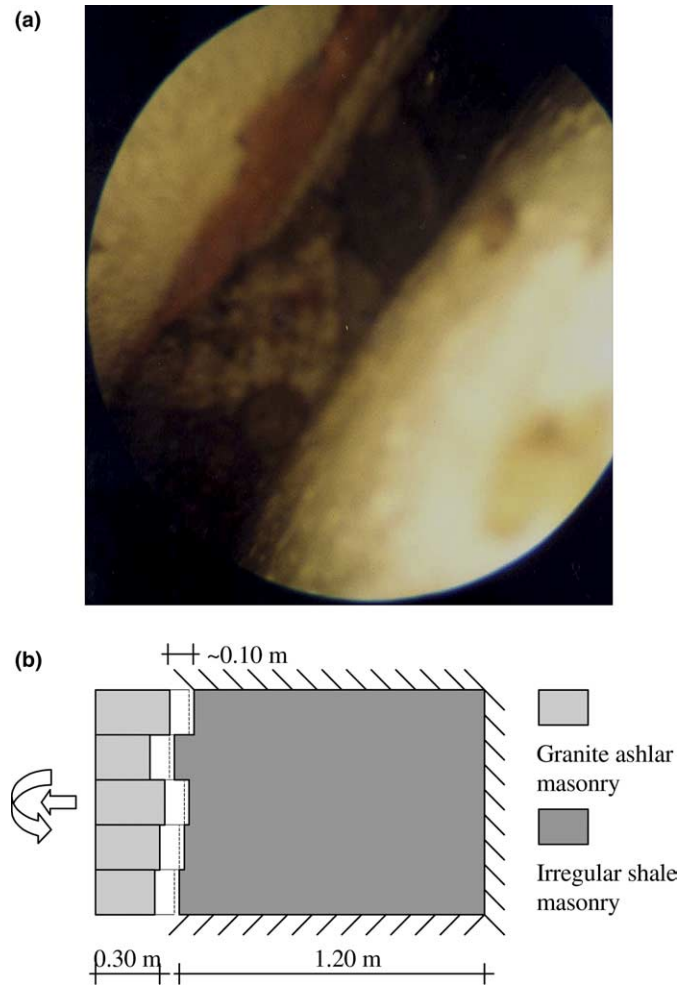
separated by a crack that reaches approximately 0.10 m width in the vicinity of the opening, see Fig. 4. Out-of-plumb movements are also visible in the granite balustrade that connects the bell-towers, as two of the stone blocks of the top rail have relative horizontal movements of around 0.02 m. It is noted that the stone ash-lars of the rail could have been connected with iron dowels in the past (cavities are present but dowels are absent).

Fig. 4. Wall of the main façade: (a) inspection with a boroscopic camera and (b) observed movements.

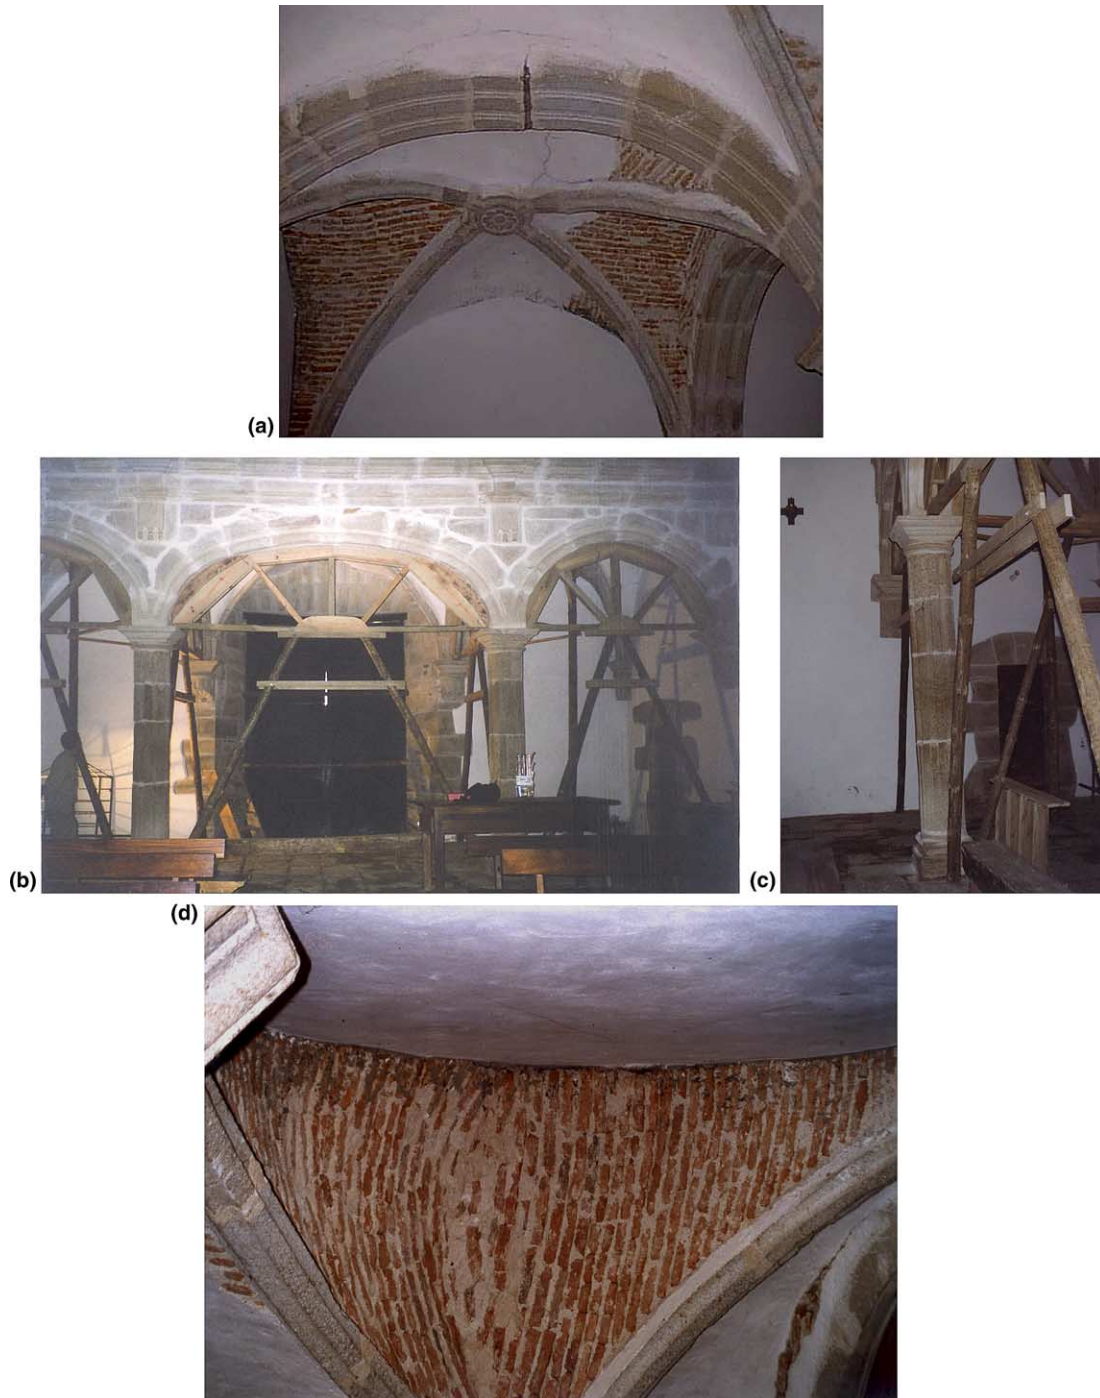
The choir features extensive cracking of the arches and vaults, see Fig. 5, being supported by temporary propping at the time of the first visit. The choir is separated from the façade, except in the brackets, and the columns are out of plumb 2.6% (around 0.08 m). The balustrade of the choir is straight, even if the diaphragm arches perpendicular to the nave exhibit significant curvature in plan, see Fig. 6, and the joints of the portico are fully filled with no sign of damage.

Fig. 5. Aspects of the damage in the choir: (a) cracked ribs; (b) temporary support; (c) columns out-of-plumb; (d) no connection between vaults and walls.

damage, which is poorly built (no connection between the vaults and the neighboring walls).

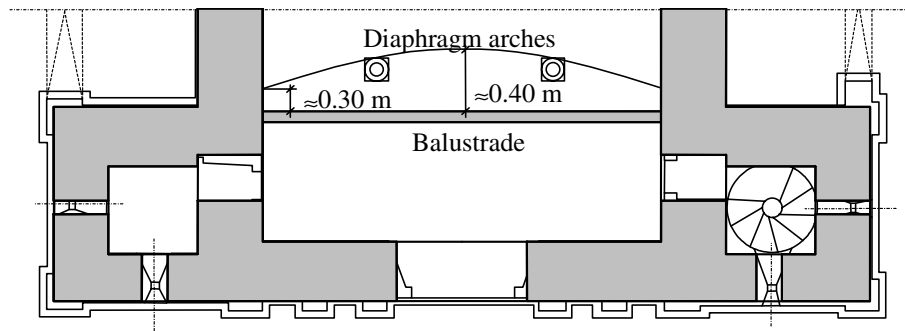
Fig. 6. Detail of choir in plan, including curvature of diaphragm arch versus straight balustrade, and adopted thickness for the plane stress model (shaded).

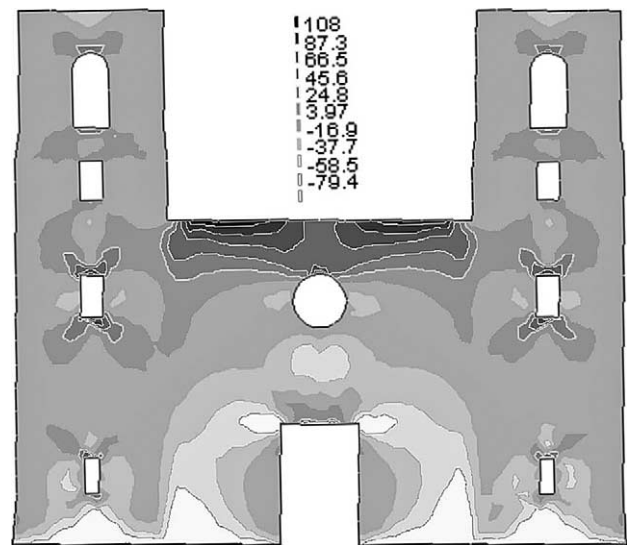
The results of the analysis, assuming linear elastic behavior of the material, are given in Fig. 7, in terms of maximum (tensile) principal stresses. Under the most unfavorable hypothesis that all permanent loads are applied simultaneously and not in agreement with the construction phases, it is observed that the maximum

Fig. 7. Plane stress analysis for vertical loading – picture of the maximum (tensile) principal stresses (10^{-3} N/mm^2) on the deformed structure.

value of the tensile stresses and the compressive stresses are extremely low, respectively, $+0.11$ (tension) and -0.54 (compression) N/mm^2 .

Even if the maximum stress values are questionable in the framework of linear elastic analysis (the values depend on the mesh refinement), this analysis demonstrates that, under the assumption of a homogeneous material for the façade, the structure should not present any damage due to vertical loading. Indeed, the structure is robust and very stiff. The localized damage of the structure, the signs that the movements of the foundations/soil, indicate that the damage is due to seismic action. Earthquakes are normally unexpected in the North of Portugal but, in the vicinity of the structure, shakes were reported in 1751 and 1858 (Mercalli intensities VI and VII, respectively). For this reason, the analysis of the structure under combined actions (vertical and horizontal) seemed necessary.

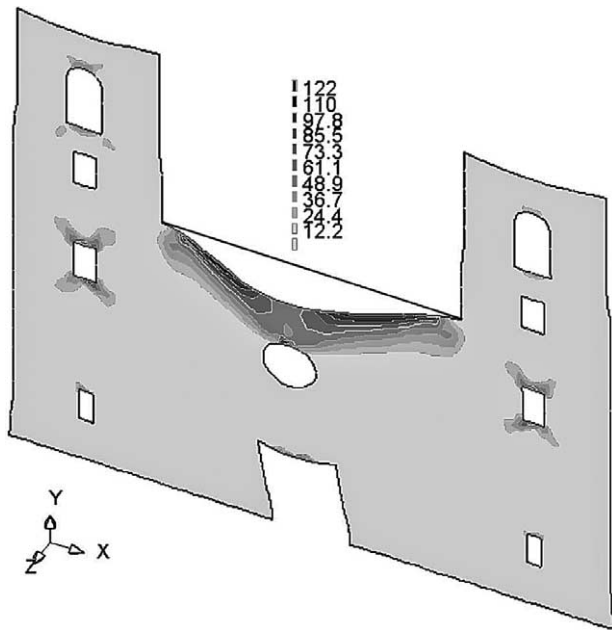
Assuming that the top of the façade is capable of moving freely and adopting linear elastic behavior for the material, the results of the analysis are given in Fig. 8, in terms of maximum (tensile) principal stresses. Again, the maximum value of the tensile stresses and the compressive stresses are extremely low, respectively, +0.12 (tension) and -0.51 (compression) N/mm². Moreover, the maximum displacement normal to the façade is only 0.4 mm, which cannot be compared with the value of 0.10 m observed.

From these results it was concluded that the assumption of a homogeneous material is incapable of justifying the damage exhibited by the structure, even with the action of the horizontal forces equivalent to the

Fig. 8. Shell analysis for vertical and horizontal loading – picture of the maximum (tensile) principal stresses on the upper layer (10–3 N/mm²) on the deformed structure.

seismic load. It is, however, stressed that the shape of the deformation shows some agreement with the observed deformation of the real structure.

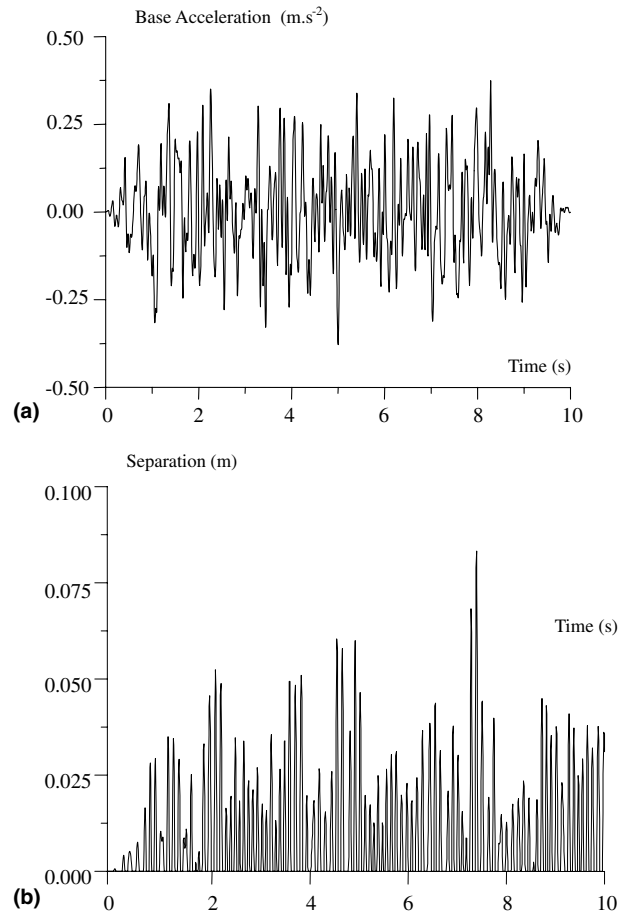
Fig. 9. Dynamic analysis with time-integration: (a) artificially generated base acceleration and (b) separation between the two leaves.

Assuming the usual damping coefficient ξ equal to 5%, a base acceleration was generated according to the Portuguese code, see Fig. 9(a). As the dynamic properties of the two leaves differ substantially, separation of the leaves will occur in the adopted dynamic, time-integration non-linear contact analysis. The response of the structure, in terms of separation (i.e., relative displacement in the z direction) of the top edge of the façade is illustrated in Fig. 9(b), where it is confirmed that separation of the two leaves reaches very large values (around 0.09 m), which is comparable to the observed separation.

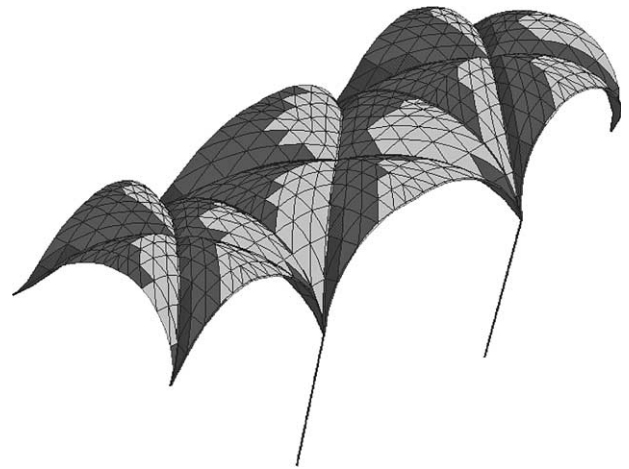
Loading included all permanent loads and static horizontal forces equivalent to the seismic loading, as before. Fig. 11 illustrates the deformation of the choir under these loads, assuming linear elastic material behavior. The deficient original conception of the choir is clear, as it moves apart from the façade and side walls, even for vertical loading. If the vaults of the choir were originally connected to the side walls, or side arches were originally placed around the borders, the behavior would be monolithic. The values obtained for the maximum horizontal displacement is 0.006 m for vertical loading and 0.016 m for the seismic loading, amounting to a total of

Fig. 11. Deformed mesh of the choir under vertical and horizontal loading.

0.022 m and confirming again the significant contribution of horizontal loading to the observed movements and damage. The value of the total displacement is well under the 0.08 m observed in the top of the columns but is in reasonable agreement with the separation between vaults and façade wall (around 0.015 m). The difference of displacement in the columns can be explained by the severe cracking of arches, ribs and vaults in the structure, which was not considered in this analysis.

This simplified analysis demonstrates that the vertical load thrust is inadequately absorbed by the columns and a connection between the side walls and the vault is missing, meaning that the original conception of the choir is inadequate.

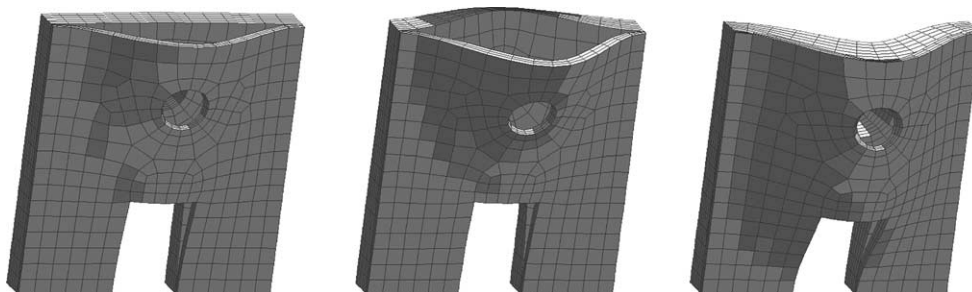
Fig. 10 presents some examples of the deformed structure through time. It was possible to obtain different configurations of separation between the two leaves (in the top and center of the wall). For example, Fig. 10(a) shows the internal wall practically in the original configuration and the external wall moving out of plane. Fig. 10(b) shows the walls moving in opposite directions. Fig. 10(c) shows the walls moving in the same direction, with small separation at the top and large separation around the opening. This last shape of separation seems to be in good agreement with the damage exhibited by the façade. Therefore, it seems possible to conclude that an earthquake was the main origin of this

damage and the insufficient connection between the leaves allowed the separation.

Fig. 10. Examples of deformed meshes through time.
