Report No. R-40.1

**PILOT PROJECT FOR FARMER-MANAGED IRRIGATED AGRICULTURE UNDER
THE LEFT BANK OUTFALL DRAIN STAGE 1 PROJECT, PAKISTAN**

**MAINTENANCE PLANS FOR IRRIGATION
FACILITIES OF PILOT DISTRIBUTARIES
IN SINDH PROVINCE, PAKISTAN**

*Volume One
Dhoro Naro Minor, Nawabshah District*

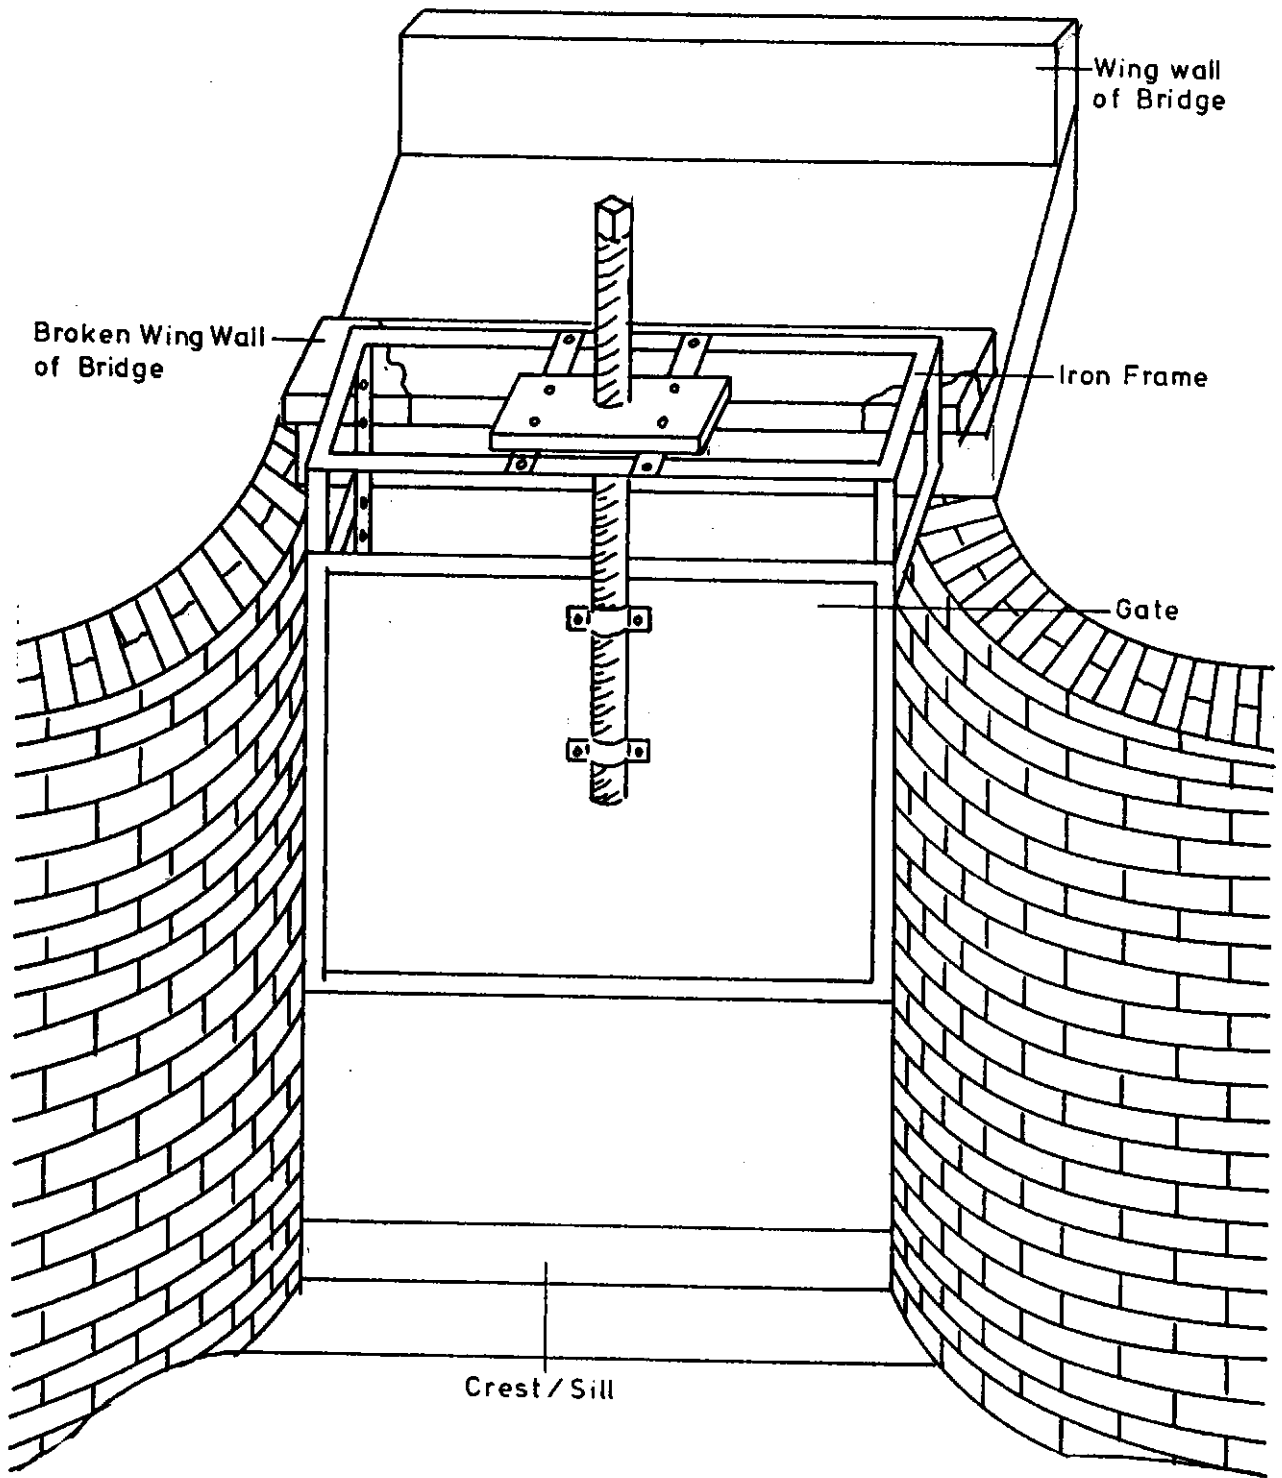
Causes: Due to lack of proper maintenance silt deposited at upstream. Shoulders are damaged. Gate opening fluctuations are main cause of silt deposition at downstream of head regulator at about 100 ft. length.

FigureA1. Head Regulator of Dhoro Naro Minor.

Remedy: Shoulders may be repaired with minimum cost. Regulator may be operated at full supply level to control sediment deposition.

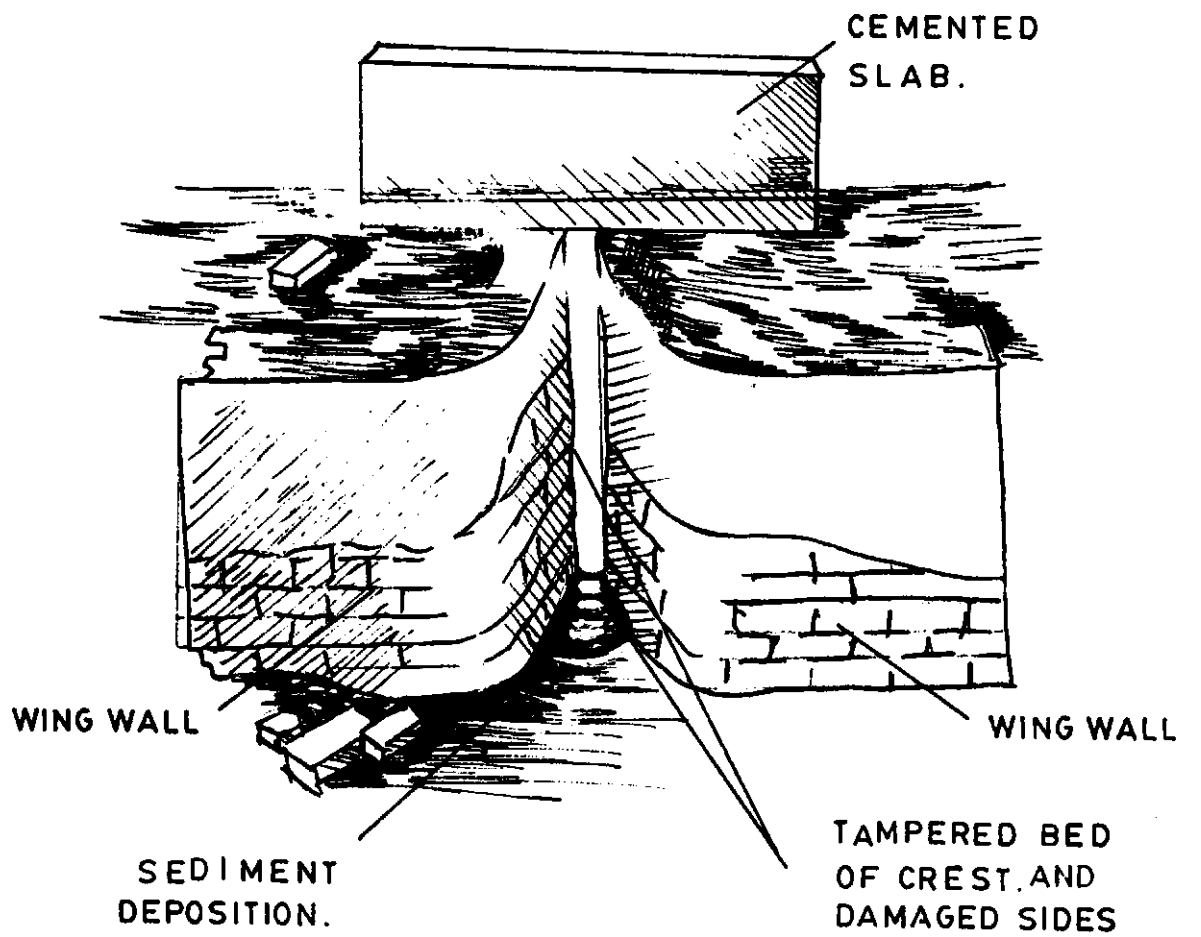
Figure A2. Outlet 1R Dhoru Naro Minor.

Causes: Tampering of throat and crest is to draw more water. The influential landowners mostly do this practice.

Remedy: Check and balance should be strictly observed. Reshaping of outlet throat and proper crest elevation should be made on the basis of available supply. Water Users Federation may be activated to stop this practice. This would be possible only when water users and concerned department will have close coordination and O&M responsibility of distributary may be shifted from ID to WUF.

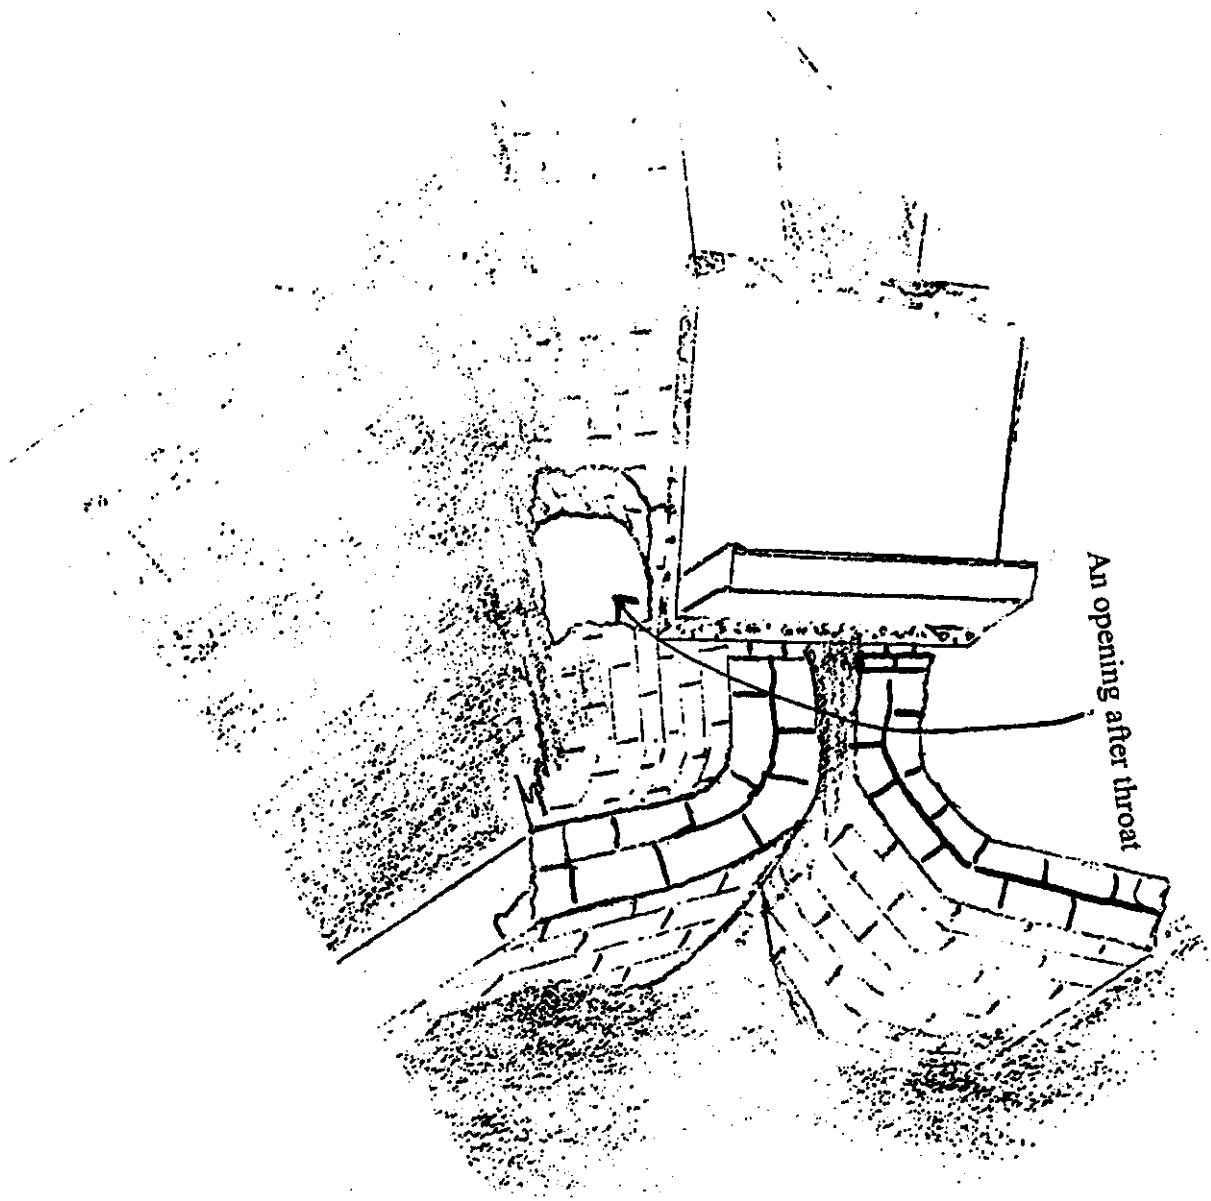
Figure A5. Outlet 1L Dhoro Naro Minor.

Causes: Tampering and damaging of the outlet was done to draw more water.

Remedy: Repairs may be done by ordinary masonry work. But these should be first remodeled on the basis of available water supply and then should be repaired accordingly. After repair the check and balance system should be strictly followed. Otherwise all the exercise will be useless.

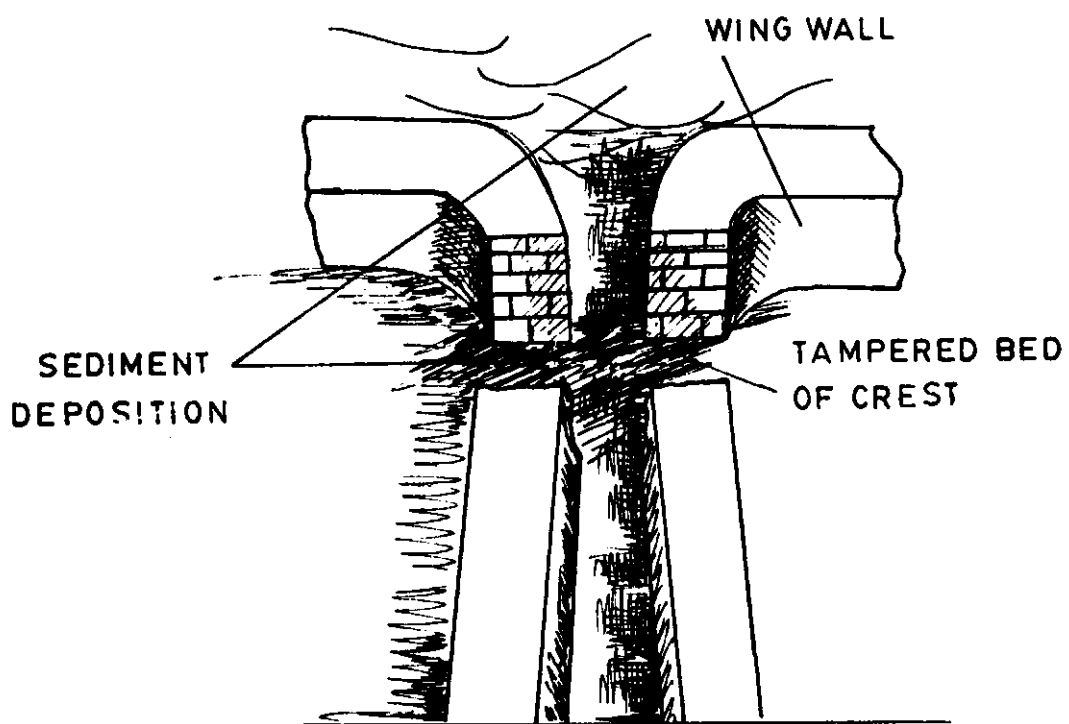
Figure A11. Outlet 2AL Dhoro Naro Minor.

Situation: The condition of these four outlets was almost same. The crest and throat of all the outlets were tampered and damaged. The roof of culverts was badly damaged. (See Figures A14-, A15, A16, A17). Also, more silt entry was observed in the watercourses.

Causes: Tampering was made to get more water and to cultivate more land. Due to lowering of crest level more silt goes into watercourse. Lack of maintenance and supervision of concerned department has led to the poor condition of structure of outlets.

Remedy: The outlets should be remodeled on the available supply of water (i.e., crest level, B and Y). After remodeling and restructuring, the beneficiaries may be made bound to maintain them properly. ID should inspect the system regularly. The coordination between water users and ID should be strengthened so that proper O&M may be made which would help to manage the system properly.

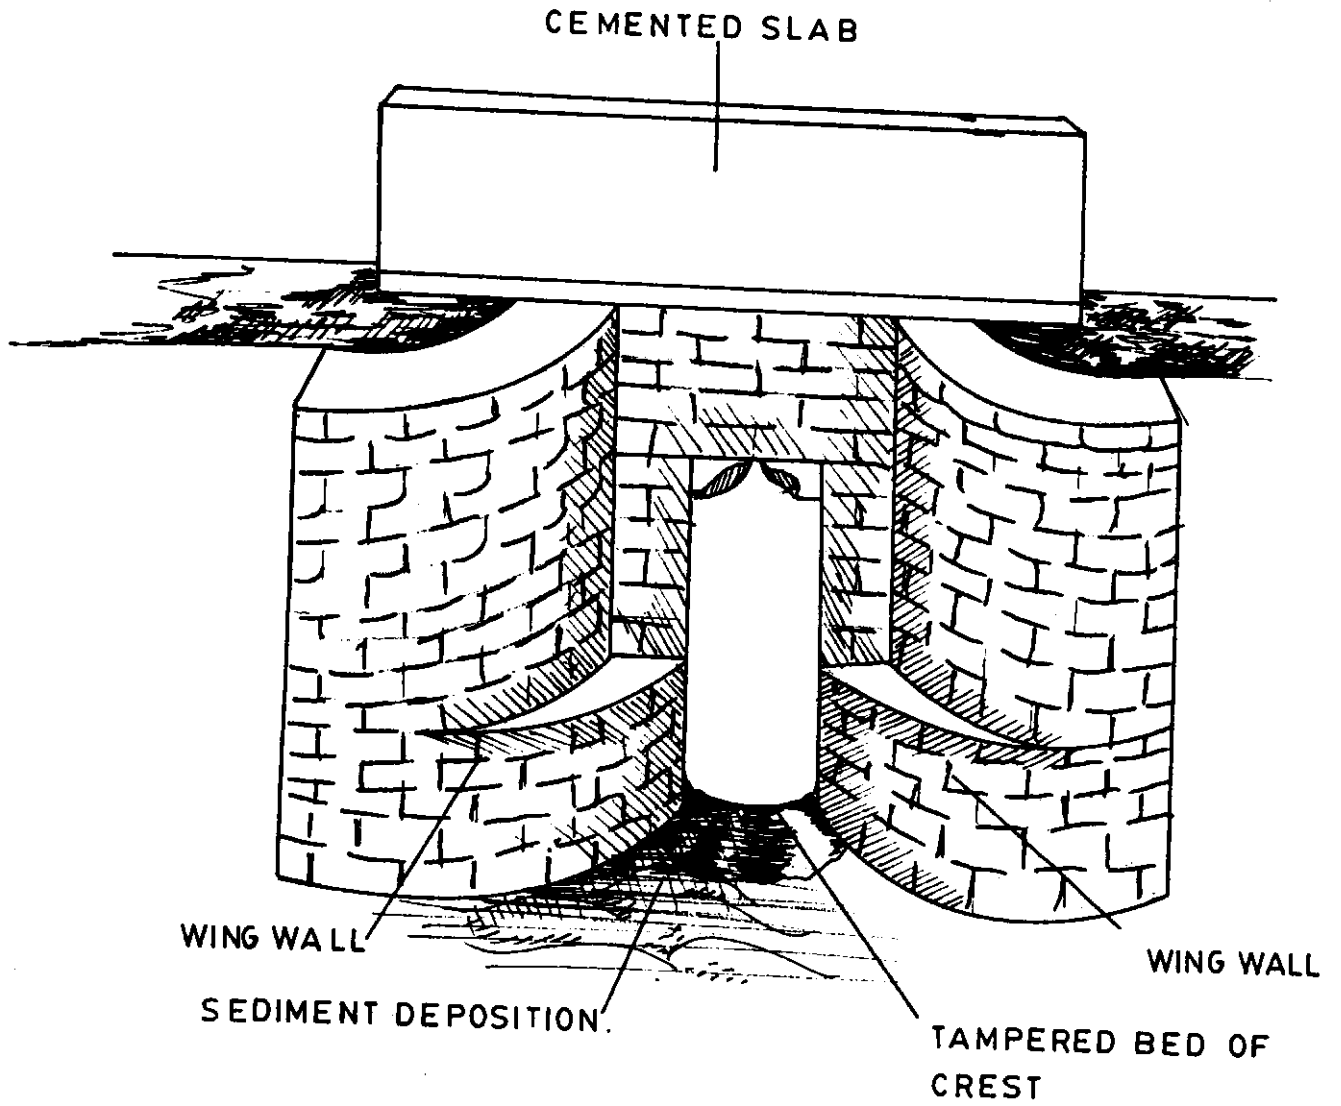
Figure A25. Outlet 10L Dhoru Naro Minor.

Causes: Because lack of proper check and balance, these situations were developed. The purpose of tampering was to get more water. This tampering mostly occurs due to two reasons: (1) due to shortage as well as excess water and (2) due to influential people.

Remedy: Outlet should be remodeled on the existing supply of water. The distribution of water should be equal from head to tail of the minor. The "equity" should be defined by the water users so that sustainable remedy may be achieved. Check and balance should be strictly followed (Figures A25, A26).

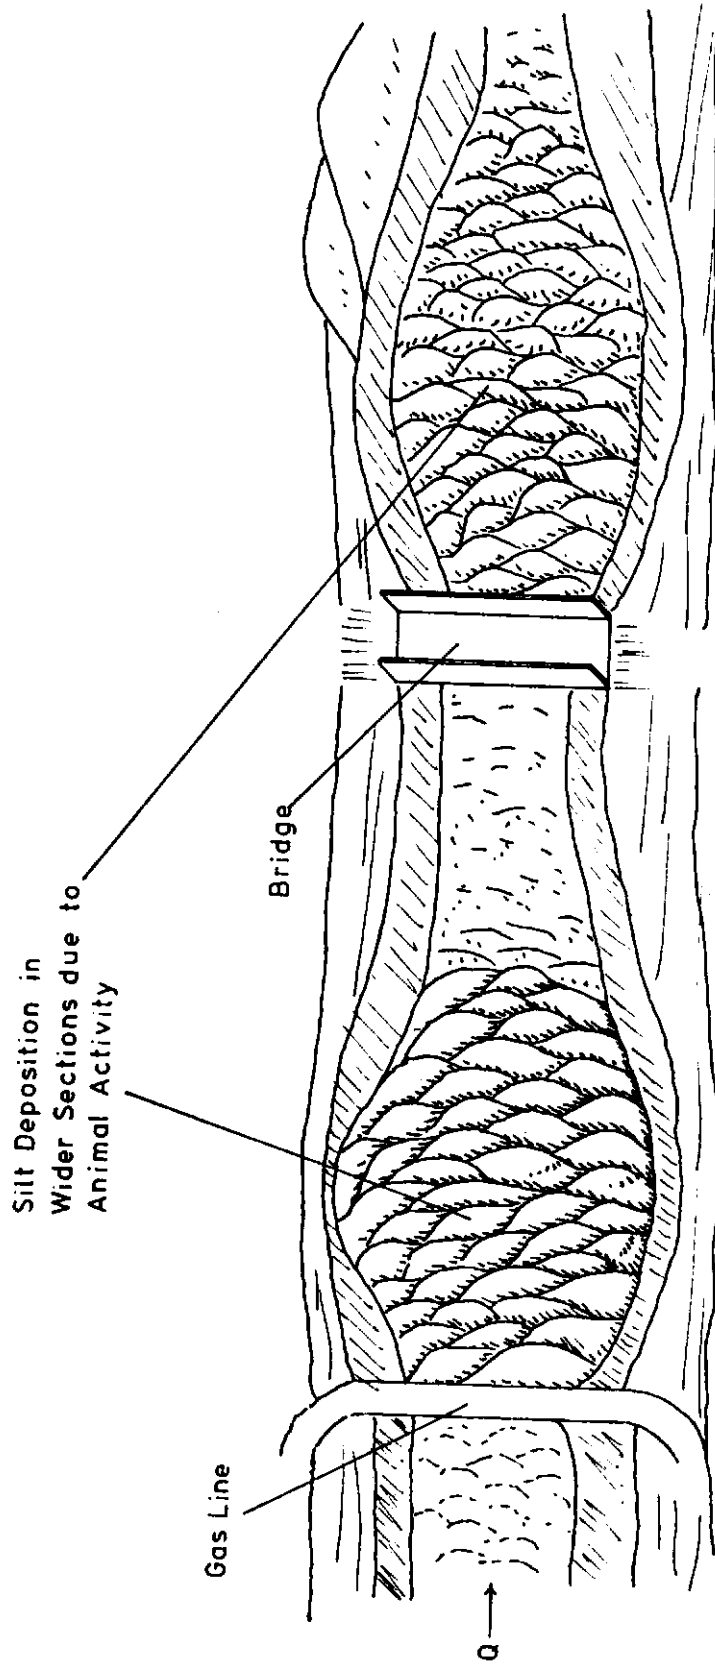
Figure A27. Dhoro Naro Minor from RD 7+200 to 7+600, two sections of 180 ft. and 120 ft. in length observed wear due to animal bathings near Mahmood Jamali link road bridge and Soi Gas crossing line.

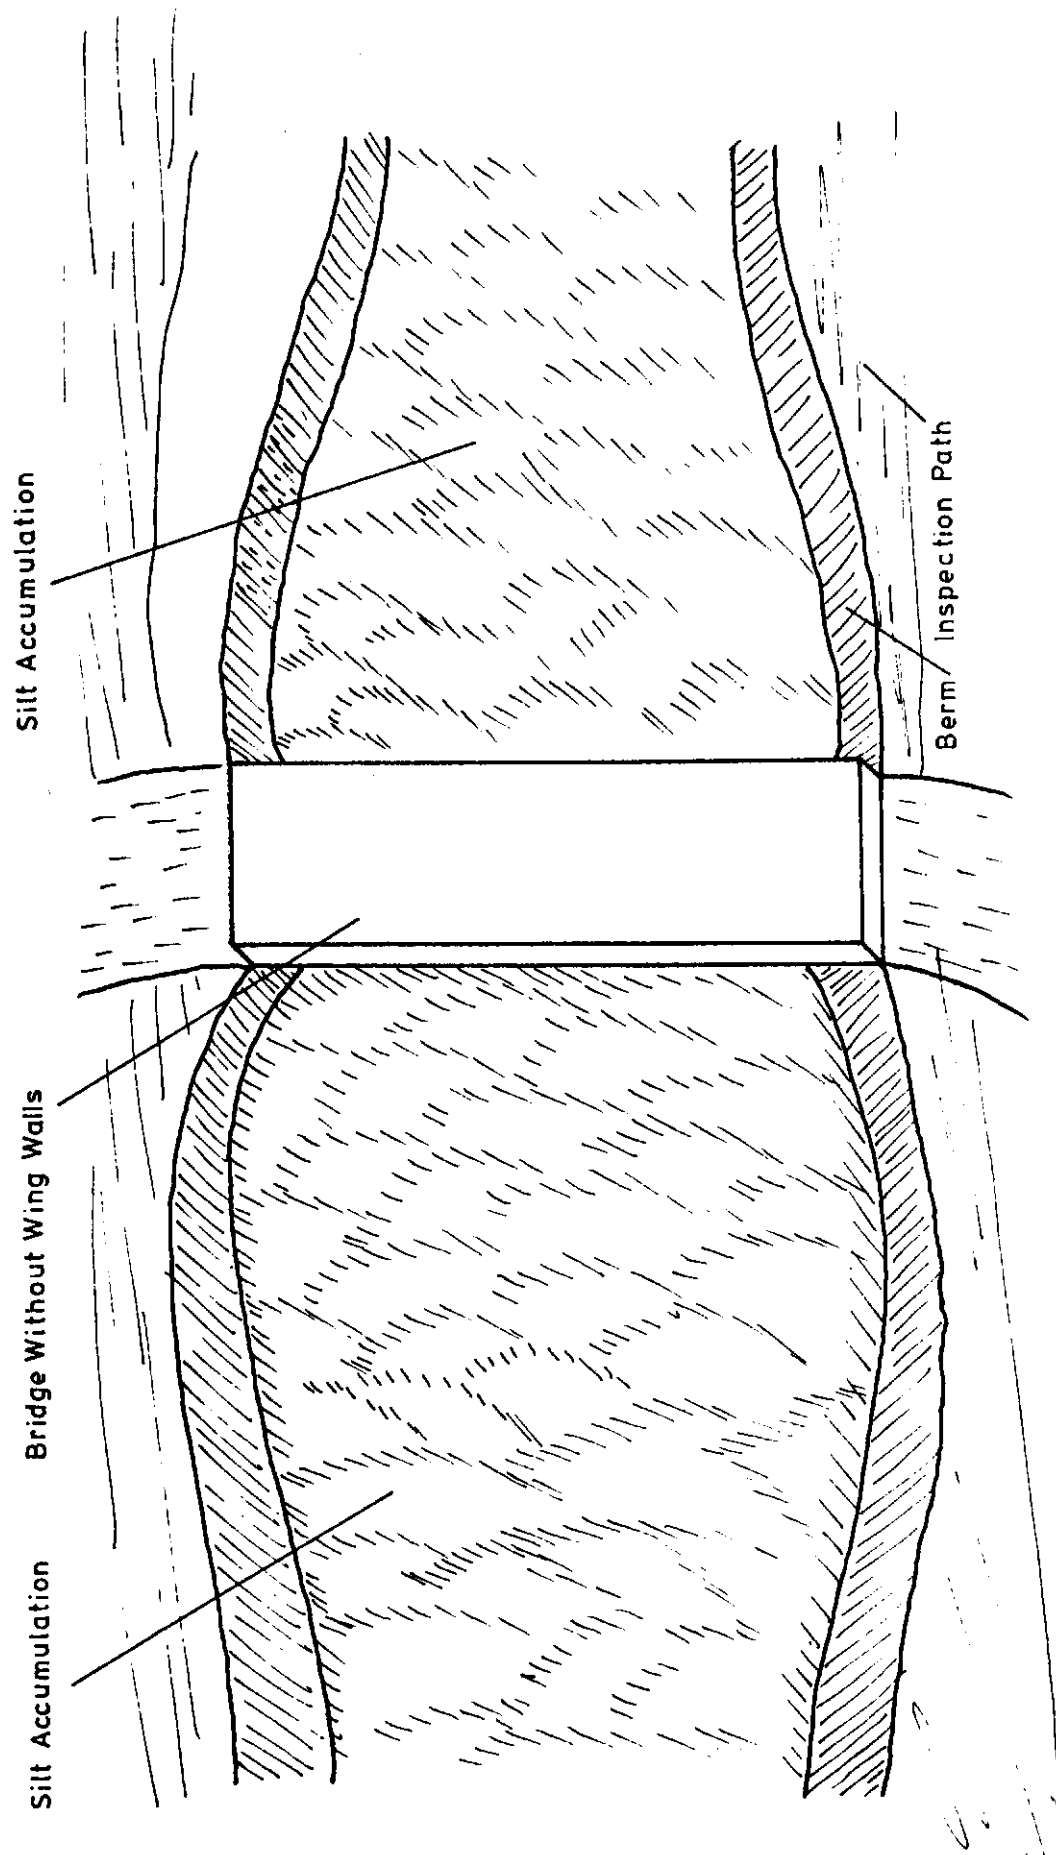
Figure A28. A bridge without wing walls at 8+971 RD of Dhoro Naro Minor.

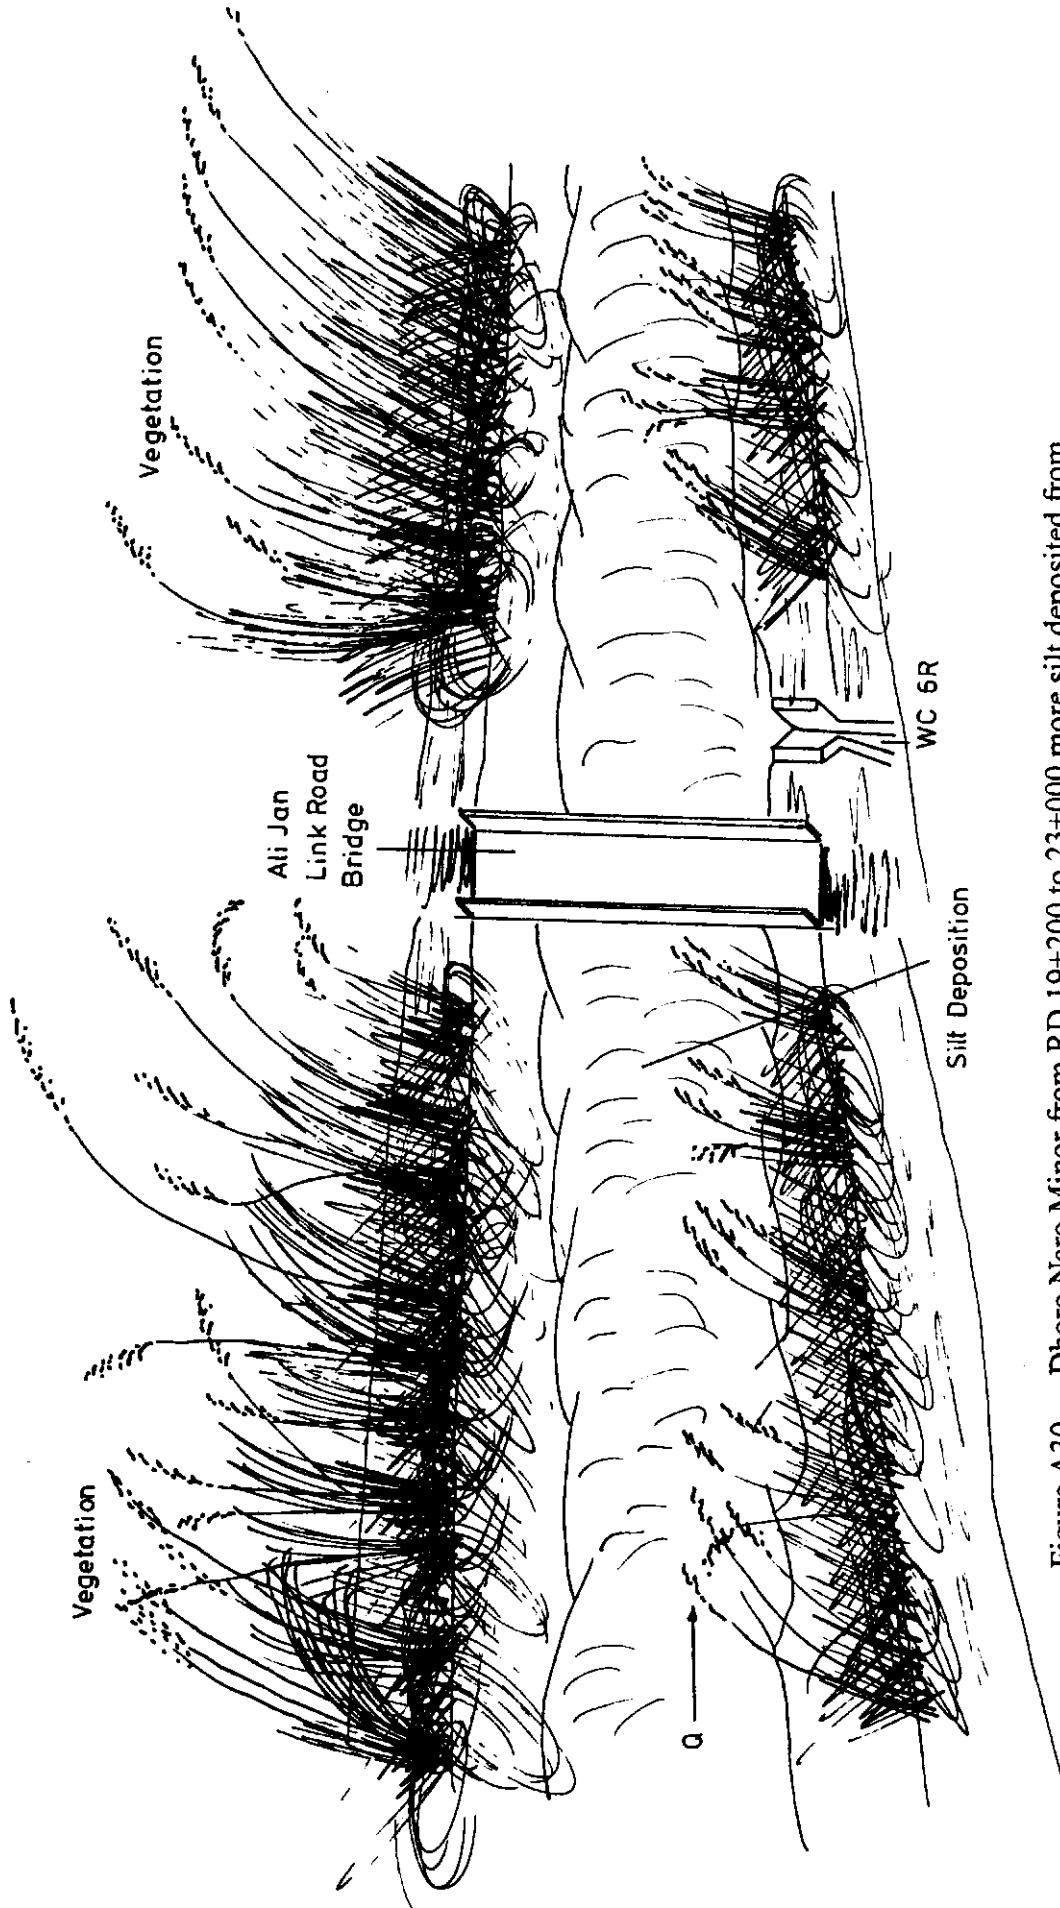
Figure A30. Dhoro Naro Minor from RD 19+200 to 23+000 more silt deposited from bank sides due to vegetation fallen into the minor. Outlet 6R and Ali Jan link road bridge situated in this section.

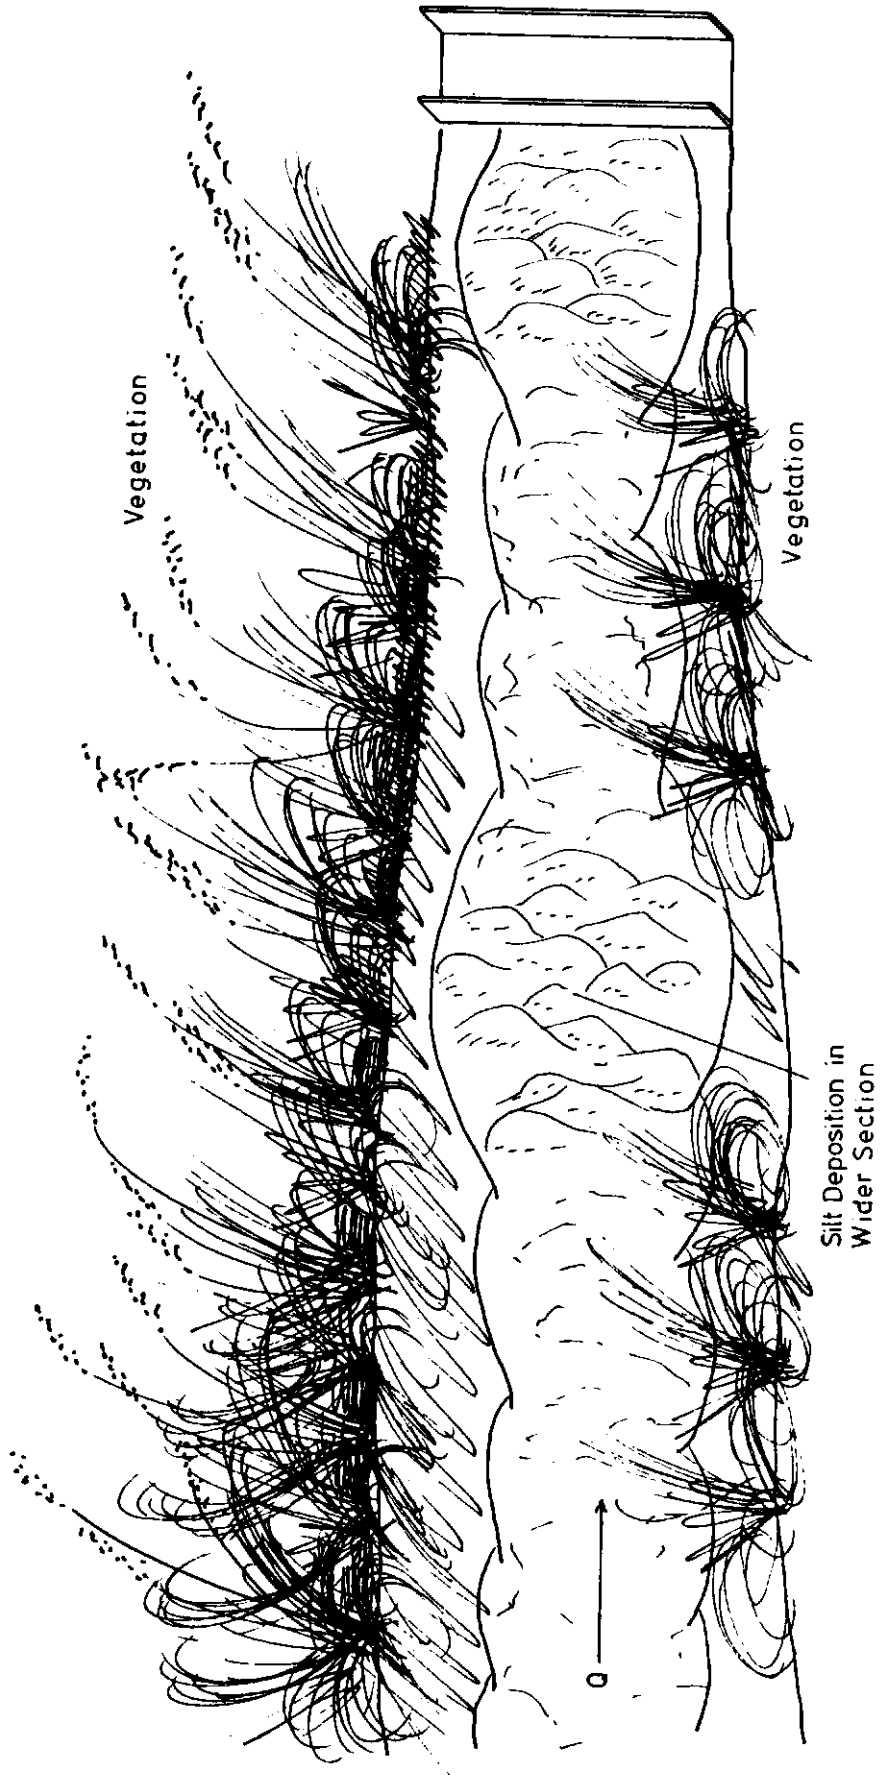
Figure A3.1. Dhoro Naro Minor from RD 24+400 to 27+526, two sections observed wider with more silt deposition at the end chiselabad link bridge observed.

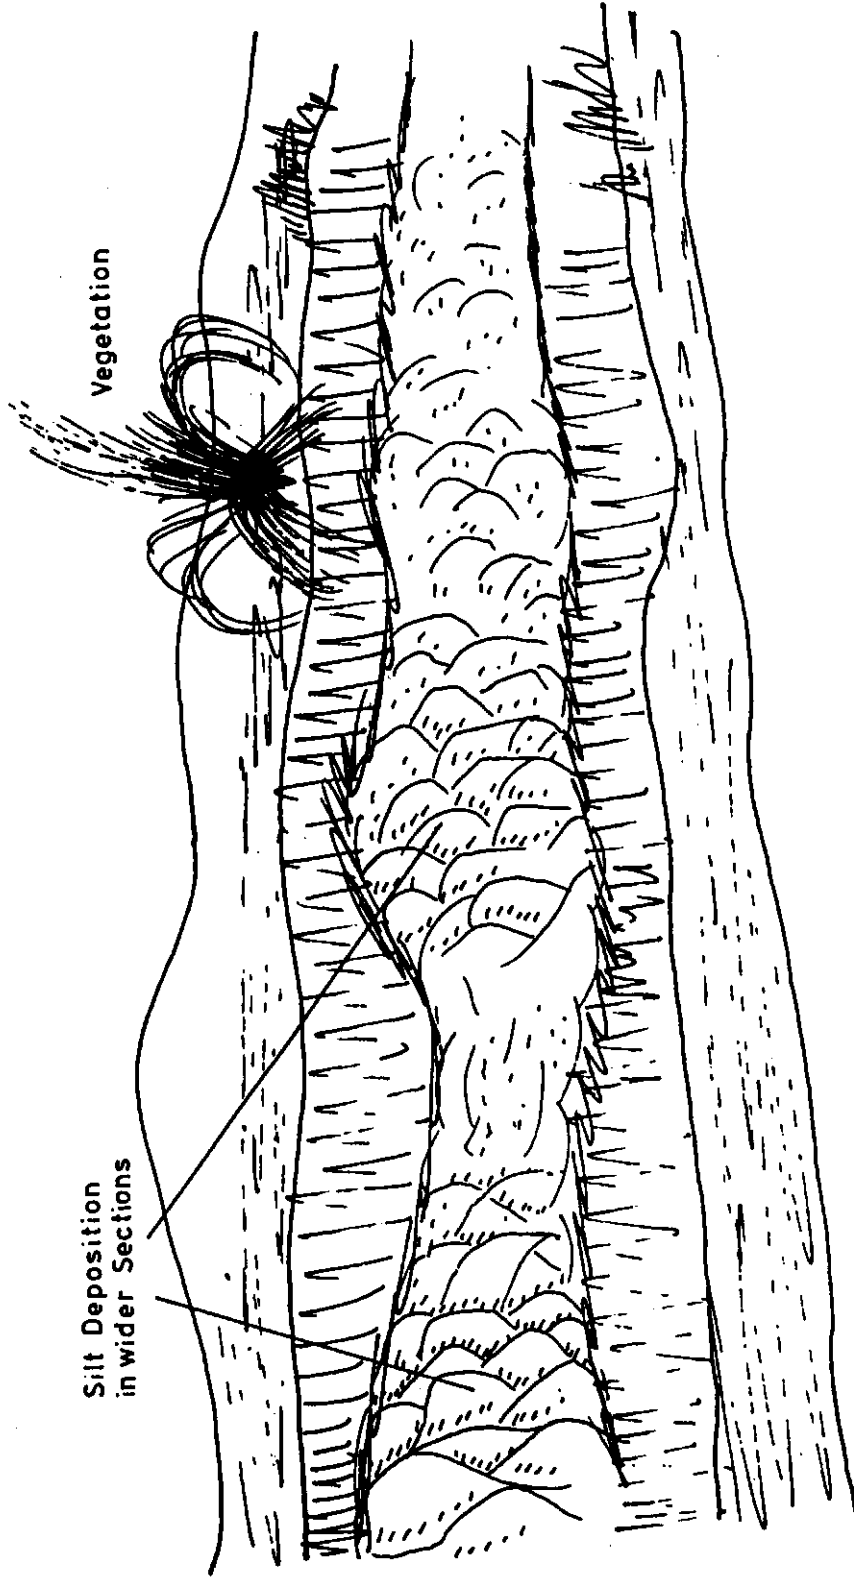
Figure B 5. Sketch of Dhoro Naro Minor from RDs 4.6 to 7.4.

- RD 04+600 to 07+400: In this section right bank observed weak at three different points of 50 and 40 ft in length. Also the same condition was observed on the left bank of the minor. Left bank was weak at three different points of 50, 70 and 10 ft in length. At these weak point, sections of the minor was observed wider of about 19 ft. Due to wider sections more silt was deposited in those sections. The main reason was the free bathing and crossing the animals. In this section there was no vegetation. Inspection path (IP) was not maintained properly.(Fig. B-5). Another reason of more sediment deposition was the re-entry of silt from the banks which was thrown over the banks during desilting of the minor.

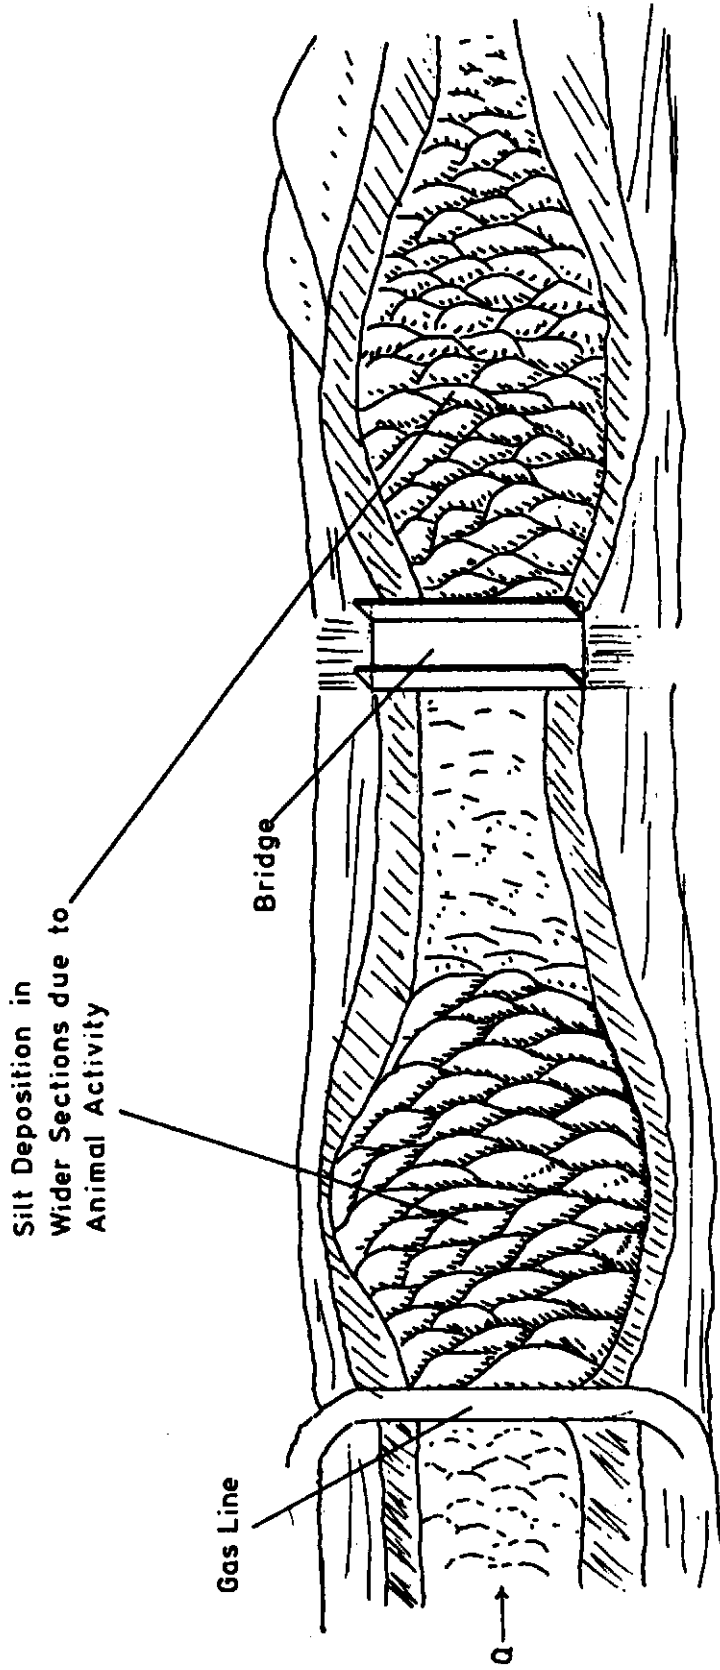
Figure B 6. Sketch of Dhoro Naro Minor from RDs 7.2 to 7.6.

- RD 07+200 to 07+600: At this location a bridge is constructed to cross the Mahmood Jamali link road, at a height of 4.5 ft.from the bed of the channel. Both banks just downstream and upstream of the bridge in the length of about 120 ft were weak and scoured due to animal bathing and crossing (Fig. B-6). Hence more silt deposition in these sections was observed.

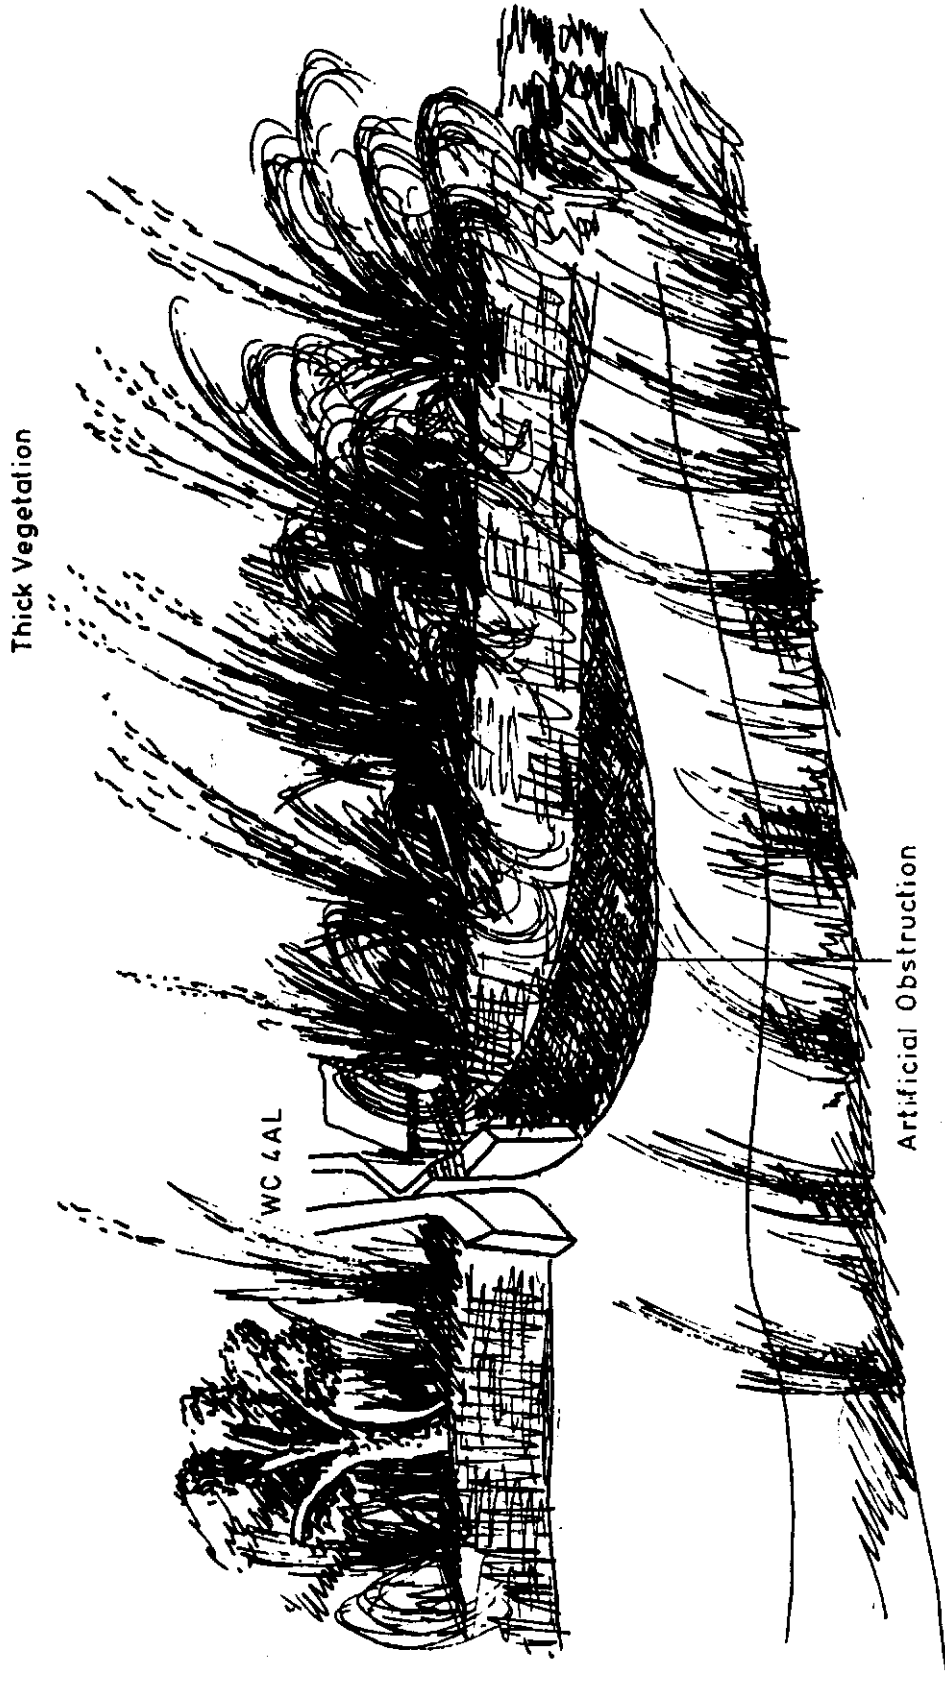
- RD 19+000: In this portion both the banks were possessing thick vegetative growth. About 10% of vegetation was falling into the minor which was disturbing the flow streamlines. The depression of 20 feet long and 1.5 feet deep and 4 feet wide was observed which was artificially created for increasing water head at up stream for outlet 4-AL. Also in this section, 70 feet long, 2 feet deep and 2 feet wide soil belt dumped artificially to restrict the flow (Fig. B-11).

Figure B 11. Sketch of Dhoro Naro Minor at RD 19.0, showing a section of artificial obstruction near watercourse 4AL.

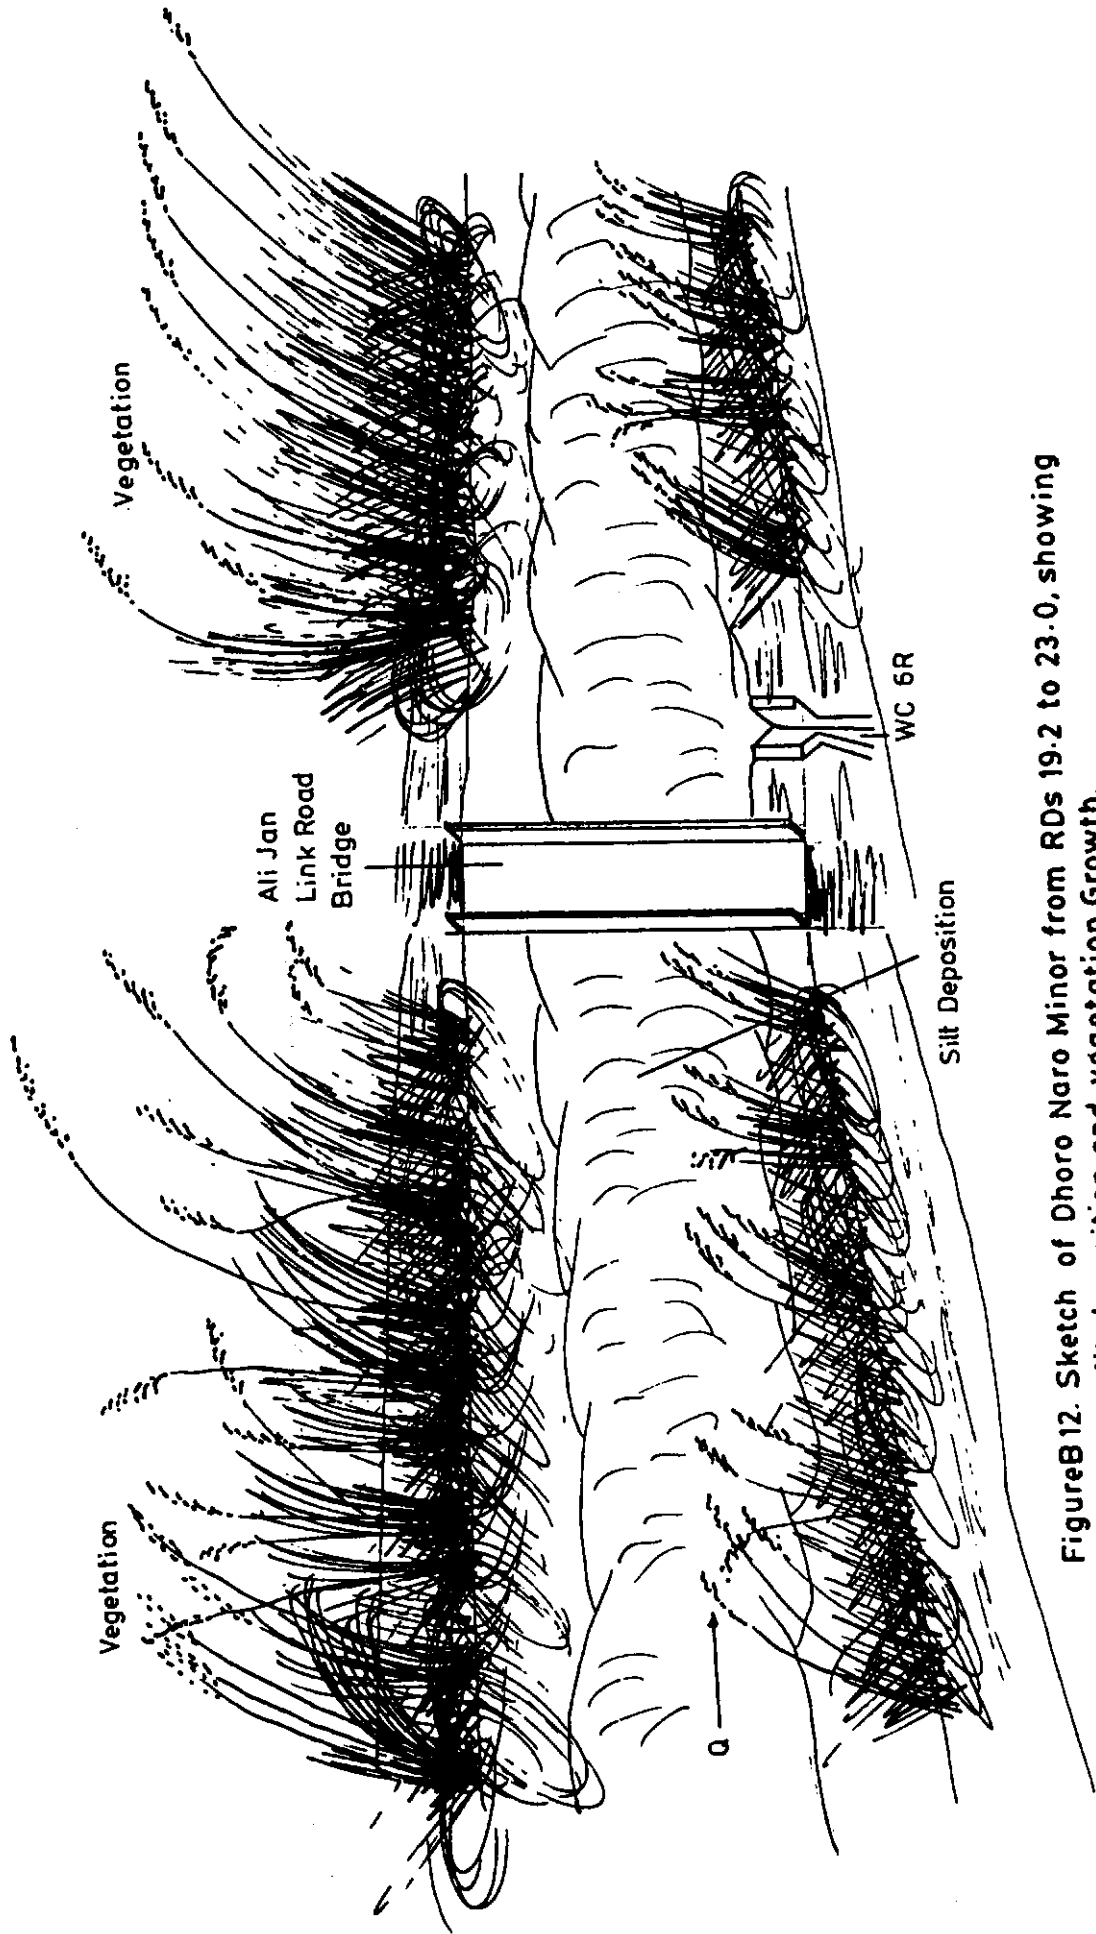
- RD 19+200 to 23+000: One and half portion of both banks of the section was covered with vegetative growth (Fig. B-12). It was above the freatic line but was fallen in to the minor flowing section, due to which silt deposition was observed. The section width was observed 9.5 ft. banks were in good condition while the inspection path was in very bad condition and was not possible to drive over it. This section has outlet 6-R and a bridge for crossing the Ali Jan link road.

FigureB12. Sketch of Dhoro Naro Minor from RDs 19.2 to 23.0, showing silt deposition and vegetation Growth.

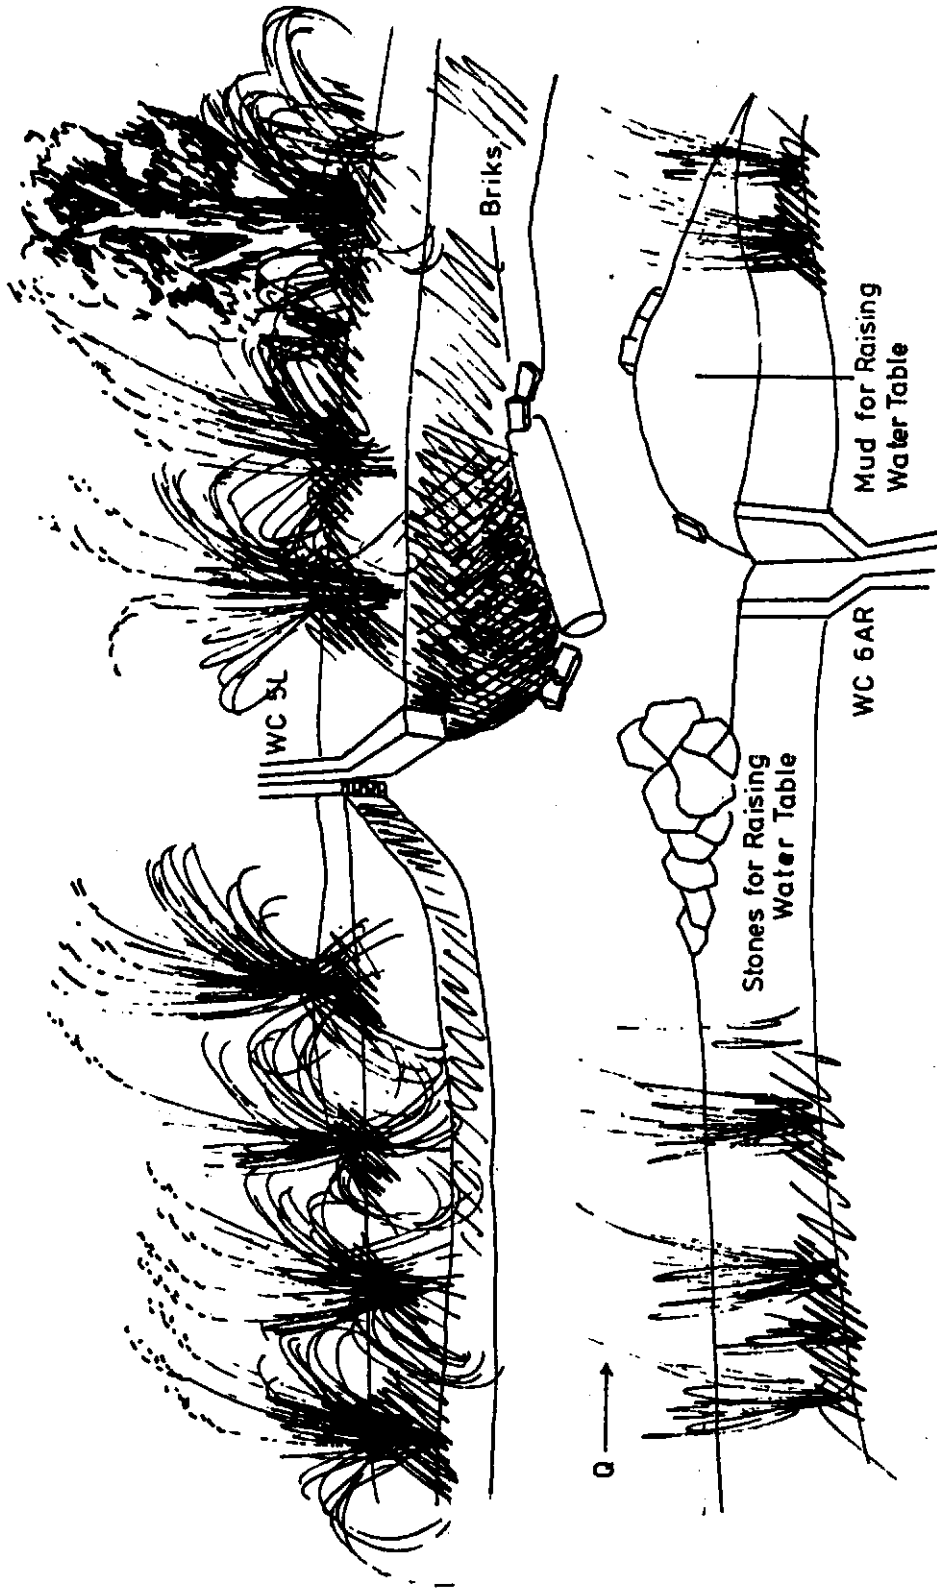
- RD 23+000 to 24+300: Both banks were covered with vegetative growth above the freatic line that was affecting the flowing section of the minor and caused silt deposition. Both banks were stable. Section width was observed 9.5 ft. At this section artificial hurdles like wooden pieces, tree steams, stone blocks and mud were dumped for getting more water (Fig. B-13).

Figure B13. Sketch of Dhoro Naro Minor Showing stones, bricks, tree steam and mud which are artificially dumped for getting more water near outlets 5L, 6AR at RD 24-17.
