Report No. R-40.1

**PILOT PROJECT FOR FARMER-MANAGED IRRIGATED AGRICULTURE UNDER
THE LEFT BANK OUTFALL DRAIN STAGE 1 PROJECT, PAKISTAN**

**MAINTENANCE PLANS FOR IRRIGATION
FACILITIES OF PILOT DISTRIBUTARIES
IN SINDH PROVINCE, PAKISTAN**

*Volume One
Dhoro Naro Minor, Nawabshah District*

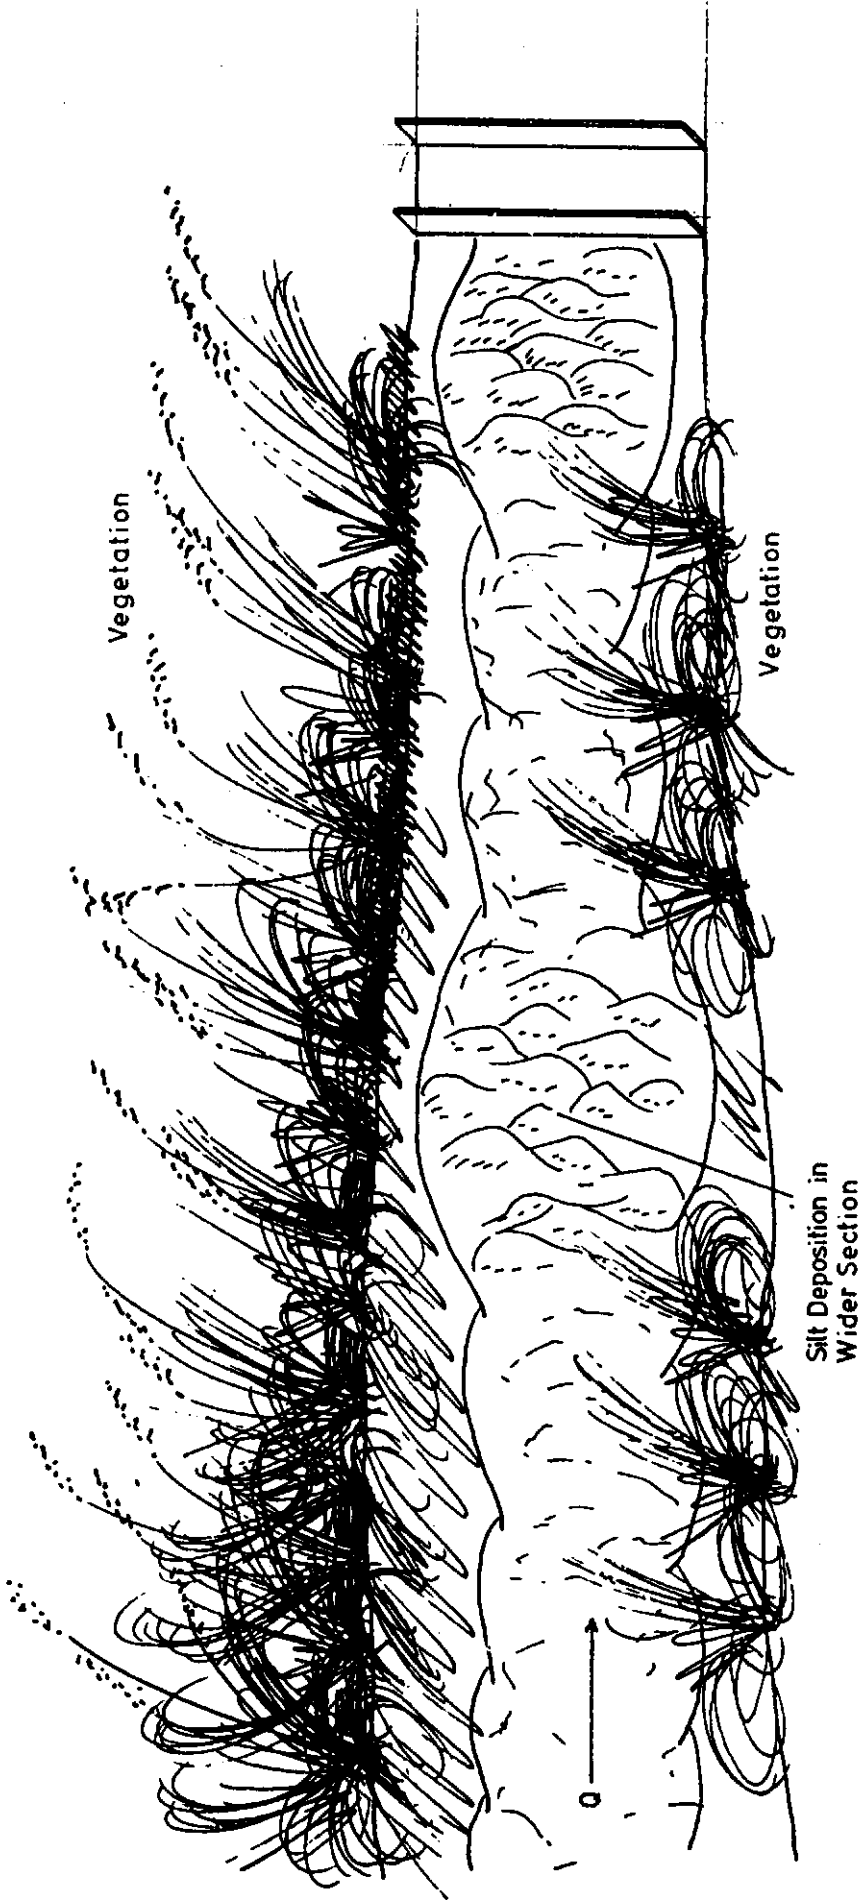
- RD 24+400 to 27+526: In this portion of the minor an un-effective and moderate vegetation growth was observed. The cross-section at the end portion was wider because of animal bathing while remaining portion was almost straight and has a proper alignment. Due to wider section some sediment deposition was observed. At the end of this section a bridge is situated for the Chisel abad link road as shown in Fig. B-14.

Figure B 14. Sketch of Dhoro Naro Minor from RDs 24.4 to 27.526, showing vegetation growth and silt accumulation in wider sections.

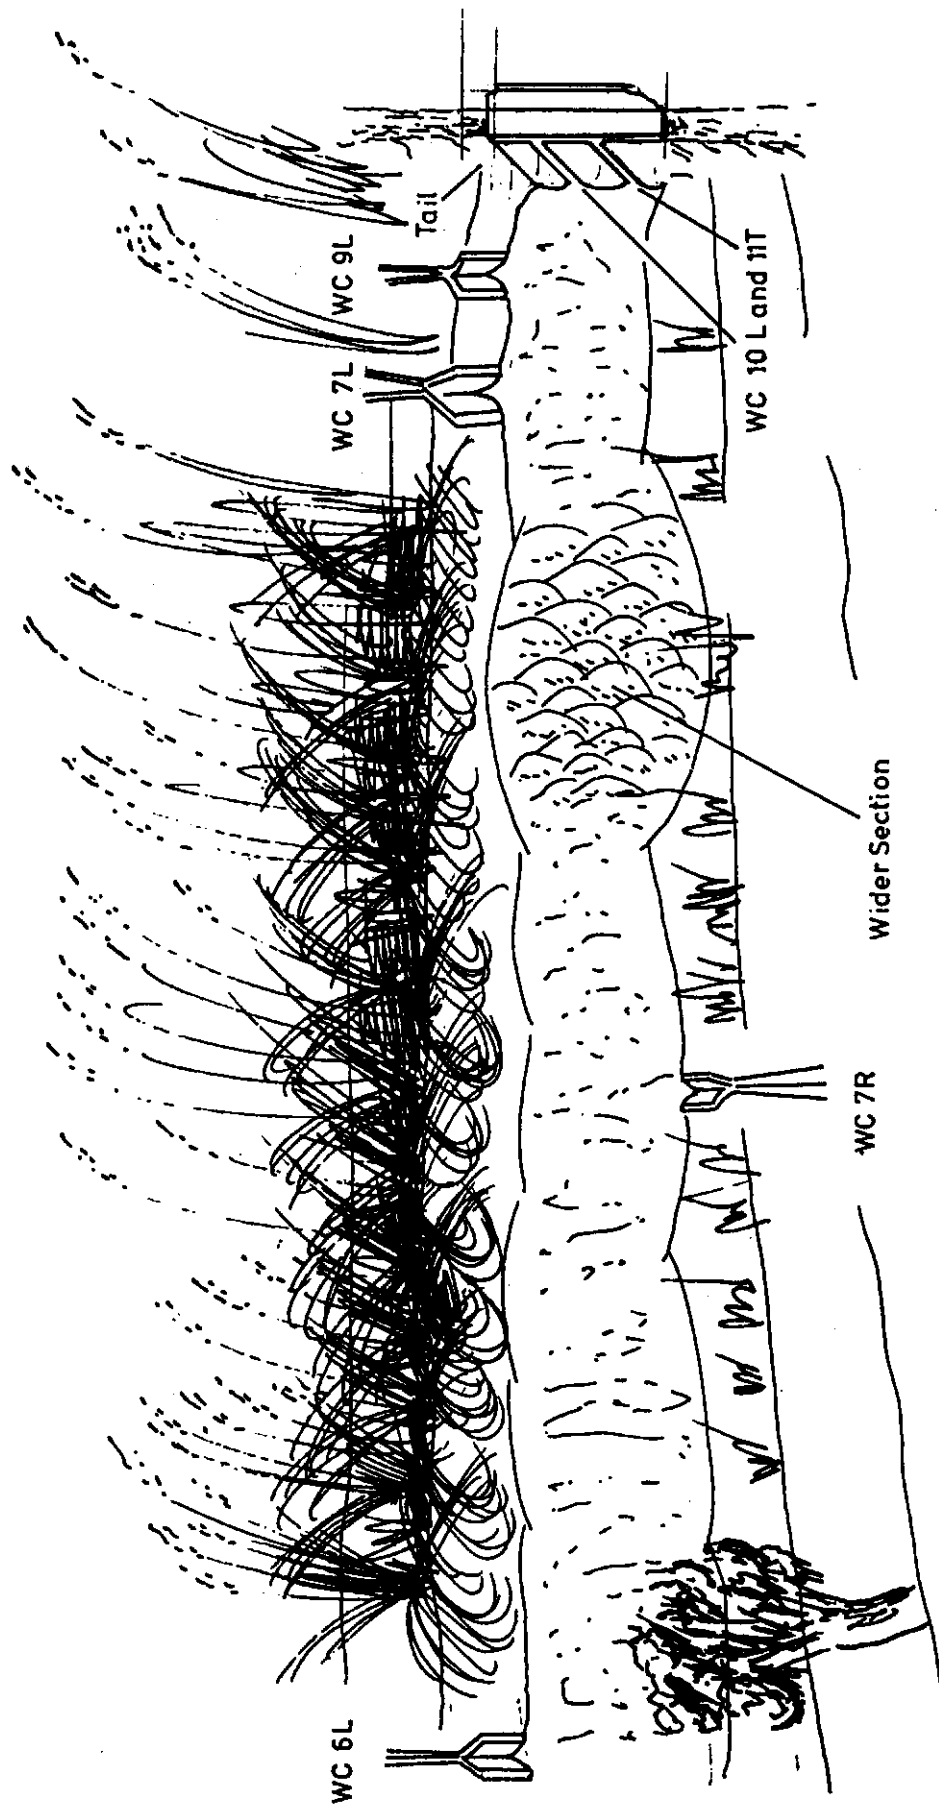
Figure 15 B. Sketch of Dhoro Naro Minor from RDs 27.526 to 32.275.

- 27+526 to 32+275: In this portion left bank was full with vegetative growth. Vegetation was falling in to the minor at some places due to which silt was deposited over there. The left bank was possessing very less vegetation. IP was not maintained properly. Section width was averagely 5.5 ft. In this portion outlets 6-L, 7-R, 7-L, 9-L, 10-L and 11-T are offtaking, as shown in Fig B-15.
