**PILOT PROJECT FOR FARMER-MANAGED IRRIGATED AGRICULTURE
UNDER THE LEFT BANK OUT FALL DRAIN (LBOD),
STAGE-I PROJECT, PAKISTAN**

**MAINTENANCE PLANS FOR IRRIGATION FACILITIES
OF PILOT DISTRIBUTARIES IN SINDH, PAKISTAN**

**Volume Two
Heran Distributary, Sanghar District**

**December 1997
Hyderabad Office
PAKISTAN NATIONAL PROGRAM
INTERNATIONAL IRRIGATION MANAGEMENT INSTITUTE**

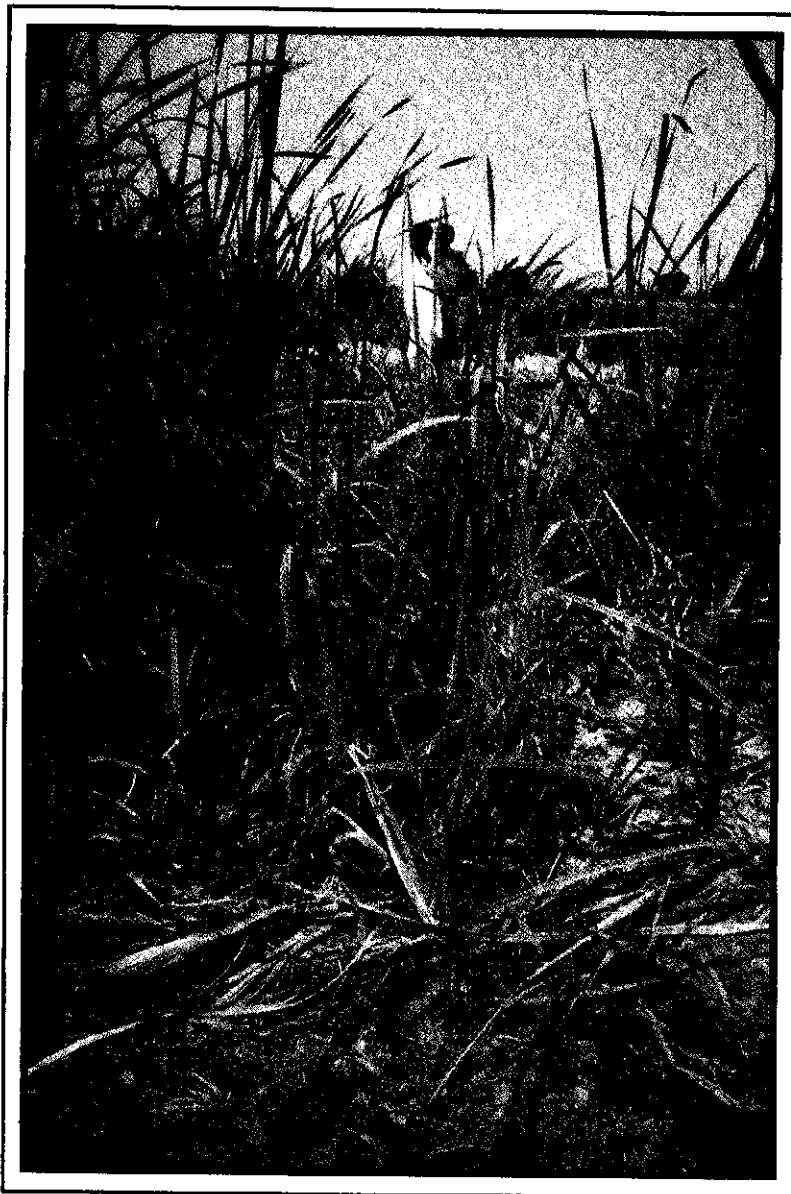
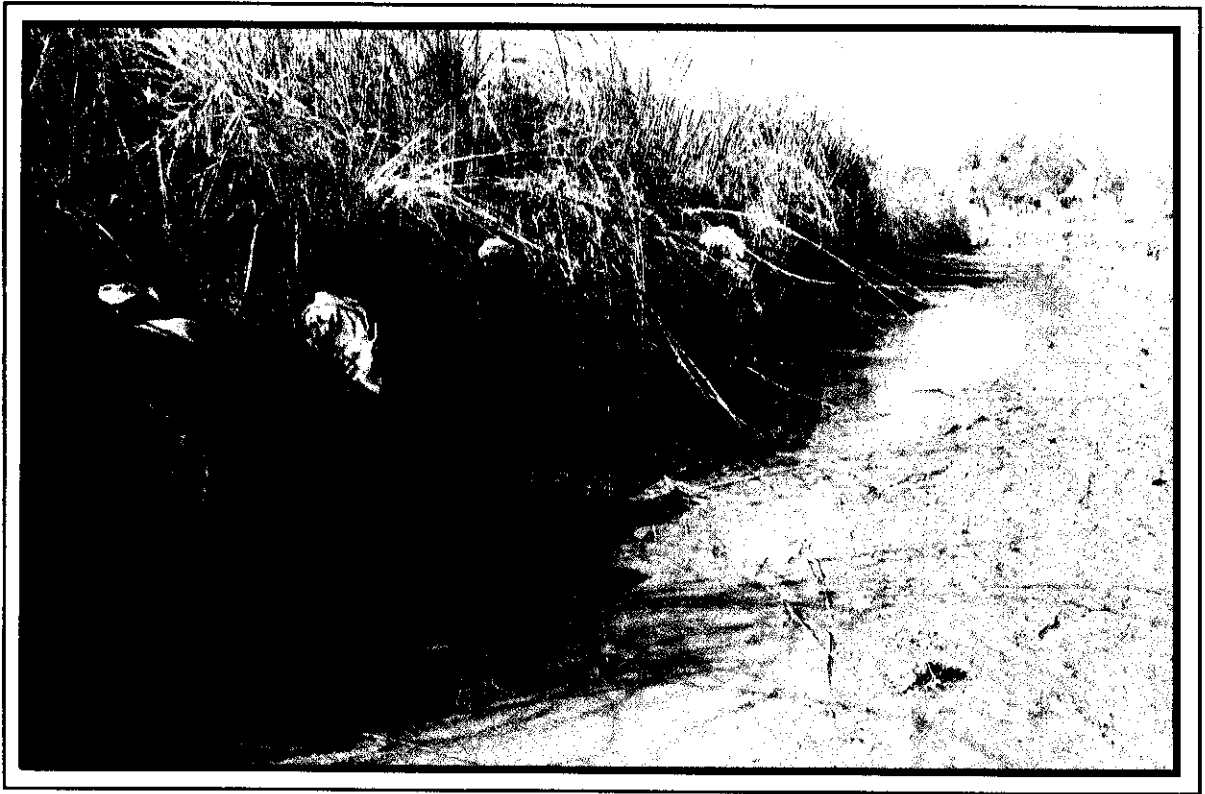
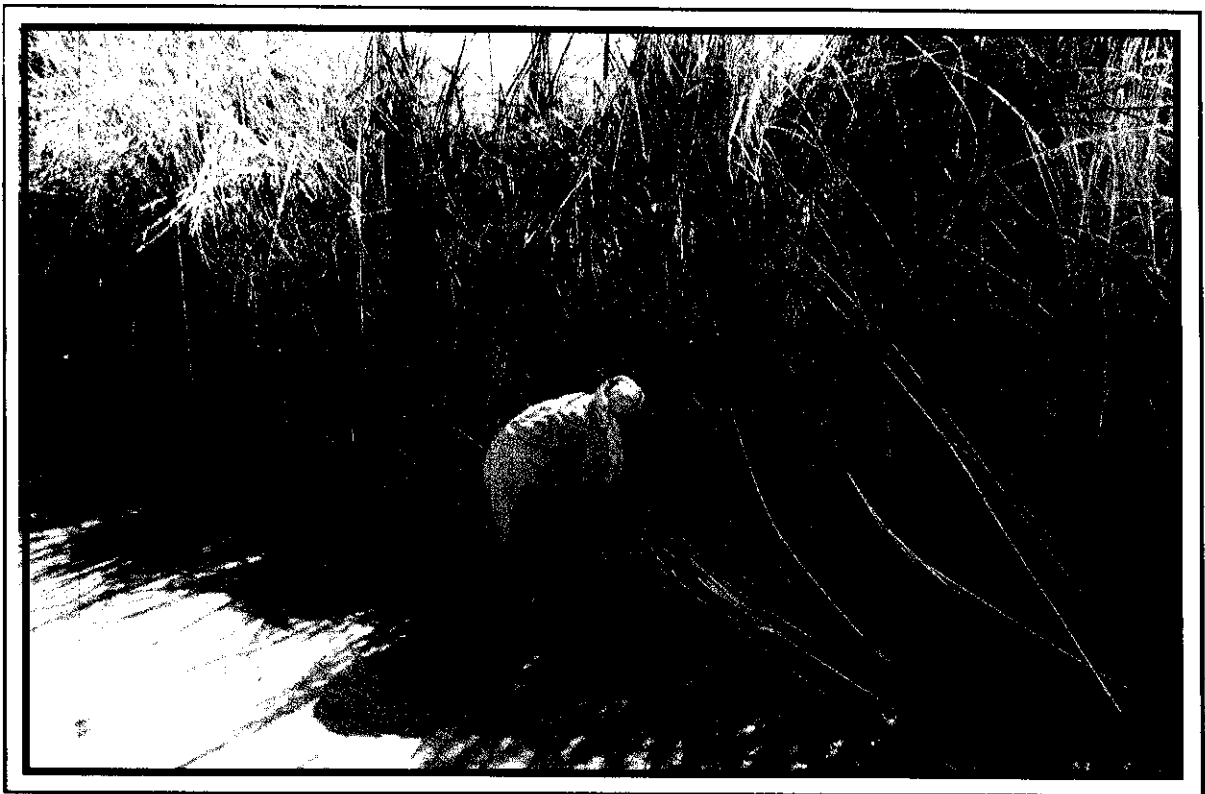
Photographs A, B, and C, are showing the condition of Non-Inspection Path from RD 23 to 27 before Rehabilitation.

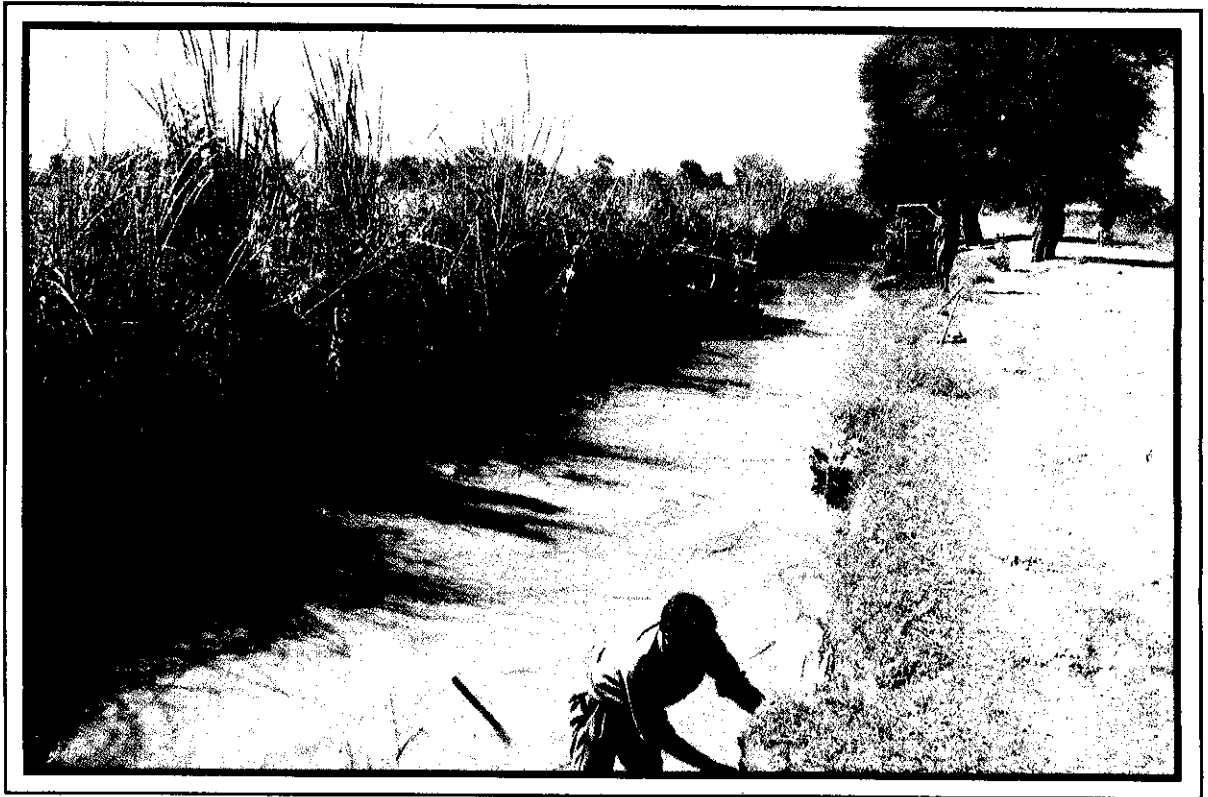
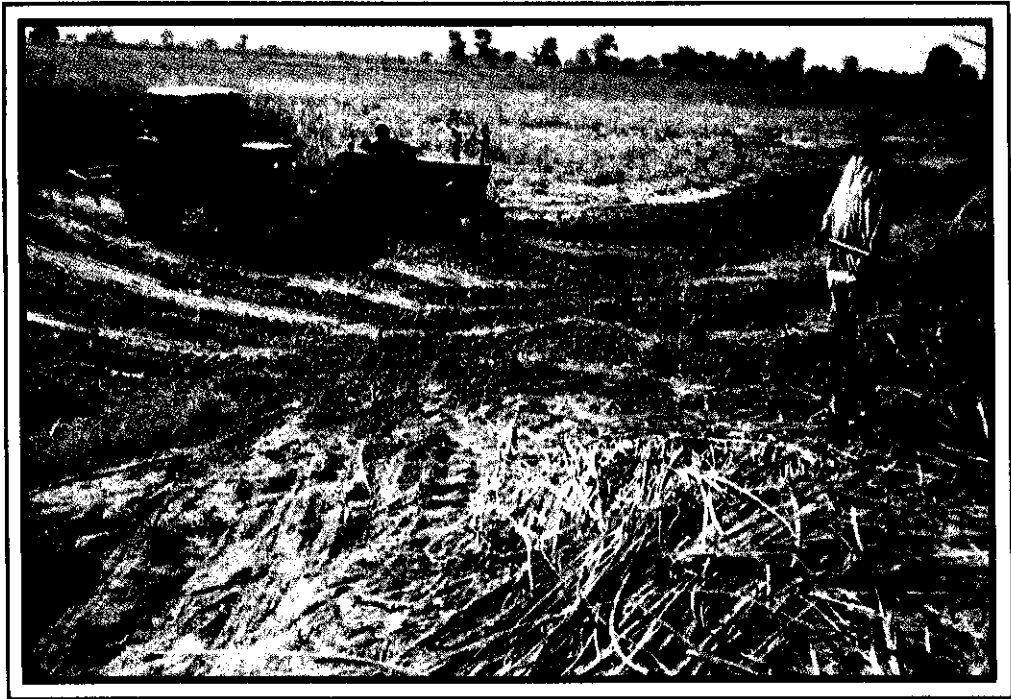
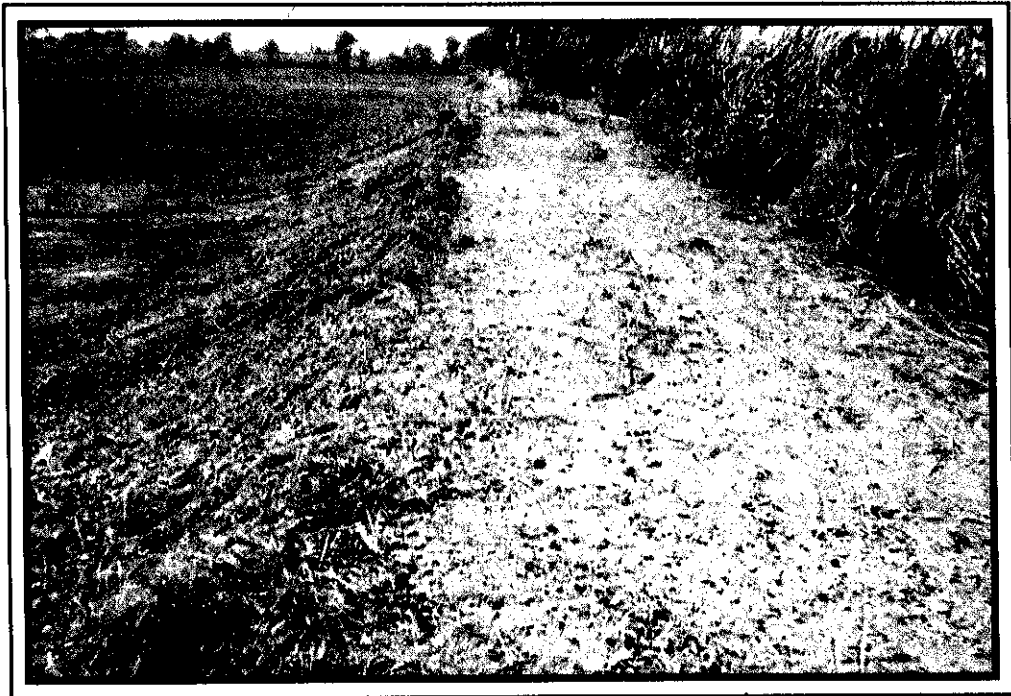
Photographs D, E and F showing the works in progress from RD 23-27.

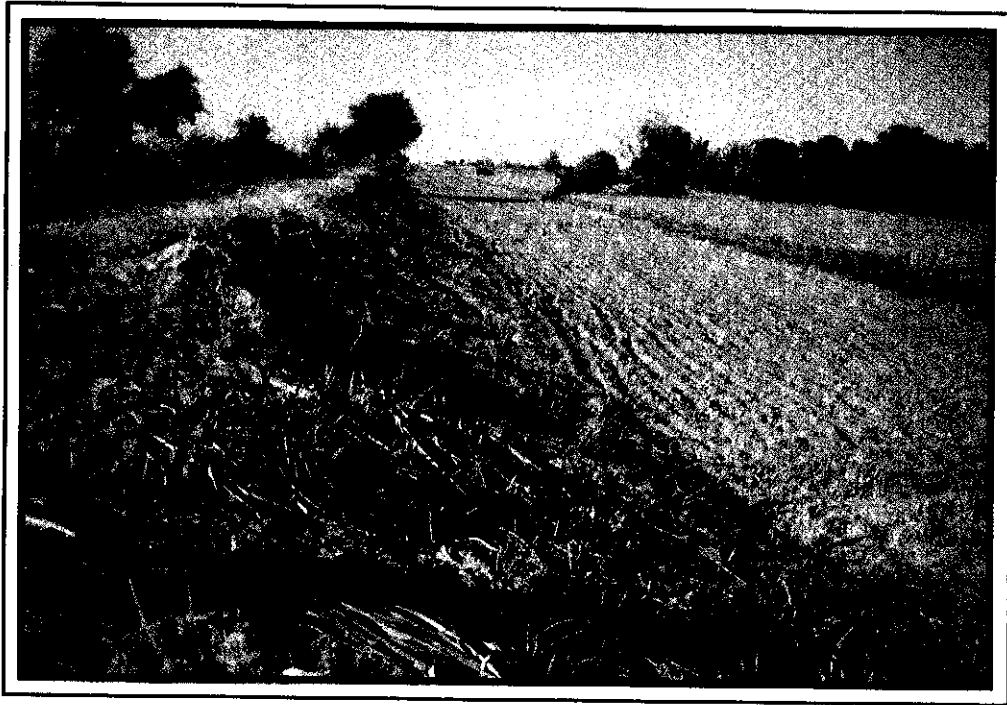
Due to continuous leakage of water from the Heran Distributary, the nearby area around this portion was always under water. Therefore no crop was being cultivated in the vicinity. Rather dense vegetation was always growing there (see Photographs A through C showing the nature and extent of the problem). The Heran WUF with the assistance from IIMI decided to rehabilitate this portion. The development scheme was prepared and presented in a meeting of the Heran WUF. The work was carried out in July- August of 1997 under the joint supervision of the members of the WUF and IIMI field staff (see photographs D, E and F showing the work under progress). The rehabilitation / stabilization of non-inspection path from RD 23 to 27 (about 4000 ft) has checked completely the leakage of water and has also stopped the occurrence of frequent breaches. About 30 acres of waterlogged and waste land has been reclaimed through this intervention. The area is being prepared for cultivation after a very long period (about 20 years). The land is being prepared for crops as given in Table 7.7 (also see photographs G, H, I and J showing the land already cultivated and being prepared for cultivation).

Photographs G, H, I, and J showing the area reclaimed.

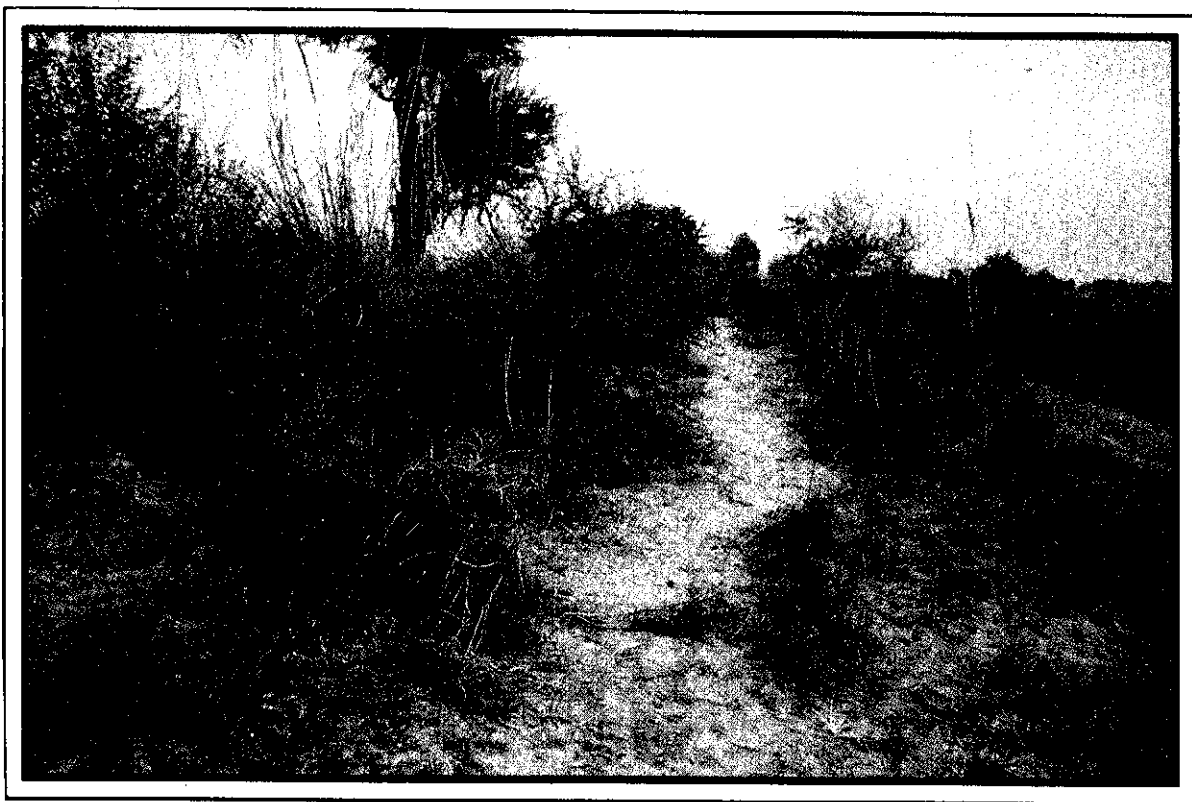
This portion of the distributary was not accessible for inspection patrolling since long time. The bank elevation was too high compared to the FSL of the channel. Therefore, this portion of the distributary was very difficult to desilt manually (see Photographs K, L, M and N showing the past and present conditions).

Photograph K. Inspection path from RD 27 to 31 before rehabilitation.

In this portion, the extra soil was removed upto required bank elevation. The extra soil was used to widen the inspection path. Also, local building contractors in the Sanghar City who needs this silt filling purpose were contacted and were encouraged to take this extra soil free of payment. This also helped in removing the extra silt quickly.

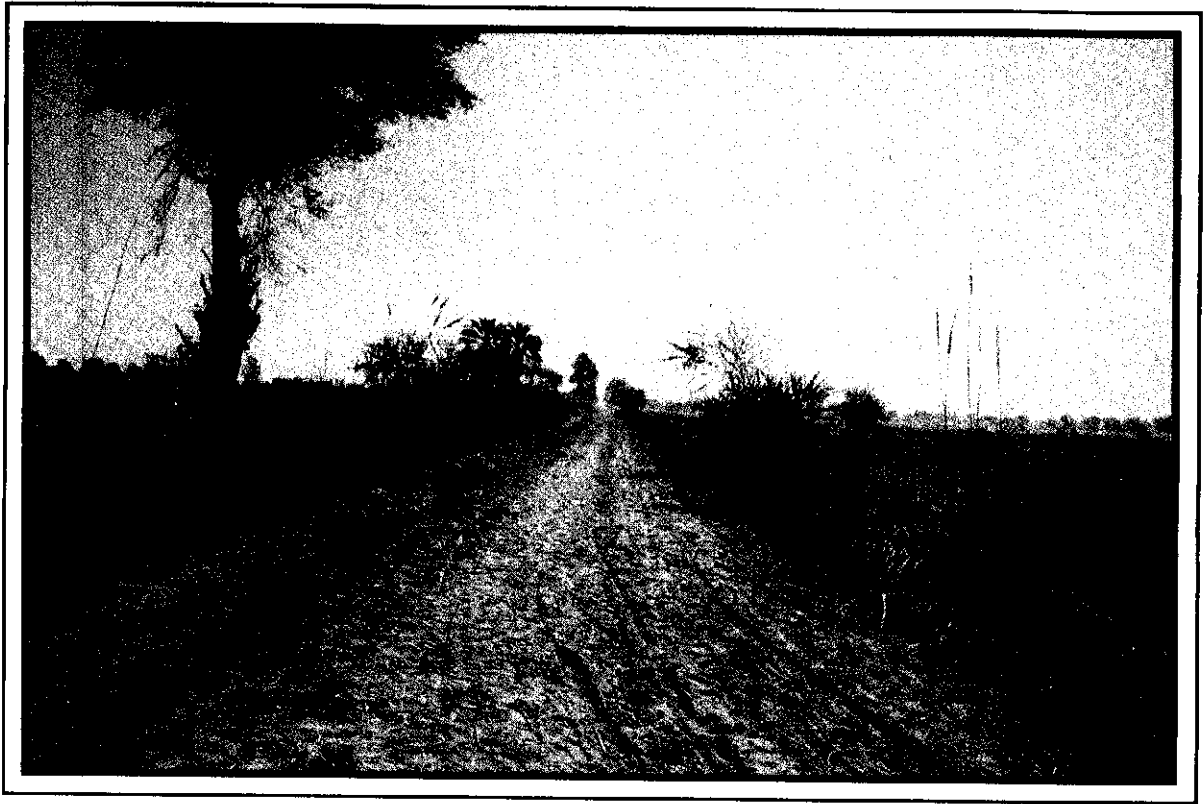
Photograph L. Inspection path from RD 27 to 31 after rehabilitation.

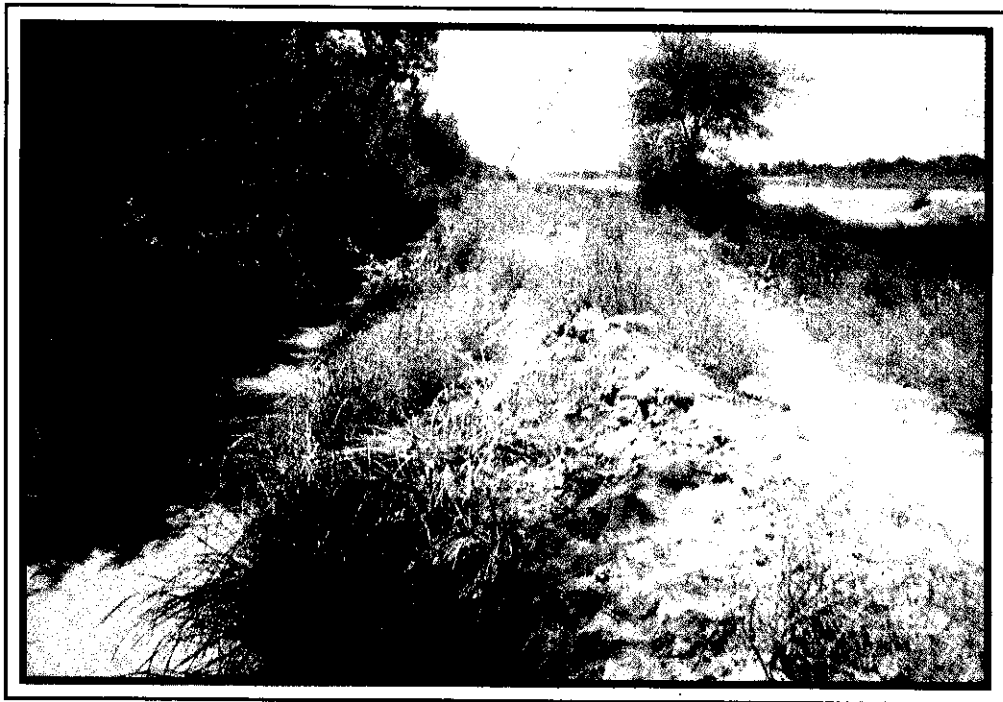
Photograph M. Inspection path from RD 27 to 31 before rehabilitation.

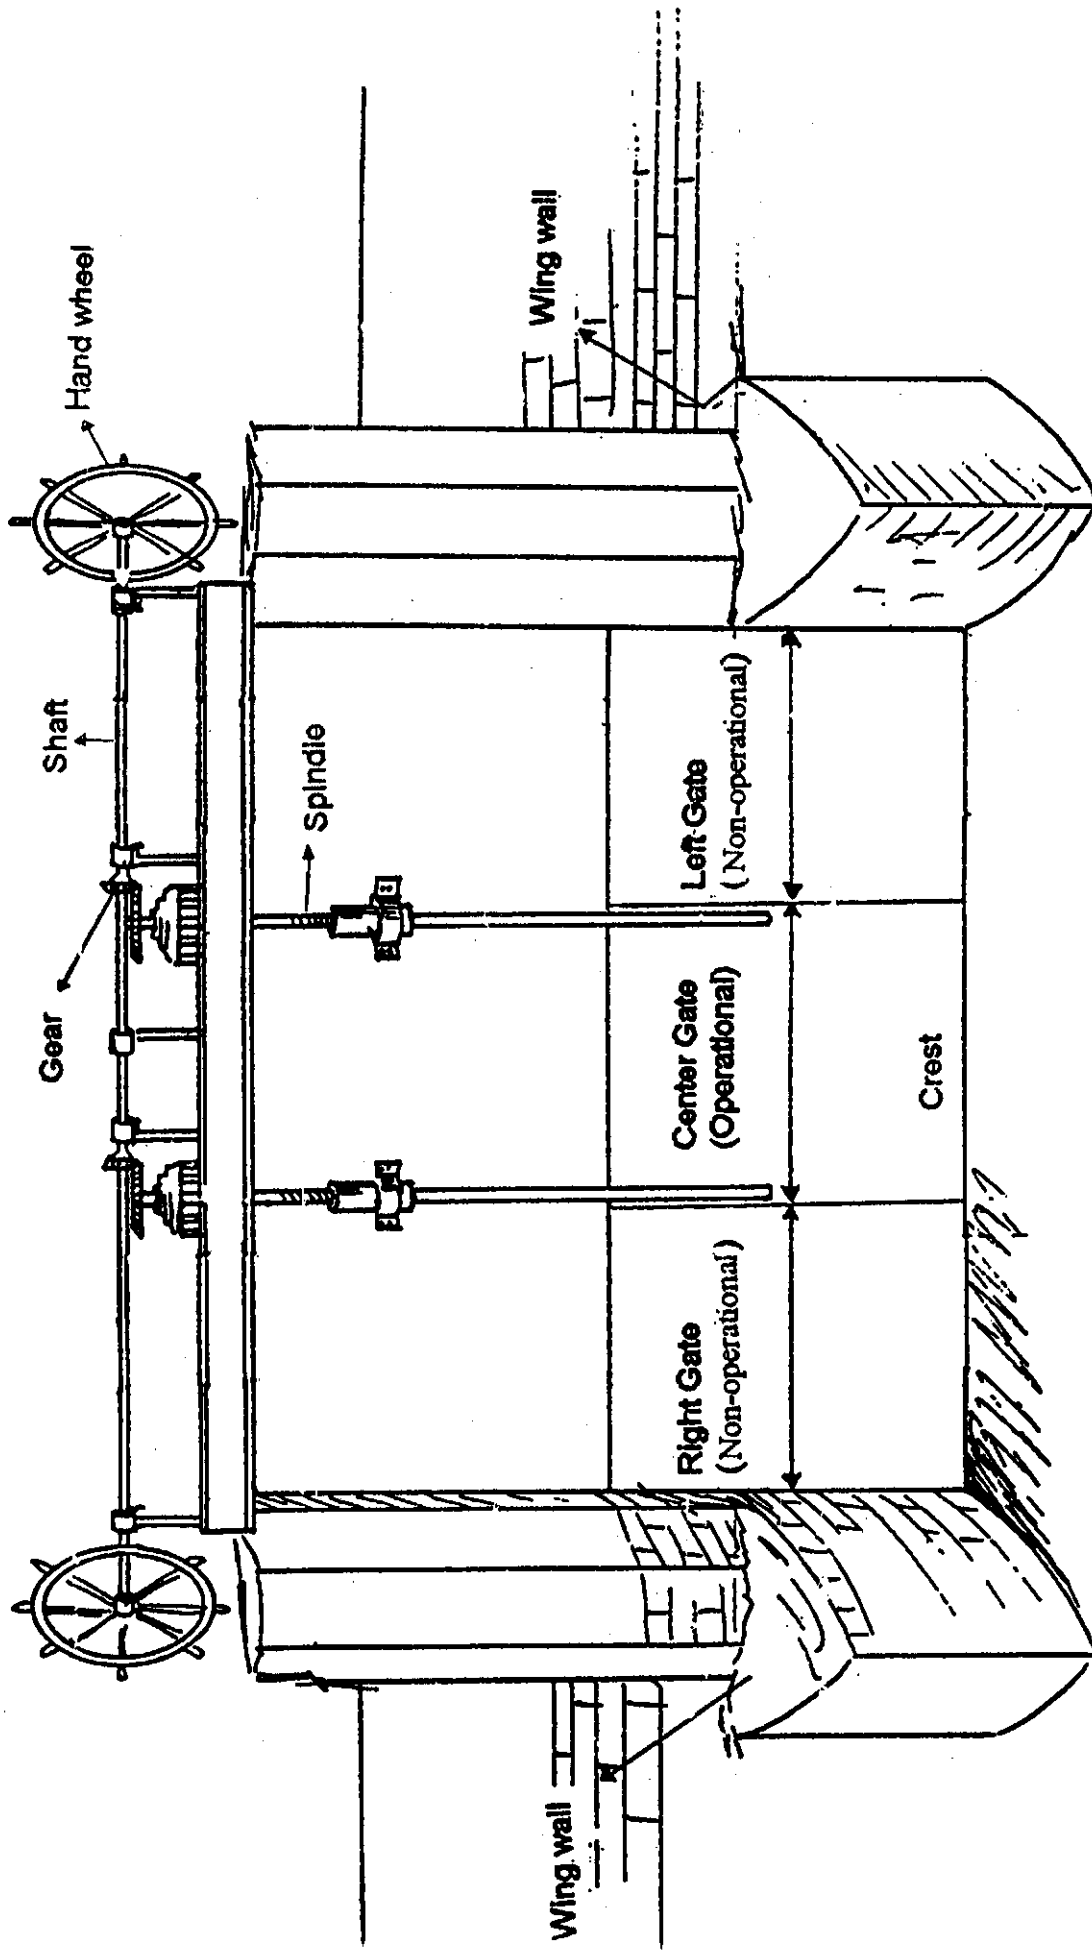
Figure A-1. Head Regulator of Heran Distributary.

The head regulator consists of three gates (see Figure A-1). Two of them are closed and the middle one is functional. There is one cross regulator situated at RD 10. The main function of this cross regulator is to control the flow in to the Khadwari Minor. The cross regulator is dysfunctional. The distributary channel has a bend of about 65 degree at RD 19. The inspection path is in good condition.

The head regulator of the Heran Distributary is a rectangular-type gate structure was constructed during the British period. It has three main gates from which only the middle one is in good working condition. The other two, on the left and right sides, are not in working condition. The head regulator requires substantial maintenance to become fully operational.

Considerable importance is given to keeping the main head regulator structure in good working condition because it is the key location from where water flow is regulated into the channel. The head regulator for the Heran Distributary is located on Nara canal at RD 129. It is a rectangular-type gate structure. It was constructed during the British period. There is a serious problem in proper functioning (see Figure A-1). There are three gates. Two of them, located on the left and right sides, are not operational. Only the middle gate is operational.

After formation of the Heran Water Users Federation (WUF), the first decision taken by the WUF was to improve the head regulator. The WUF of the Heran Distributary pointed out in a FICC meeting that the main gate of the distributary had been out of order for a long time and they requested to the SDO, Irrigation Department, Bakhoro Sub-division, for repairs. The SDO informed them that the Irrigation Department had no funds and, therefore, he was unable to repair the gate in the near future. However, he allowed the Heran WUF to repair the gate, in case they were able to arrange for funds. The Heran WUF submitted an application to the Irrigation Department for necessary permission and started the work. For this purpose, a contribution of Rupees five hundred (500) from each watercourse was collected and the head regulator was rehabilitated. Total expenditures for maintenance were about Rupees six thousand (6,000). The Heran WUF financed the full cost of the repairs.

The WUF of the Heran Distributary repaired the head regulator of the main channel by spending Rupees Six Thousand only (Rs: 6,000) from their own resources.

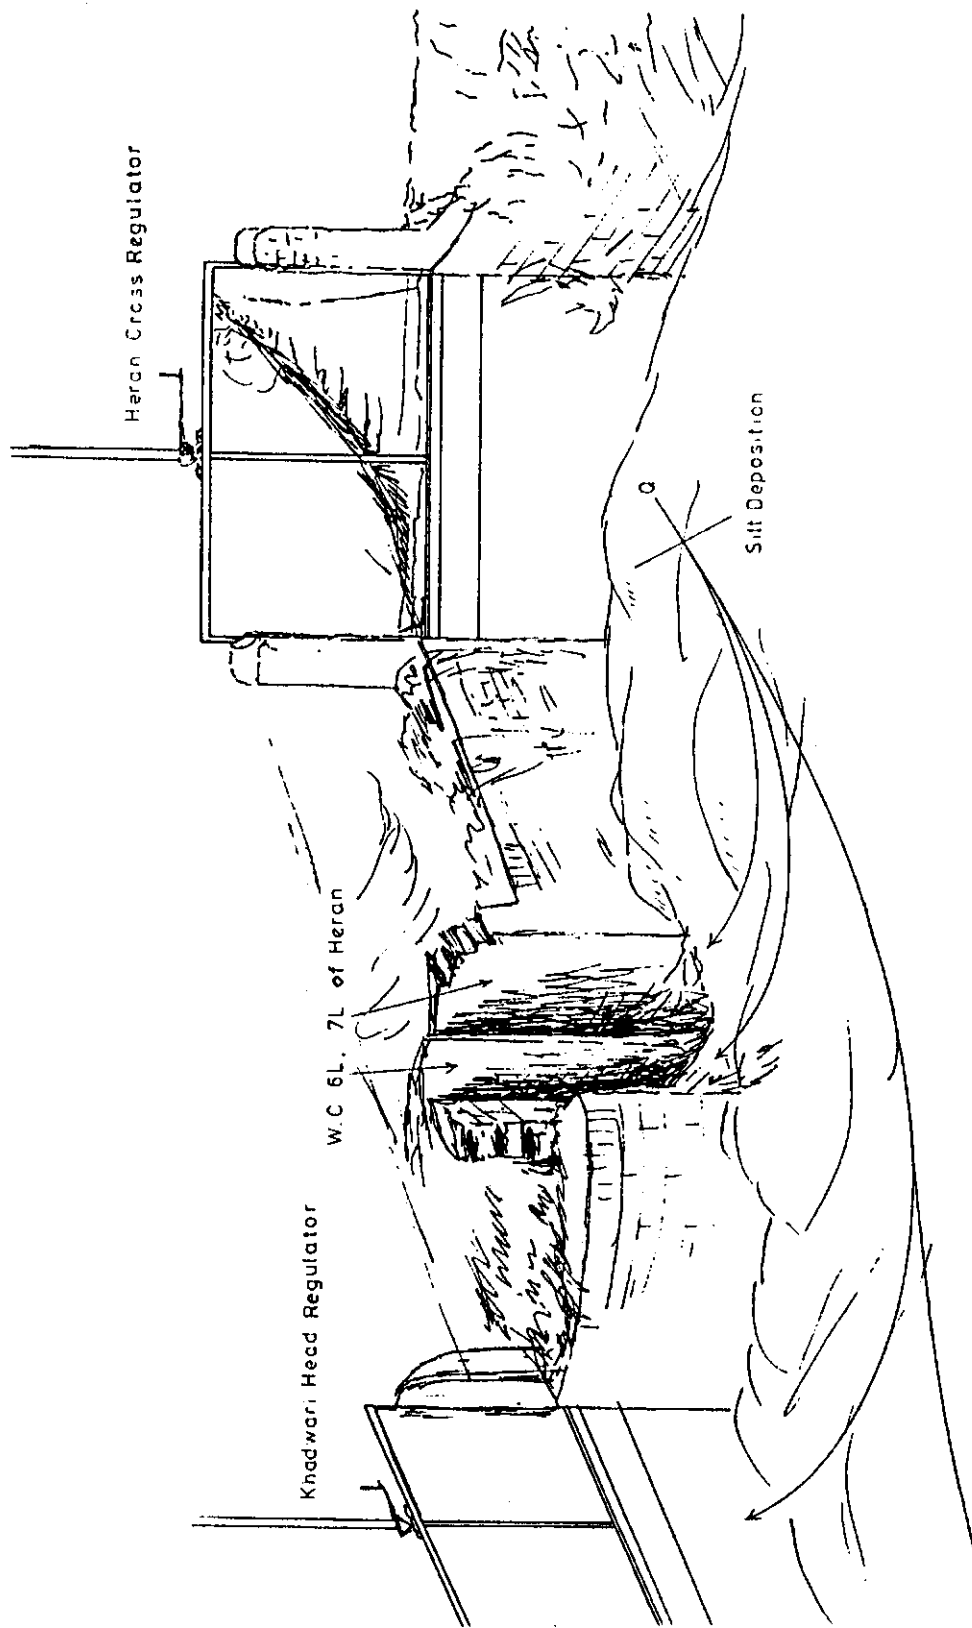
Figure A-2. Sketch of Heran Distributary at RD 10.0.

The cross regulator of the Heran Distributary situated at RD 10 is a rectangular gate structure with an iron frame (see Figure A-2). The main function is increasing or decreasing water flow into the Khadwari Minor. This is an old structure and due to the lack of proper maintenance, it was not in good working condition. The iron frame was broken. There are two holes in the frame from where water was leaking. The Heran WUF is considering to repair this gate soon.

The head regulator of the Khadwari Minor is located near RD 10. This regulator is operated almost on a daily basis for regulating flows to the Khadwari Minor. This gate is in good working condition (see Figure A-2).

HERAN D. Cross regulator is situated at RD 10. It is rectangular in shape (Figure A-2). It has an iron frame. The main function of this cross regulator is to control flow in the Khadwari minor. This regulator is there since early days. Due to lack of proper maintenance, it was not in good working condition. The iron frame is broken. There were several holes in the frame from where water was leaking.

HERAN D. The head regulator for the Khadwari minor is located at RD 10 of the Heran Distributary. It was the only control point for increasing or decreasing discharge in the Khadwari Minor. This is rectangular type with fixed iron frame. This regulator is operated almost on daily basis for Khadwari minor. This gate was in good working condition (Figure A-2).

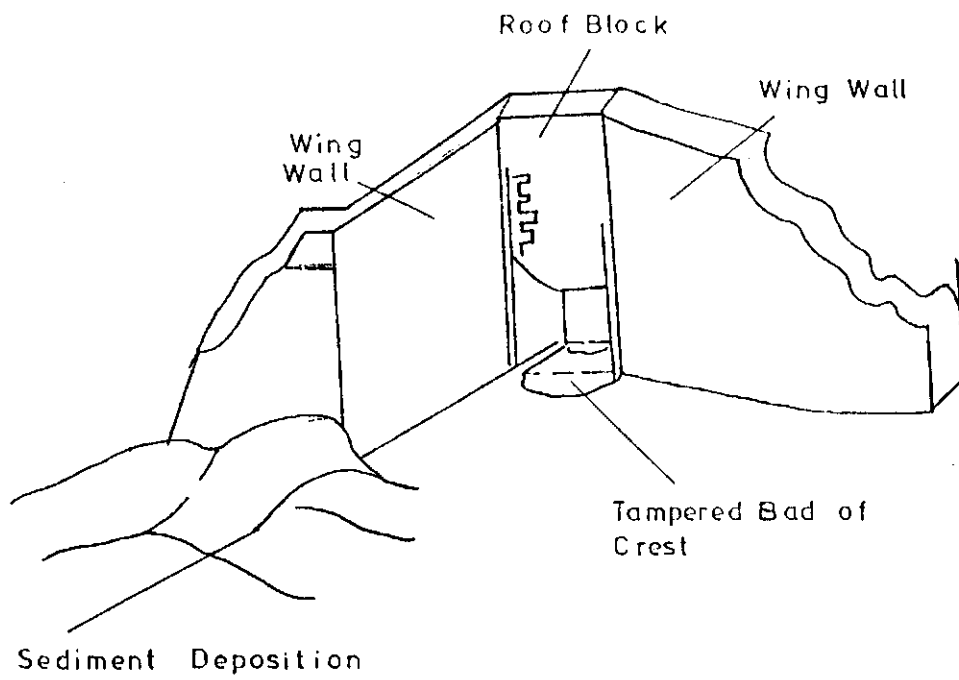
Figure A-3. Outlet 1-L Heran Distributary.

Type	It is an Adjustable Proportional Module (APM).
Condition	Its crest is tampered. The wing walls are in good condition. There is considerable amount of silt deposition near the left wing wall. It was tampered for drawing more water during the current season. (see Figure A-3)
Remedy	The outlet needs to be repaired for restoring its original condition.

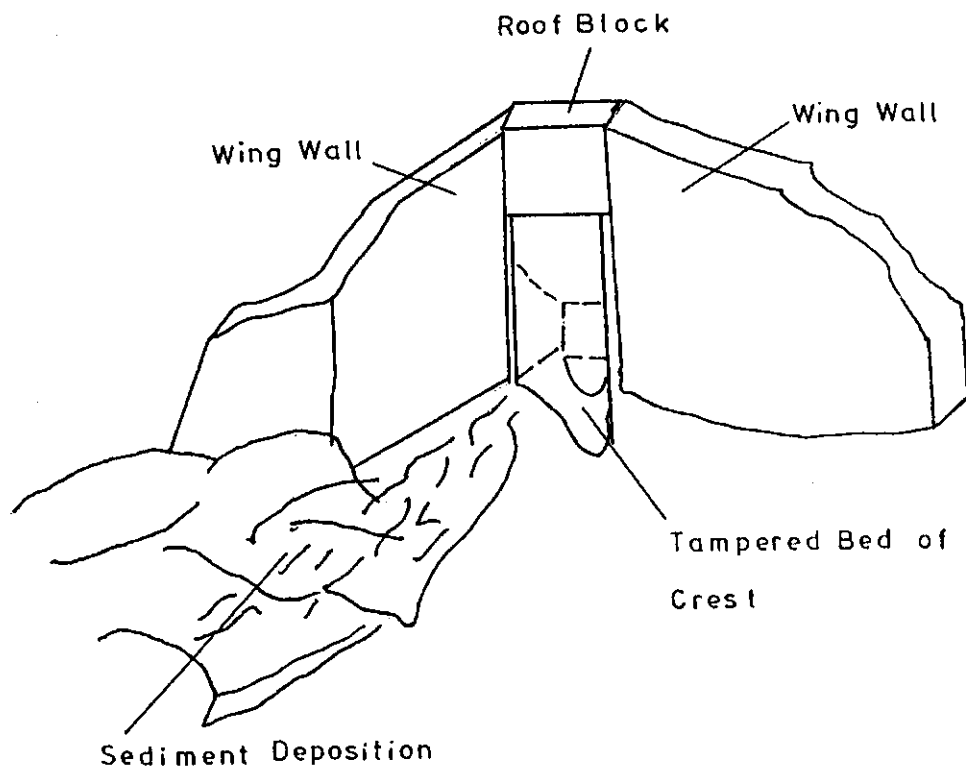
Figure A-4. Outlet 3-L & 5-L of Heran Distributary.

Condition Its crest is tampered. The side walls of the orifice are also tampered to provide space for the passage of more water. There is considerable amount of silt deposition on the left wing wall. It has been tampered for the simple reason of drawing more water (see Figure A-4).

Condition The crest as well as walls of the orifice are tampered. (see Figure A-4). There is considerable silt deposition near the right wing wall of the outlet.

Remedy The outlet needs to be repaired for restoring its original condition. It is also necessary to remove the silt deposition on the right wing wall. (see Figure A-4)

Remedy The outlet needs to be repaired and rehabilitated to its original design. It is necessary to remove the silt deposition on the right wing wall.

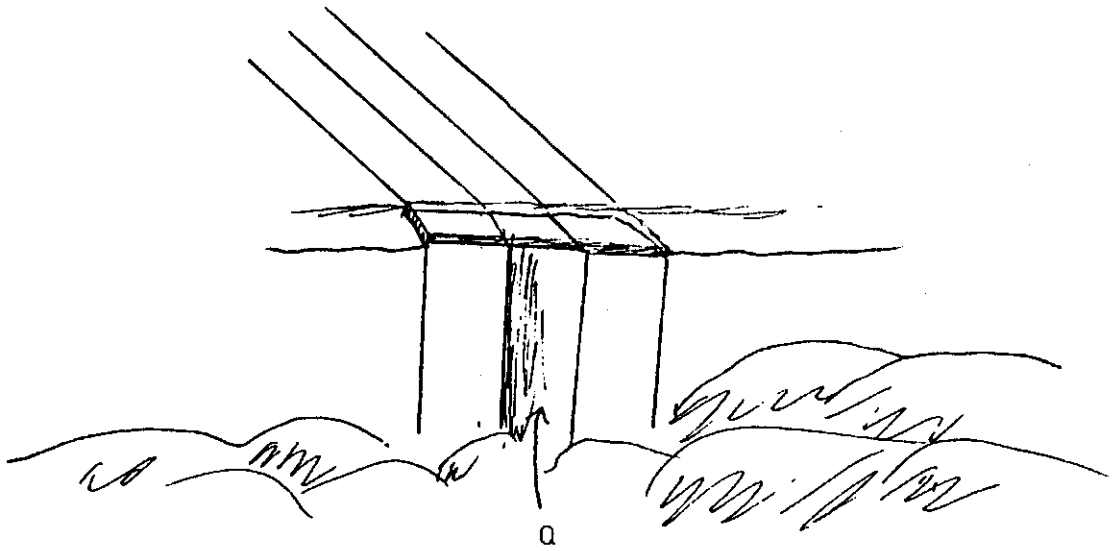
Figure A-14. Outlet 6-T of Khadwari Minor.

Type	It is an Open Flume.
Condition	There is no permanent structure to control the discharge. There are two simple rectangular block. Water can flow beneath and around these blocks. There are no wing walls. (see Figure A-14).
Remedy	The outlet needs to properly designed and constructed.

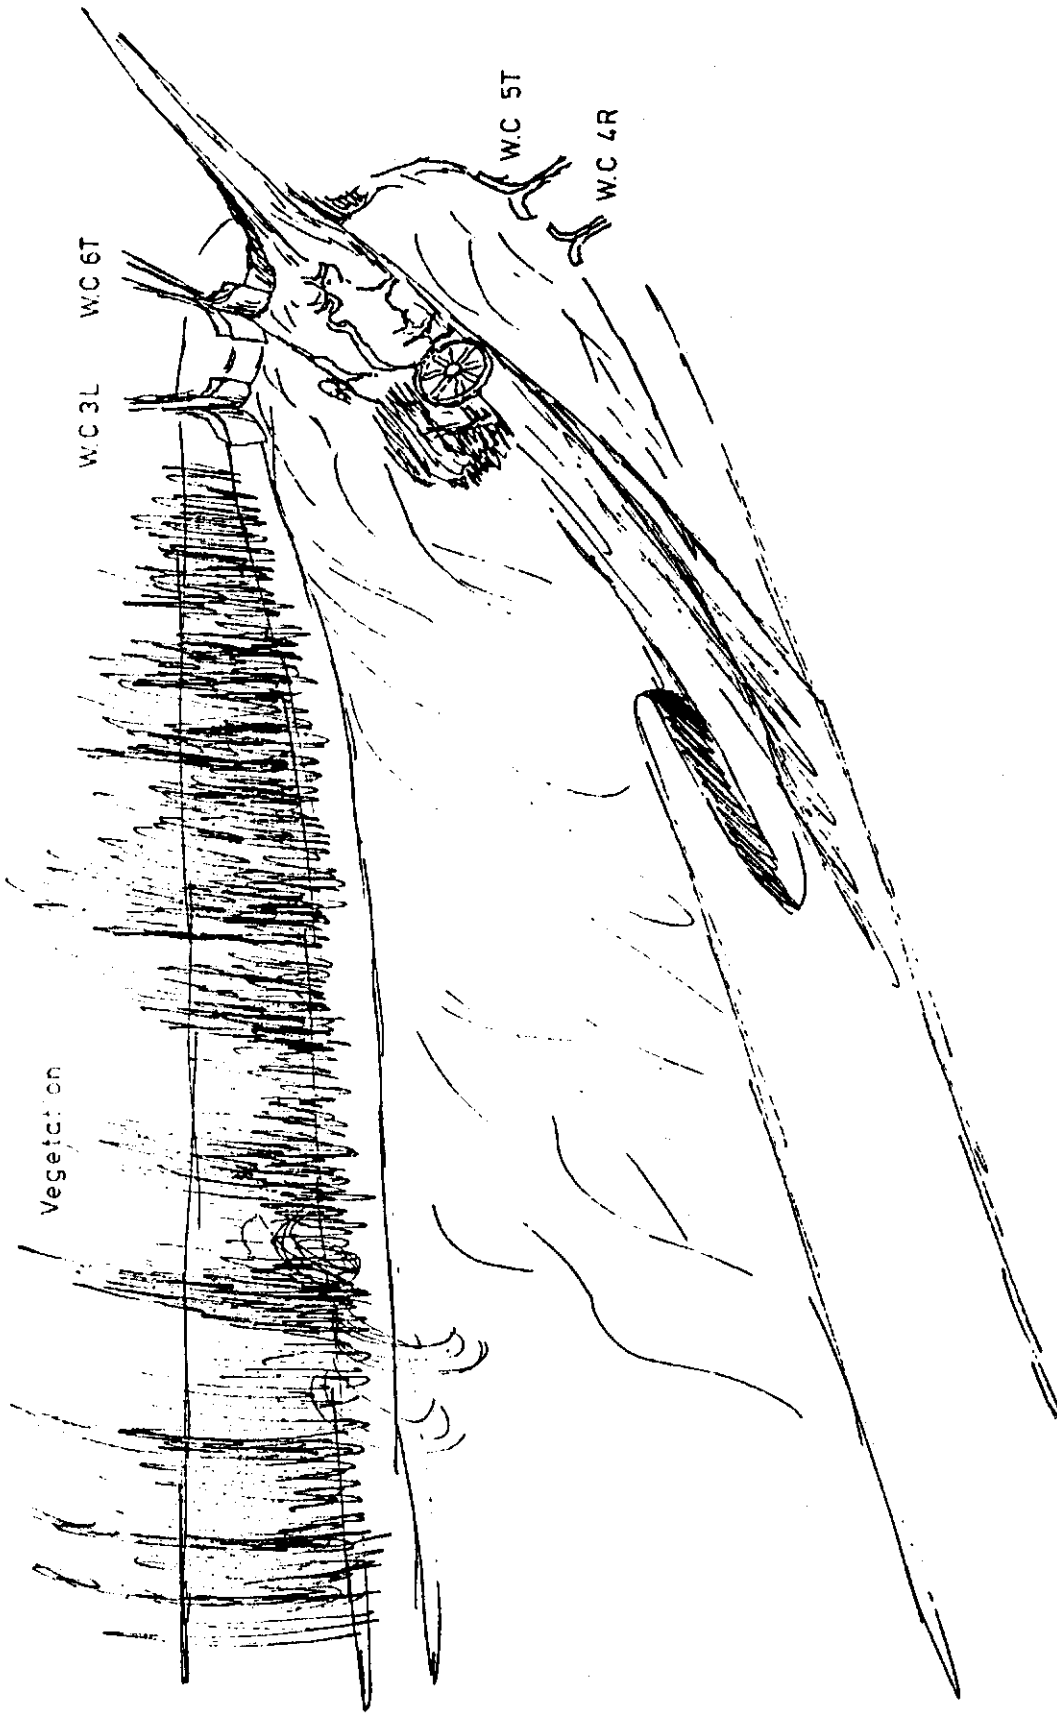
Figure B-10. Sketch of Khadwari Minor from RDs 13.0 to Tail Before Development.

11.48 to 12.0	Condition	There is considerable vegetative growth on the left bank. The shape of the bank is irregular. There are cuts. The right bank is almost clean but it has some cuts also. The bed of the minor is in good condition. The path is in good condition.
	Remedy	The banks need to be redressed. The vegetation also needs to be removed from the left bank.
12 to 13	Condition	There is considerable vegetation on left side. The bank on the right side has soil erosion due to which a cavity has formed. There is considerable amount of silt deposition. Due to silt deposition water spills over the left bank. The inspection path is in good condition. However, some farmers draw water directly by cutting the inspection path.
	Causes	Lack of maintenance.
	Remedy	The bed needs to be desilted. The cavity and cuts in the inspection path need to be redressed. Vegetation needs to be removed.
13 to tail	Condition	There is considerable vegetation on the left bank. The right bank is almost clean. There is considerable amount of silt deposition. Due to silt deposition water spills over the right bank. The extreme tail portion of minor has become wider due to the sitting and crossing of the animals. (see Figure B-10). The inspection path is in good condition.

Causes	Lack of maintenance and sitting of animals.
	Remedy	The bed needs to be desilted. The vegetation on left bank needs to be removed.
