Research report 2014:05

# Surface fatigue initiated transverse defects and broken rails – an International Review

*Department of Applied Mechanics / CHARMEC*  
CHALMERS UNIVERSITY OF TECHNOLOGY  
Gothenburg, Sweden 2014

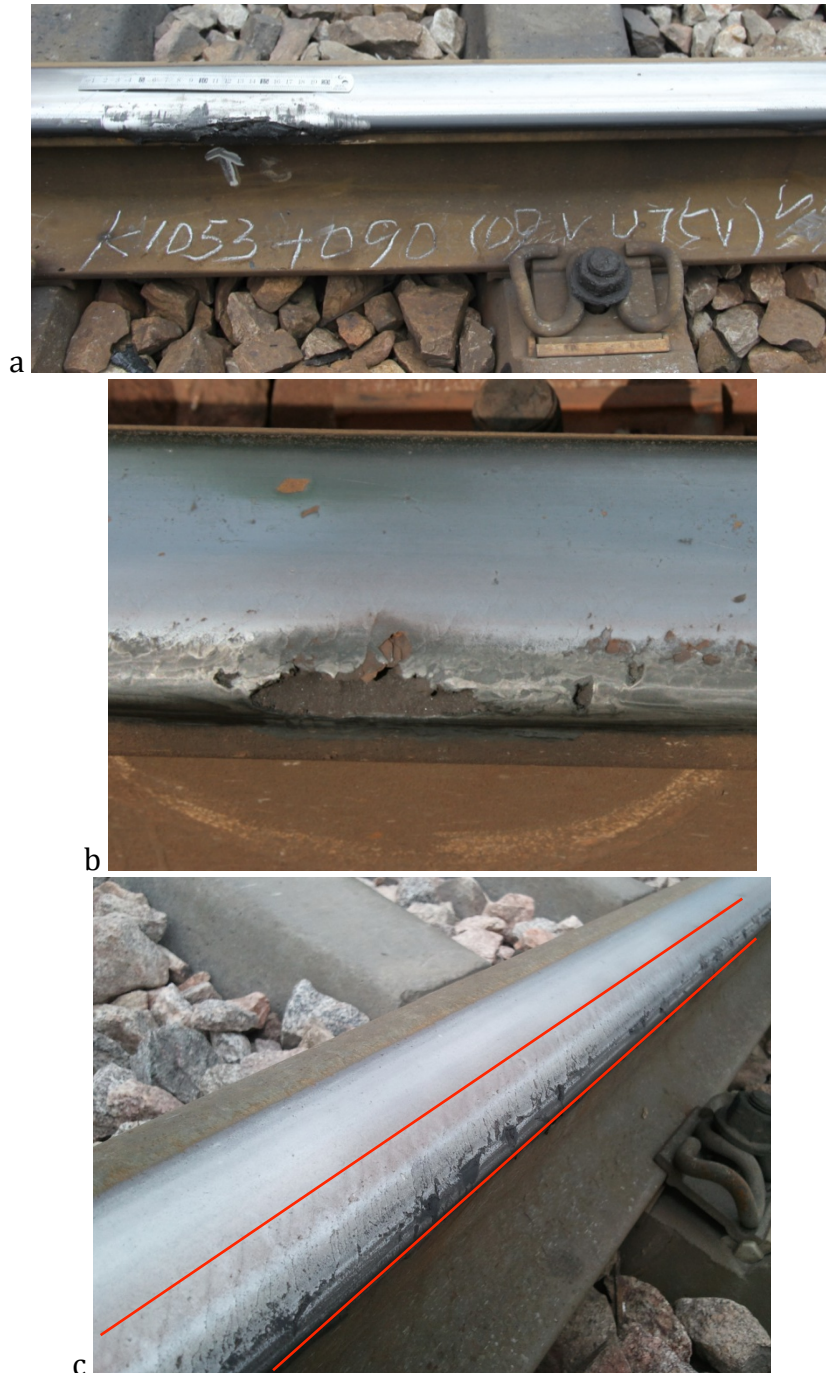
Figure 1 Rail damage corresponding to the cases reported above **a)** shelling caused by incorrect super-elevation causing cant excess; **b)** shelling caused by excessive lubrication in order to reduce the lateral wear **c)** head checks and shelling caused by the use of as-rolled rail, which is not a suitable choice for the current conditions.

The cracks presented have not formed complete rail breaks. It is therefore difficult to assess the critical crack size. However judging from Figure 1b, the critical crack size should be larger than some 10% of the railhead area.

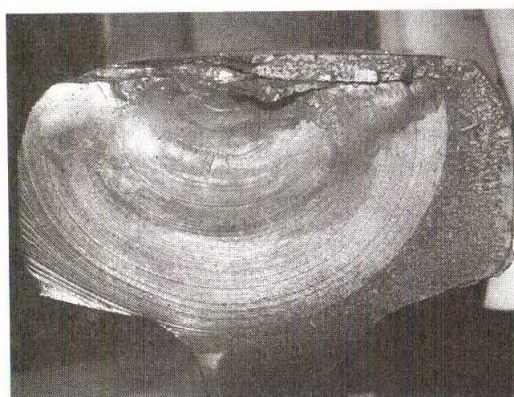
Figure 2 Example of transverse fatigue crack of the railhead. Rail removed from single track [1].

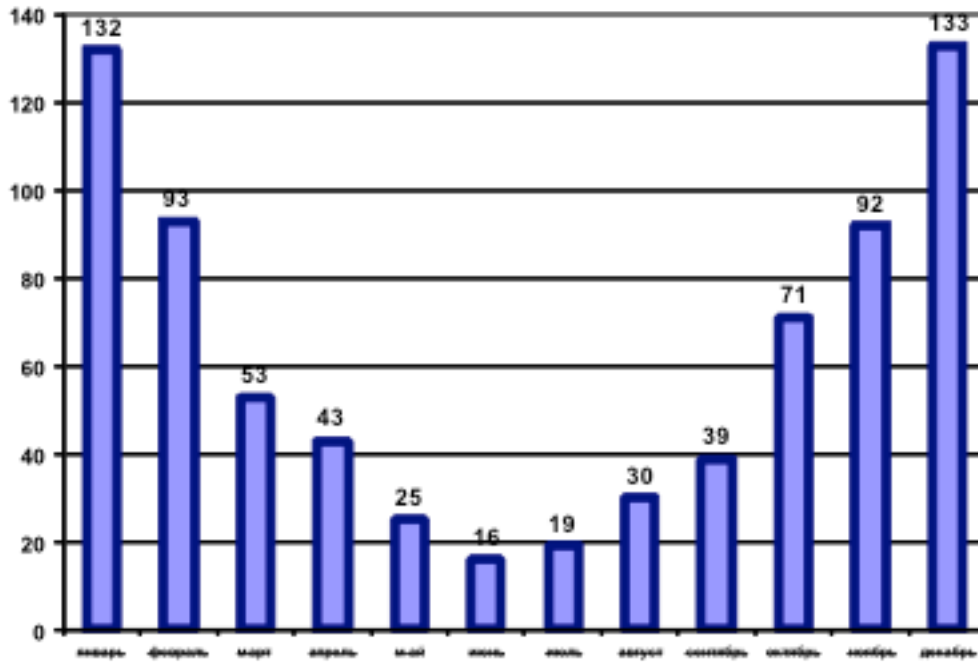
The influence of climatic conditions on rail breaks for the Russian Railways is presented in Figure 3 (from [1]). It is seen that rail breaks are up to 8 times more likely during winter than during summer.

Figure 3 Example of transverse fatigue crack of the railhead. Rail removed from single track [1].

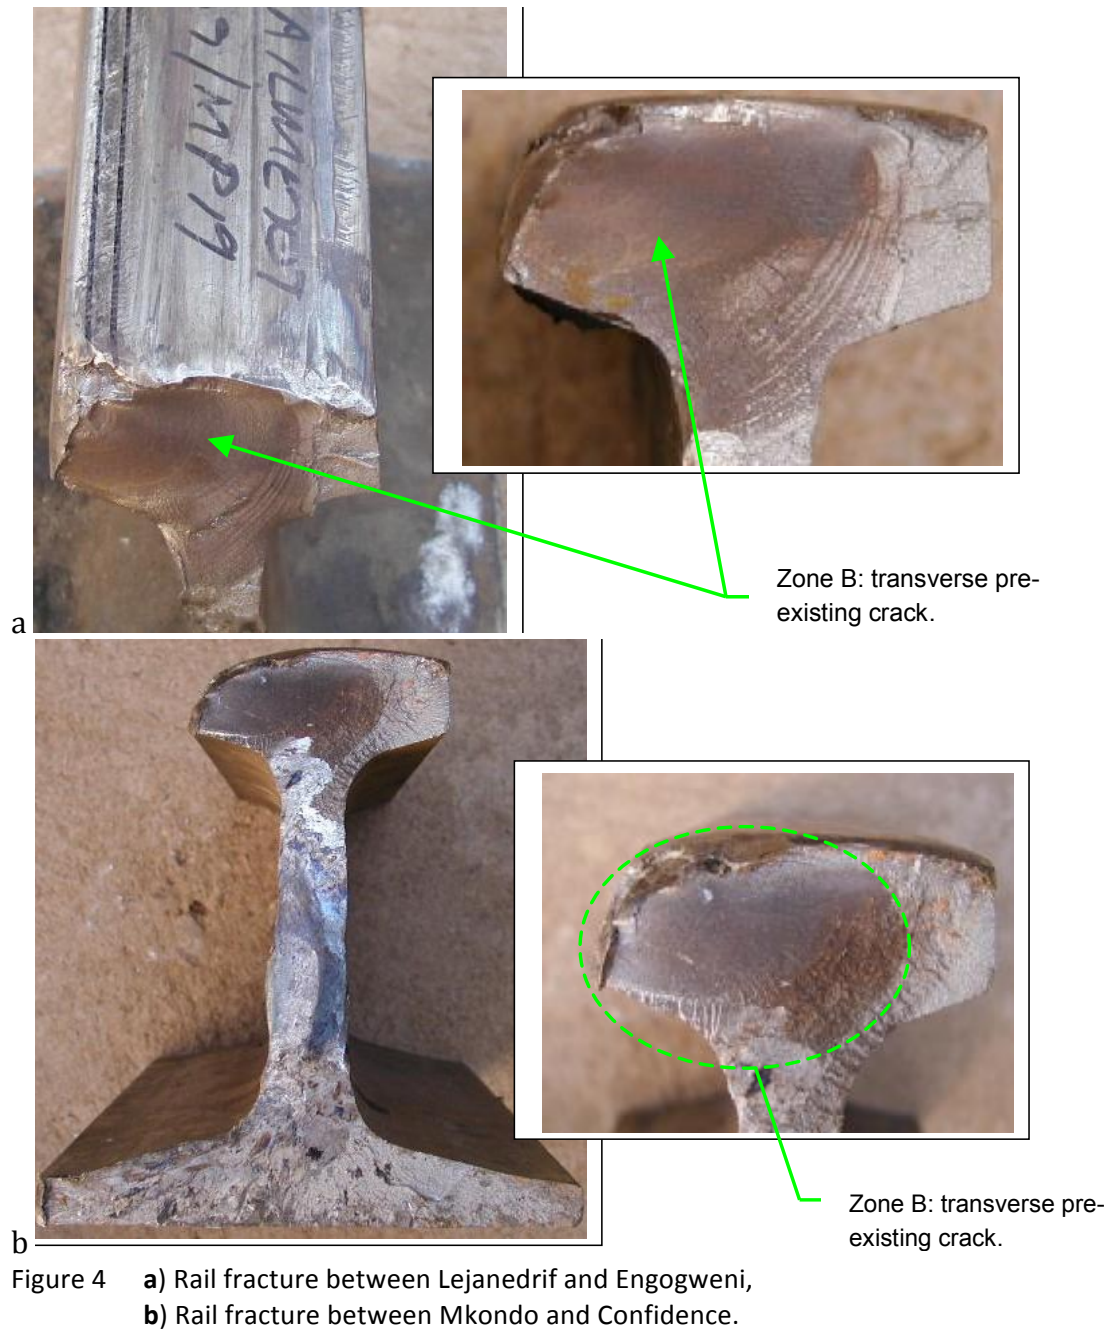
\* In the figures the upper "deteriorated" region is taken as initiation before deviating into a transversal direction. Note that this region need not correspond to inclined propagation. The data summary states that the deviation depth is not clear.

The two fracture surfaces (both resulting in rail breaks) are fairly similar in appearance. At final fracture the crack basically extends close to, or into the web. It can be noted that for both cases the propagation in the rail head was slightly inclined (not shown in the pictures below).

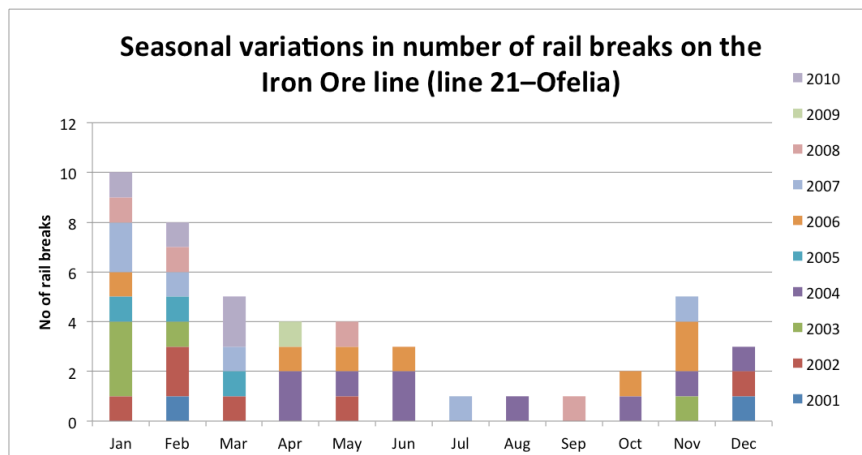
Figure 5 Annual variations in the number of rail breaks on part of the Swedish Iron Ore line. Picture courtesy Kalle Karttunen.

The influence of winter conditions in Sweden can be estimated from Figure 5. Note that the distribution over the year is very similar to that in Russia.

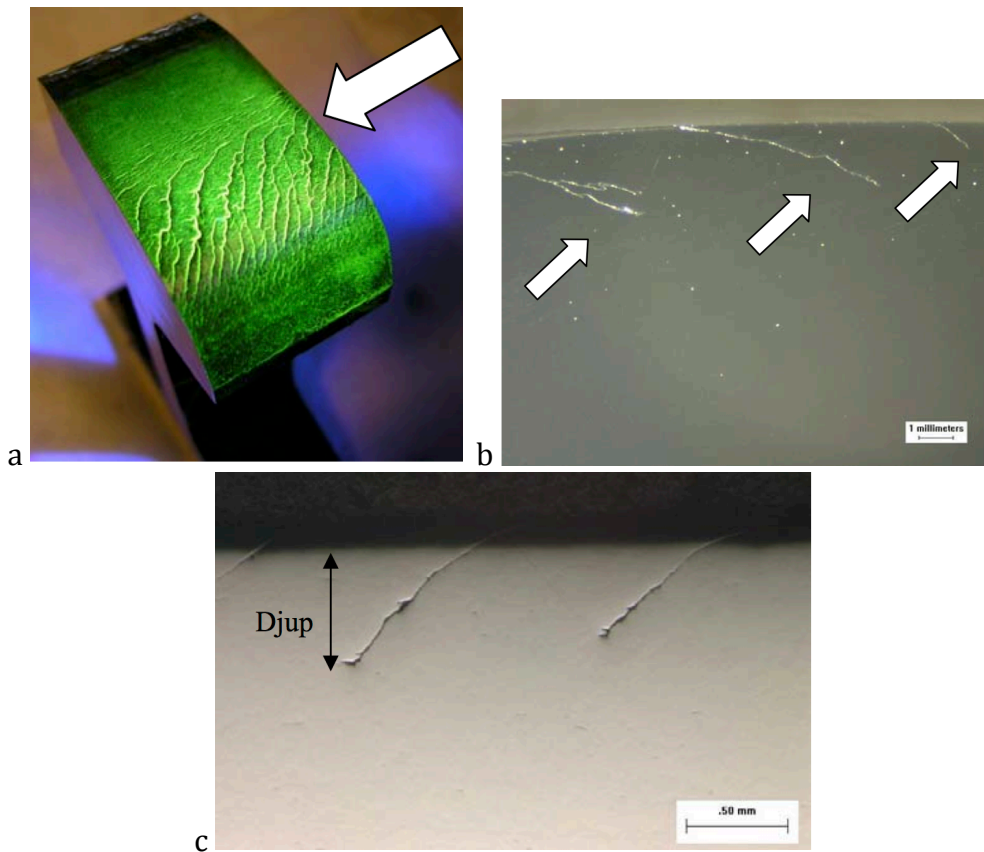
Figure 6 Investigations of the headchecks from the rail sample taken out north of Torneträsk. **a)** Headchecks at the top of the rail **b)** Transversal section **c)** longitudinal section

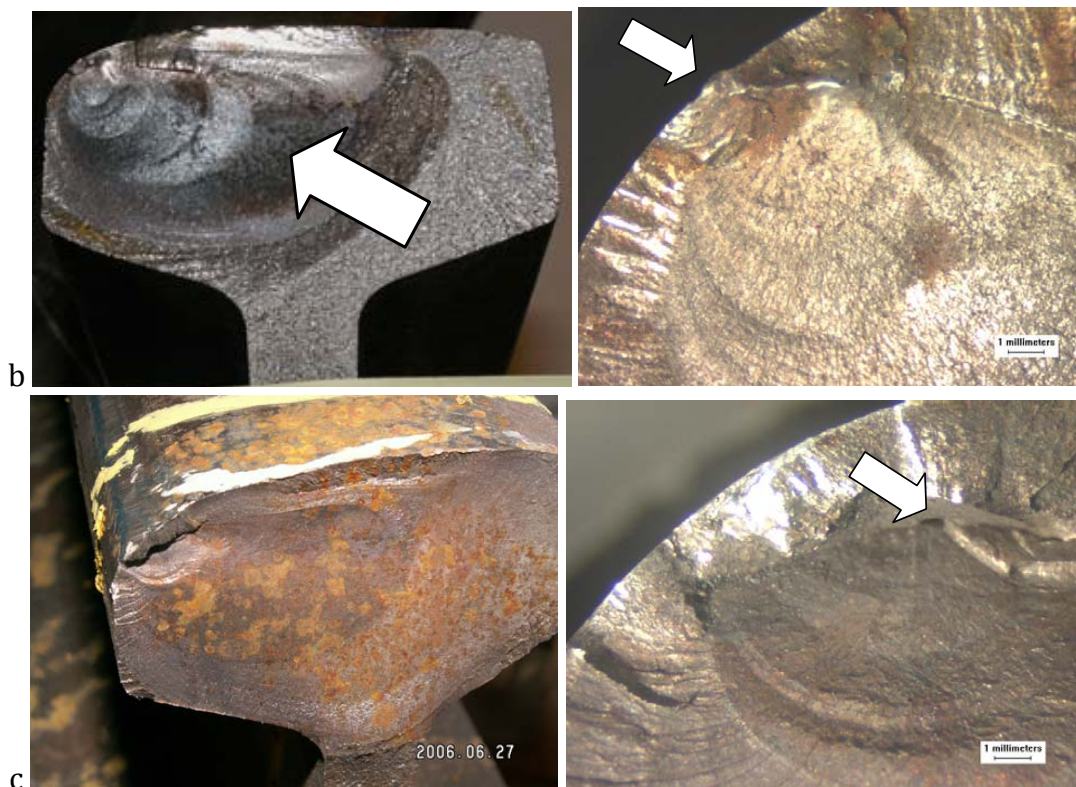
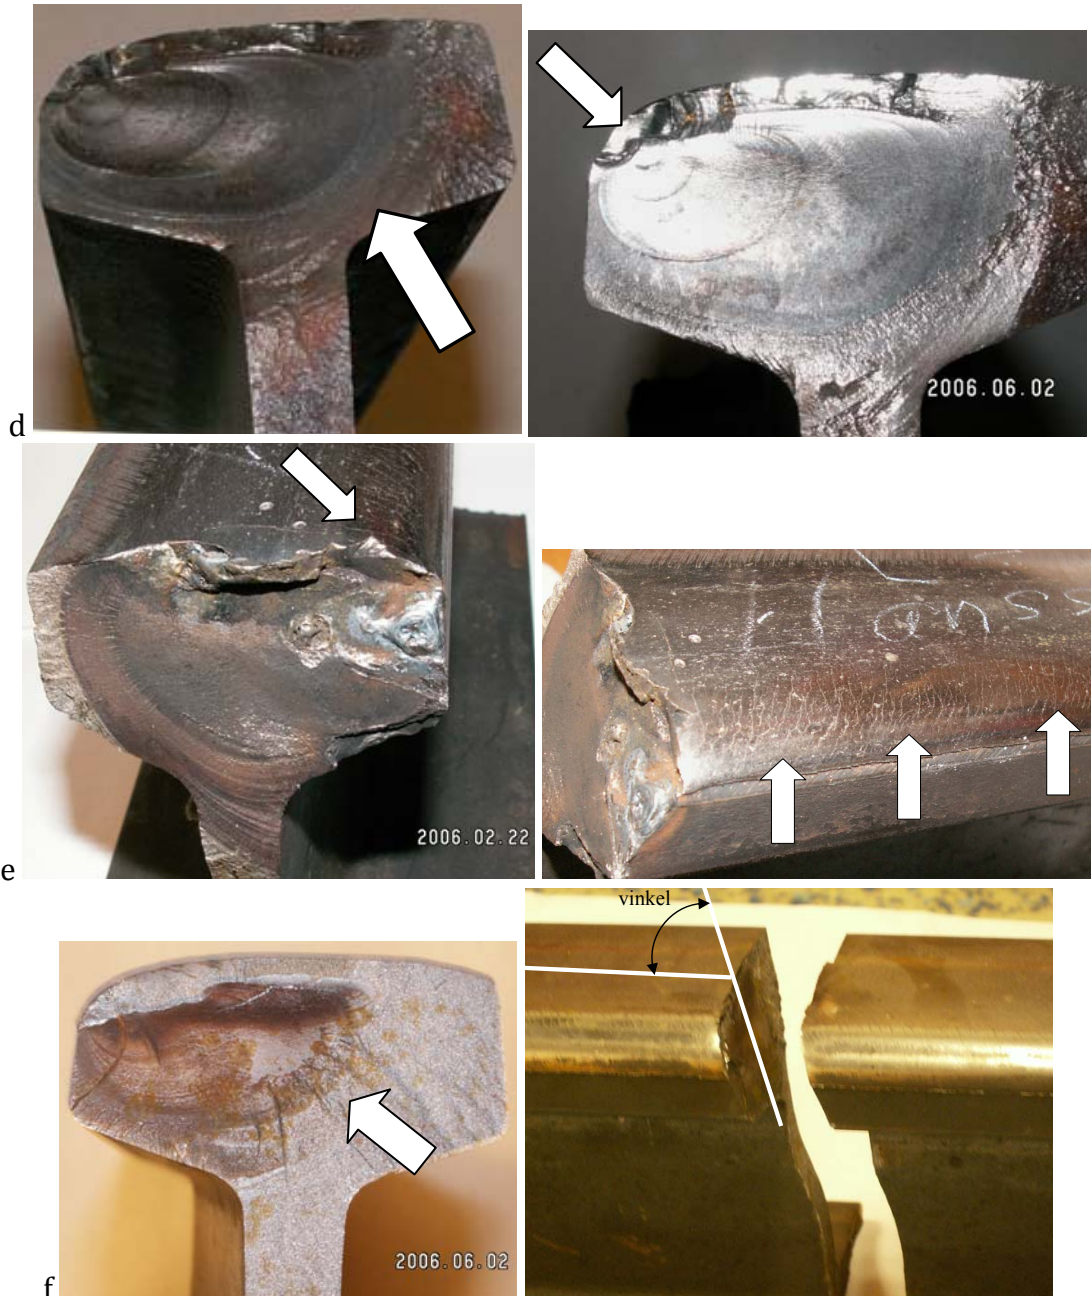
Figure 7 Fractures surfaces of the investigated rail sections **b–f** as detailed above.

With the exception of rail **f**, the crack size at fracture is fairly constant between the rails. Note that the traffic on the line is almost uniform (heavy haul) and that all failures occurred during winter.

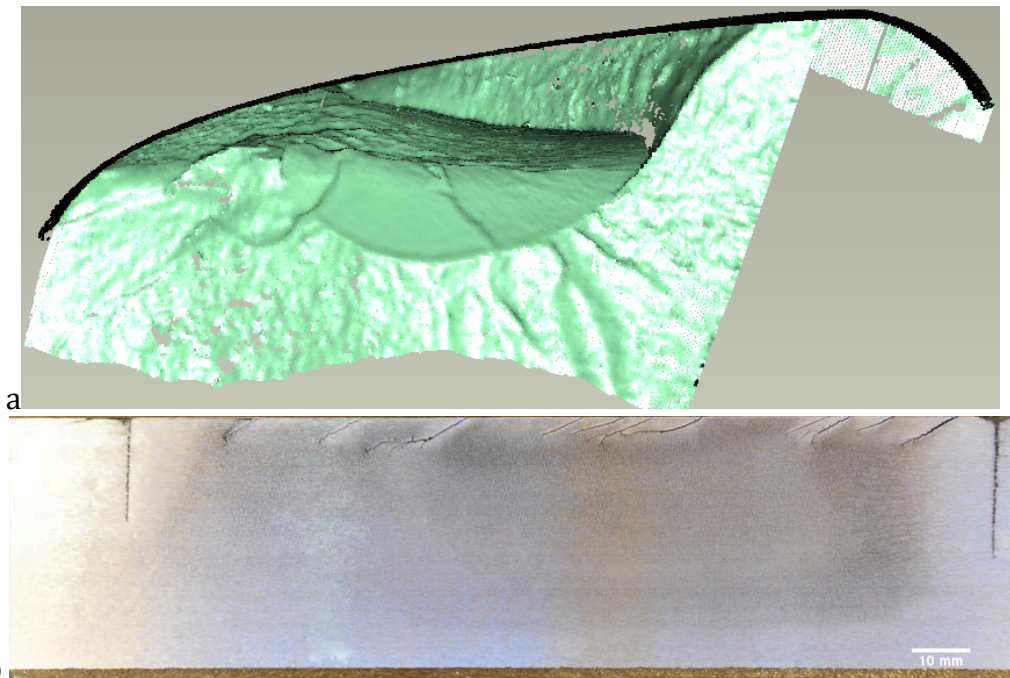
Depth at downward deviation .....**a)** 7.5 mm (broken open crack)  
**b)** 5 mm (section with multiple cracks)

Figure 8 a) Crack broken open and measured with laser scanning  
b) Sectioning of a rail surface containing multiple cracks.

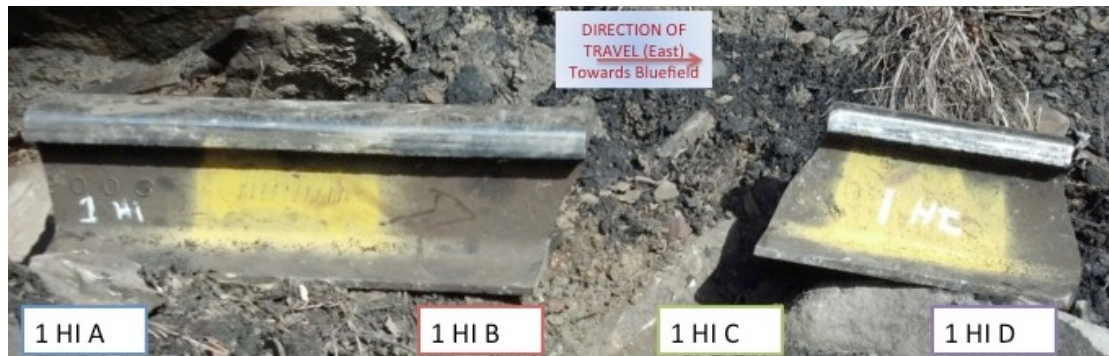
Data related to five fractures (four of which reported here). The fractures are reverse TDs – cracks originated in plastic flow at bottom of gage face.

Figure 9 Overview of fractured rail

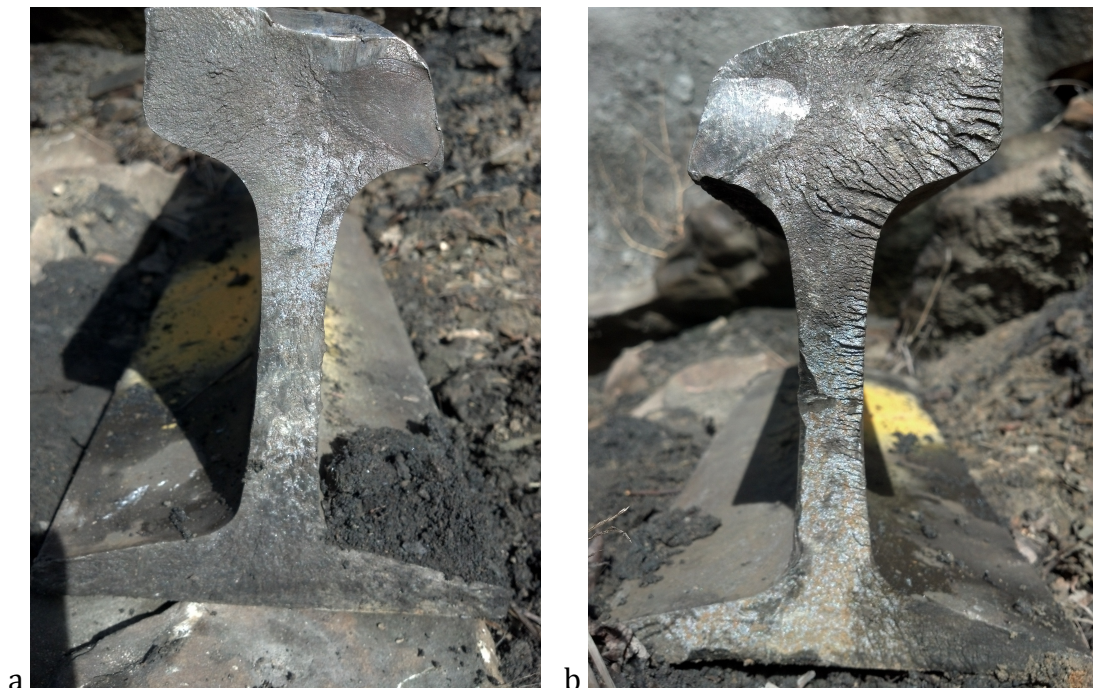
Figure 10 Fractures at sections 1HiA (a) and 1HiB (b)

The fractures have initiated as fatigue cracks related to plastic flow at the bottom of the gauge corner. At final fracture the fatigue crack size corresponded from roughly 17% for HiA, HiB and HiC to around 5% for HiD.

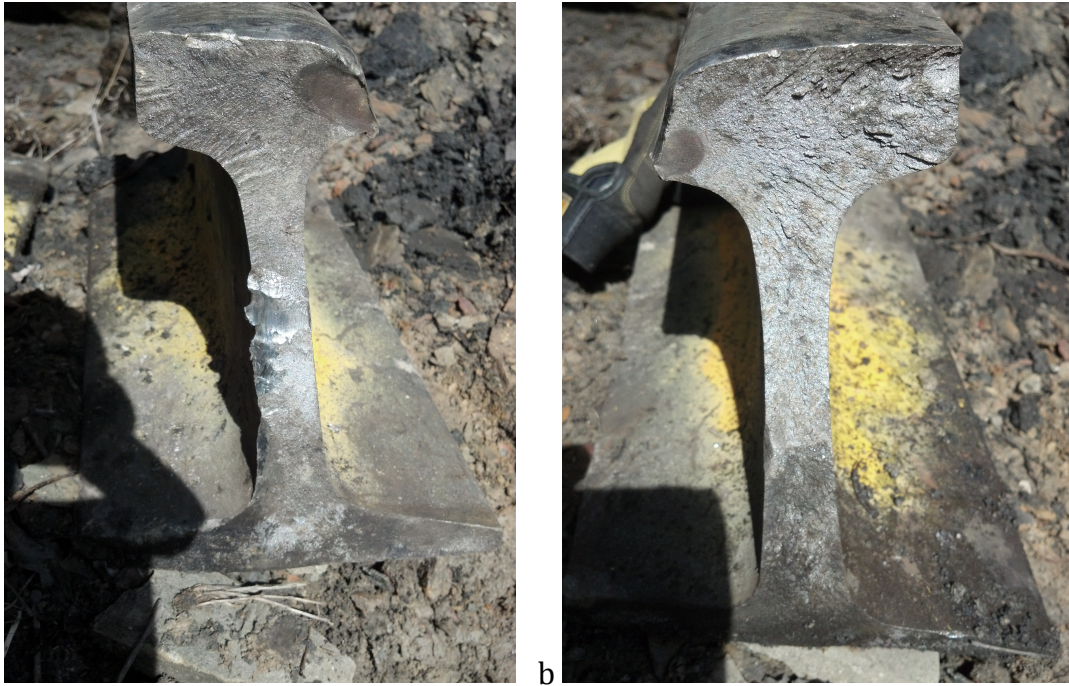
Figure 11 Fractures at sections 1HiC (a) and 1HiD (b)

The fracture was in mid December, which means temperature effects would influence the rail. Note that this is a multiple fracture. Thus, the HiD fracture may have been affected by significantly increased load magnitudes owing to the other fractures.

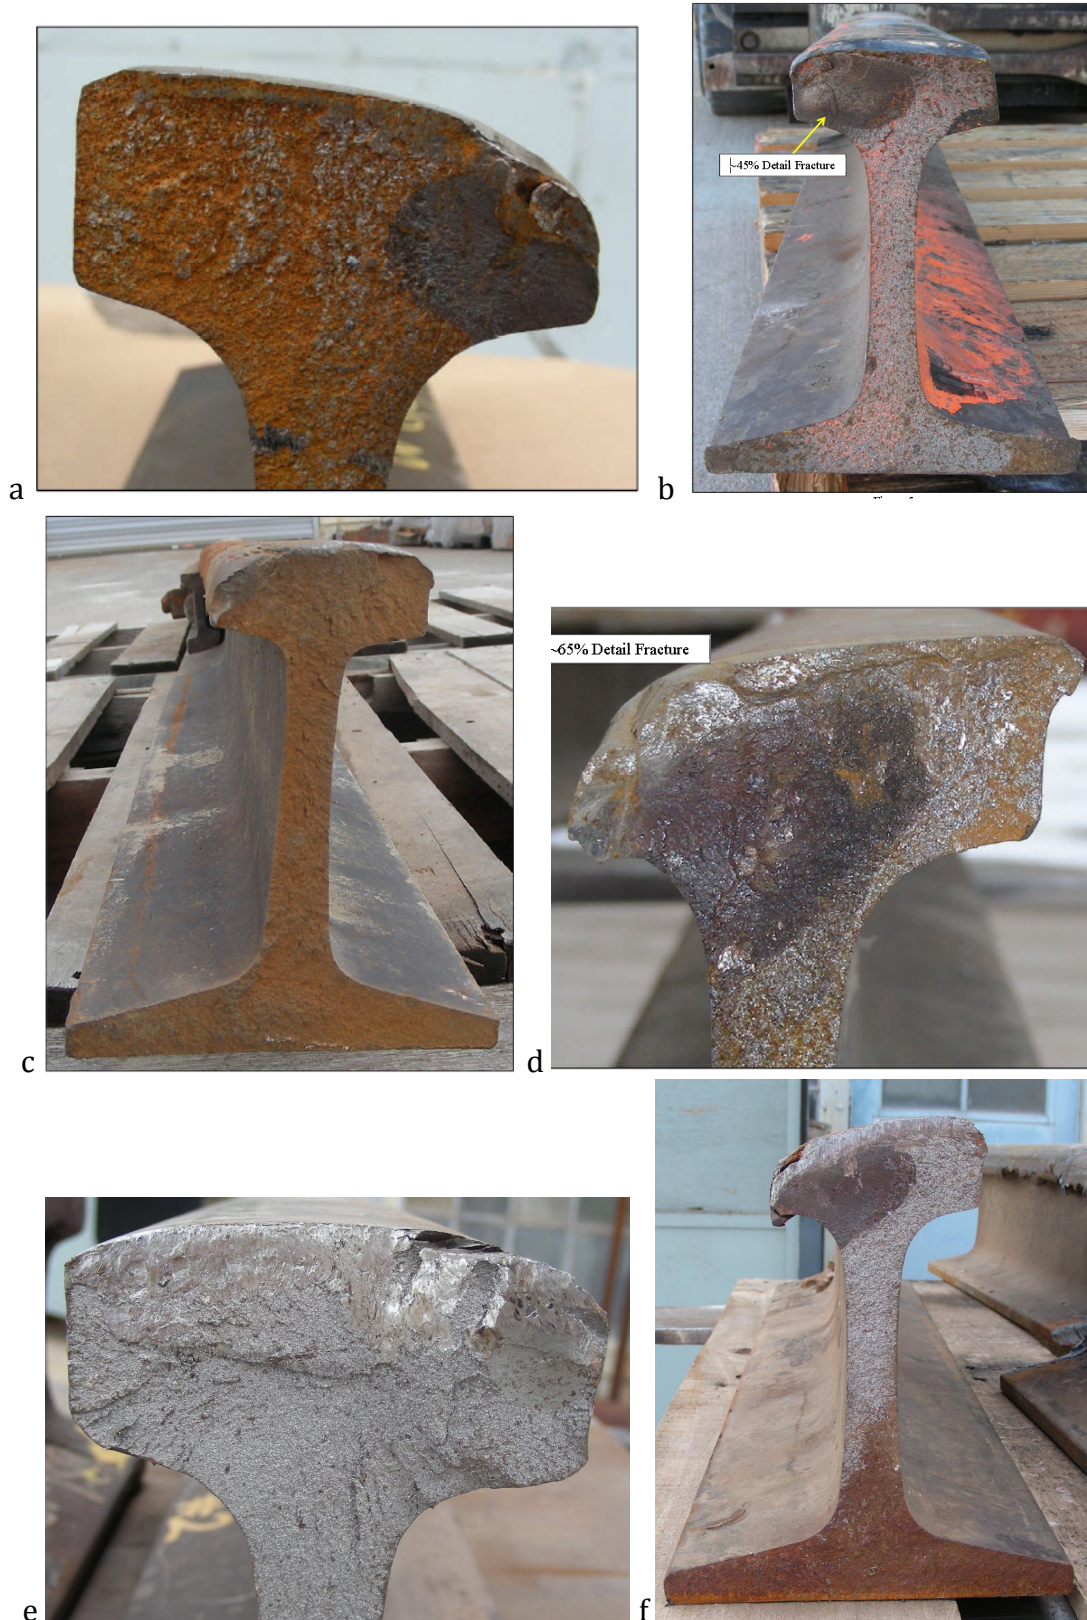
There is a rather large deviation in critical crack sizes for these rails even though the initiation site seem very similar.

Figure 12 Overview of fractured rails

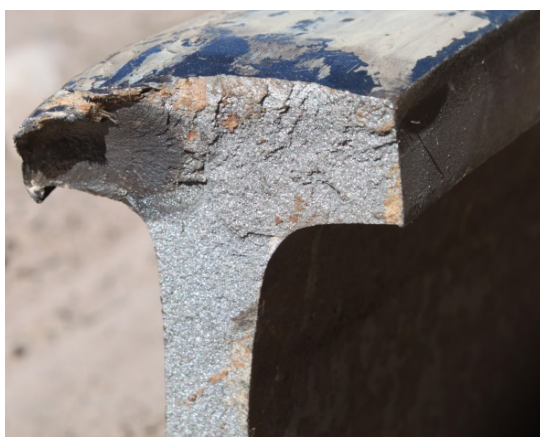
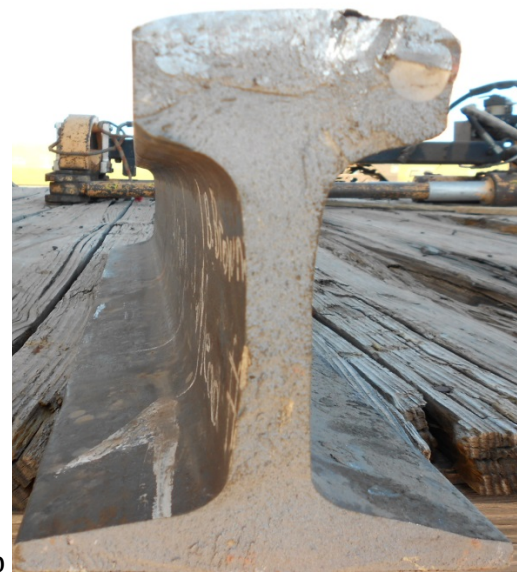
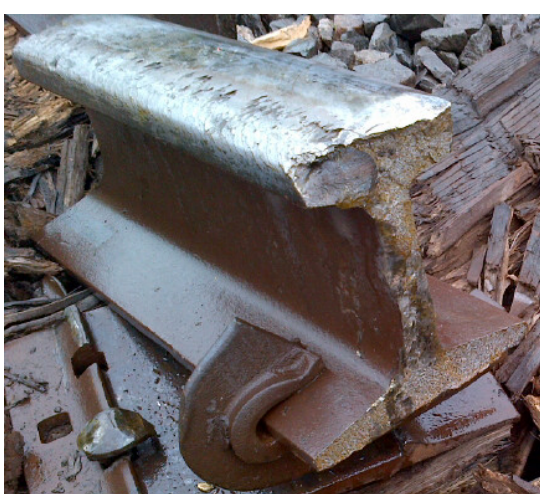
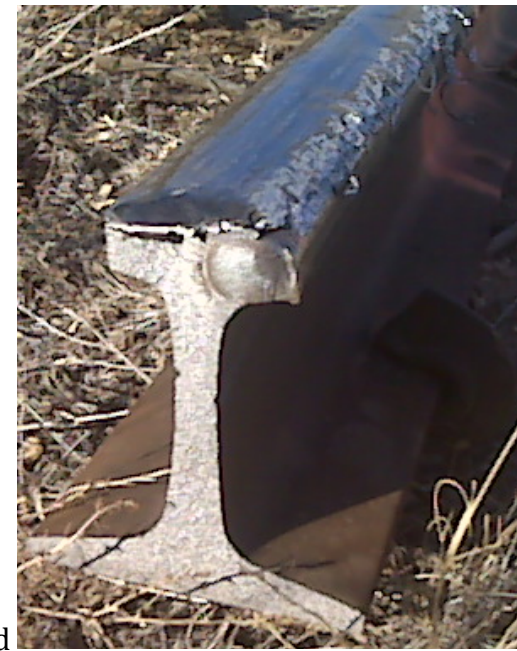
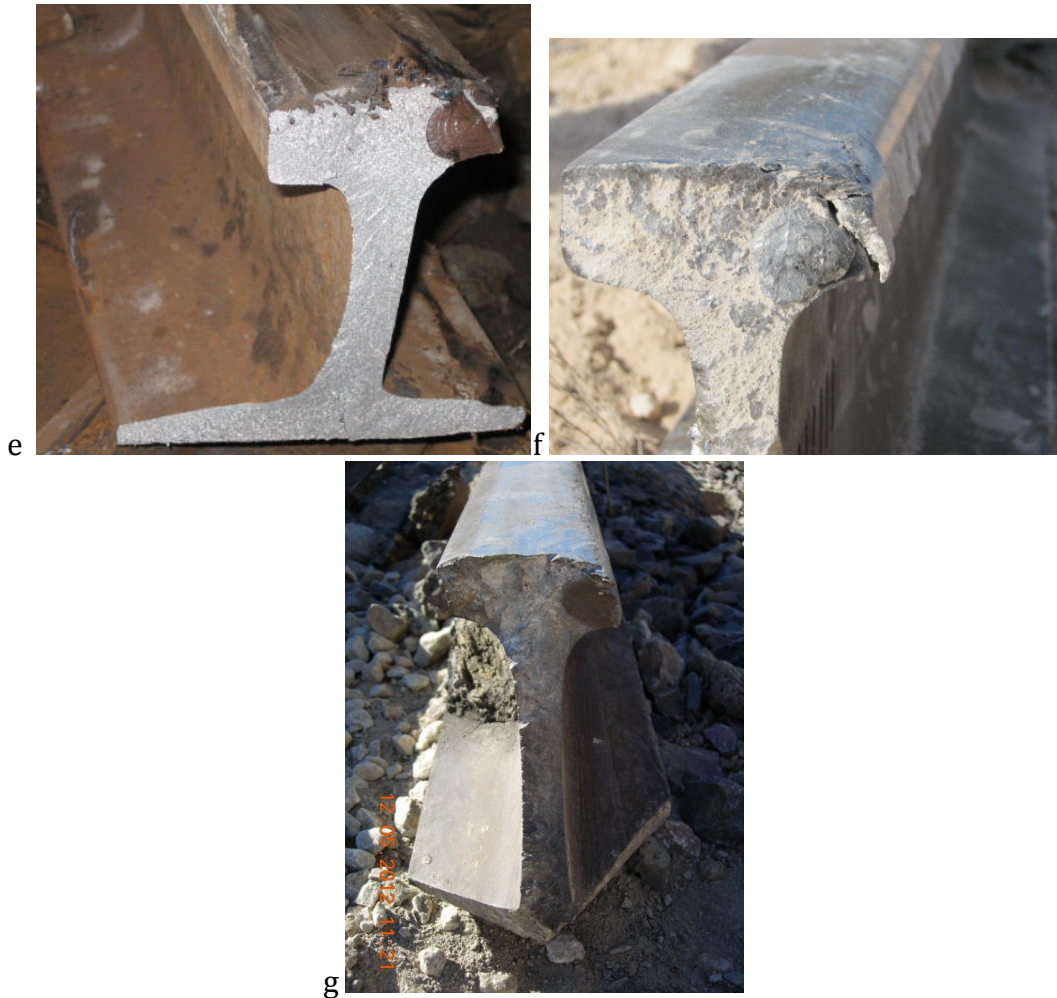
Figure 13 Overview of fractured rails

Note that the critical crack size is very roughly approximated from the photos. Although there is considerable scatter, there is consistency in critical crack sizes and initiation sites.
