### THREE CASE STUDIES: MOISTURE CONTROL IN A HOT, HUMID CLIMATE

Warren R. French, P.E., RRC, CCS, President  
French Engineering, Inc., Houston, Texas

## PRE-MANUFACTURED HOME IN SOUTHEAST TEXAS

### MODERN OFFICE BUILDING IN LOUISIANA

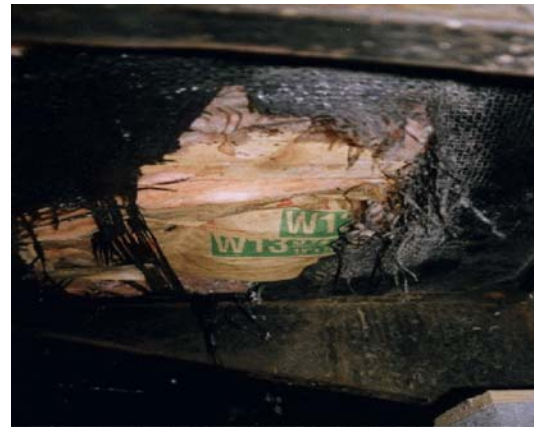
**Figure 4**

We observed that the interior vinyl wall covering, most likely utilized in an attempt to reduce maintenance, represents a low permeance wall covering on the “wrong” side of the wall. In addition, the heavy sheet vinyl floor covering also represents a low permeance floor material. Based on information provided, each of these conditions were most likely exacerbated by excessively low interior temperatures within the living space during the summer cooling season. In the Kitchen and Breakfast Room, we observed that the manifestation of moisture accumulation and mold within the floor system occurred primarily along the joint lines of the OSB floor deck, where vapor drive would find the least resistance.

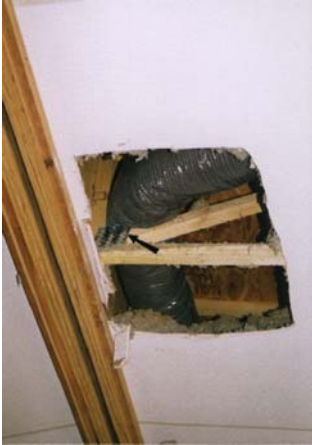
**Figure 5**

Other locations observed to be exhibiting suspected moisture accumulation and mold growth were along the ceiling in several different areas. One location in the ceiling corner of the Master Bathroom was believed to be associated with openings in the vinyl siding and related trim occurring within the exterior cladding due to poor workmanship. Selective demolition in another location in the ceiling of Bedroom No. 2 was found to be immediately below the location of an air conditioning flexible duct. This same situation was also observed in the Living Room ceiling, where selective demolition revealed that the minimally insulated flexible duct was wedged into a joint of the wood roof truss immediately adjacent to, and in contact with, a perforated metal gang-nail plate. Since the roof

truss space has vents that allow direct infiltration of outside warm, moist air, it is suspected that the immediate contact of the duct with the metal gang-nail plate has “super-cooled” the gang-nail plate to a temperature below the exterior dewpoint, causing continual condensation, moisture accumulation, and potential mold growth. See Figure 5.

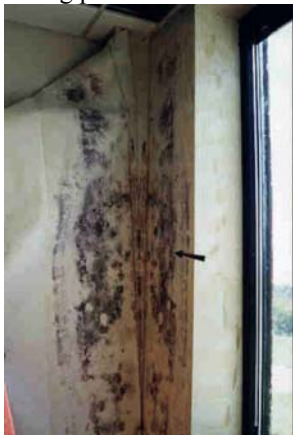
**Figure 8**

Finally, we used appropriate pressure taps through the building envelope at window perimeters to determine that the building interior was being maintained at a negative pressure with respect to the outside conditions. Based on information provided, it was further determined that the building tenant had added a large exhaust fan that had not been accounted for within the original balance and adjustment of the HVAC system. This addition, as well as other tampering with the dampers controlling outside air, contributed to the negative pressure conditions within this building. These conditions would combine to significantly increase the pressure difference between the interior and exterior, with the exterior being relatively higher virtually all of the time. Other problems included direct water leakage at a flashing located above the garage that allowed water infiltration when weather systems originated from the North. In addition, a portion of the first floor of this building was composed of split-face concrete masonry units (CMU) that had been subject to chronic water infiltration during periods of inclement weather.

A number of different recommendations were implemented in order to correct each of these issues. We recommended removal of the vinyl wall covering and replacement using acrylic paint or high permeance (low vapor resistance) wall coverings. In addition, we recommended balancing and adjusting the supply air and exhaust air comprising the HVAC system, as well as establishment and implementation of an effective and proficient control system for the interior temperature and humidity. We further recommended that the HVAC supply air registers be moved further away from the exterior walls so that impingement of cold air is minimized at these surfaces. As a final adjustment, we recommended that the gaps and cracks within the brick masonry be sealed and that consideration be given in the future to applying a clear masonry sealer to the exposed brick surfaces. Other recommendations implemented at this project included comprehensive renovation of the garage flashing that had been previously leaking, as well as application of an elastomeric coating at the split-faced CMU.
