NLR-TP-99033

Development and evaluation of a hard patch repair method for composite stiffened wing panels

A.L.P.J. Michielsen, L.C. Ubels and F. Baas

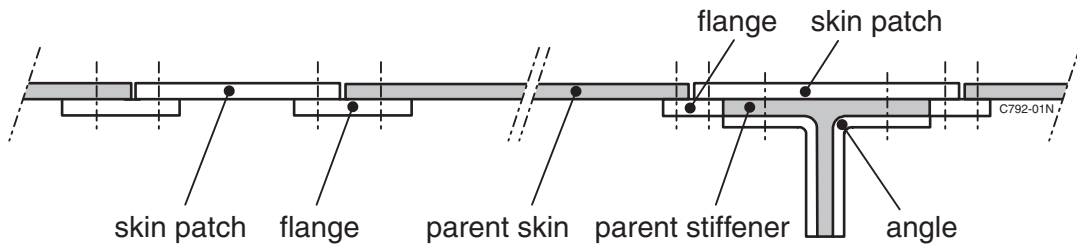
Figure 1: Principle of the hard patch repair method

This paper presents a repair method for a composite wing structure, which is thought to be suitable as field level repair. Field level repair can be defined as a repair, which is performed at a forward operating base with limited facilities. Moreover, the repair method must be suited to be accomplished on aircraft without back-side access. Large disassemblies are not allowed, as these increase downtime and thus serviceability. In the presented approach, the repair is performed by removing the damaged area and by filling the gap with a patch. The pre-cured patch is mounted with a flange that is bolted (and bonded) to the interior skin surface (fig. 1). The method was developed on small panels and validated on a large panel.

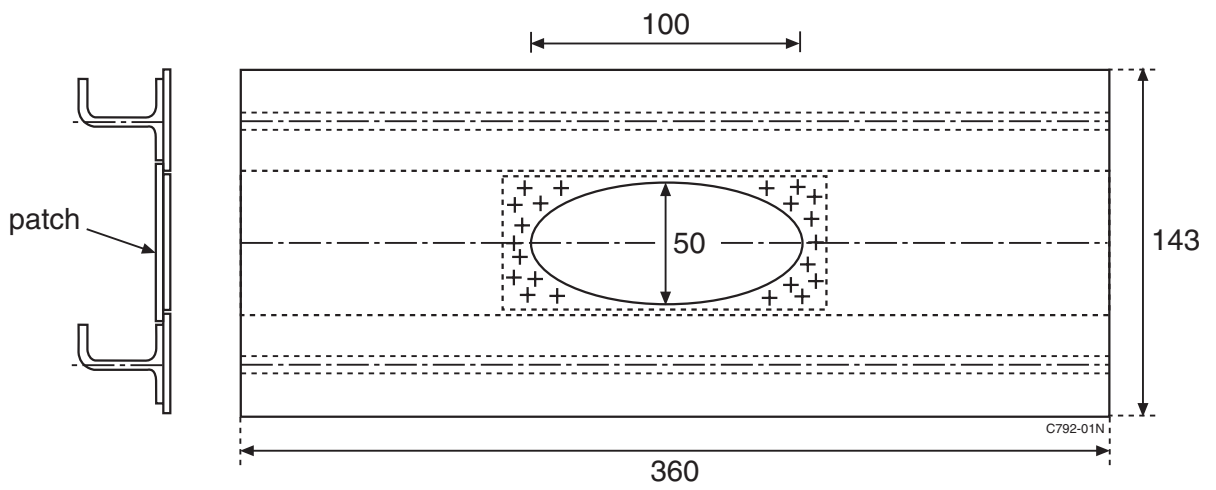
Figure 2 presents the developed skin repair method which can be applied on J-, blade- and I-stiffened configurations. The ‘imaginary’ damage was positioned mid-bay between the stiffeners in the centre of the panel. The damage was removed by cutting an elliptical hole around the damage. This shape was chosen to allow easy access for repair. The direction of the major axis of the ellipse is in the direction of the forces on the panel. Two different pre-cured patches were made from the same material as the panel. The first patch was made of two flat parts which were bonded together: an elliptical plate which fills up the hole in the skin and a rectangular plate which forms the flanges of the patch. An alternative patch consisted of a single piece and had the same external dimensions, except that the centre of this part was elevated (dimpled). With the chosen geometries, it was still possible to insert the patch from the outside through the hole of the panel. The patch was bonded with a cold curing adhesive and riveted with blind fasteners. Bolted repairs are the most common for battle damage repairs because of reliability and relatively fast application to a damaged part. They are to be preferred over bonded repairs. Therefore, one configuration was tested with rivets only, the bond layer was omitted (specimen J-skin-4). For each configuration a repair manual was written with detailed information how to perform the repair [Refs. 4,5,6 and 7]

Figure 2: Skin repair patch in a lightly loaded J-stiffened panel

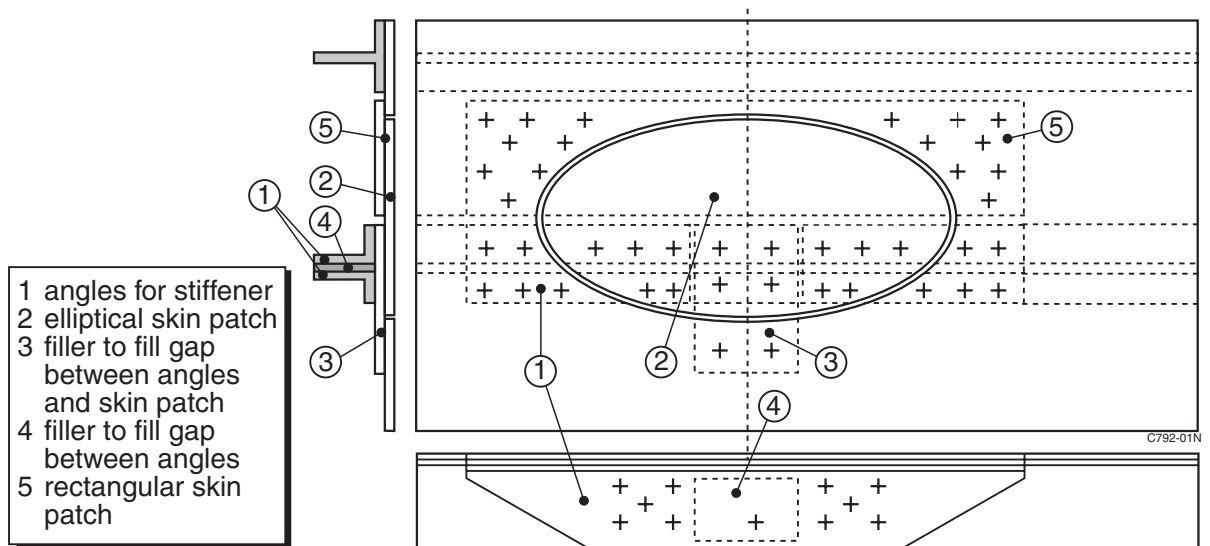
Figure 3 presents a skin-stiffener repair in a blade-stiffened panel. The imaginary damage was located directly above one of the stiffeners. To restore the required strength, both the skin and the stiffener had to be repaired. The repair of the stiffener was performed with two carbon/epoxy angle-sections. These angle-sections were attached to both sides of the stiffener. A small flat part was used to fill the gap of the removed web between the angles. The repair of the skin was performed with a skin patch. The skin patch consisted of an elliptical plate bonded to a rectangular plate both made from carbon/epoxy. The rectangular part of the skin patch was attached underneath the skin between the stiffeners. Again, small plates were used to fill the gap between the substitute stiffener and the skin. Both rivets and adhesive were used to attach the replacement parts.

Figure 3: Skin-stiffener repair in a lightly loaded blade-stiffened panel

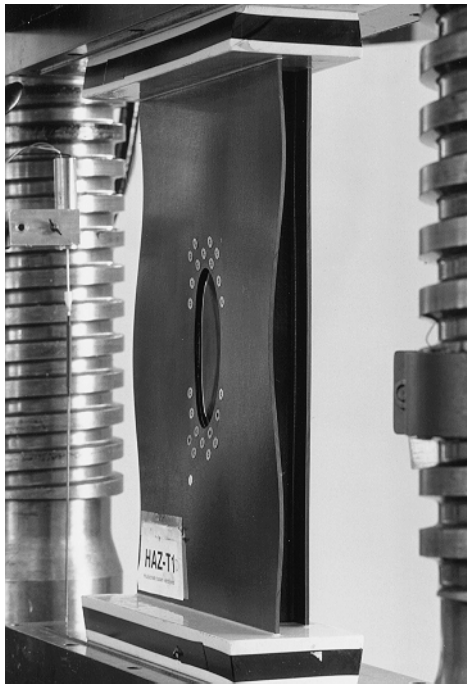
- Static compression tests were performed at room temperature and at a temperature of -85°C or -50°C . The required strength of 100% DUL was obtained for all configurations. Figure 4 presents the deformation of an intermediately loaded I-stiffened panel with a skin repair subjected to 120% DUL (specimen I-skin-2). Figure 5 presents failure of an intermediately loaded panel with a skin-stiffener repair (specimen I-stiff-1). In this case, panel failure originated from the parent structure and was not initiated by the repair.
- Several panels were fatigue loaded at 50% DUL following a residual strength test up to 70% DUL. Figure 6 presents a panel (specimen I-stiff-4) in which several rivets failed during fatigue loading. Even with these failed rivets, sufficient residual strength was obtained.

Figure 4: I-stiffened panel with a skin repair subject to 120% DUL (692 kN) in compression (specimen I-skin-2)

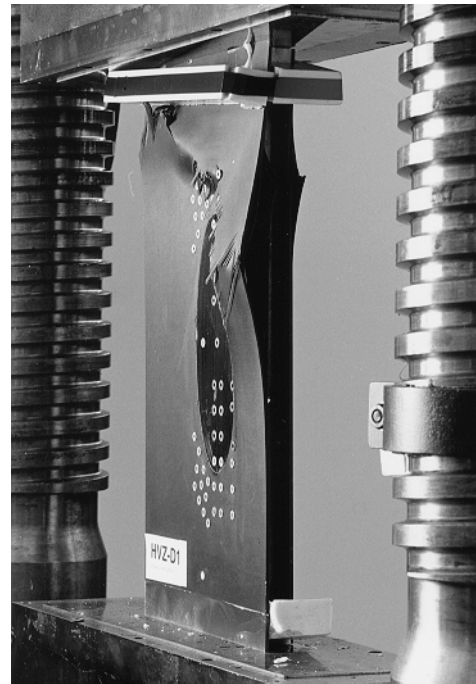
For the lightly loaded blade- and J-stiffened configurations, significantly higher load levels were obtained than required, as both types of repairs resulted in thickening of the skin, preventing the skin from buckling. In case of the intermediately loaded I-stiffened panels, failure of the panels was obtained at a load level only slightly above the required load level. The tests showed that the repair methods developed, fulfilled the requirements with respect to the structural strength.

Figure 5: Failed intermediately loaded panel repair (specimen I-stiff-1)

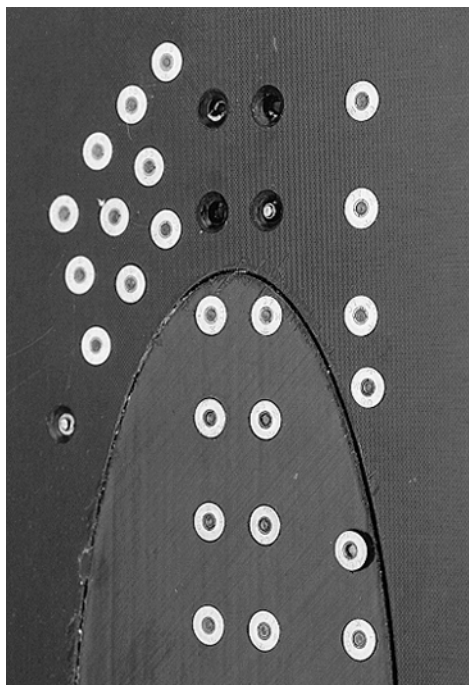
Figure 6: Failed rivets of a skin-stiffener repair in an intermediate loaded panel (specimen I-stiff-4)

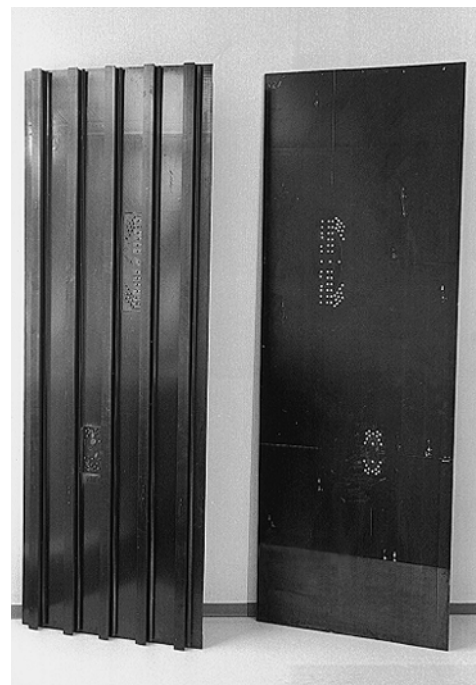
The positions of the repairs in the 5-stiffener panel are indicated in figure 7. The repairs were performed by OGMA, based on the repair manuals [Refs. 5,6] written by Techcare. Some of the prescribed tools of the repair manual were not available at OGMA so the repairs were accomplished with tools that were available. It was found that the geometry described in the repair manuals did not correspond with the actual geometry of the structure to be repaired. At 'field level' several modifications to the geometry were applied and the repair was accomplished. The repairs were inspected by C-scans, and indicated a good quality.

Figure 7: Skin repair and skin-doubler repair in I-stiffened panel
