NASA TECHNICAL NOTE

NASA TN D-6979

APOLLO COMMAND MODULE LAND-IMPACT TESTS

by J. E. McCullough and J. F. Lands, Jr.
Manned Spacecraft Center
Houston, Texas 77058

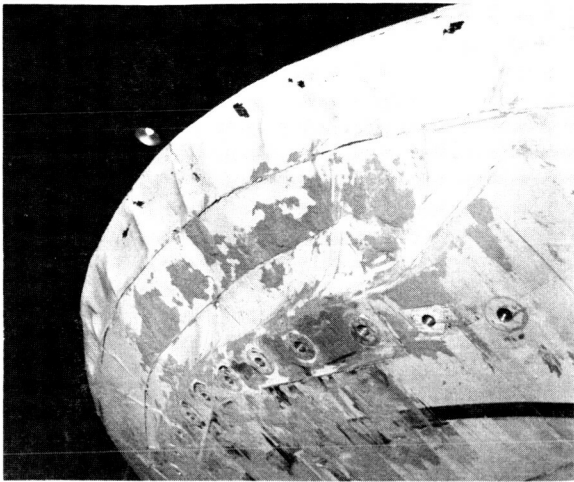
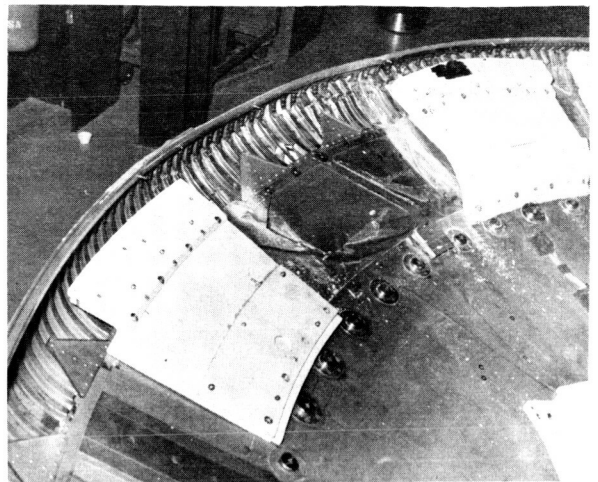
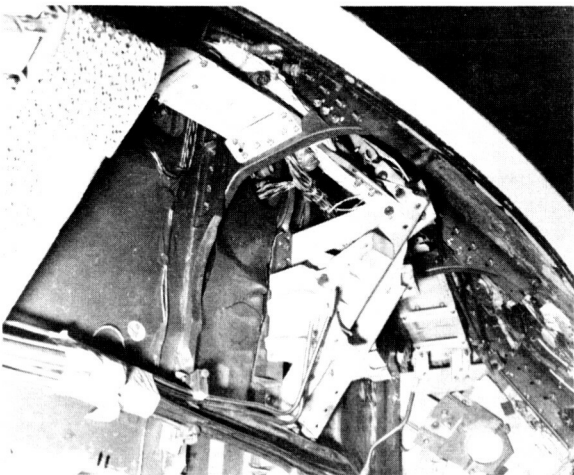
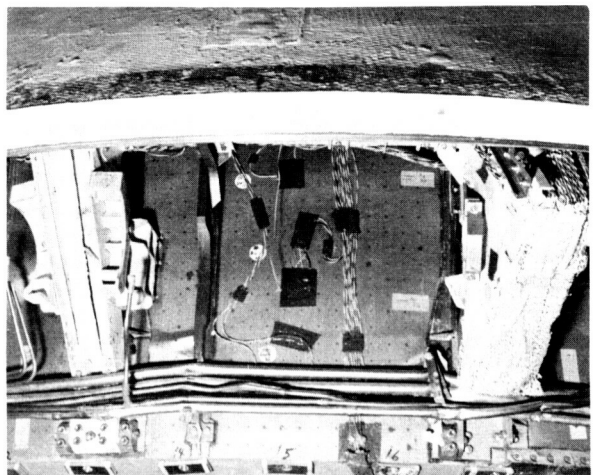
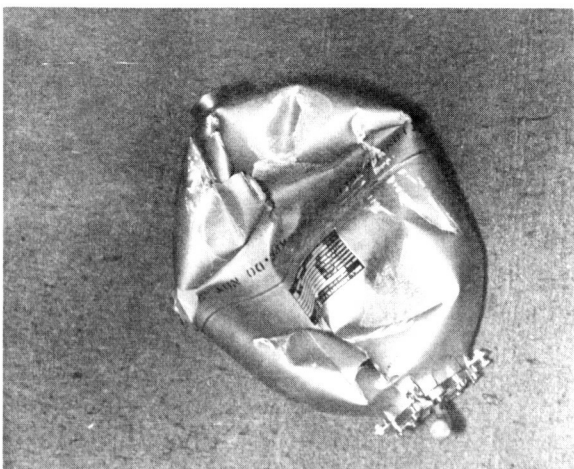
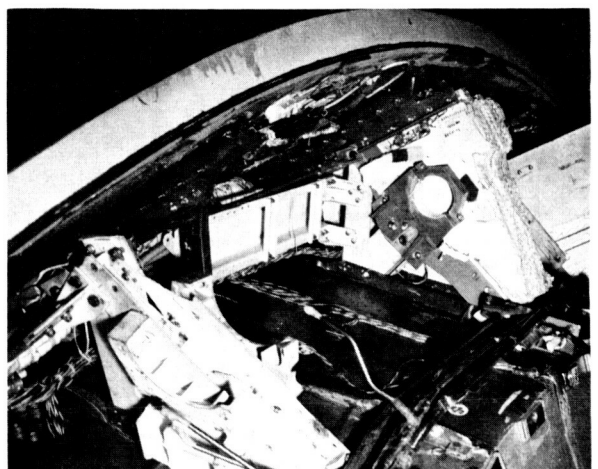
Figure 25. - Impact damage to CM-009 in test 31.

Damage to spacecraft structures caused by 0° roll landings was less extensive than had been expected. The damage was limited largely to the +Z area of the aft bulkhead, heat shield, and crew-compartment sidewall. The aft heat shield was crushed into the aft equipment bay, causing damage to the RCS oxidizer tanks and related equipment installed in that area. Frames and cores were crushed, fractured, and debonded from the sidewall throughout a sector of approximately 60° . Several face-sheet cracks and separations occurred in the honeycomb core of the crew-compartment sidewall. These openings could admit toxic fumes from the ruptured RCS tanks into the crew compartment. Apparently, no other failures occurred either in primary structure or in secondary equipment. The primary damage sustained during the impact test of CM-009 (typical of the 0° roll landing damage) is shown in figure 25.

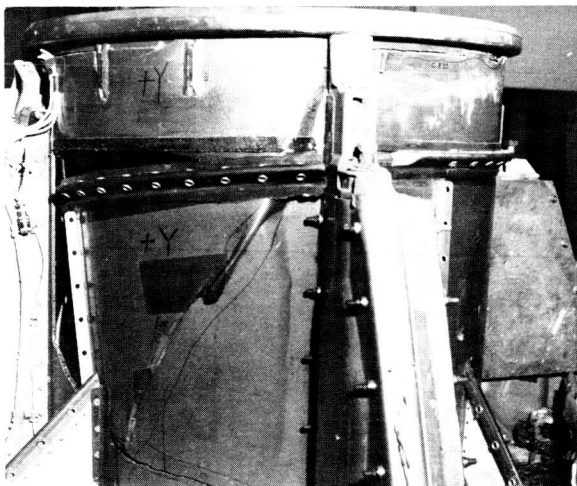
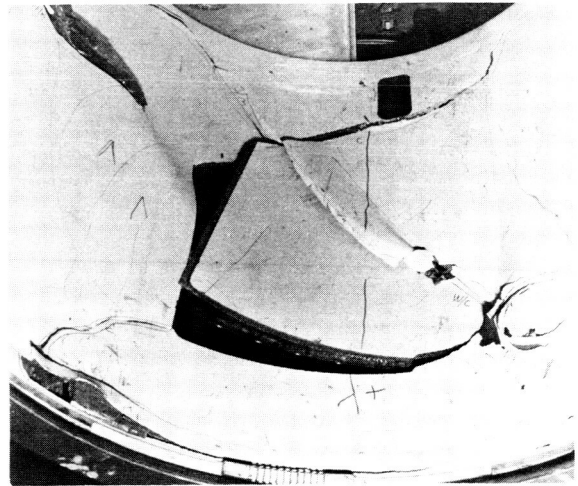
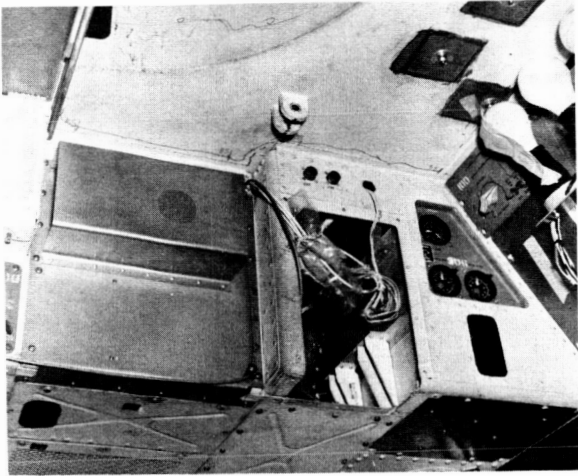
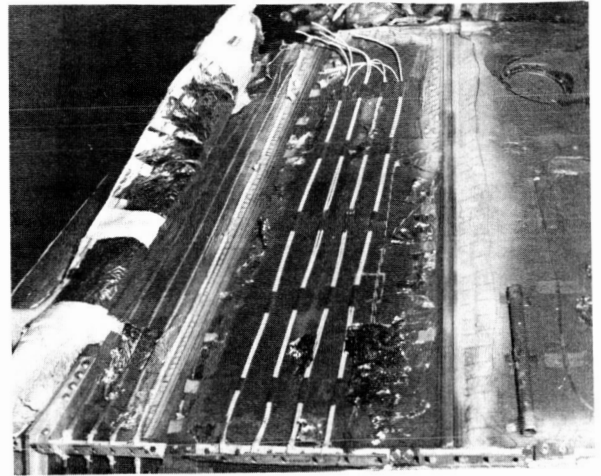
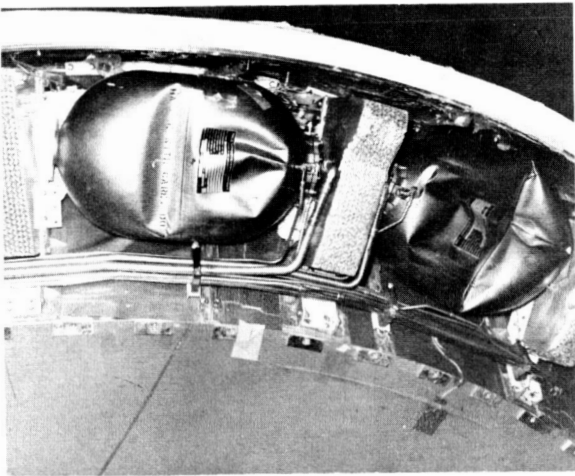
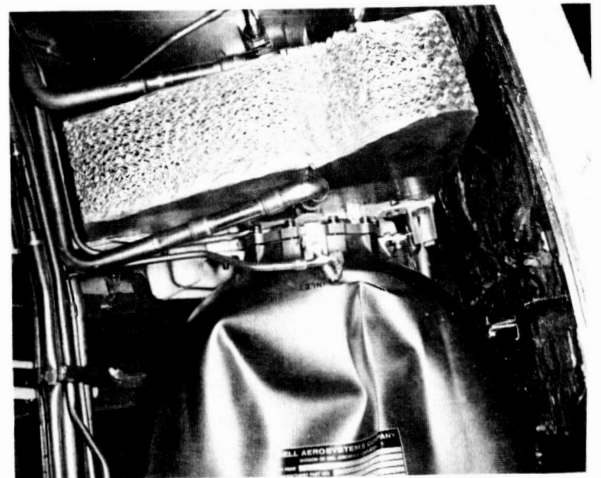
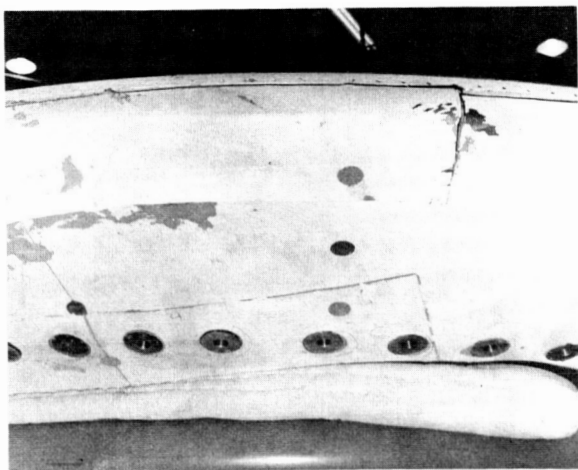
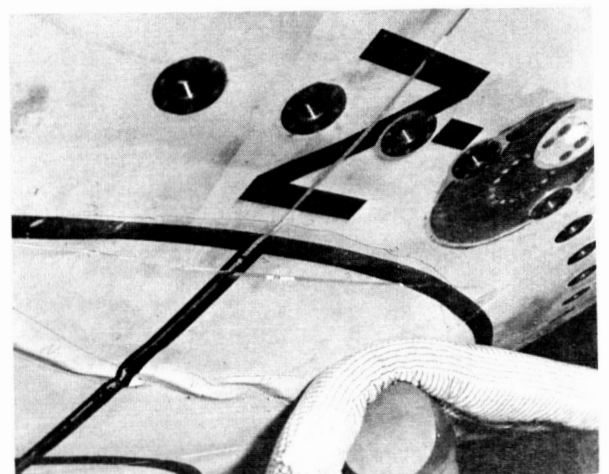
Figure 29. - Impact damage to CM-008.

Conditions were selected for the test of CM-008 to assess the damage to the upper deck and docking tunnel should the second impact of a land landing occur on this area. The test conditions to achieve such an attitude at second impact included a roll of 180° , a pitch of -27.5° , and a horizontal velocity at initial impact of 25 fps. The kinematics of the test of CM-008 are shown in the photographic sequence of figure 28. The upper deck, the docking tunnel, and the $+Z$ sidewall of the crew compartment were damaged extensively (fig. 29). Many fractures occurred in the structures of the docking tunnel and upper deck, and extensive debonding of the main-display-panel support occurred. However, all damaged members remained attached to the structure of the test vehicle and did not present a significant crew hazard. The aft bulkhead was buckled approximately 6 to 8 inches into the crew compartment by the aft heat shield, and the crew-compartment sidewall was cracked completely through its core on the $+Z$ side. The initial impact conditions for test 63 (second test of CM-009) were selected to determine the effects of a secondary impact on the $+Z$ sidewall.

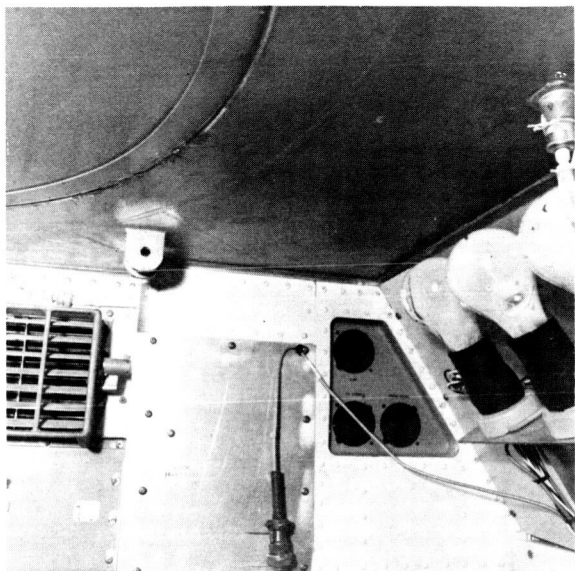
(a)

Although the docking tunnel contacted the impact surface on the +Z sector, the loading was light and no damage occurred to the tunnel. Debonding occurred between the forward bulkhead and the sidewall on the +Z side (fig. 31(a)), but no debonding occurred on the main display console.

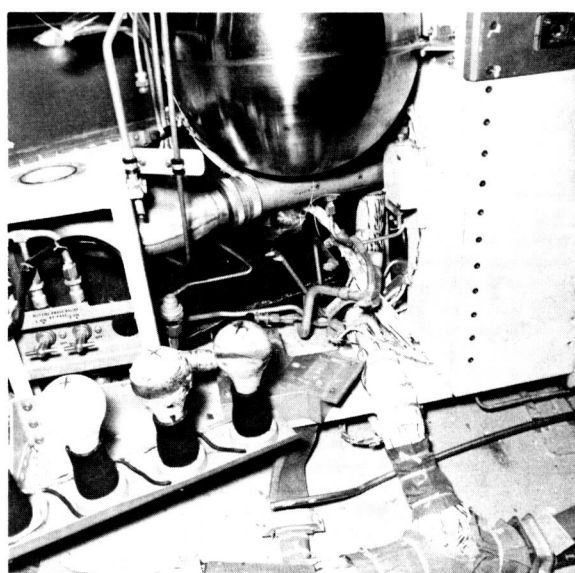
(d)

sidewall, which caused the equipment shelves to deflect under their own weight approximately 2 inches. Although extensive damage occurred on the sidewall in the oxygen surge tank area (fig. 31(d)), the surge tank was not damaged.

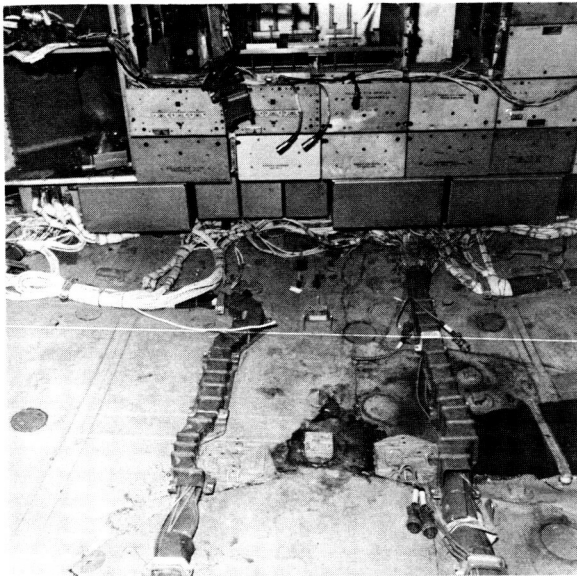
(e)

The aft-bulkhead core failed in shear in an area approximately 6 feet in diameter in the +Z sector, and a crack through both face sheets extended approximately 36 inches from the center in the +Z direction (fig. 31(e)). The oxidizer tanks were crushed, and the fluid from the tanks escaped and entered the crew compartment through the crack in the aft bulkhead. The aft bulkhead was separated from the crew-compartment sidewall through an included angle of 196° (fig. 31(f)).

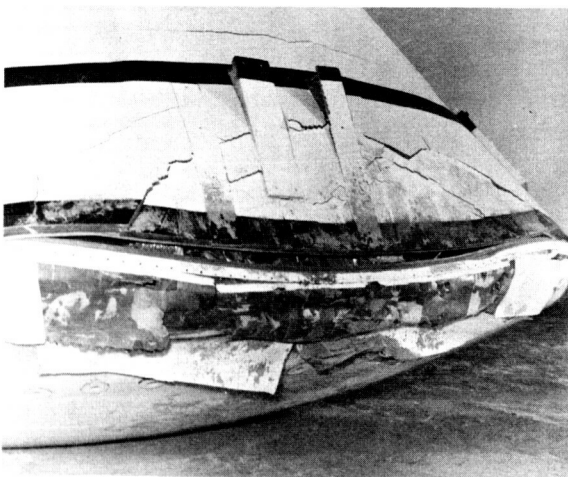
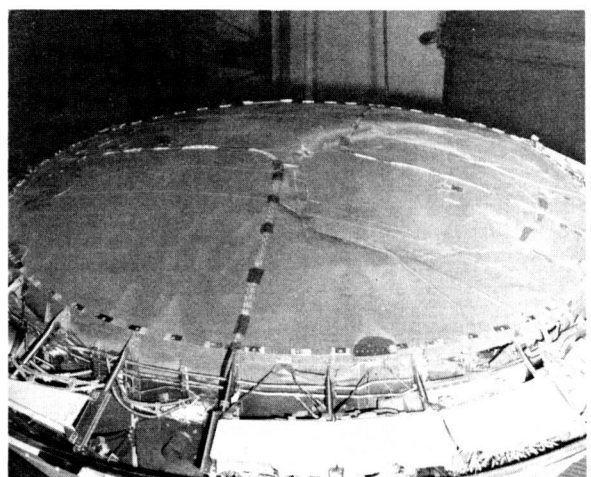
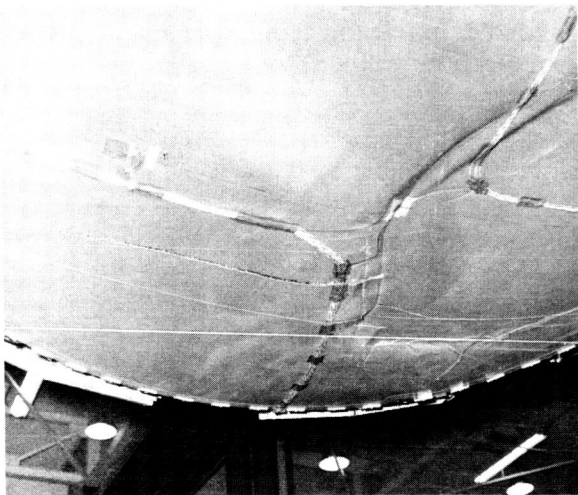
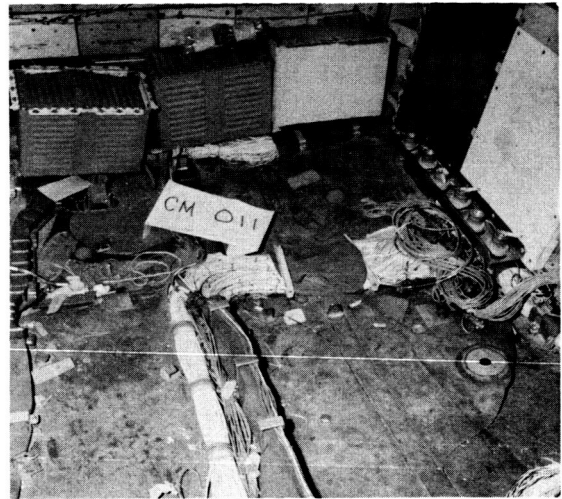
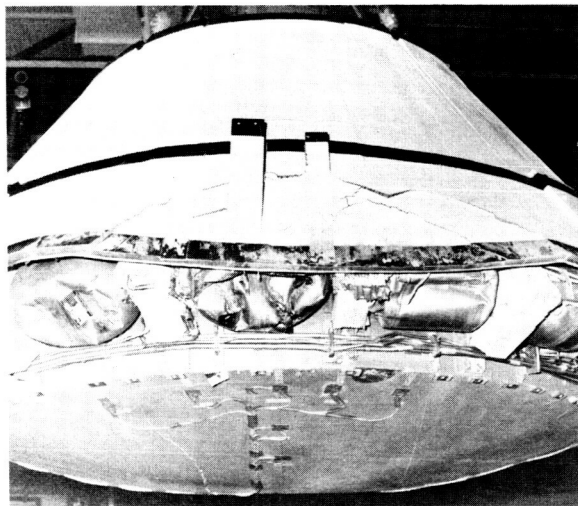
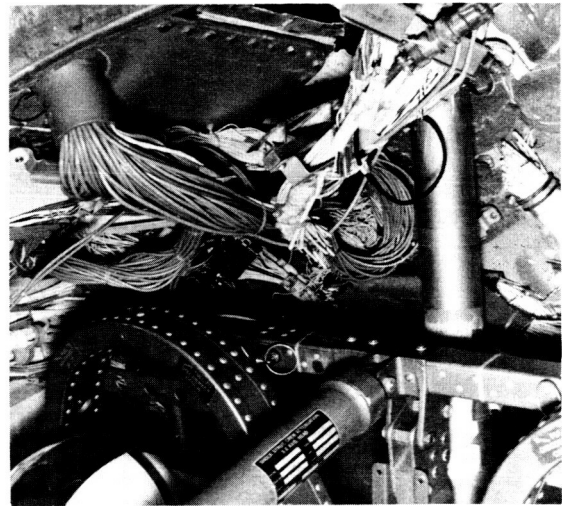
Figure 33. - Impact damage to CM-011.

Test 64 with CM-011 was conducted at a horizontal velocity of 54 fps, equivalent to the maximum wind velocity in which the launch vehicle can be operated. The resulting kinematics were even more violent than those of test 63 with CM-009. The second impact of CM-011 occurred at a pitch attitude of approximately 300° and loaded the aft sidewall and heat shield more severely in the X axis direction and less in the Z axis direction than did the test conditions of CM-009. The aft area of CM-011 was damaged to a greater extent than that of CM-009. However, the separation of the aft bulkhead from the aft sidewall was less extensive, occurring throughout a 110° segment of the sidewall. The damage included numerous cracks in the aft bulkhead and sidewall that could permit the passage of toxic fumes and fluids from the aft equipment bay. On second impact, the sidewall beneath the crew hatch was crushed inward and upward from 12 to 18 inches, which fully compressed the Z-Z struts of the crew couch and produced high accelerations in the crew-couch system. The kinematics of the CM-011 test are shown in figure 32, and typical damage is pictured in figure 33.

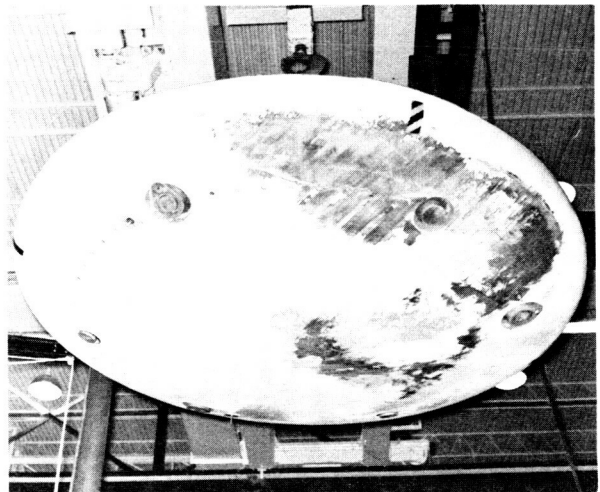
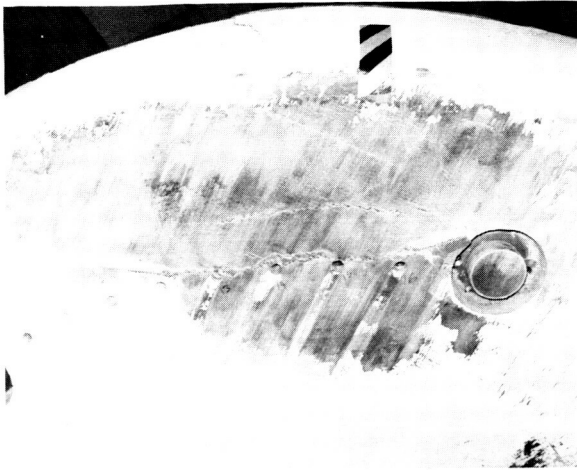
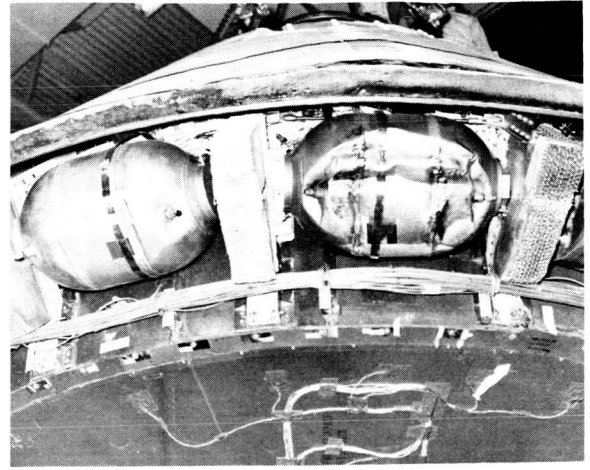
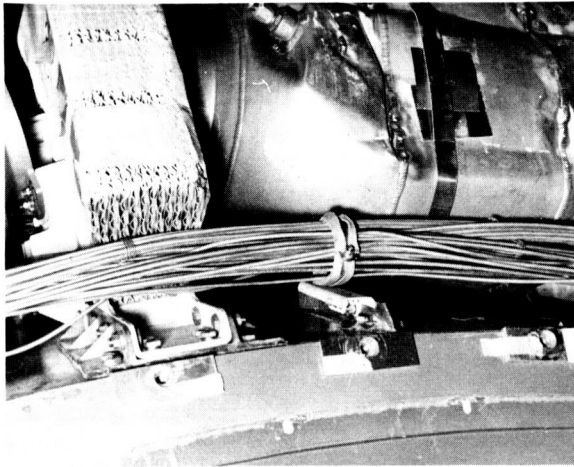
Figure 43. - Damage to CM-002B in test 68.

Less damage was sustained by CM-002B than by any other spacecraft tested in the program (fig. 43). Damage was limited primarily to the +Z section of the aft heat shield where some slight buckling occurred outside the bolt circle. No damage was apparent on the crew-compartment aft bulkhead. A slight debonding of one sidewall frame occurred.

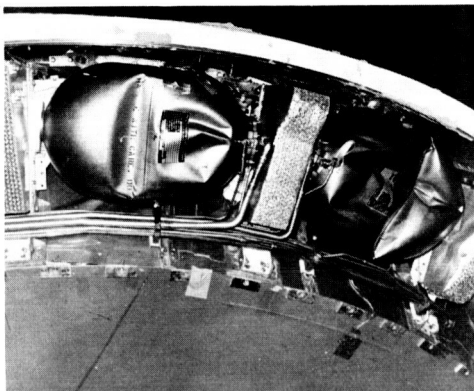
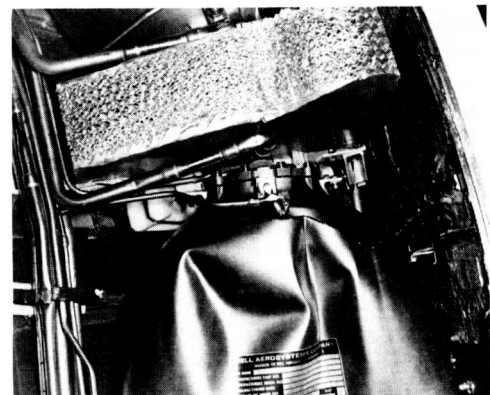
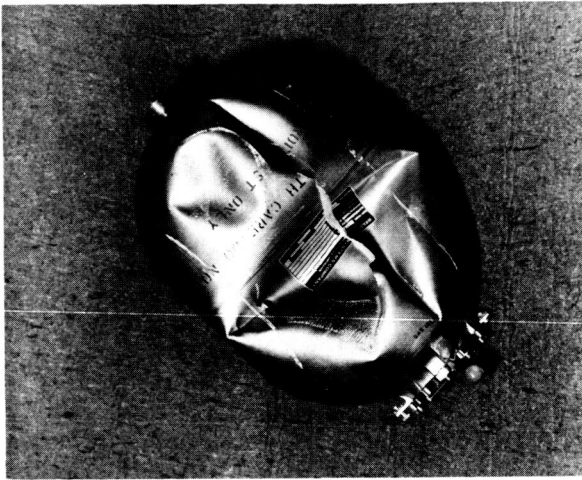
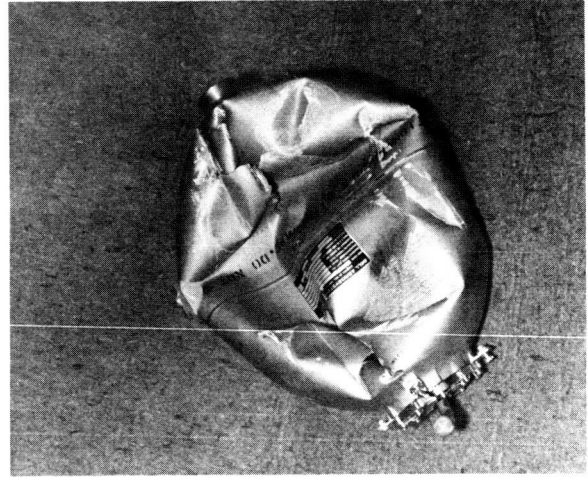
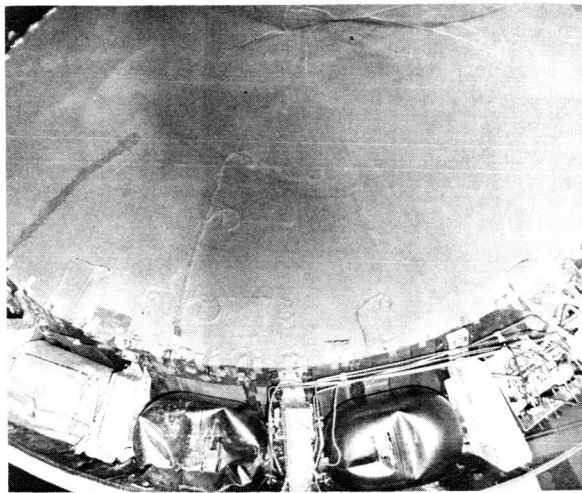
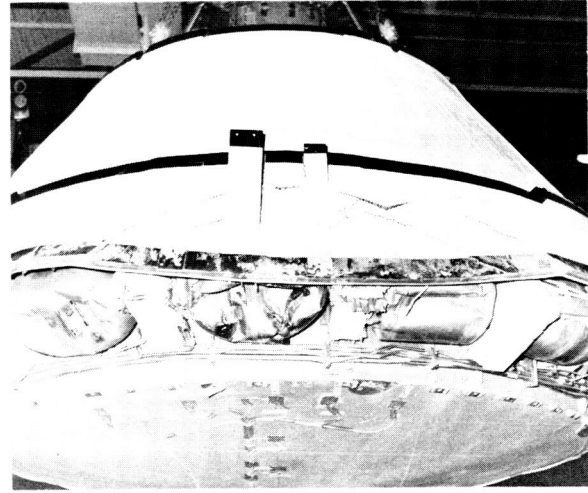
Figure 44. - Typical impact damage to RCS tanks.

The RCS tanks. - One or both RCS oxidizer tanks were crushed or ruptured by the aft-heat-shield ballast during all of the spacecraft-impact tests except test 68 with CM-002B. However, none of the fuel tanks

was crushed to such an extent that spillage of the fluid was imminent. Nothing can be concluded about the possibility of a fire resulting from the rupture of the RCS plumbing. Neither this plumbing nor the type of ballast that is most likely to damage this system (fig. 11) were installed on any of the test vehicles. However, extensive damage in areas containing plumbing is indicative of a high probability of toxic-fume release from the oxidizer tanks and a significant possibility of fire caused by the mixing of oxidizer with the fuel from ruptured lines. In most tests, numerous cracks in the aft bulkhead and sidewall provided routes to the crew compartment for the released fluids and fumes. Typical damage caused to RCS tanks by a land impact is shown in figure 44
