**APOLLO 15 MISSION REPORT**

**MANNED SPACECRAFT CENTER  
HOUSTON, TEXAS  
DECEMBER 1971**

MSC-05161

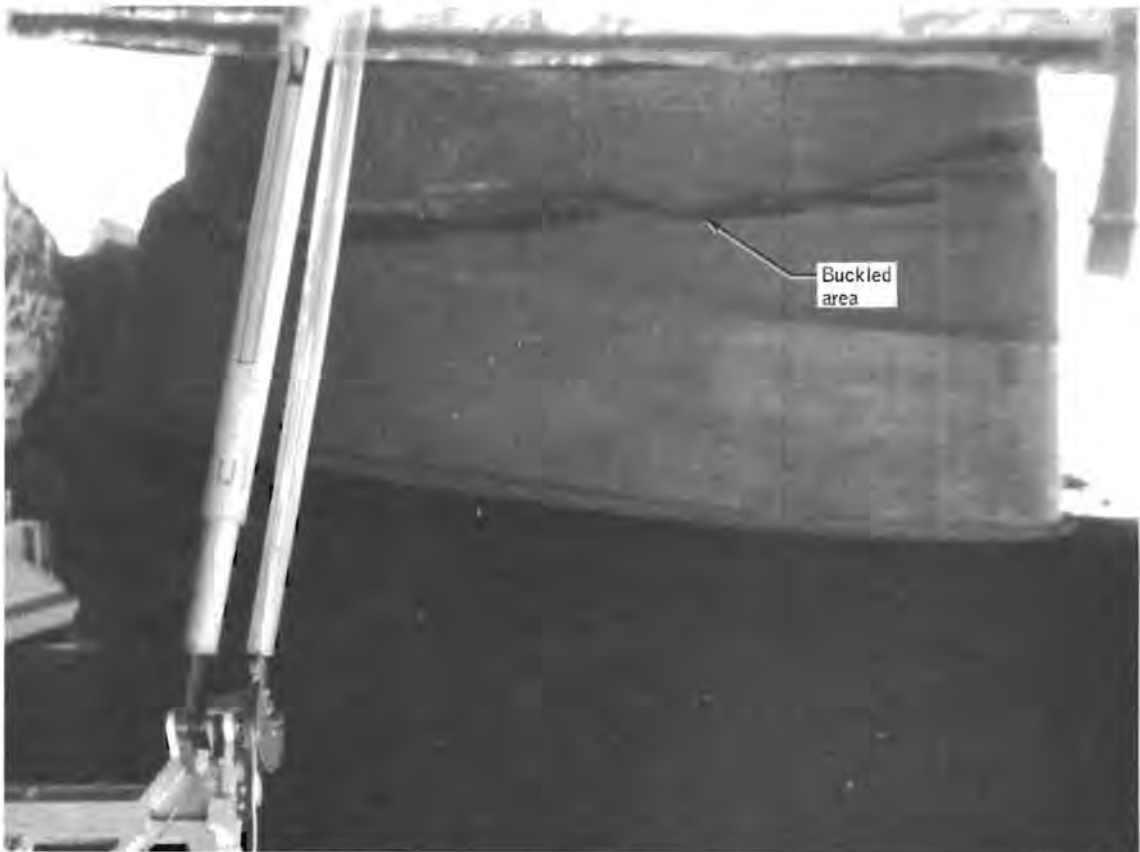
At touchdown, the lunar module was located partially inside a small crater with the rim of the crater directly underneath the descent engine skirt. The descent engine skirt buckled during landing. This is accounted for in the touchdown dynamic analysis, and was expected as the skirt length had been extended 10 inches over that of previous vehicles. This buckling was noted by the crew and confirmed by photographs of the damaged skirt (fig. 7-1). The crew reported that there was a gap between the exit plane of the skirt and the lunar surface, indicating that buckling was probably caused by a buildup of pressure inside the nozzle due to proximity to the lunar surface, and not due entirely to contact of the nozzle skirt with the lunar surface. The crew also reported that the buckling seemed to be uniform around the skirt periphery and that the exit plane height above the surface was uniform.

Figure 7-1.- Buckling of descent engine skirt.

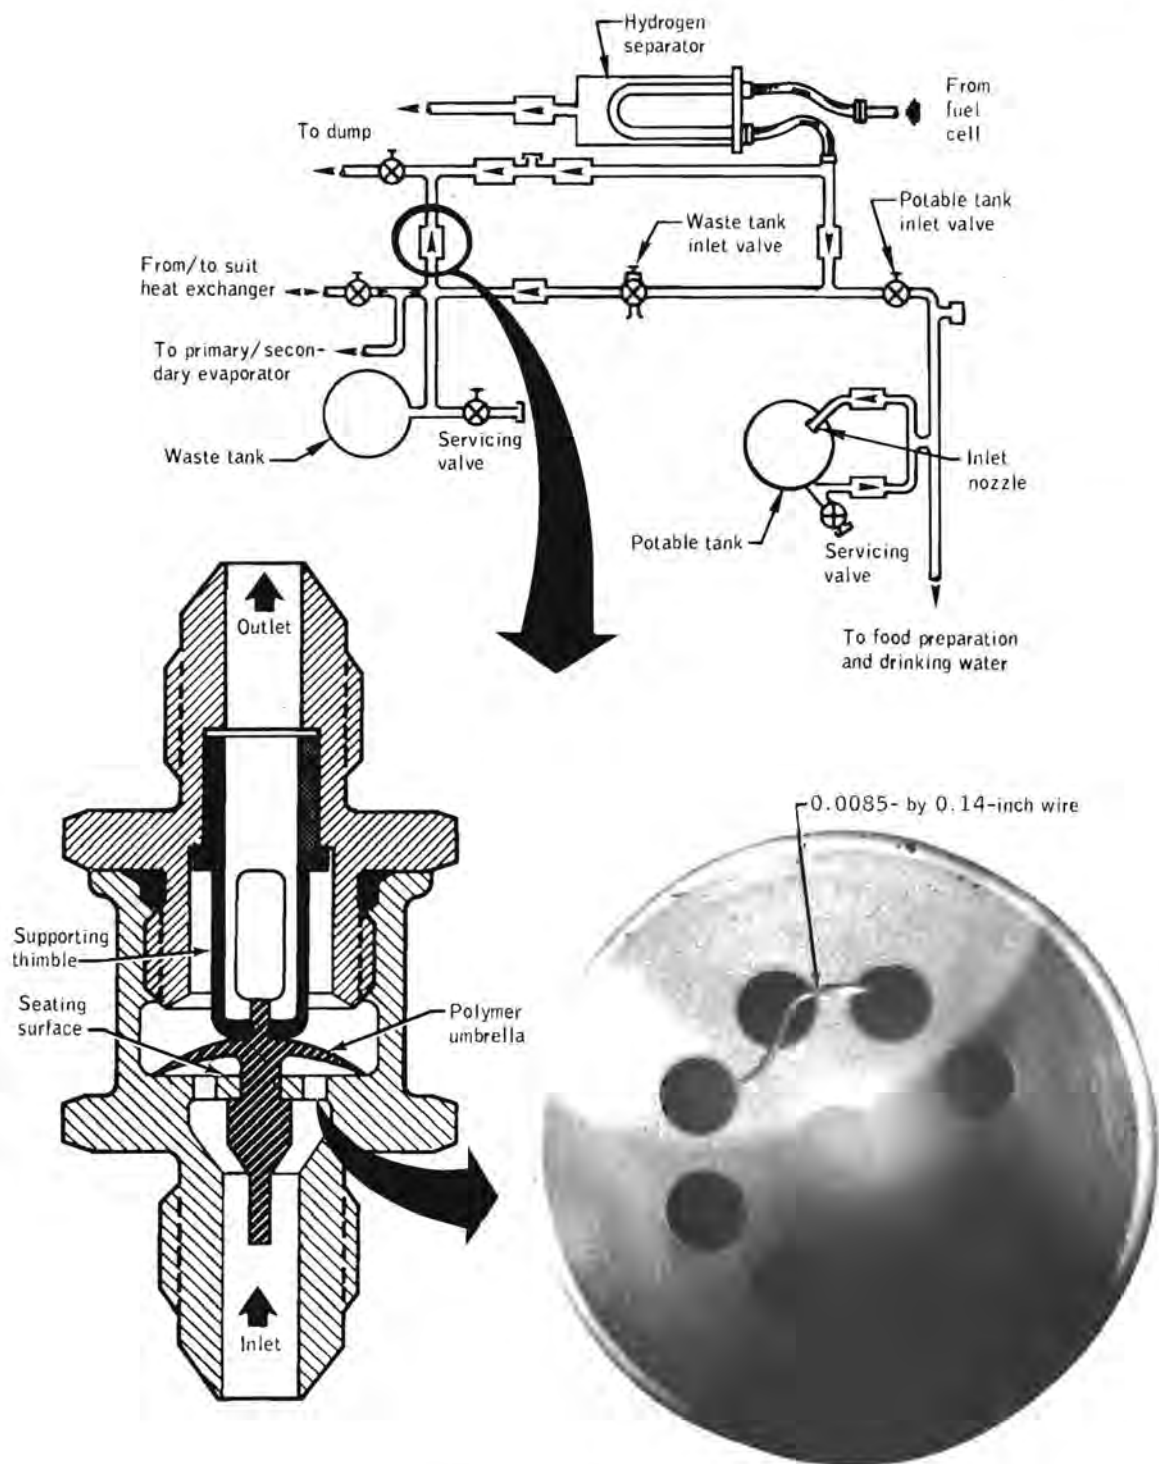
Figure 14-9.- Water management system and failed check valve details.

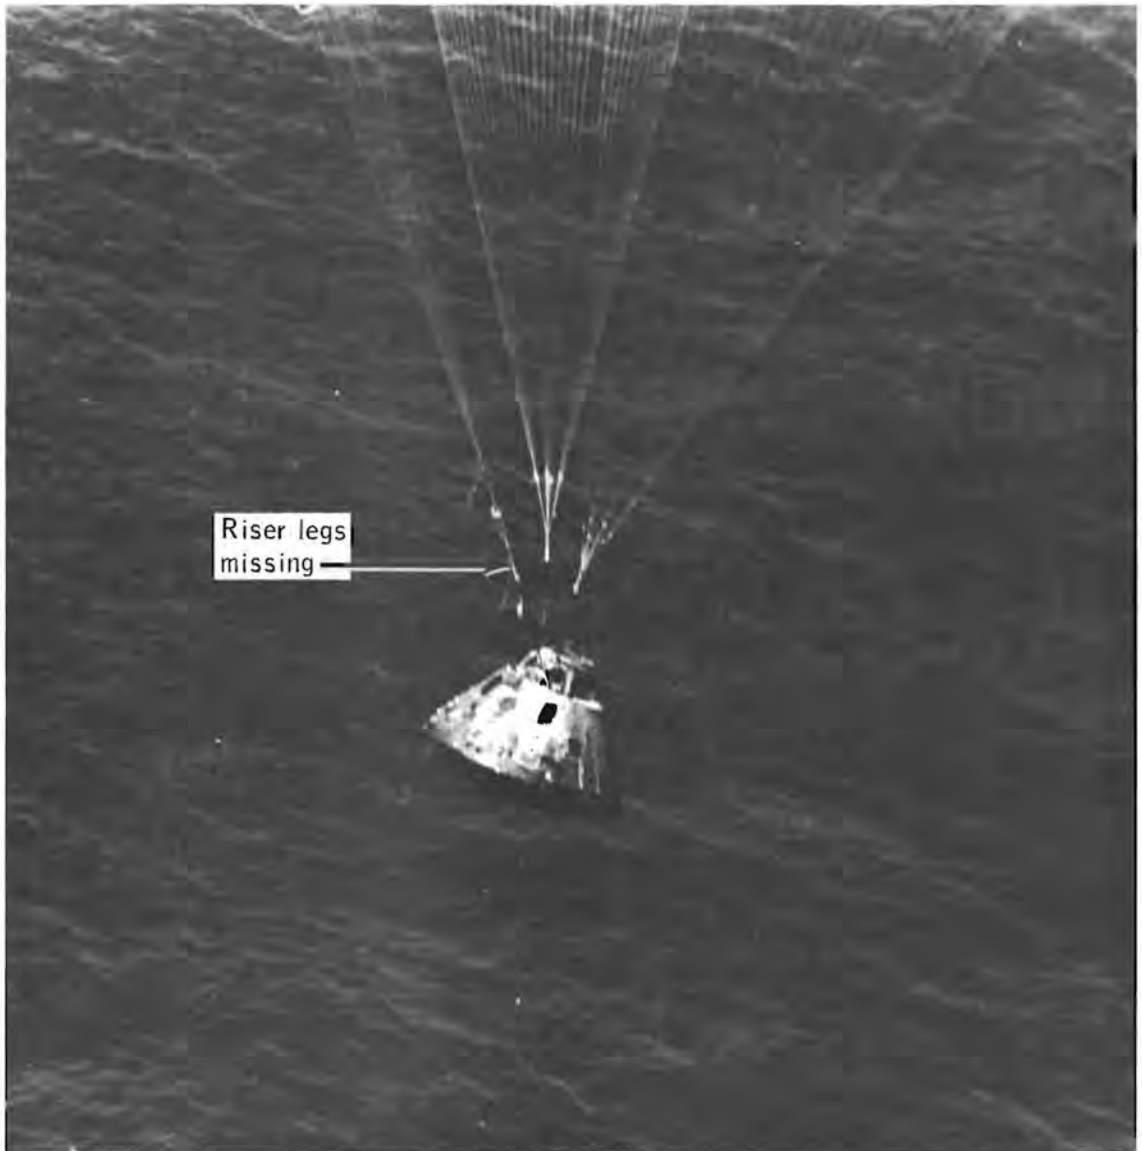
Figure 14-11.- Parachute riser damage noted during final descent.

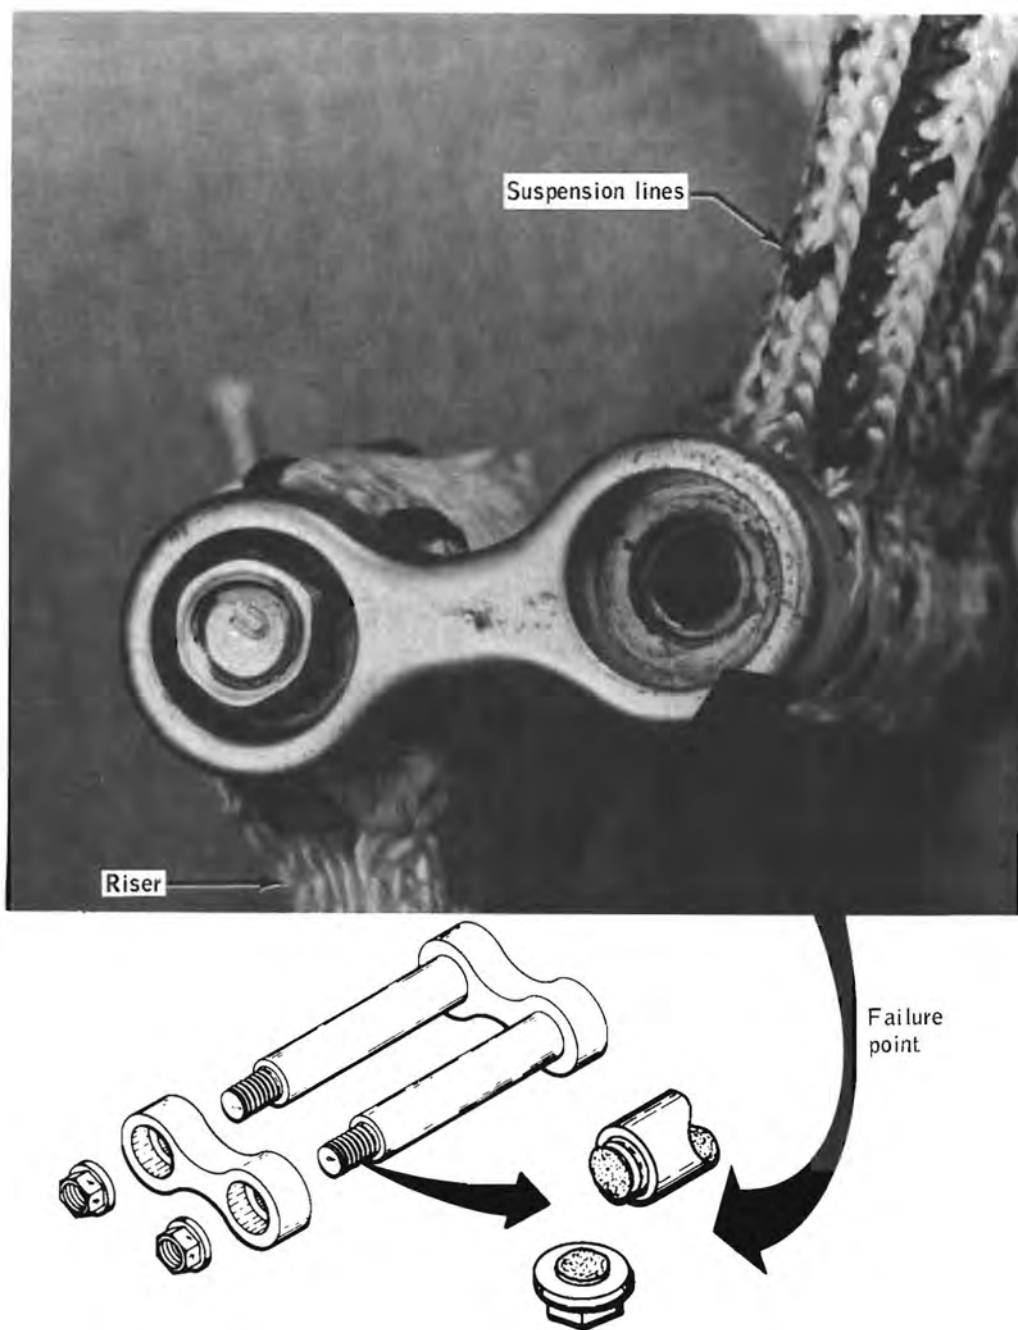
Figure 14-12.- Main parachute connector link failure.

In order to eliminate critical processing operations from manufacture of the connector links, the material was changed from 4130 to Inconel 718.

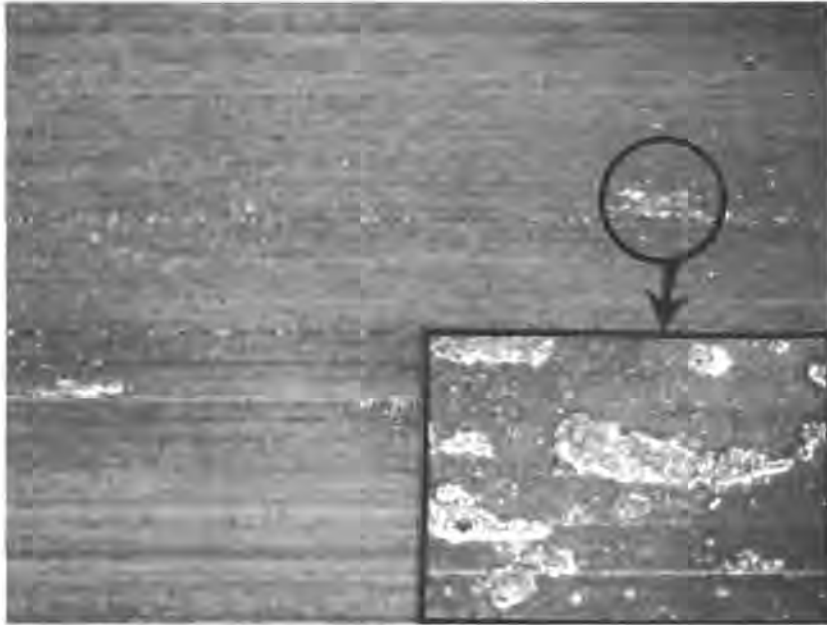
A 10-foot leader coated with a silver oxide compound is spliced to the beginning and end of the magnetic tape roll to activate the end-of-reel sensors on the tape transport. There has been a history of this material flaking off and affecting tape performance. Tape screening procedures were implemented by the manufacturer in 1968 to eliminate this problem. No further problems were encountered until Apollo 15. The recording method for Apollo 14 and previous missions was considerably different than that for the Apollo 15 mission. Bit packing densities for the Apollo 15 mission tape approach 9000 bits per inch while those for the previous missions were only 800 bits per inch. Abnormalities in the tape would have considerably more effect with the higher packing density. The utilization of the Apollo 15 mission recorder is also considerably higher, allowing more time for deposits to build up.

Figure 14-14.- Recording tape photographed under 50 power and 400 power magnification showing silver oxide deposits.

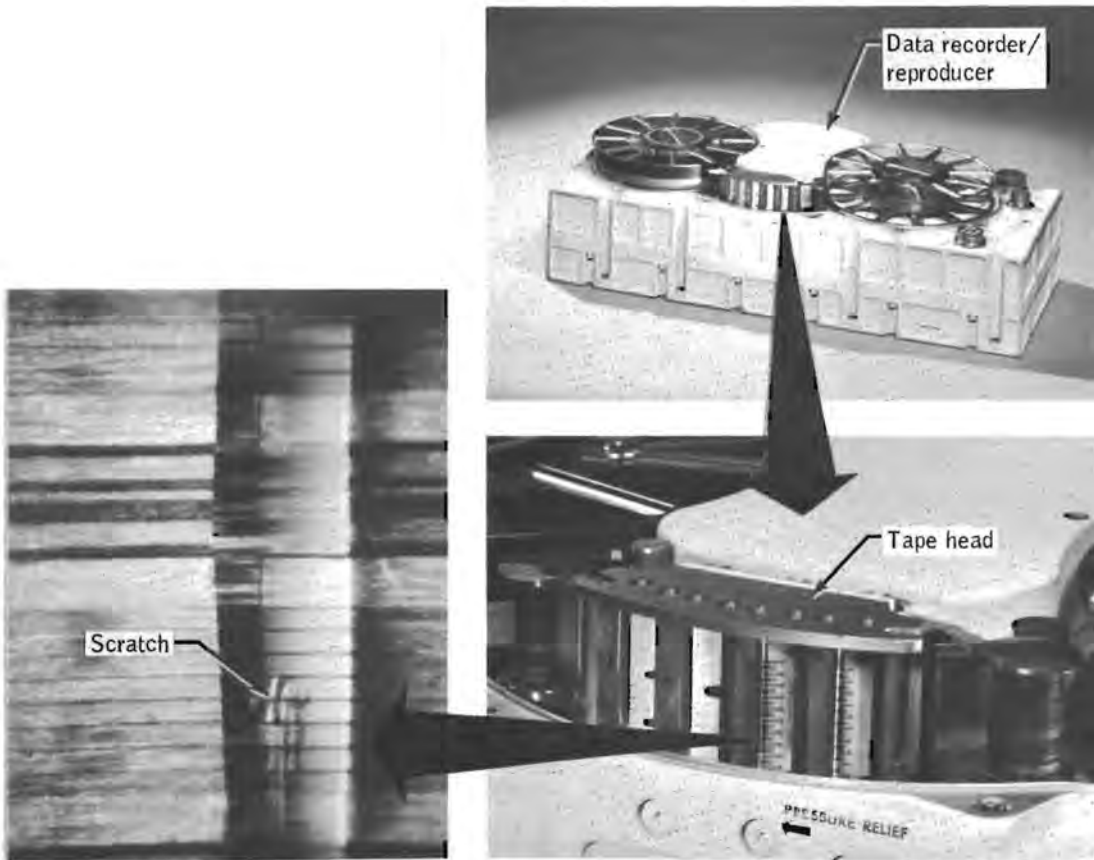
Figure 14-15.- Data recorder/reproducer and scratches on head.

Removable head covers have been provided to protect the heads from handling damage when the recorder covers are not installed. These covers have been used since early in the buildup cycle of the Apollo 16 and 17

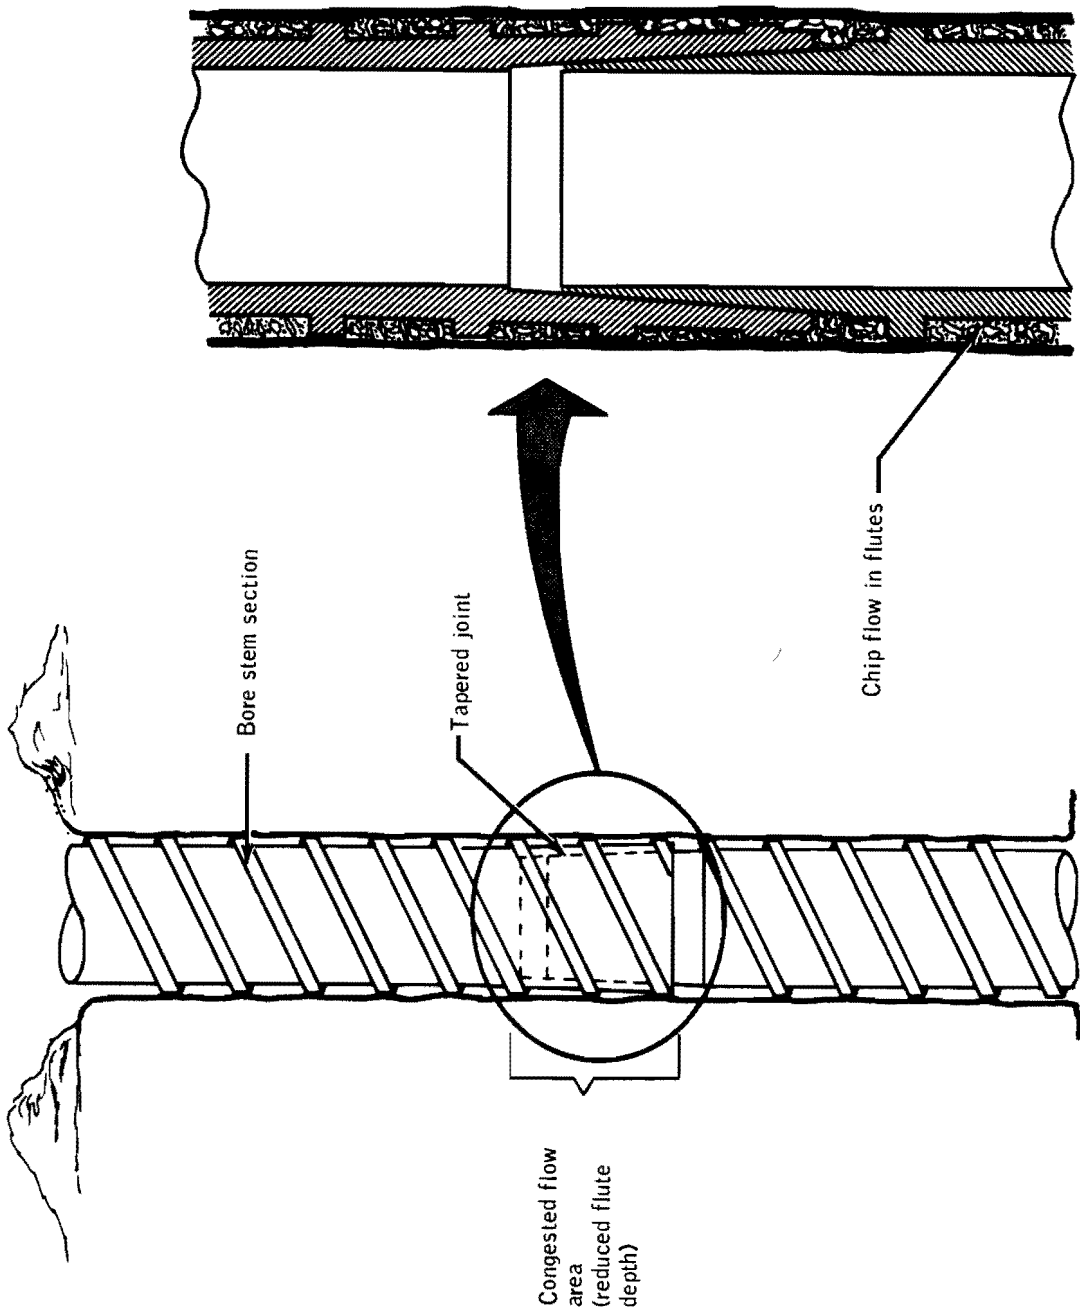
The performance of the drill power-head and the core stem was good. However, full depth penetration with the bore stems was a problem and extraction of the core stems from the hole was difficult (see sec. 14.4.1). The two bore stem holes were drilled to a depth of about 172 centimeters (70 inches) instead of the desired 294 centimeters (120 inches), with one of the bore stem strings probably sustaining damage at a point slightly above the first joint [about 105 centimeters (43 inches) below the surface] (see fig. 4-6).

Figure 14-41.- Congestion at bore stem joints.

- a. The bore stem joints will be changed from boron/fiberglass tapered joints to threaded titanium inserts which provide continuous flutes

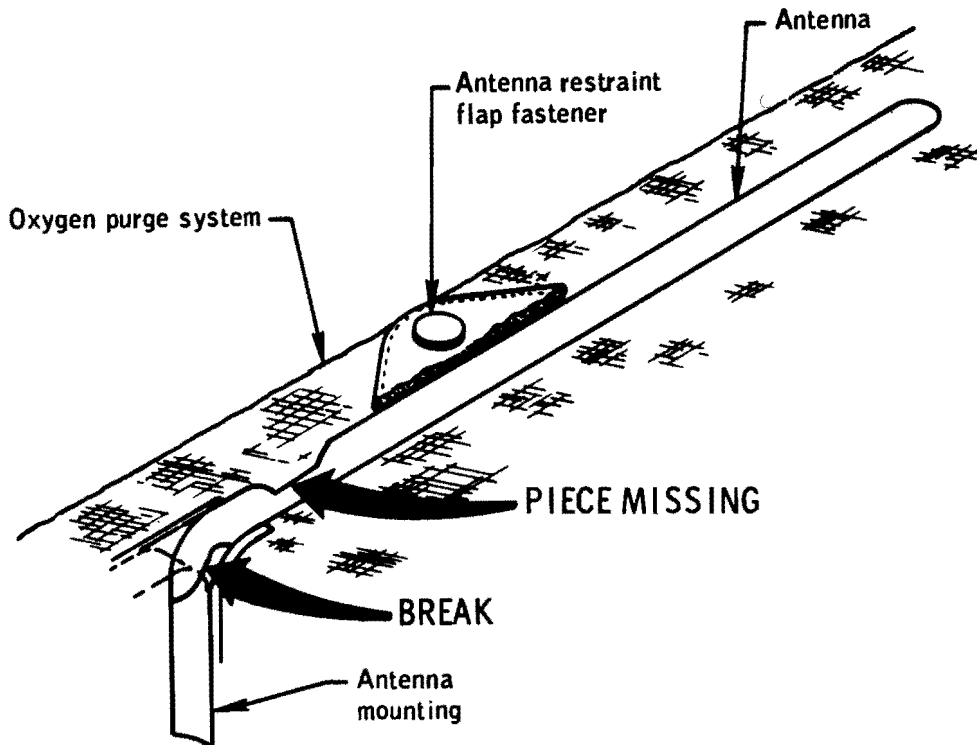
The communications check at the beginning of the second extravehicular activity was initially unsuccessful for the Lunar Module Pilot because his antenna was broken (sec. 14.5.6). The crewmen taped the antenna to the

Figure 14-51.- Damaged antenna stowed on oxygen purge system.

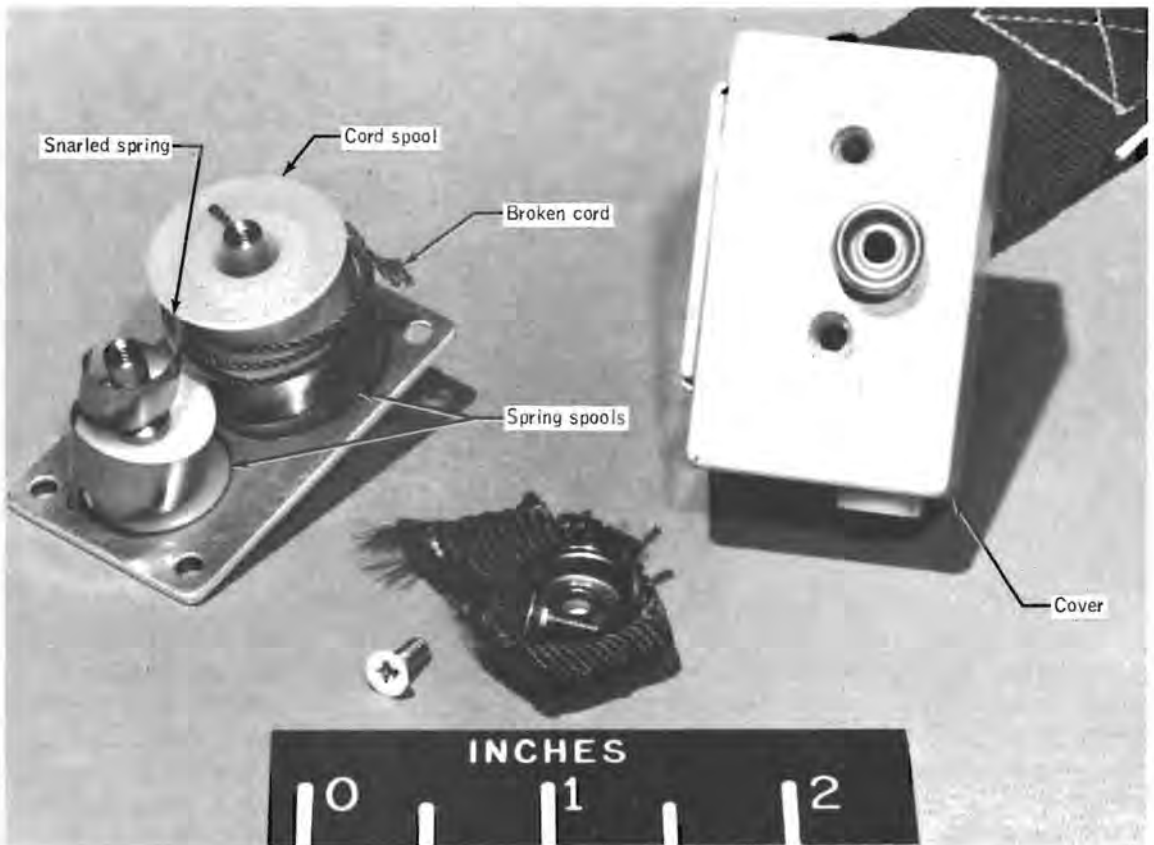
- f. Both retractable tethers (yo-yo's) failed (sec. 14.5.7).
- g. The tongs were difficult to operate during the third extravehicular activity; however, a backup pair was supplied for such a contingency and these operated satisfactorily.

Figure 14-52.- Commander's tether (cover removed).

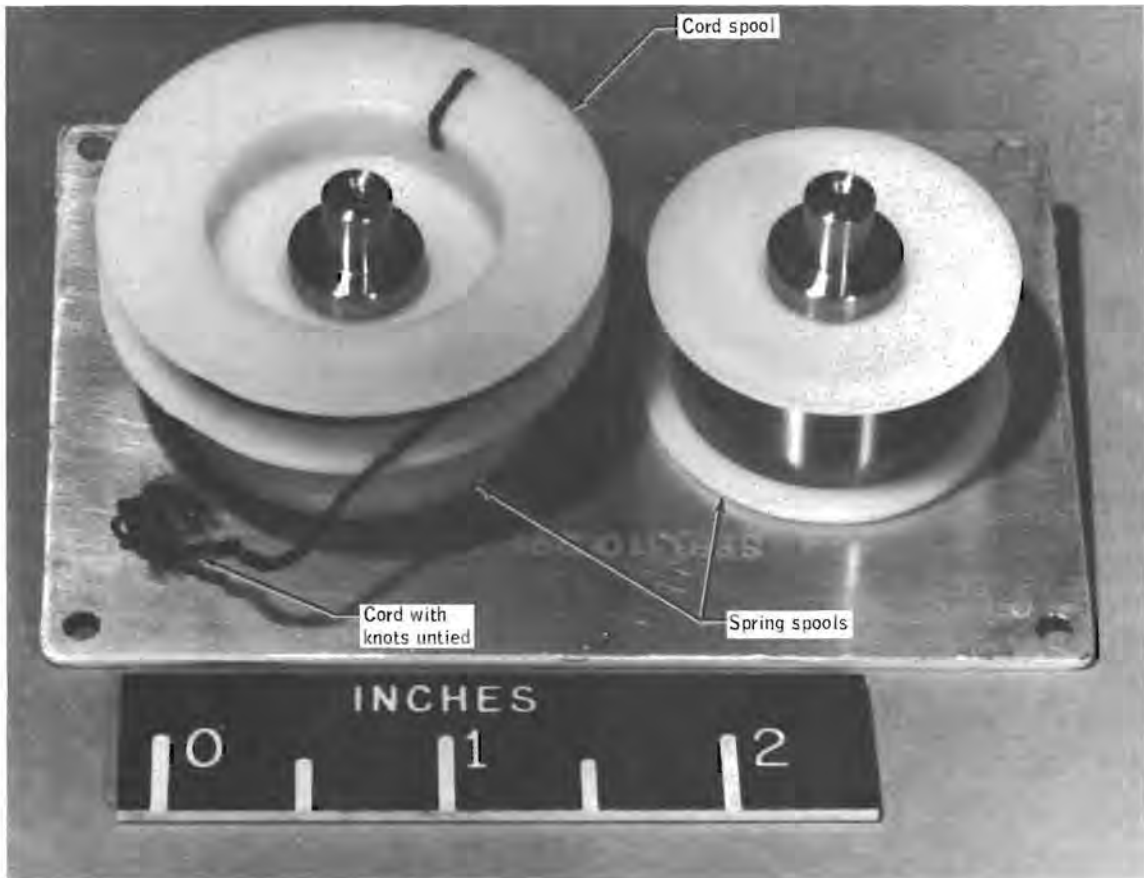
Figure 14-53.- Lunar Module Pilot's retractable tether (cover removed).
