NASA TM X-67945

SHOCK AND VIBRATION TESTS OF A SNAP-8 NaK PUMP

by A. J. Stromquist, R. B. Nelson, and Lawrence Hibben
Lewis Research Center
Cleveland, Ohio
October, 1971

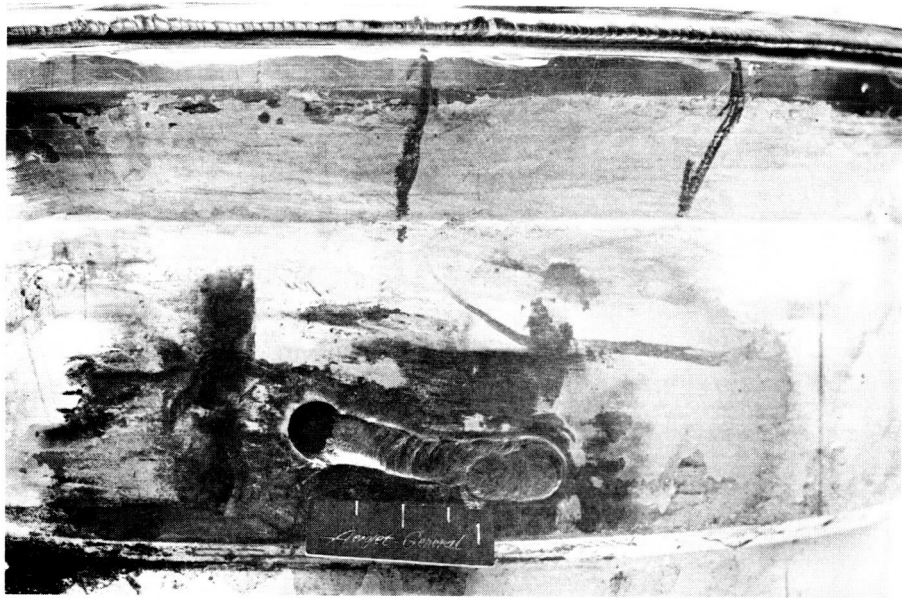
The general outside condition of the unit revealed the vent valve on the stator housing had broken off at the tube to housing weld joint. The stator housing was deformed around the base mount locating hole (fig. 5) as a result of the failure of the holding strap allowing the stator housing to bounce against the pin in the base. Both of the thermocouple header locating lugs are loose but still intact. A subsequent helium leak check of the winding area showed no leakage to be present. This indicates the ceramic was not cracked through in the lug area. All three pump housing to motor housing pin to lug joints were frozen. Rapping these with a hammer did not dislodge the pins. Dye penetrant inspections of all bolt covers showed no defects.

Figure 5. - Result of stator housing bouncing on base mount locating pin during environmental testing.

1. Design a prototype mounting system that will thermally isolate the pump from the structure while allowing thermal growth and still preload the pump sufficiently to prevent any free motion and consequent amplification of the vehicle loads.
2. A minor redesign of the thrust bearing antirotation and pivot pins to strengthen them.
3. An analysis of the pump housing to motor housing pin to lug joints to determine if clearances should be altered or material changed to prevent freezing of these joints.

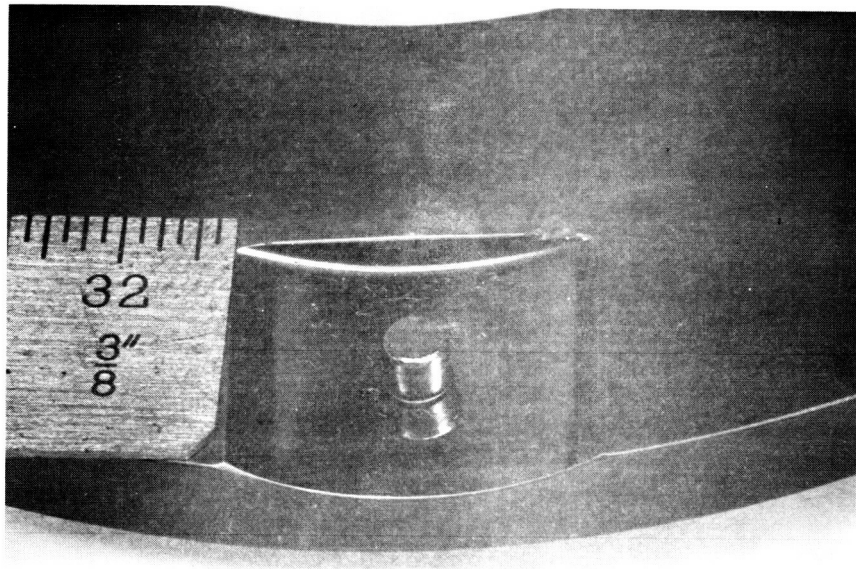
The thrust runner, support rings, and thrust pads show no signs of damage. However, the gimbal ring was chipped in both socket areas which mate with the bearing support ring as shown in figures 6 and 7. The backplate had numerous burnish marks at the interface to the housing. The housing had matching burnish marks related to the backplate and also radial indentations approximately 0.005 of an inch deep in four places matching the configuration of the backplate. The pins at the two socket joints (the side that mates with the support ring) of the motor end thrust bearing gimbal ring have both been partially sheared in the same direction. One pin was loose on the backplate mating side as seen in figures 8 and 9. The motor end backplate and housing have similar damage points as the housing and backplate on the opposite end. The antirotation pins in both housings (pins that keep the backplates from rotating during operation) were both worn to a cone shape as seen in figure 10.

Figure 6. - Thrust bearing gimbal ring.

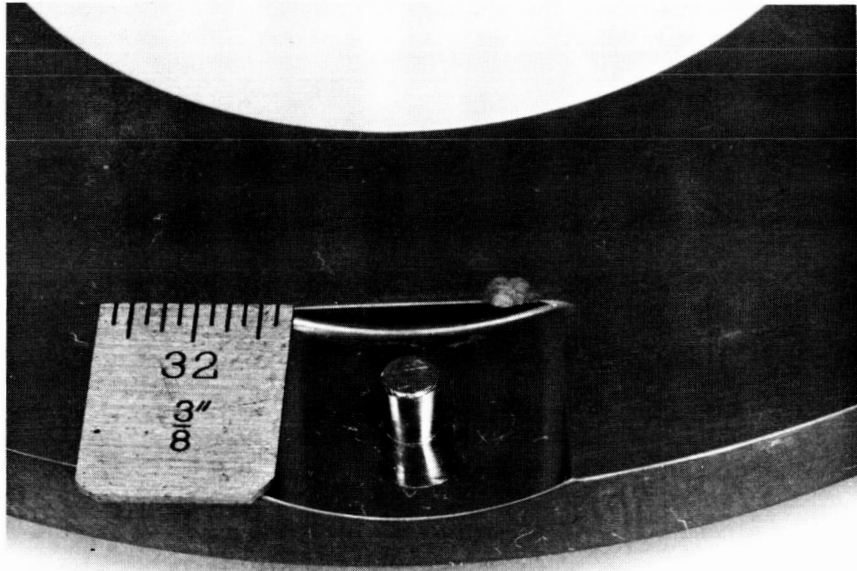
Figure 7. - Pump end thrust bearing gimbal ring.

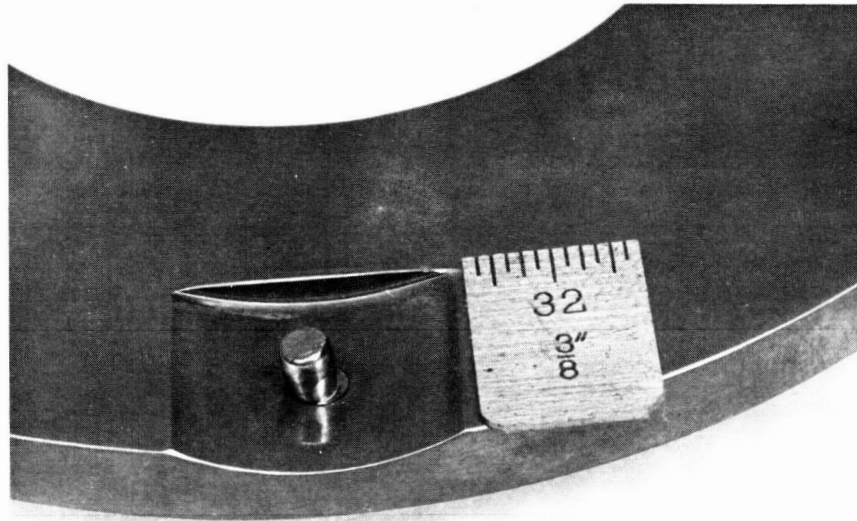
It is problematical whether the gimbal bearing support pins which were partially sheared and bent could remain intact through a long endurance test with hot NaK. It is also problematical whether the debris found as a result of this damage would have eventually found its way into the bearings and caused further damage. It is possible the recirculation system, which contains a filter, may have removed the debris.

Figure 8. - Motor end thrust bearing gimbal ring with partially sheared and bent pin.

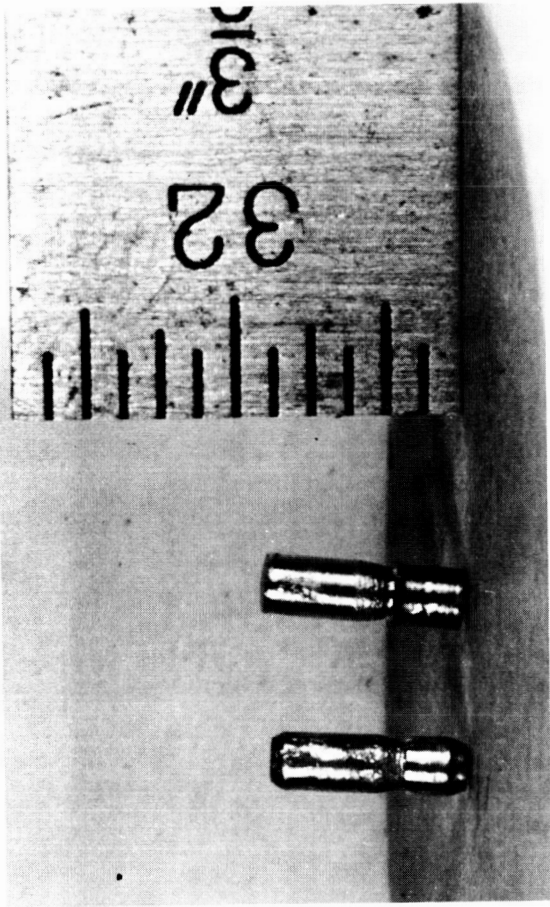
Figure 10. - Pump end thrust bearing anti-rotation pins. Wear produced by action on end plate. Bottom part of pins were in the housing.

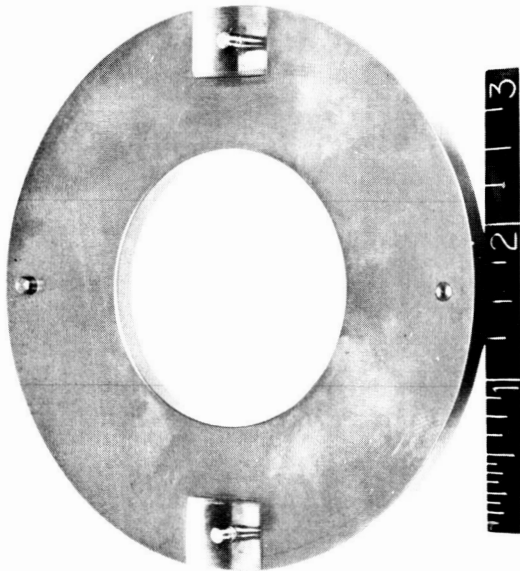
Figure 9. - Motor end thrust bearing gimbal ring showing loose pin.

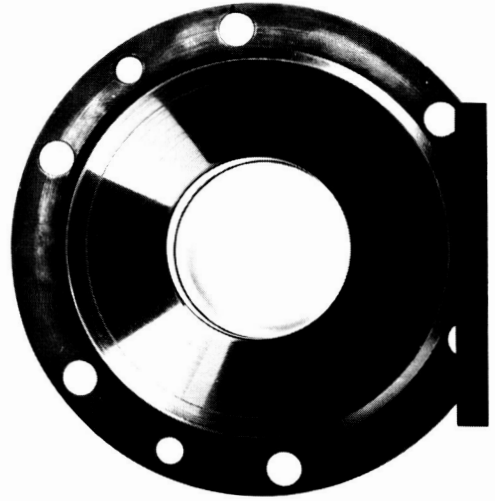
The suction housing and impeller vane faces showed marks that were produced by foreign particles getting between the interfaces. The suction housing has one significant scratch approximately π radians (180°) across the face (fig. 11). All other components of the pump motor assembly showed no sign of damage as a result of the environmental test.

Figure 11. - Suction housing of NaK pump showing scratches.
