MISHAPS WITH OXYGEN IN NASA OPERATIONS

by Paul M. Ordin
Lewis Research Center
Cleveland, Ohio

TECHNICAL PAPER proposed for presentation at
Oxygen Compressors and Pumps Symposium
sponsored by the Compressed Gas Association
Atlanta, Georgia, November 9-11, 1971

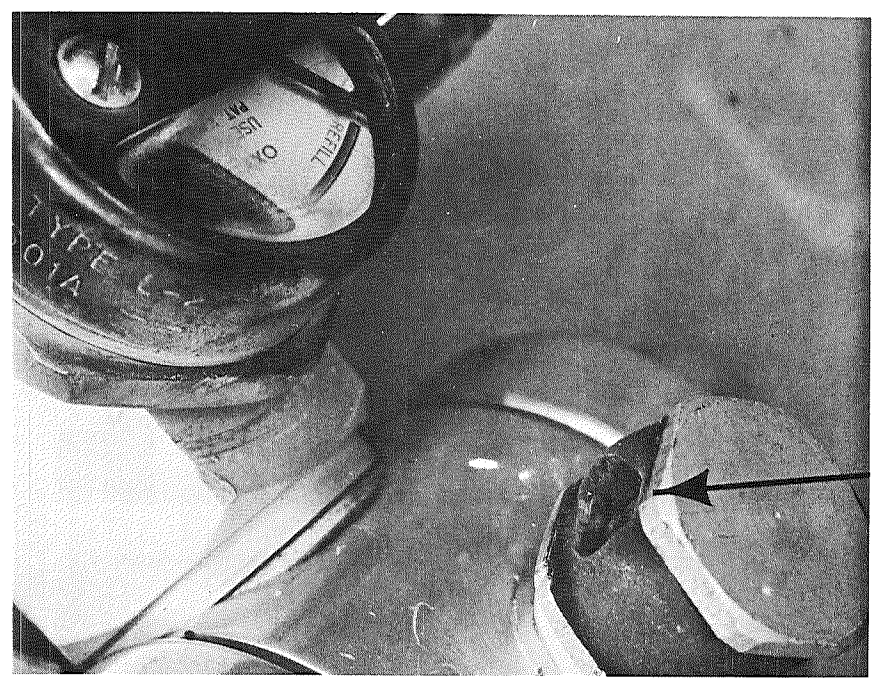
The mishap was caused by procedural deficiencies which did not provide sufficient quality control; by the use of incompatible materials and by system design limitations resulting in galling between the stainless steel inlet valve camshaft and aluminum housing. The galling of the metals was most likely responsible for the metal particles found in the system. Redesign of the inlet valve camshaft assembly and the installation of a filter screen in the regulator are minimum changes required. The various rubber and plastic soft goods used in the regulator are listed in Table 1. With the exception of the TFE Teflon on the regulator inlet valve seat, all the materials are considered incompatible with high pressure oxygen systems.

Figure 6. - External view of resuscitator regulator illustrating ruptured safety valve and flash damage to the pressure gauge.

resuscitator were unacceptable. Acceptable substitutes have been recommended.

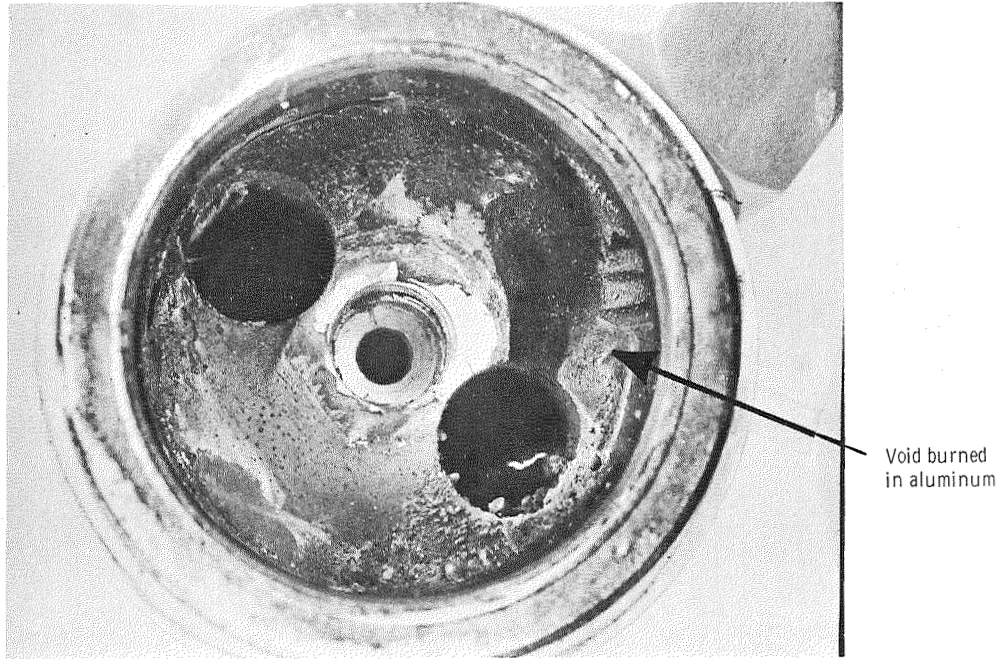
equipment for launch facility operations. The probable source of the fire was the regulator primary seat made of nylon. Ignition was most likely promoted by small metal particles which were found in the system. A schematic diagram of the resuscitator regulator is shown in Figure 5 and a photograph of the ruptured safety valve in Figure 6. A view into the regulator body illustrating the burned portions is shown in Figure 7.

Figure 7. - View of inner surface of aluminum regulator body.

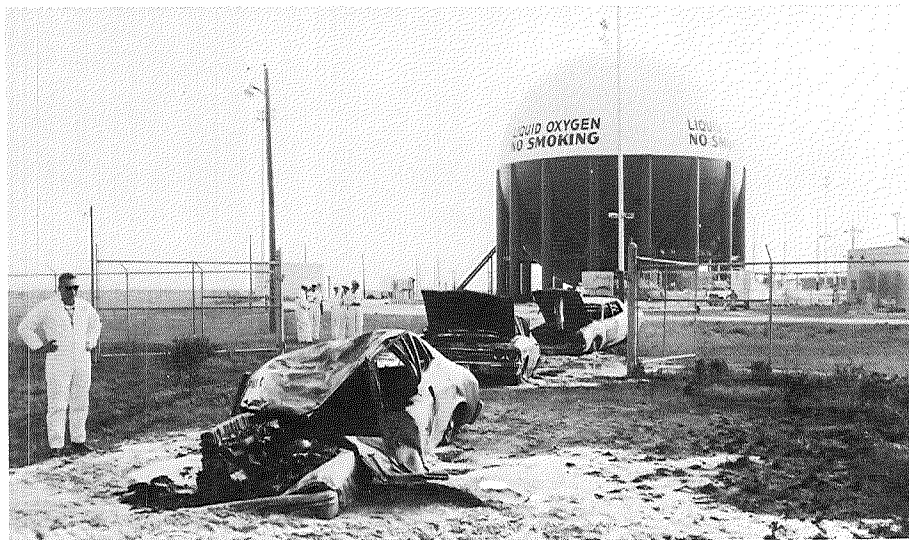
A photograph showing the burned cars and their positions with respect to the fence and oxygen tank is shown in Figure 10. Detail comments from the official report on the accident (ref. 8) concerning results of the examination of each of the cars included the following:

- (a) The fire was first observed by the operator in the engine compartment which upon examination indicated the most intense heat. It is believed that the point of ignition occurred in the engine compartment.
- (b) The driver stated that vehicle had been operated for a sufficient time to be at normal operating temperature and that the vehicle ignition had been off for approximately five minutes when fire was first noticed.
- (c) Normally, engine metal under the above conditions would attain an exhaust manifold temperature of above 600°F or above. Underhood temperatures increase after engine shutdown due to stoppage of the entire cooling system. It is believed that the increased, or high, temperatures caused vaporization of gasoline from the

Figure 10. - Burned cars in relation to oxygen tank and fence.

Working or operating vehicles in oxygen clouds or oxygen enriched environments is hazardous since it provides an increased potential for ignition. The minimum spark energy required for ignition, the flash point and the autoignition temperature are all decreased. The deficiencies responsible for the accident included a combination of system design, procedural and training limitations. The overall loading and dumping systems should include methods of verifying, tracking and control of oxygen clouds. Procedures for alternate routes for emergency vehicles and fire control of personnel entry into oxygen clouds should be prescribed.

The safety training courses should include additional information to insure recognition and safe practices concerning LOX vapor hazards. Safe operations in and around areas suspected of having LOX vapors should be outlined in the safety courses.

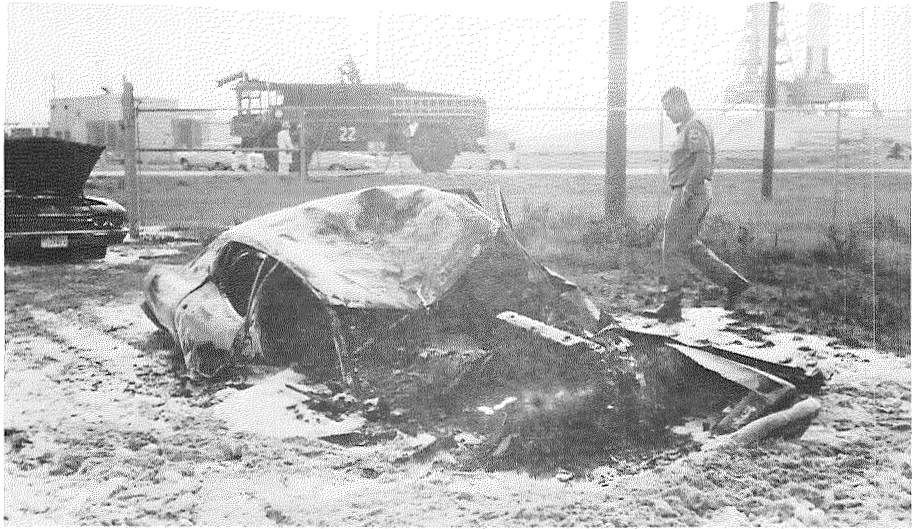
Figure 11. - Damaged car number 1.

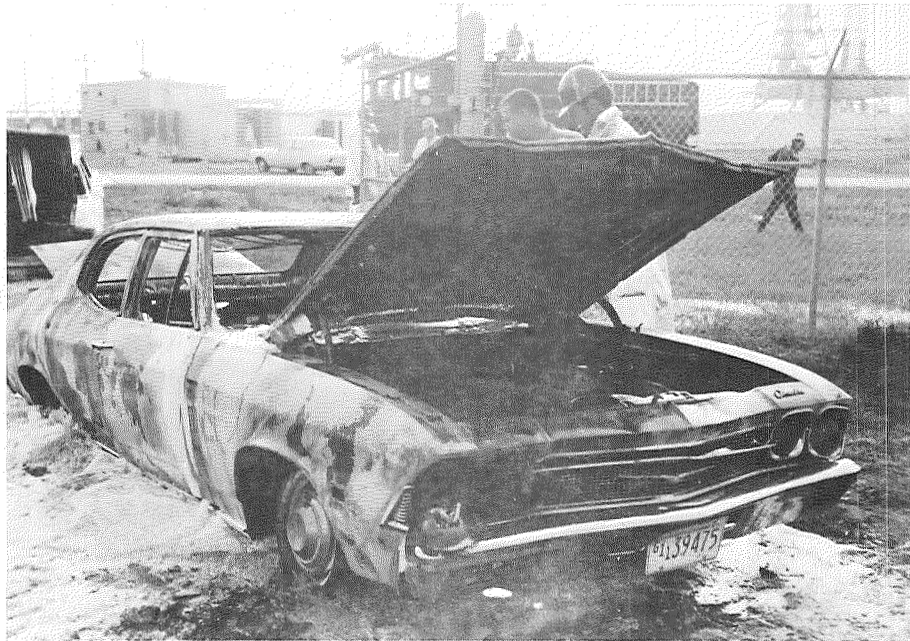
Figure 12. - Damaged car number 2.

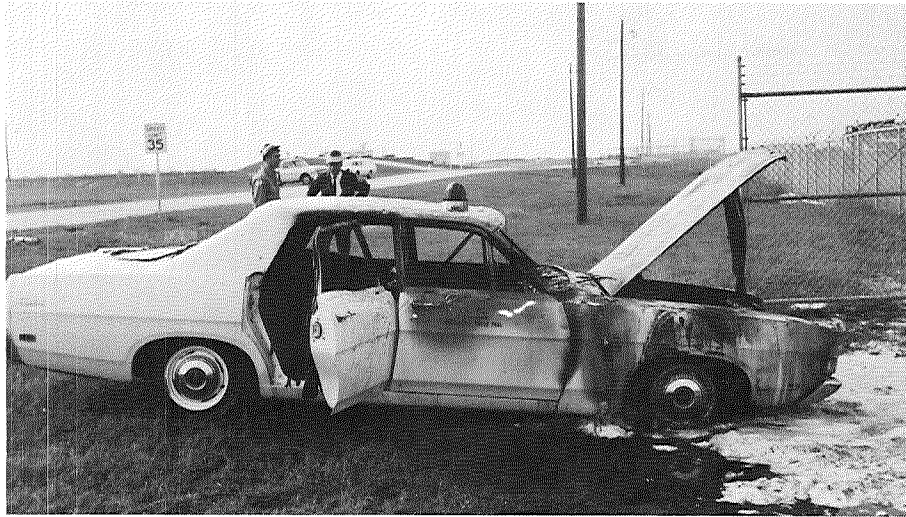
Figure 13. - Damaged car number 3.

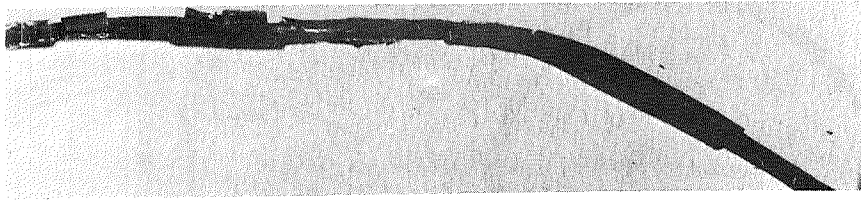
The insulation on the power wires may have become abraded due to vibration of the conduit and the rubbing of the wires against each other. The method of assembling leads into the conduit may have introduced strains into the wires causing increased insulation wear. These conditions could then lead to situations where sufficient energy, produced by shorting power leads, could ignite the surrounding Teflon. Most probably, the Teflon insulation fire progressed into the electrical conduit tubing at the top of the tank, opening the tank to the service bay. With the burn-through of the conduit, the pressure increased in the bay resulting in separation of the panel which enclosed the bay. The panel separation from the bay probably caused sufficient shock to close the oxygen supply valves. In all likelihood, the oxygen system (in tank 1) developed a leak either as a result of the shock when the panel separated or from the dynamics of the events associated with the failure of the tank 2 electrical conduit. A photograph of the oxygen tank in the service module bay is shown in Figure 19.

Figure 20. - Damaged Teflon insulation.

- (a) Redesign and replacement of O₂ tanks, and supply systems in the service module.
- (b) Provision of additional battery power for backup operation of the command service module.
- (c) Review and refinement of Apollo systems for contingency operation and contingency plans.
- (d) Review and analysis of all liquid oxygen systems in Apollo and other systems.
- (e) Review and analysis by all NASA agencies for hazards and unidentified deficiencies in all ground based as well as flight systems using LOX and other oxidizer.
- (f) Renewed awareness of the criticality of metals and materials combined with heat/ignition sources in oxygen systems.
- (g) Increased review of anomalies when they occur.
- (h) Closer quality control contacts to be maintained with vendors, subcontractors and suppliers.

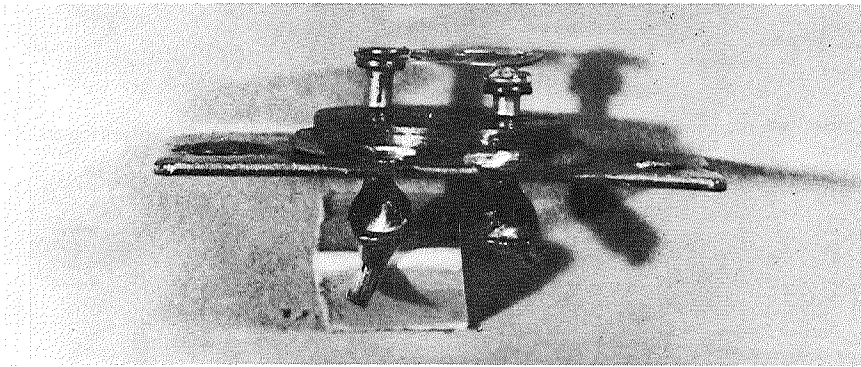
were connected in series with each of the heating elements to avoid excessive temperatures. The heater circuit would be automatically opened when the internal heater tube wall temperature reached 90°F and closed at 70°F. The use of the heaters to assist in detanking required a manual mode of operation which resulted in the switches opening under a load at twice the normal operating conditions for each heater. Tests showed that opening the switches under these conditions would fuse the contacts closed at the instant of power interruption. Tests have verified that with the heater on, for the duration experienced during prelaunch operations, fan motor wire insulation would be severely degraded. A photograph of the fan motor wire damage from simulated heater tests is shown in Figure 20. A fused thermal switch control obtained under simulated tests is shown in Figure 21.

Figure 21. - Fused thermal switch control.
