NASA TN D-5654

APOLLO COMMAND MODULE MOCKUP FLAMMABILITY TESTS

*Manned Spacecraft Center
Houston, Texas*

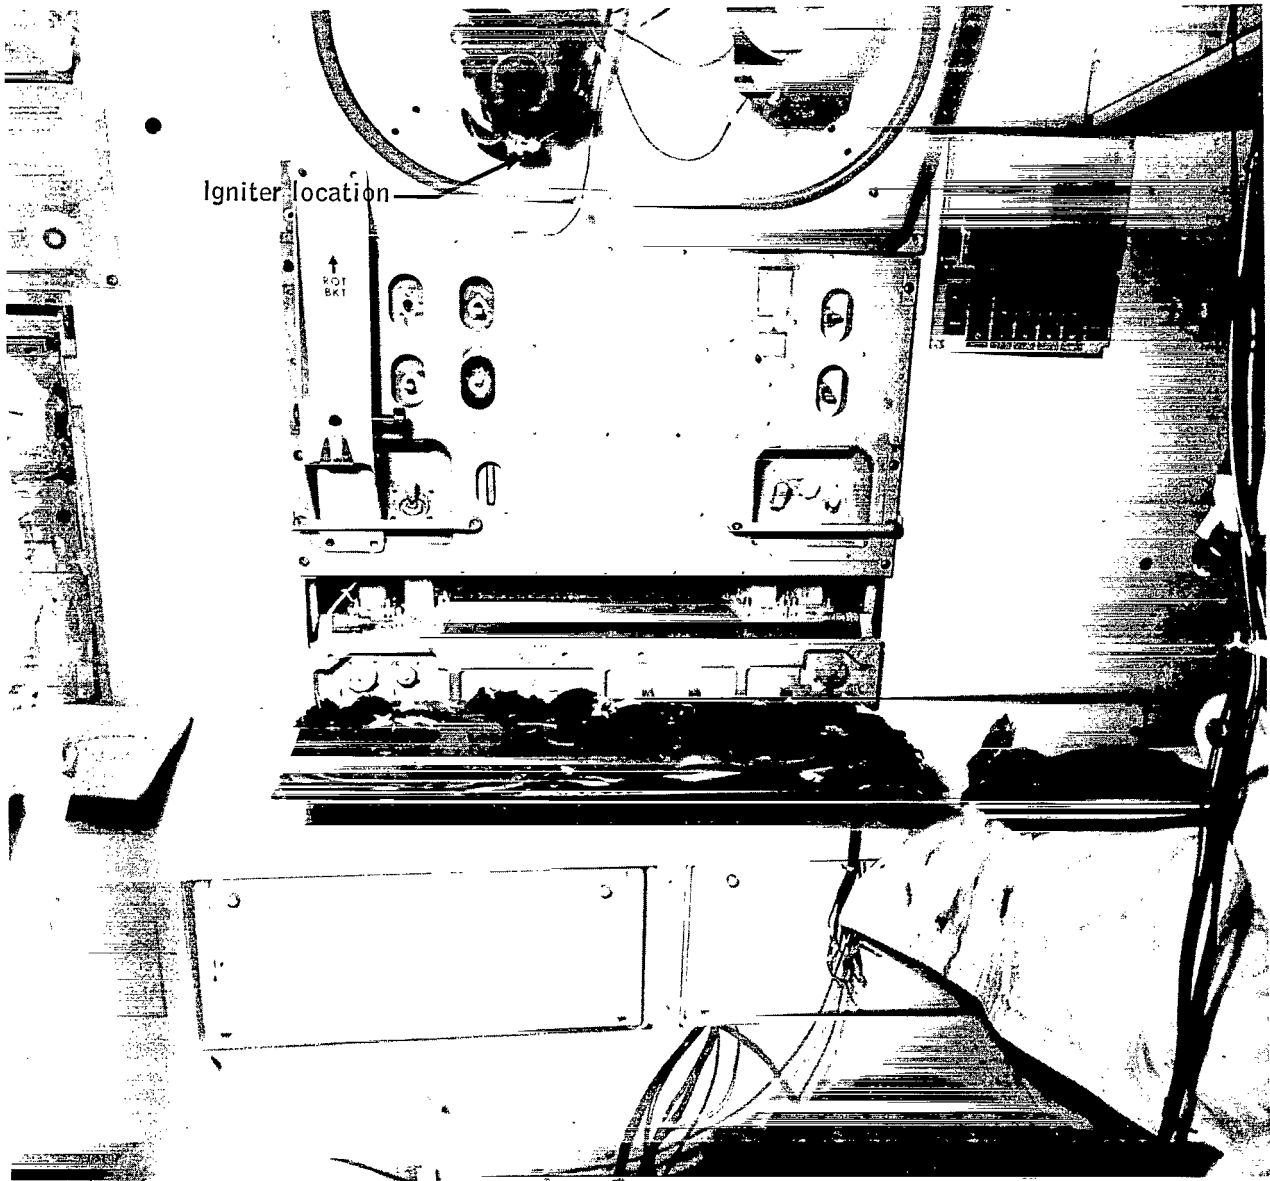
Figure 24. - Post-test damage (test 136).

The maps, star charts, and plastic overlays burned rapidly and provided a propagation path to a procedures manual located at the foot of the right-hand (RH) couch. The cabin ambient temperature rose to 165° F at 115 seconds after the time (T) of application of power to the igniter, indicating a rapid heat buildup. The Fluorel material surrounds the eyepiece heater; therefore, a flammability hazard exists in this region.

Guidance-and-navigation eyepieces (6.2 psia 100 percent oxygen). - Fluorel insulation over the heater on the G&N eyepiece was ignited, burned with considerable dripping of flaming particles, and resulted in secondary ignition of Mylar-covered maps on the worktable.

Corrective action — The Fluorel insulation was replaced by a metallic strap. Various materials are under investigation as a substitute for the Mylar map overlay. Housekeeping procedures will be developed to reduce to a minimum any hazard associated with the crew flight-data file.

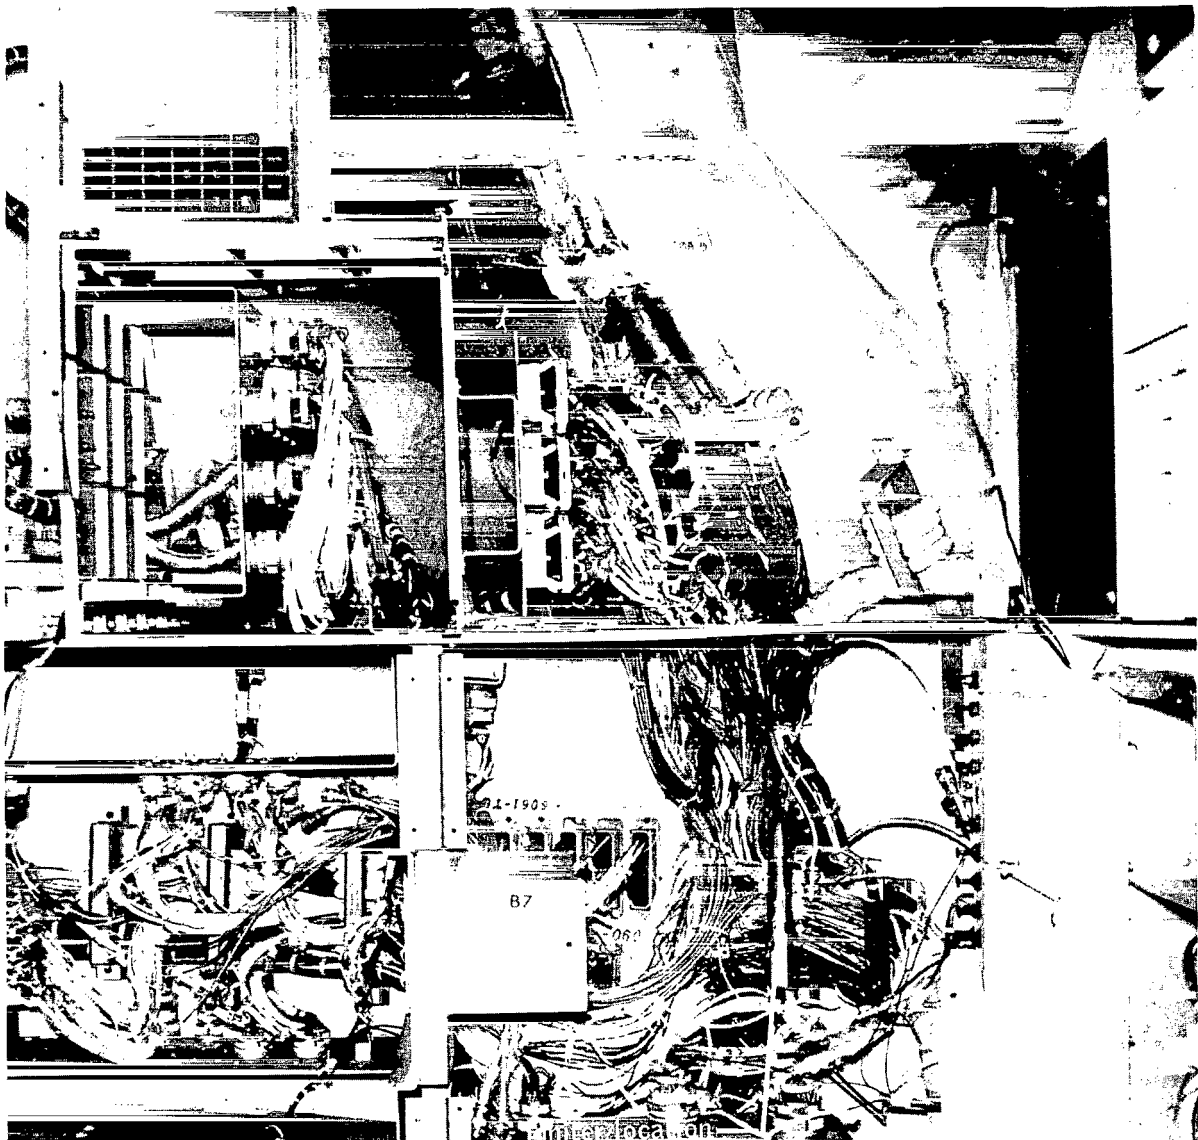
Figure 34. - Post-test damage (test 219).

In test 219, the coaxial cable ignited, and an area extending approximately 48 inches above the ignition location burned before the test was terminated. The fire and heat resulting from this test produced considerable damage to adjacent wire bundles. A significant result was that smoke was not produced in visible quantities until after the fire had become fairly large. In this environment, the crew would be suited; therefore, the products of combustion would not be detected by odor, and the fire probably would not be detected until smoke was observed in the cabin.

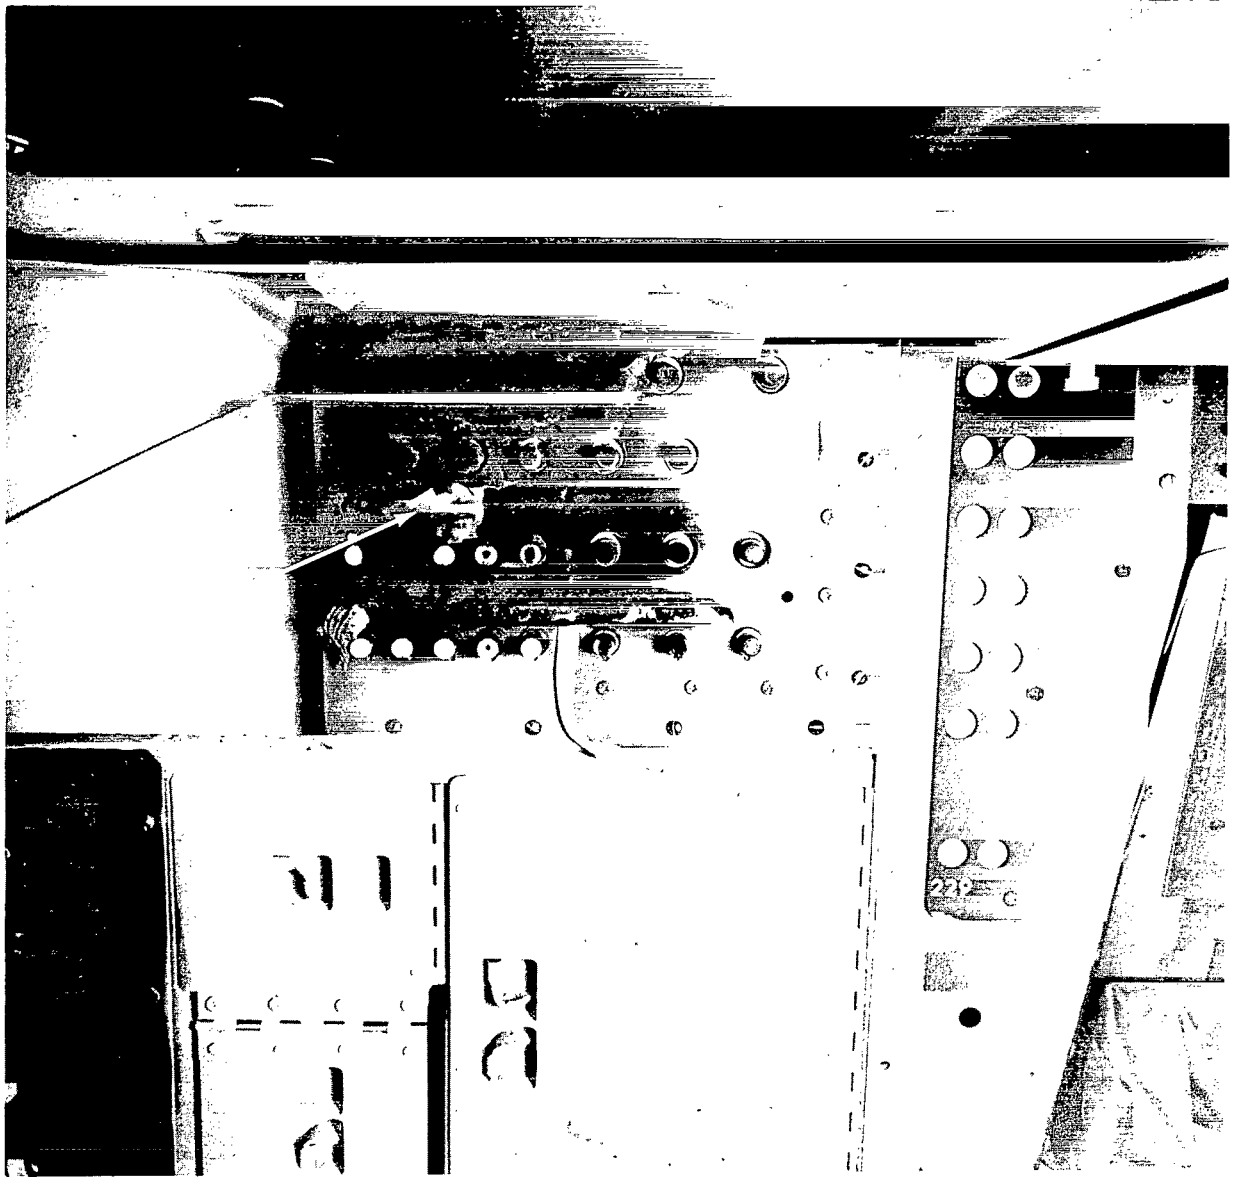
Figure 41, - Post-test damage, face of panel 225 (test 306).

A pronounced increase in damage was noted in test 302 (meter in panel 2), test 303 (switch in panel 2), test 306 (CB in panel 225), test 312 (silicone-laminate cover on panel 8), test 326 (wire bundle leading to ground-support-equipment (GSE) window), and test 330 (Teflon wrap on wire bundle exiting from forward end of RH floor tray).

Circuit-breaker panel (16.2 psia 100 percent oxygen). - The igniter was located under the conformal coating. A 0.090-inch thickness of Ladicote was applied over the conformal coating. Light smoke was observed 38 seconds after ignition. Heavy smoke was observed at T + 2 minutes 20 seconds. At T + 3 minutes 15 seconds, the fire had propagated to the upper LH corner of the EL panel and had become quite intense. The test was terminated at T + 4 minutes 27 seconds. The silicone-laminate back cover was completely destroyed, and the wiring and circuit breakers were severely damaged. The Ladicote did not prevent the propagation of the fire. During the oxygen/nitrogen tests at 16.2 psia, fire propagation occurred at a slower rate. The test was terminated at T + 6 minutes 15 seconds.

Corrective action — No satisfactory replacement materials or alternate systems have been found to replace critical components in the circuit-breaker panel; therefore, these results were instrumental in the decision to use a 60-percent-oxygen/40-percent-nitrogen launch atmosphere in the Apollo command module.

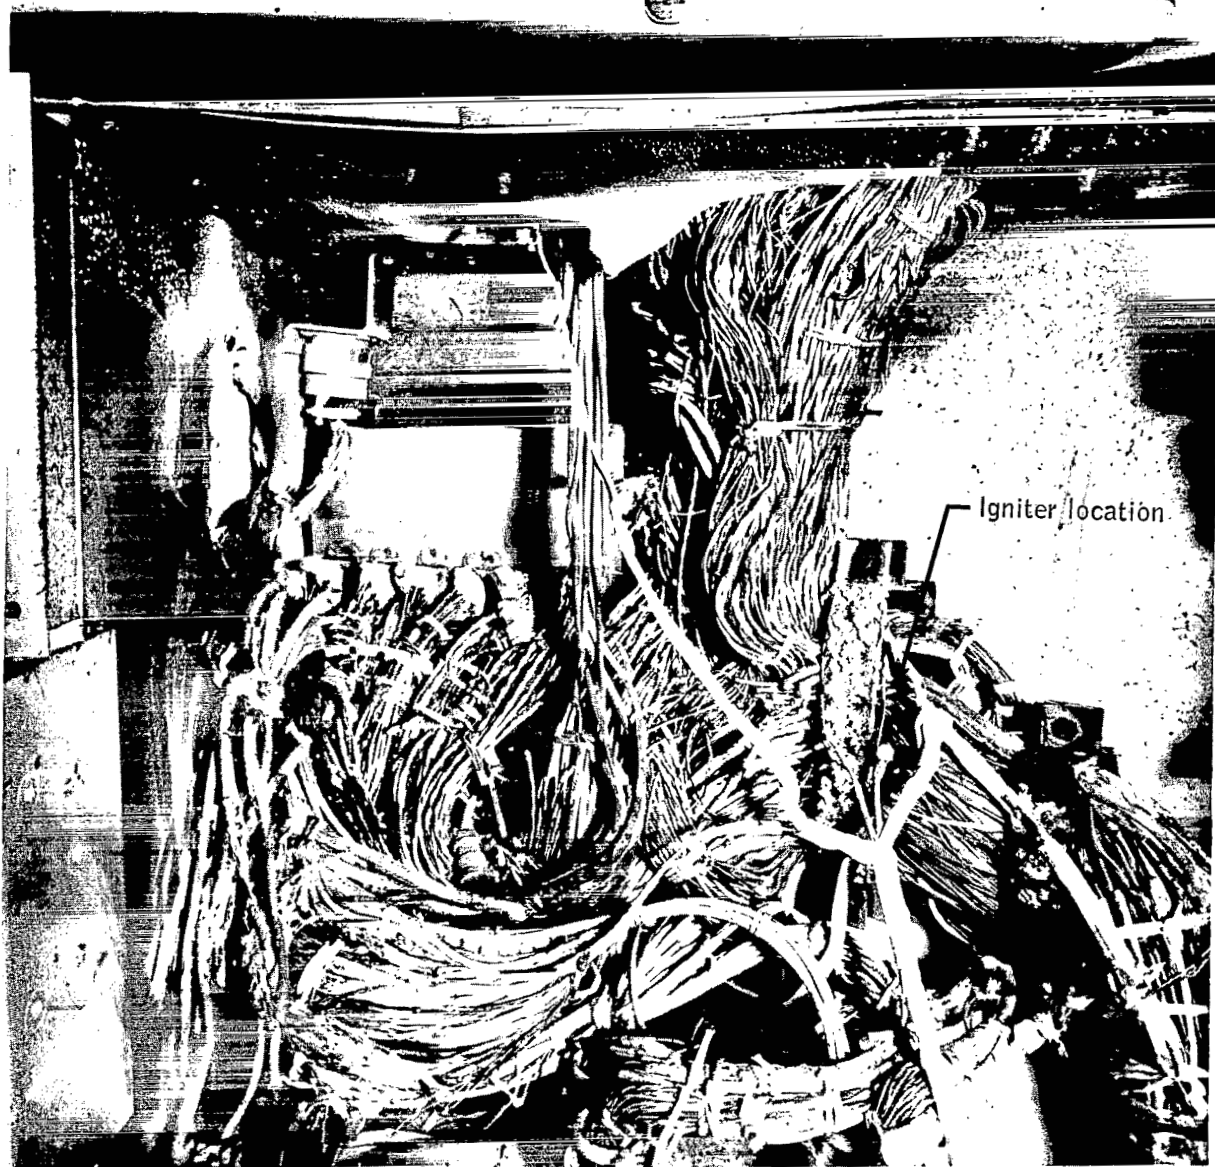
Figure 45. - Post-test damage above girth shelf (test 319).

In test 319 (igniter adjacent to coaxial cable in the lower equipment bay (LEB)), significant quantities of coaxial cable in the test region burned, and a large fire resulted which destroyed the Teflon insulation on approximately 75 percent of the wires in this region. Propagation took place along the coaxial cable to the region above the girth shelf where the coaxial cables are wrapped individually with aluminum tape to provide fire protection. The aluminum tape was ineffective in preventing propagation in this atmosphere, and the fire proceeded up the vertical bundle of coaxial cable until the test was terminated.
