NASA TM X-52336

**CENTAUR SOLID STATE INVERTER FAILURE DURING SIMULATED  
FLIGHT IN AN ENVIRONMENTAL SPACE CHAMBER**

by Ralph F. Schmiedlin and B. J. Dastoli

Lewis Research Center  
Cleveland, Ohio

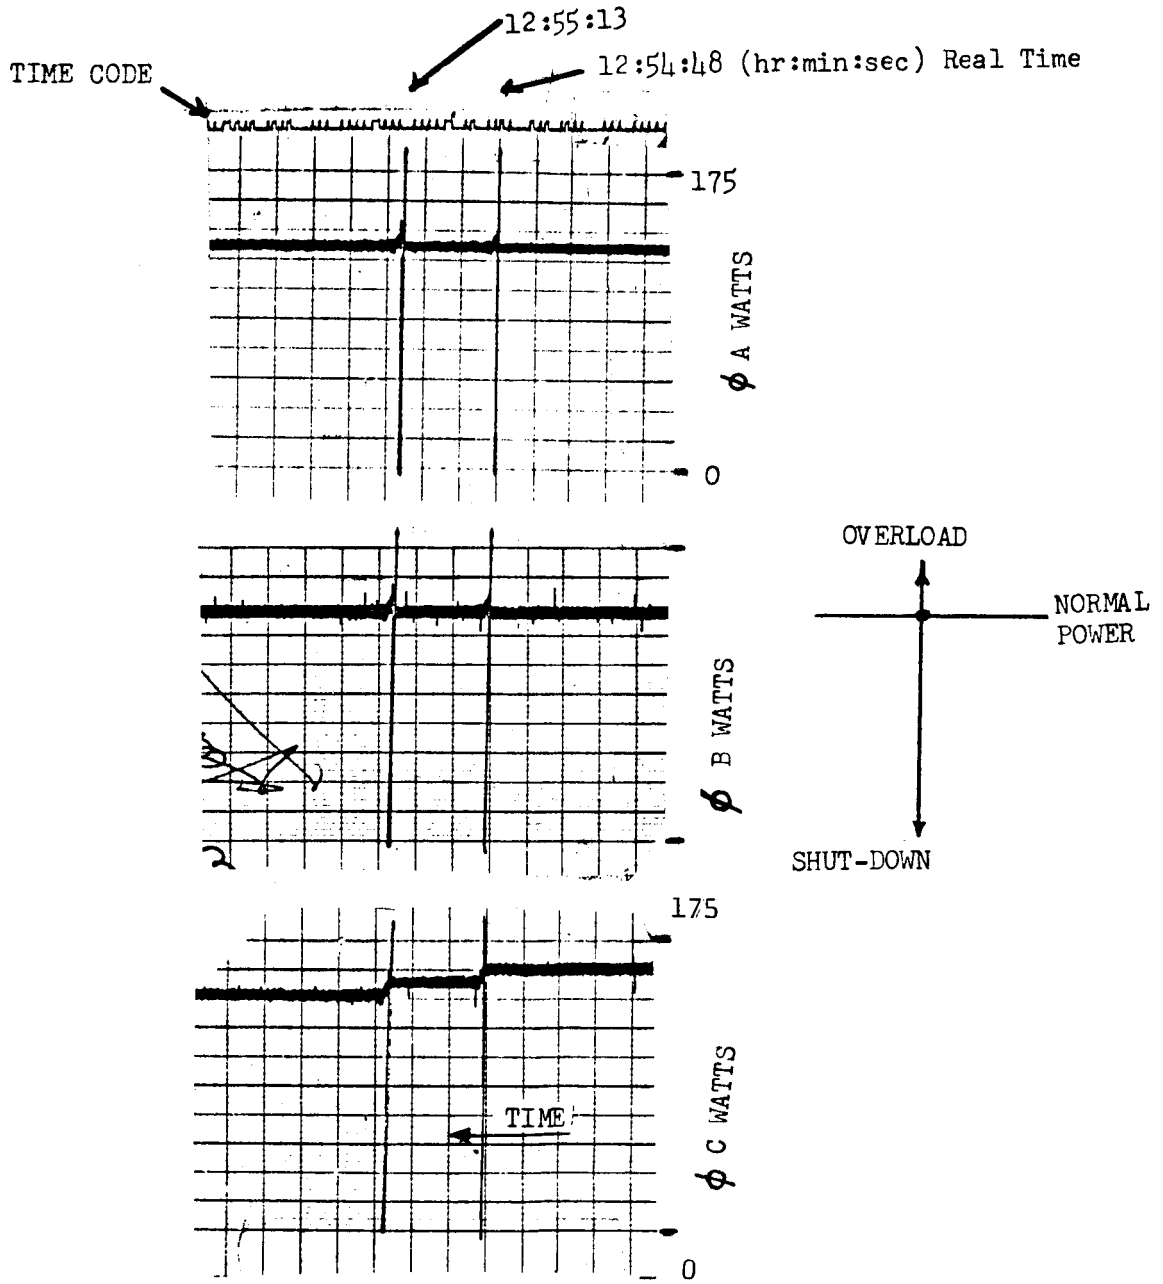
Data of output power (fig. 3) show that approximately 31 minutes after inverter start two overloads occurred 25 seconds apart in all 3 phases of inverter output. Also shown in figure 3, the inverter properly shut itself down with inverter output power dropping to zero after each momentary overload. There were no apparent detrimental effects on the inverter operation from these occurrences because the inverter continued to operate normally for an additional 48 minutes before the final failure occurred.

Figure 3. - Inverter output power showing three phase overload and inverter shutdown.

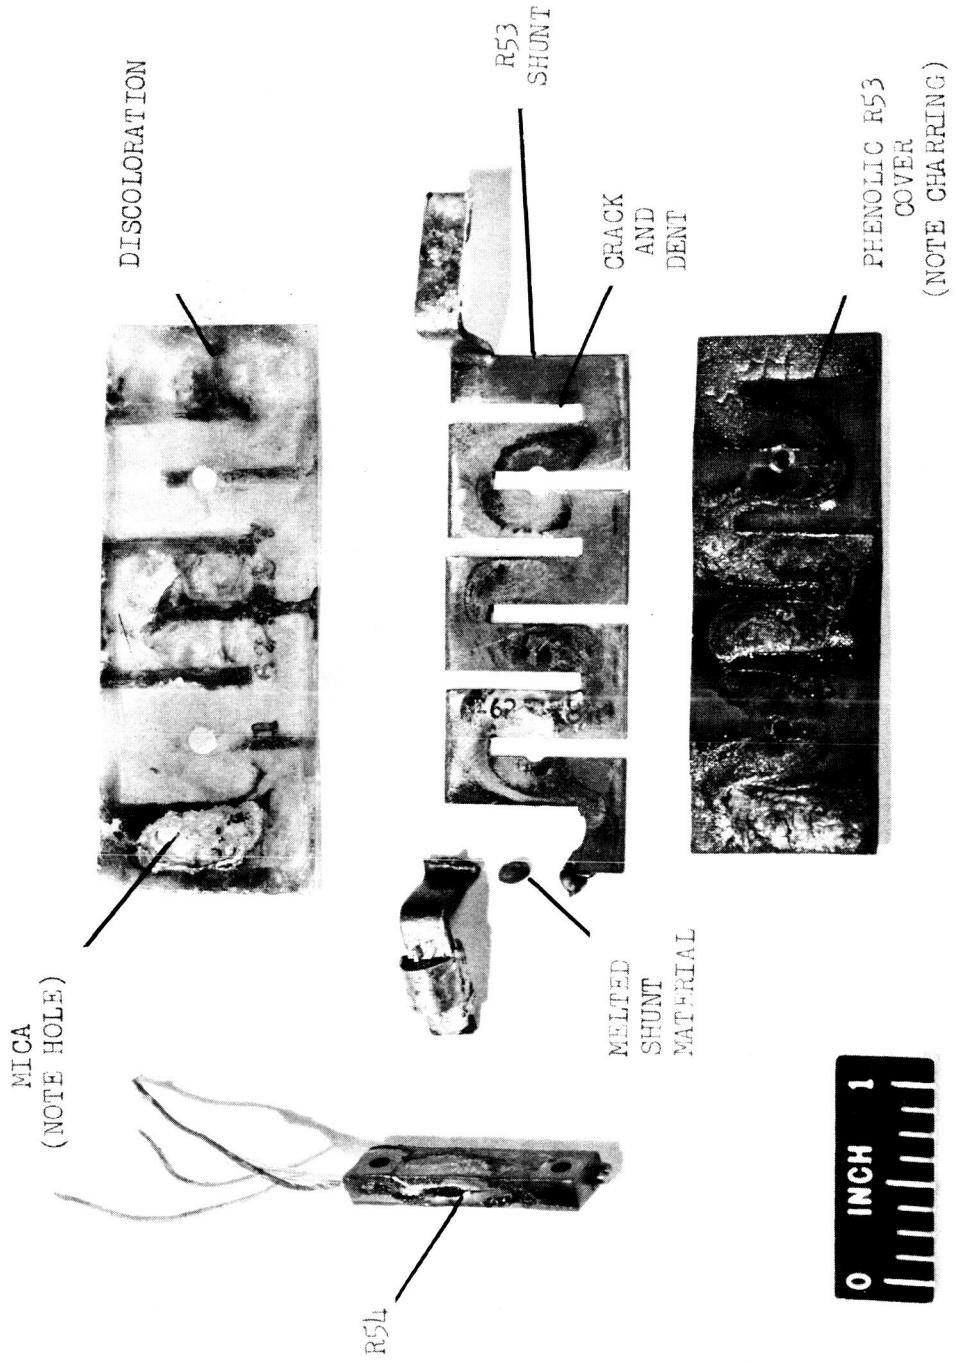
Subsequent inspection revealed that the inverter failure was the result of the overload sensing shunt melting open (fig. 5). Further examination of the inverter also revealed that the overload adjustment potentiometer R54 and resistor R55 (fig. 2) were damaged by excessive current. Replacement of these three components restored the inverter to operational condition.

The failed inverter components are shown in figure 5. The mica (3 mil measured thickness) that insulates R53 from electrical

ground is shown with a hole burned through as a result of the arcing.

Shunt.- In the failed inverter (serial number-25), R53 had other defects at time of installation (determined during the failure analysis). A crack was noted next to an area which was dented toward the surface facing the mica in one sector of the shunt (figs. 5 and 8 (a) and (b)). The discoloration on the mating mica surface indicates lack of contact between the mica and the shunt near this dented area (the discoloration is caused by condensation of gases from the charred phenolic shunt cover insulator).

Shunt cover.- A nearly uniform charring of the R53 phenolic shunt cover, probably due to sustained overheating during previous tests or by heat conducted along the shunt during the arcing period, is also shown in figure 5. If the heating had resulted only from the final failure, this would probably have resulted in much greater charring toward the end where the shunt melted. The R53 phenolic cover was warped and charred to the degree that non-uniform cooling was effected and the part was not adequately performing its function.

Figure 5. - Inverter failed components.

Special care must be taken in manufacture and inspection to see that the shunt is free of all burrs, chips, dents, cracks, etc. and that other foreign matter does not get imbedded between the mica insulator and the shunt for the heat sink.

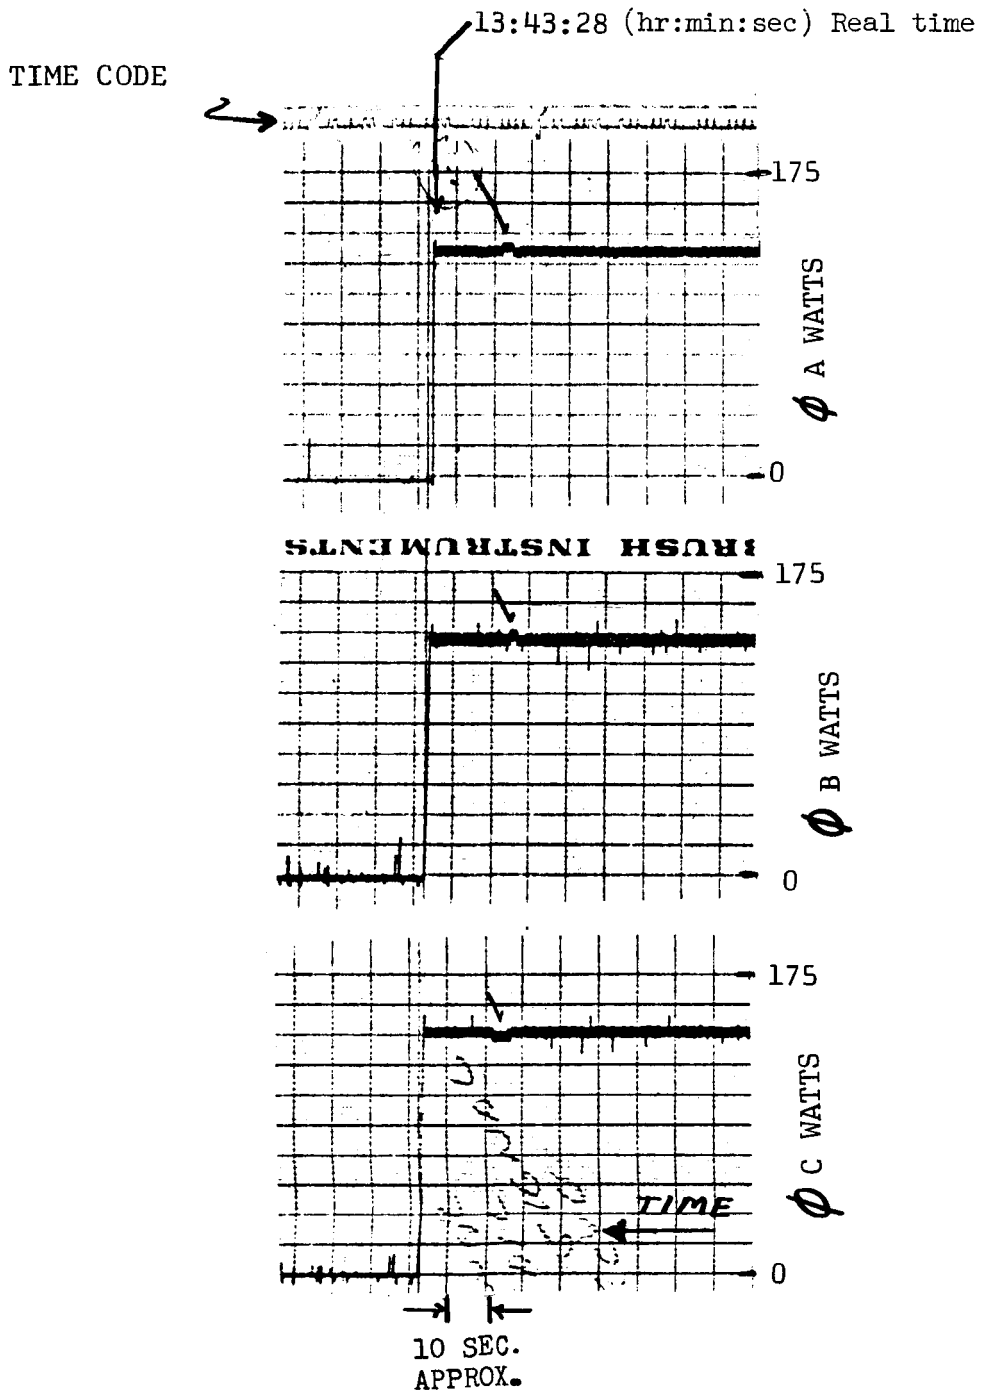
Subject test inverter.- The data indicates that at the time of the final malfunction, output power fell to zero (fig. 6) at the same instant that a high input current excursion above 40 amps began (fig. 7). The high input current condition continued for approximately 9 seconds. The input voltage dropped to 14 volts during this period. Referring to inverter power circuit (fig. 2) it should be noted that a short circuit to ground of the overload sensing shunt would draw excess current through the facility metering shunt even with zero inverter output. The input current was limited by facility line resistance to below the 200 amperes required to trip the facility protective breaker. The arcing was sustained for 9 seconds until a section of the shunt material was consumed and input voltage returned to no-load value.

Figure 6. - Three phases, output power at time of inverter failure.

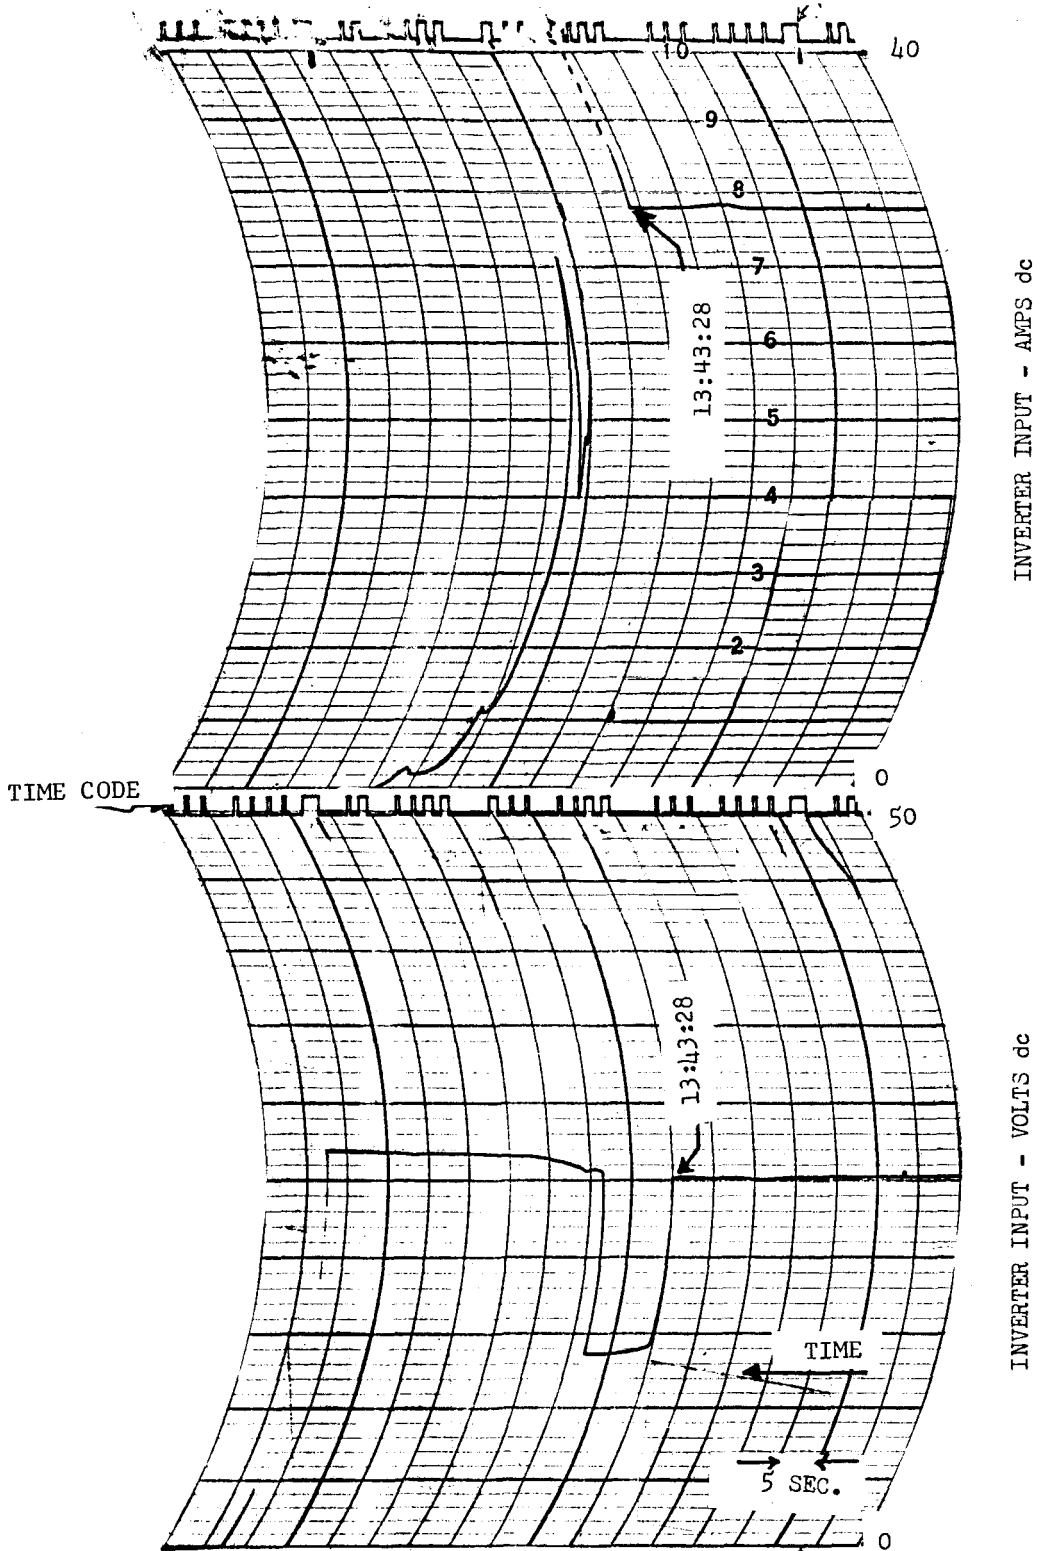
Figure 7. - Input current and voltage of inverter at time of failure.

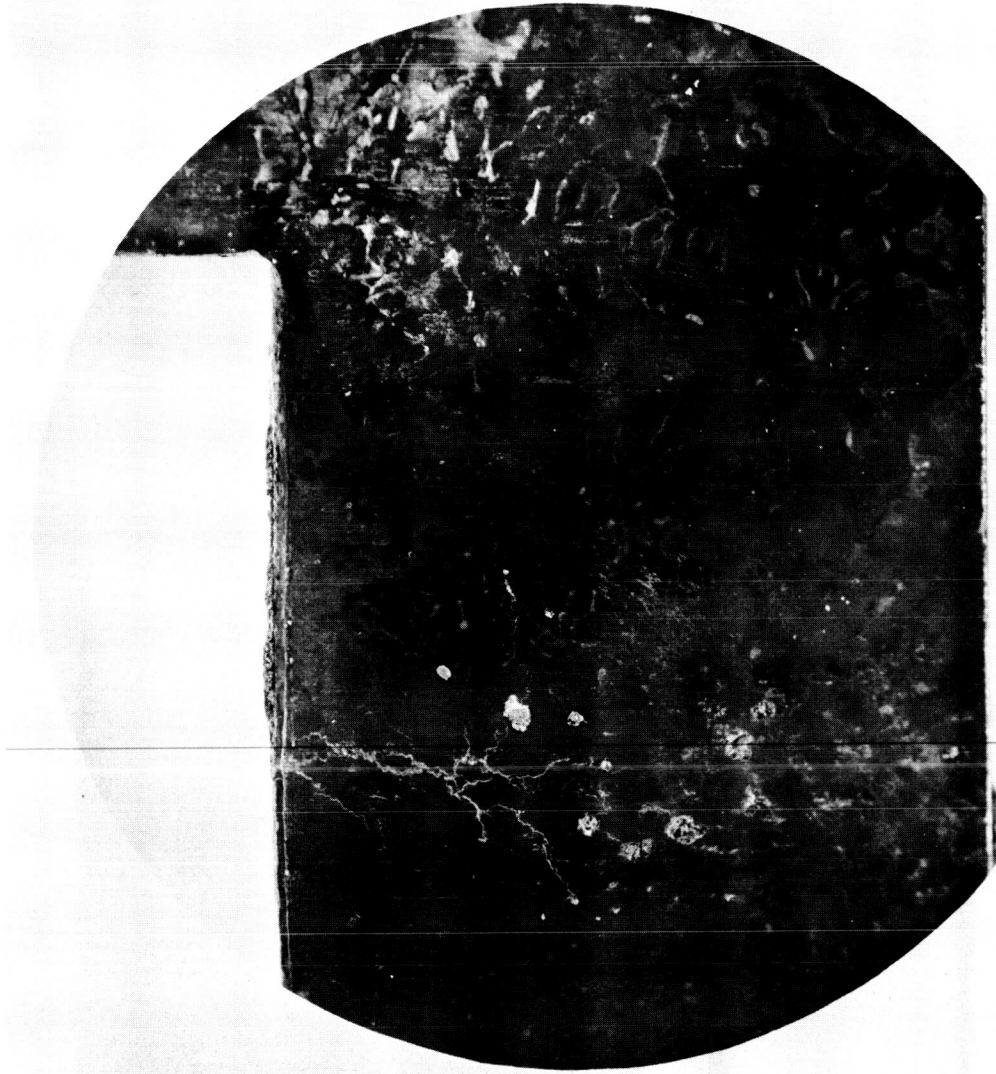
Metal particles detected on another section of the failed shunt but not directly related to the failure are shown in figure 8 (a) and (b). It is quite likely that such a particle may have been located at the failed area. Due to relative motion between the shunt, the mica, and the heat sink, (caused by cyclic heating and cooling of the inverter in various tests), the particle could have finally worn through the mica, causing shorting and arcing to ground. It was also noted during inspection that the lead at the failed end of shunt R53 was relatively rigid and had been flexed for installation which induced stress at the terminal of the shunt. This heavy, long lead also was unsupported, which would allow stress to be induced by vibration, under some conditions.

Figure 8(b). - 15X magnification of same area of figure 8(a) showing cracked area and high point material.

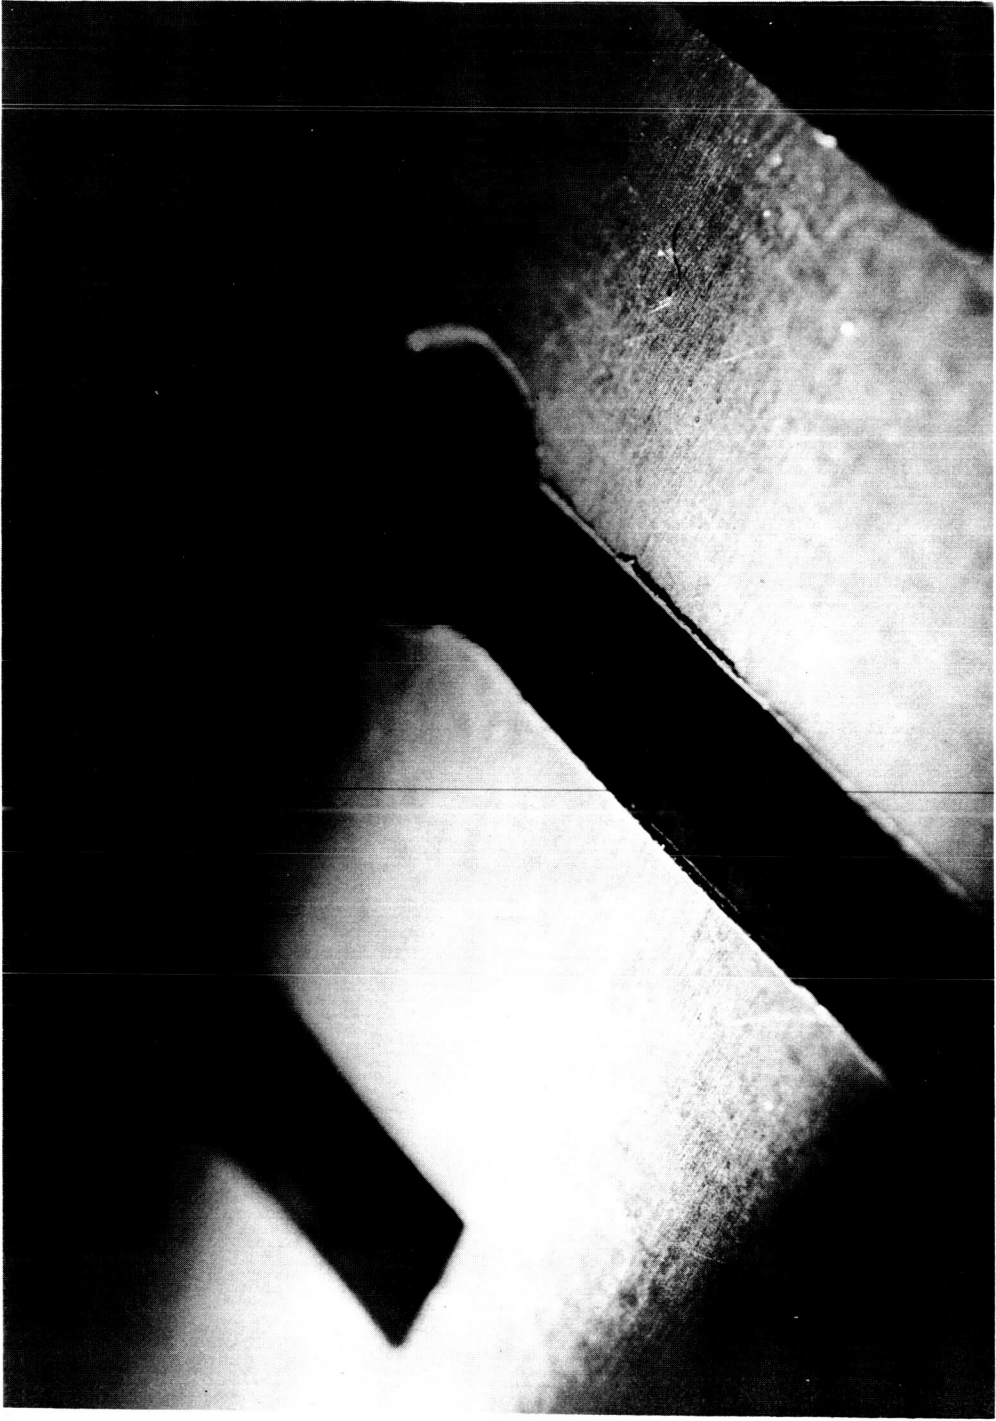
Other inverter shunts.- The fact that the foreign matter was common to the shunts of some other inverters is indicated by several additional cases of R53 failures both at LeRC and in the field. During the assembly of the replacement parts into the failed inverter at Lewis, a piece of foreign matter caused a short to ground through a 5-mil-thick mica insulator. Later examination showed this shunt to have burrs around nearly all cutouts. One of the typical burrs is clearly evident in figure 9. Further microscopic investigation showed that very small metal chips are imbedded in the shunt material itself, especially around the mounting holes (fig. 10).

Figure 9. - 10X magnification of R53 showing raised burr along edge of shunt.

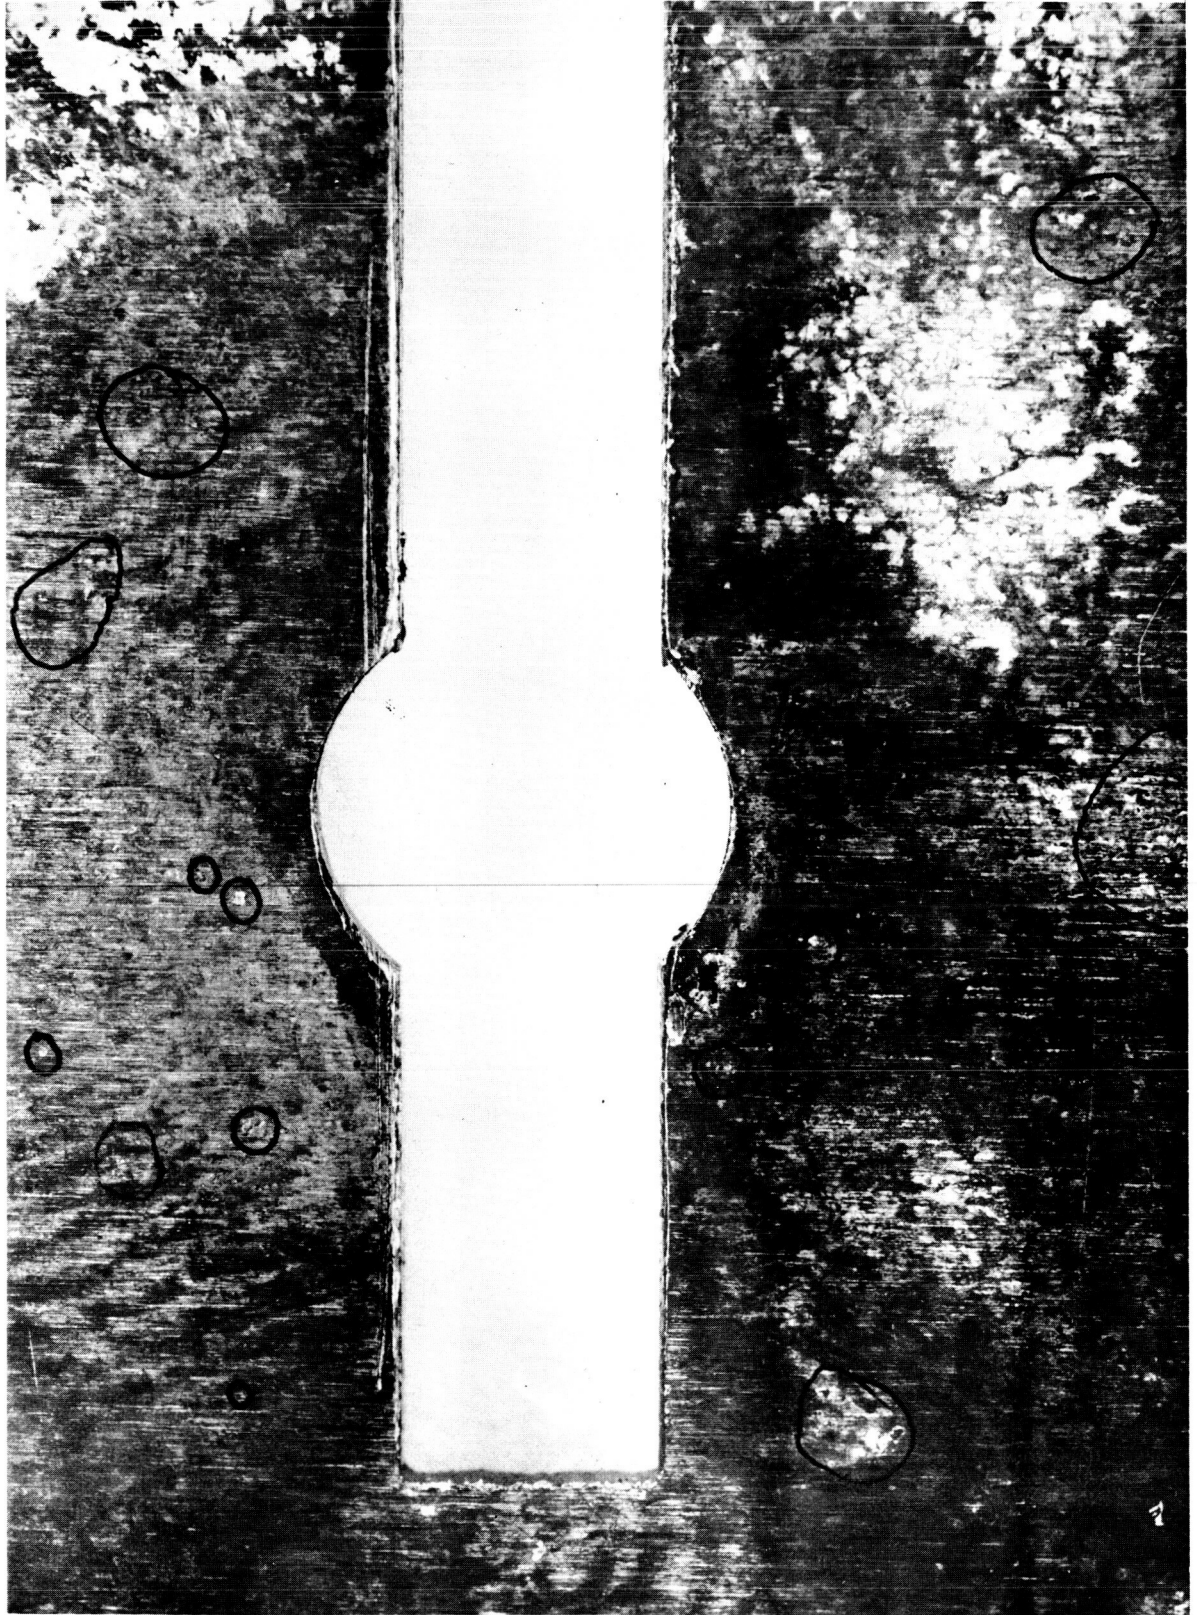
Figure 10. - 10X view of portion of shunt showing small metal chips in area of mounting hole.

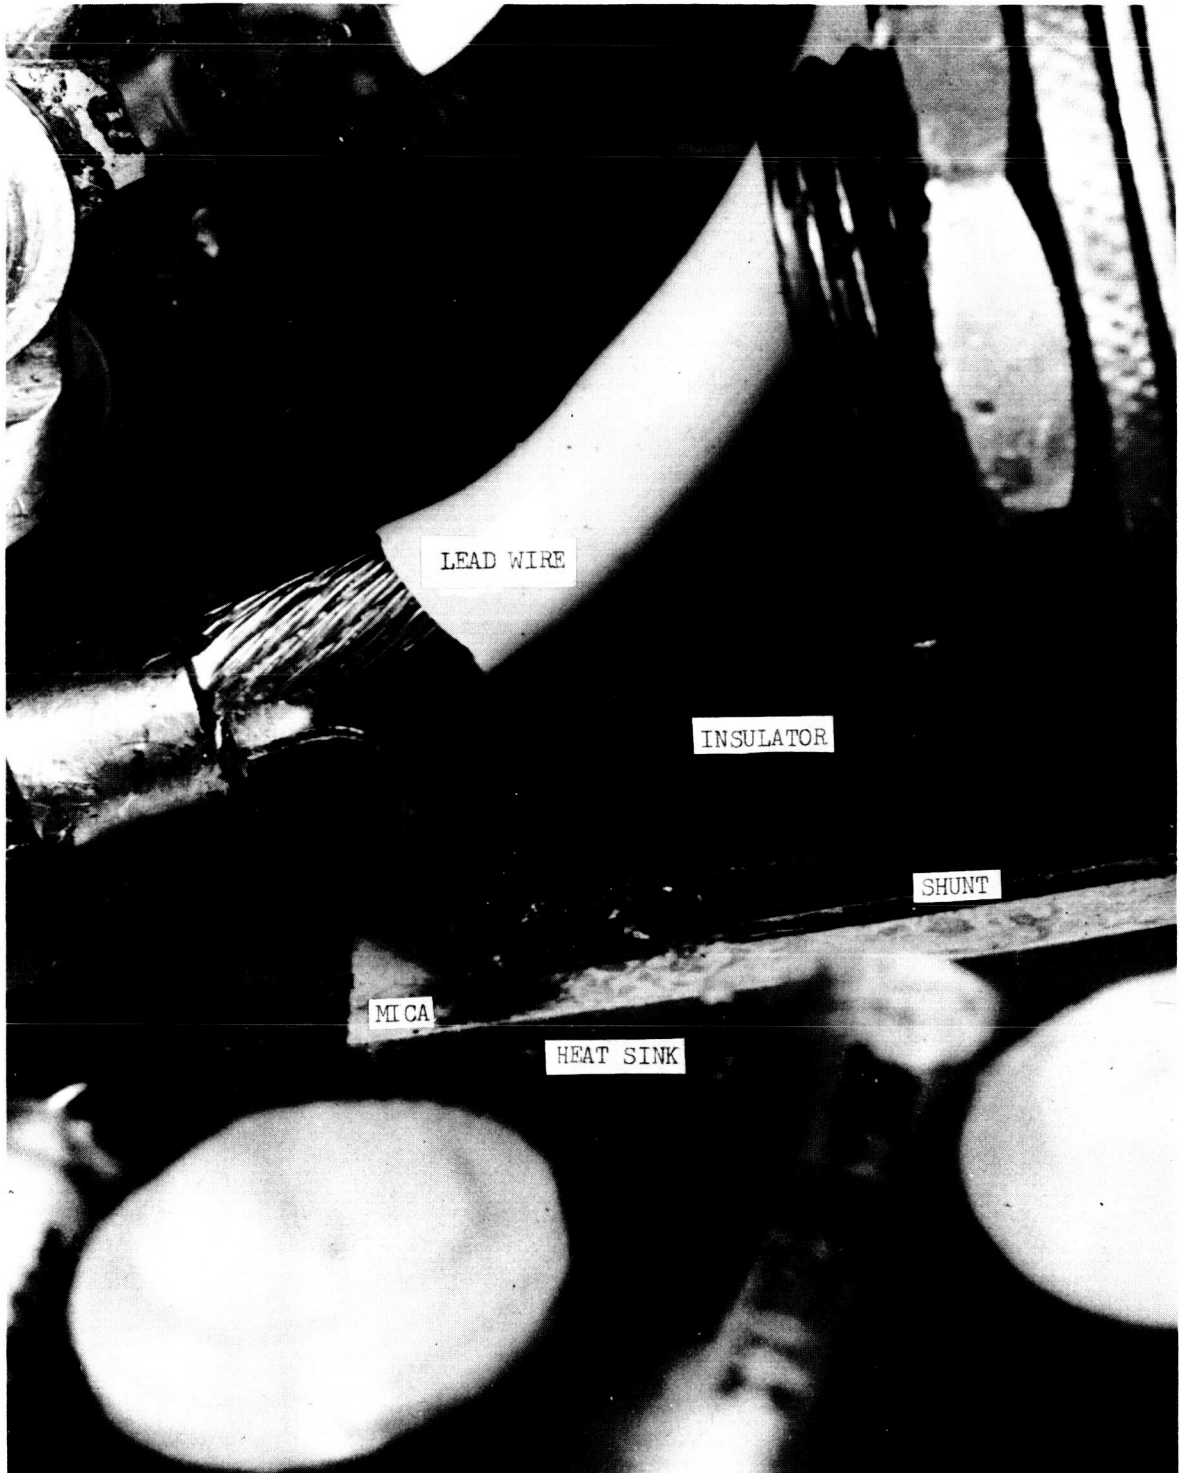
In a field case (failure analysis of inverter serial number 29, on April 9, 1965 at Convair) a burr on the shunt was found to have worked through the 2-mil-thick mica insulator. As a result of this failure, the 2-mil insulator was replaced with a 5-mil insulator on succeeding inverters. This failure is shown still assembled in figure 11.

Figure 11. - Failure of inverter shunt by shorting to the heat sink (ground).
