Soils and Foundations

Damage to railway earth structures and foundations caused by the 2011 off the Pacific Coast of Tohoku Earthquake

Junichi Koseki^{a,*}, Masayuki Koda^b, Shinji Matsuo^c, Hideaki Takasaki^c, Torajiro Fujiwara^c

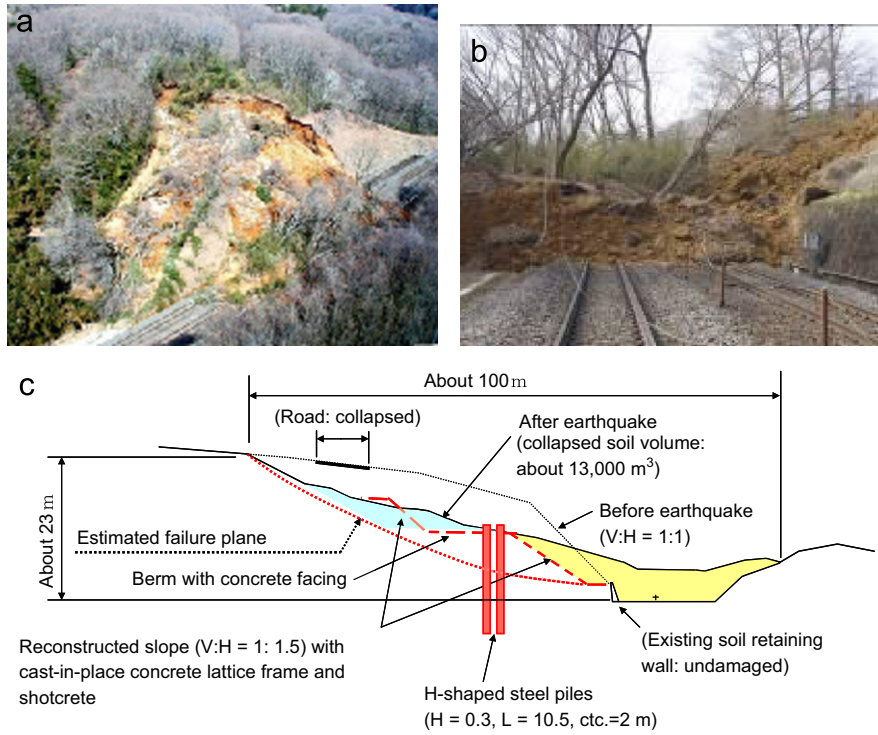
Fig. 2(a) shows the collapse of a cut slope (V:H=1:1) along the JR Tohoku Line, located at 179k100m between Toyohara and Shirasaka Stations. It had a maximum height of about 23 m, and consisted of volcanic ash-origin soil called loam. Several boring surveys, conducted after the earthquake, have revealed that this soil layer exhibits typical SPT-N values of 2–4. As shown in Fig. 2(b), the collapsed soil fully covered the railway track, while the masonry soil-retaining wall that had been constructed at the toe of the cut slope was found intact.

In contrast, cut slopes in the adjacent areas consisting of the same soil type, which had a maximum height of 14 m, were found to have survived the earthquake. The apparent cohesion of this type of soil, mobilized by the suction effect under partially saturated conditions, may not have provided sufficient resistance against the earthquake load exerted on

Fig. 2. (a) and (b) Collapse of cut slope along JR Tohoku line at 179k100m between Toyohara and Shirasaka stations and (c) its reconstruction.

the failed slope, while it may have been sufficient to support the other lower slopes.

As shown in Fig. 2(c), the failed slope was reconstructed into a more gentle slope (V:H=1:1.5), which was covered with a cast-in-place concrete lattice frame and shotcrete. H-shaped steel piles were imbedded to increase the resistance to sliding failures.

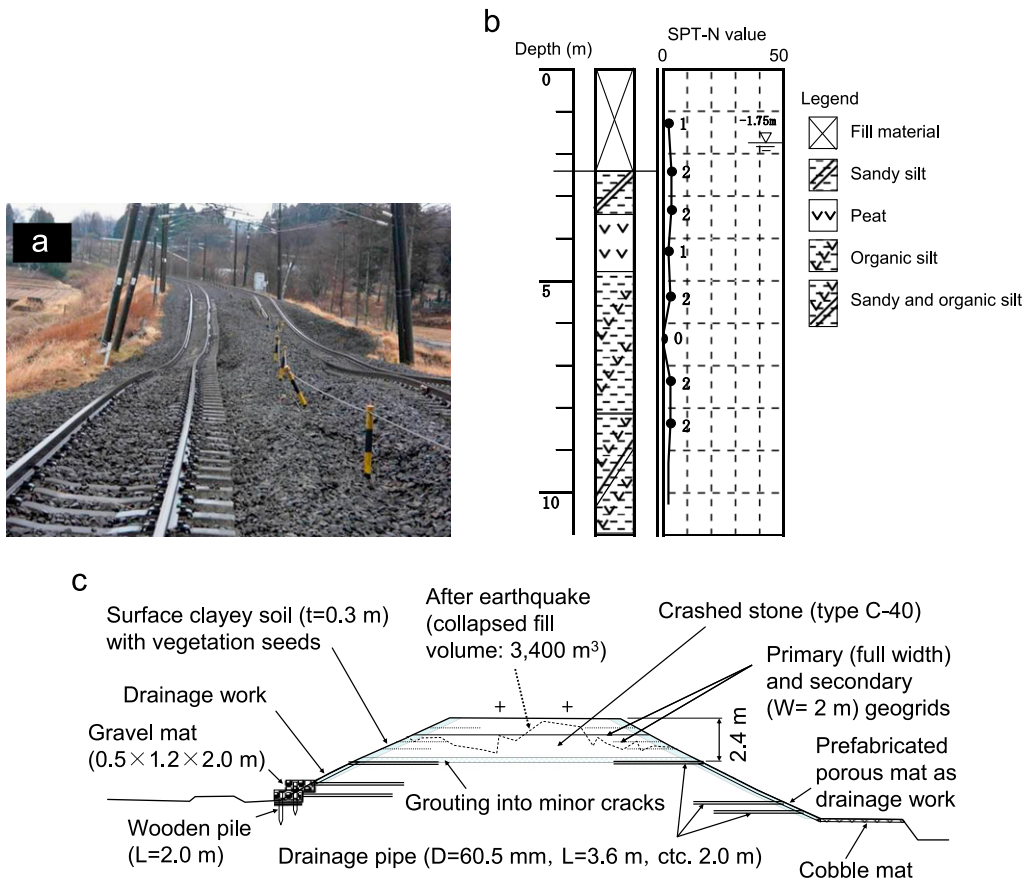
Fig. 3. (a) Excessive settlement of embankment along JR Tohoku line at 200k400m between Izumizaki and Yabuki stations, (b) results from boring survey conducted after earthquake and (c) its reconstruction.

As shown in Fig. 3(c), the failed embankment was reconstructed into a reinforced embankment having the same dimensions as the one before the failure, with a slope of V:H=1:1.6 to 1:2.2. For the fill material, a gravelly soil consisting of crushed sand and/or volcanic stone particles was used, which was well compacted and reinforced by geogrids inserted at a vertical spacing of 30 cm. Full-width geogrids are used as primary reinforcements, while shorter and weaker geogrids with a width of 2 m are used as secondary reinforcements. The drainage capacity was also enhanced by using horizontal drainage pipes in the fill and gravel mats at the toe of the fill.

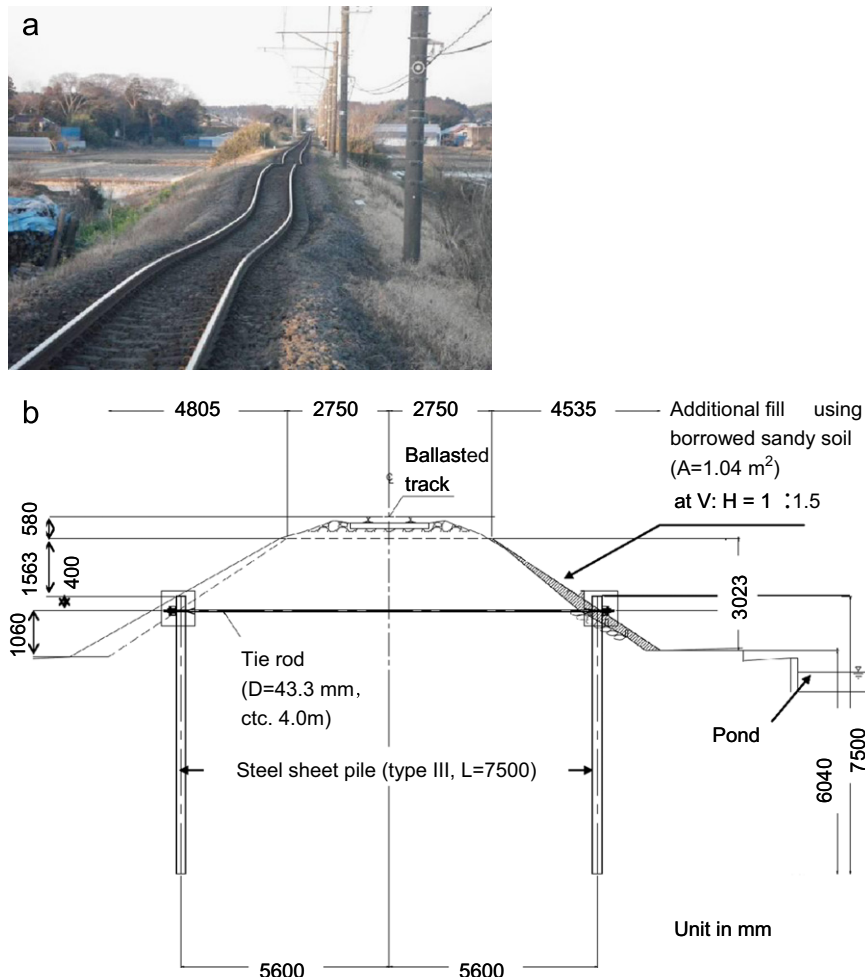
Fig. 4(a) shows the excessive settlement of an embankment along the JR Narita Line, which was located at 25k500m between Aziki and Kobayashi Stations. It had a height of about 3 m and was filled on sandy subsoil layers in a lowland area. After the earthquake, sand boiling from the subsoil level was observed at the level ground adjacent to the embankment. Therefore, the occurrence of liquefaction in the subsoil would have been the major cause of the excessive settlement of the embankment.

Fig. 4. (a) Excessive settlement of embankment along JR Narita line at 25k500m between Aziki and Kobayashi stations and (b) its reconstruction.

As shown in Fig. 4(b), the failed embankment was reconstructed into an unreinforced embankment, having dimensions which are similar to those before the failure, with a slope of V:H=1:1.5. A pair of steel sheet piles, connected to each other at the top with a tie rod, was imbedded at the toe of the embankment. This measure is expected to prevent the possible deformation of the subsoil layers which may again liquefy during future earthquake-related events.

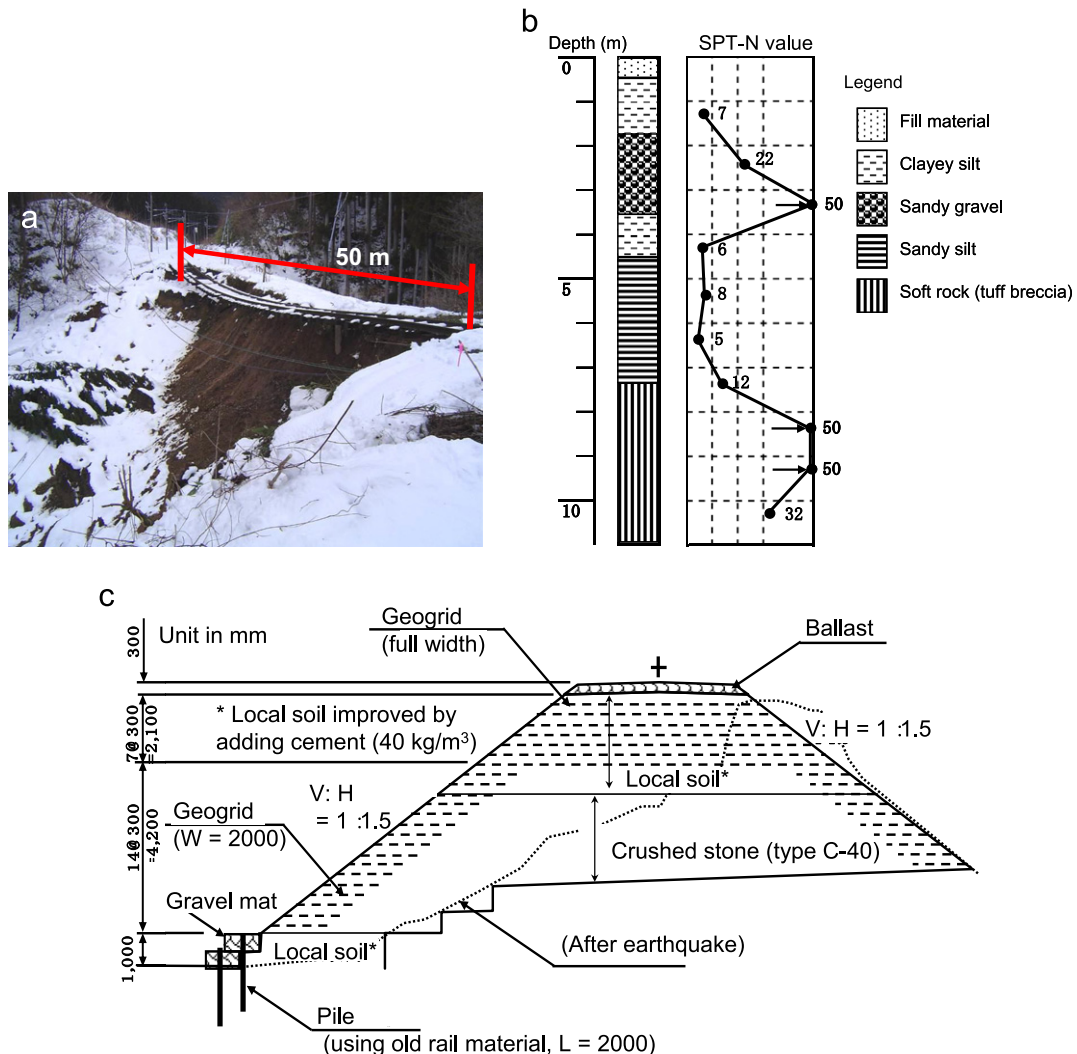
Fig. 5(a) shows the collapse of an embankment along the JR Senzan Line, which was located at 30k300m between Sakunami and Yatsumori Stations. It had a maximum height of about 10 m and was constructed by filling a valley in a mountainous area. The results from a boring survey, conducted after the earthquake to reveal the subsoil conditions, are shown in Fig. 5(b). The subsoil layers consisted of clayey and sandy silts, sandy gravel and soft rock. In particular, the soft rock was tuffaceous, occasionally sandwiching highly weathered clayey zones.

Due to the earthquake, the embankment suffered from sliding failure, which resulted in the loss of the top of the railway track. The collapsed soil at its toe part was found to

be very soft, namely, consisting of a clayey material with high water content. It was reported that during the reconstruction work, some local groundwater escaped from one of the side surfaces of the failure plane at its middle height. Based on these observations, it may be inferred that the fill originally consisted of crushed mud–stone particles, which had been brought from a nearby tunnel excavation site, while a part of the fill had been deteriorated by slaking partially due to the supply of groundwater. Future investigations are required on the details of the local ground conditions, including the state of the groundwater, especially during and after heavy rainfall events.

Fig. 5. (a) Collapse of embankment along JR Senzan line at 30k300m between Sakunami and Yatsumori stations, (b) results from boring survey conducted at the toe of embankment after earthquake and (c) its reconstruction.

As shown in Fig. 5(c), the failed embankment was reconstructed into a reinforced embankment having dimensions which are similar to the ones present before the failure, with a slope of V:H=1:1.5. The lower part of the embankment is filled using a gravelly soil, consisting of crushed sand stone particles, with 2-m-wide geogrids as the secondary reinforcement. In order to reduce the use of gravelly soil, which requires long-distance transportation, the upper part is filled using a cement-treated soil, which is

available nearby. The upper part is further combined with full-width geogrids as the primary reinforcement. The drainage capacity was also enhanced by placing gravel mats at the toe of the fill on the downstream side of the valley.

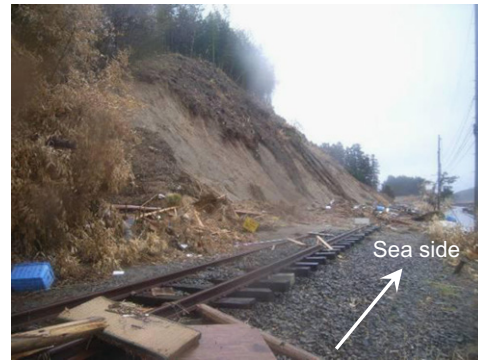
Fig. 6 shows the tsunami-induced damage to a cut slope along the JR Ofunato Line, which was located at 89k900m between Wakinosawa and Otomo Stations. The slope surface suffered from a shallow slide for a longitudinal length of about 100 m, among which shotcrete covering had been made for about 20 m.

Fig. 6. Tsunami-induced damage to cut slope along JR Ofunato line at 89k900m between Wakinosawa and Otomo stations.

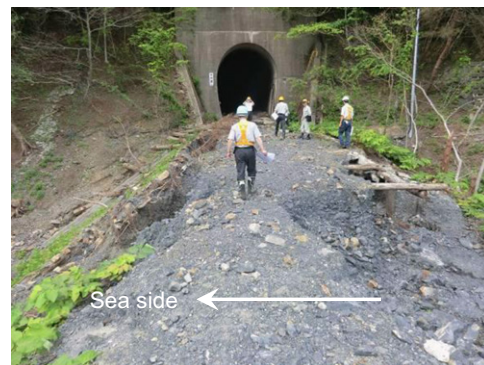
Fig. 7 shows the tsunami-induced damage to an embankment along the North Rias Line of the Sanriku Railway, which was located adjacent to the Hiraiga Tunnel between Shimanokoshi and Tanohata Stations. The overflow of the tsunami caused severe erosion of the ballasted track and the fill body. Similar damage patterns were observed at many other embankments, including railway stations constructed on embankments, as shown in Fig. 8.

Fig. 7. Tsunami-induced damage to embankment along North Rias line of Sanriku Railway between Shimanokoshi and Tanohata stations (adjacent to Hiraiga tunnel).

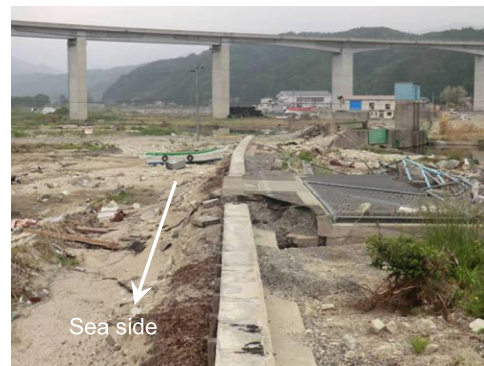
Fig. 8. Tsunami-induced damage to Orikasa station on embankment along JR Yamada line.

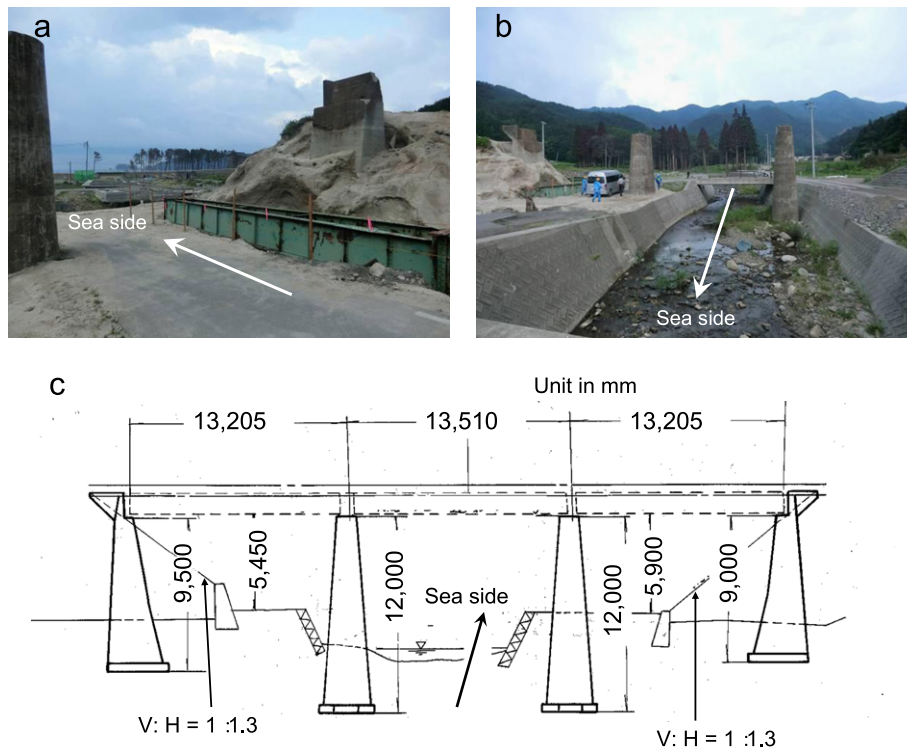
Fig. 9(a) and (b) show the tsunami-induced damage to the backfill soil of a bridge abutment along the JR Yamada Line, which was located adjacent to Namiita-kaigan Station. In addition to the washing away of the bridge girders, the overflow of the tsunami caused severe scoring around the abutment body. As shown in Fig. 9(c), the top of the backfill soil of the abutment and that of the bridge girders were located at a height of about 6 m above the ground level.

Fig. 9. (a) and (b) Tsunami-induced damage to backfill soil of Namiita-gawa bridge abutment along JR Yamada line near Namiita-Kaigan station and (c) original cross-section.

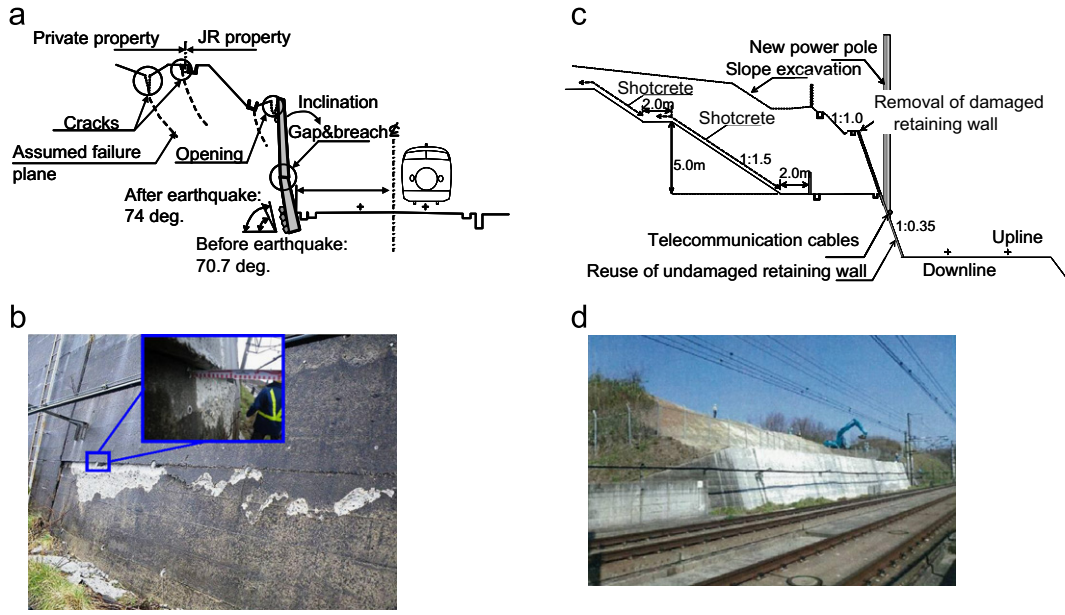
The above damage was possibly affected by the fact that the wall was relatively high, namely, about 7.4 m excluding the embedment. It can be inferred that the earthquake responses of the wall and the cut slope may have been different from each other, inducing an accumulation of the

opening at the wall top and the breach of the wall body, which was accompanied by the formation of several cracks in the original ground behind the wall, as shown in Fig. 11(a).

Fig. 11. (a) and (b) Inclination and breach of retaining wall along JR Tohoku Shinkansen line at 345k642m between Sendai and Furukawa stations and (c) and (d) its restoration (after East Japan Railway Company, 2011).

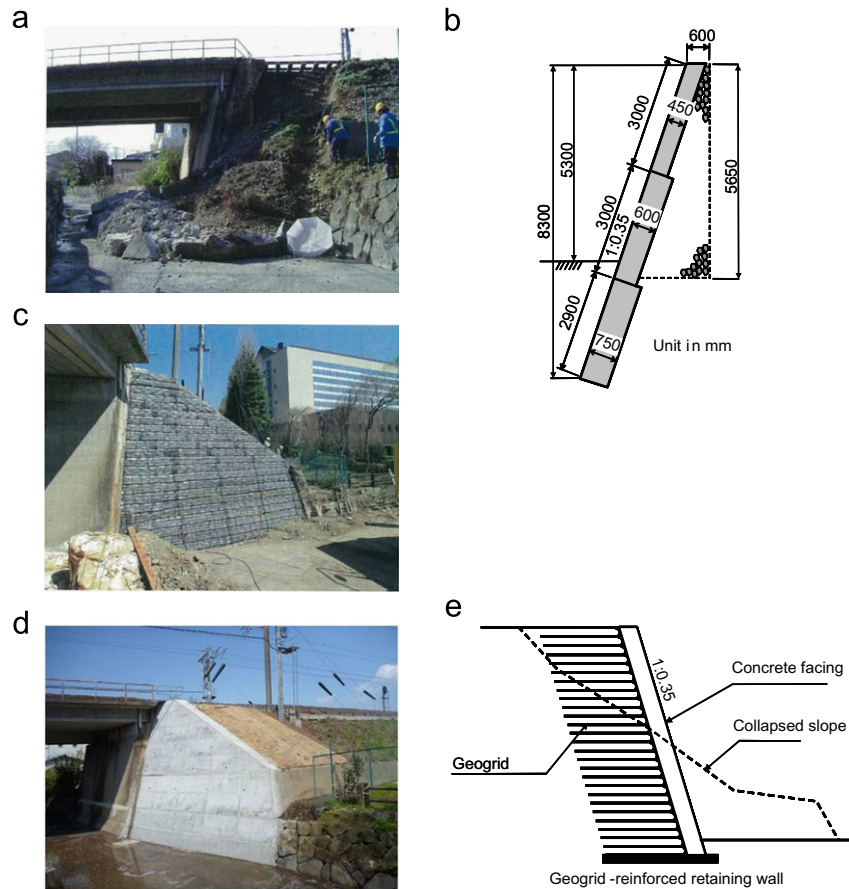
Fig. 12(a) shows a damaged retaining wall, which is located at the Shichigobori Bridge abutment along the JR East Tohoku Kamotsu Line at 350k047m between Nagamachi and Sendai Cargo Terminal Stations (East Japan Railway Company, 2011). A water channel existed in front of the wall, which had a height of 5.3 m from the base of the channel, as shown in Fig. 12(b). Both the wall and a part of the backfill soil collapsed due to the earthquake motion. The backfill consisted of sandy soil with gravel. The collapsed retaining wall was built with the bridge, and was one of four retaining walls on which no previous deformation had been recorded.

According to the records, there were some deformations and slides in the embankments around the bridge after the Miyagi-Ken-Oki Earthquake in 1978. Some drainage pipes (length of 3600 mm, outside diameter of 60.5 mm and interval spacing of 1000 mm) had been inserted into the embankment slope as countermeasures to increase both the drainage capacity and the shear strength of the embankments.

The above countermeasures seem to have acted effectively in reducing the extent of the damage to the embankments, which settled moderately by about 100 mm. On the other

hand, the wall and its backfill, beside the abutment, had been without any countermeasures, and thus, completely collapsed.

Fig. 12. (a) Collapse of retaining wall beside abutment of Shichigobori Bridge along JR Tohoku Kamotsu line at 350k047m between Nagamachi and Sendai cargo terminal stations, (b) its side view and (c), (d) and (e) its reconstruction by using geogrid-reinforced soil (after East Japan Railway Company, 2011).

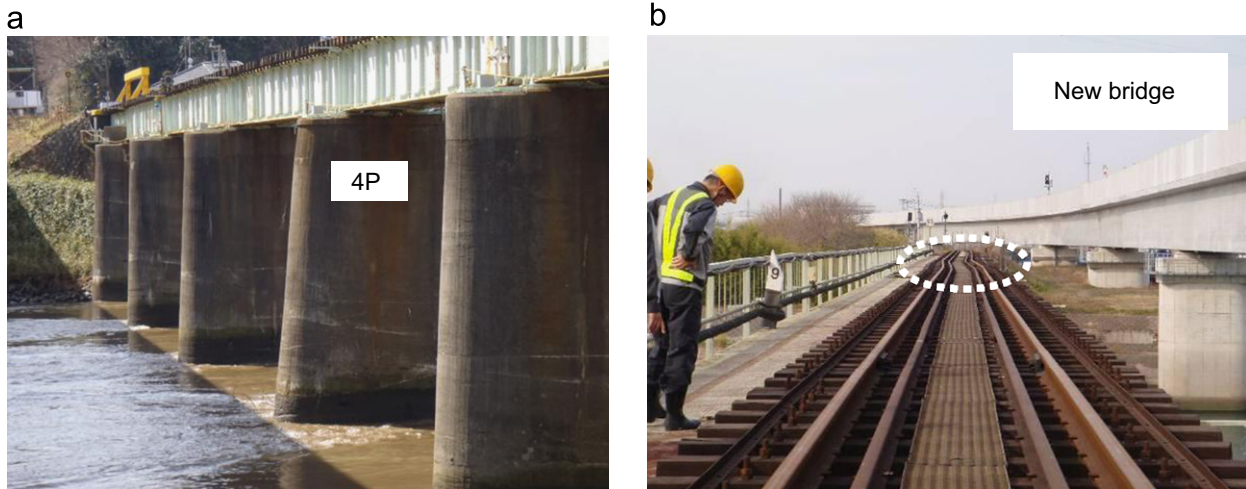
Fig. 13(a) shows the inclination and the settlement of Pier 4P, located at the Naka-gawa Bridge on the JR East Suigun Line at 0k956m between Mito and Hitachi-Aoyagi Stations. This pier was supported by a wooden pile foundation resting on subsoil layers consisting of 11.15-m-thick silt to fine sand layers with SPT-N values in the

Due to the earthquake, the foundation moved 200 mm horizontally and settled 50 mm down at the top of the pier (East Japan Railway Company, 2011). As shown in Fig. 13(b), track deformation occurred with the pier displacement.

Fig. 13. (a) Inclinometer and settlement of Pier no. 4 of Naka-gawa bridge along JR Suigin line at 0k956m between Mito and Hitachi-aoyagi stations and (b) rail track deformation on the bridge.

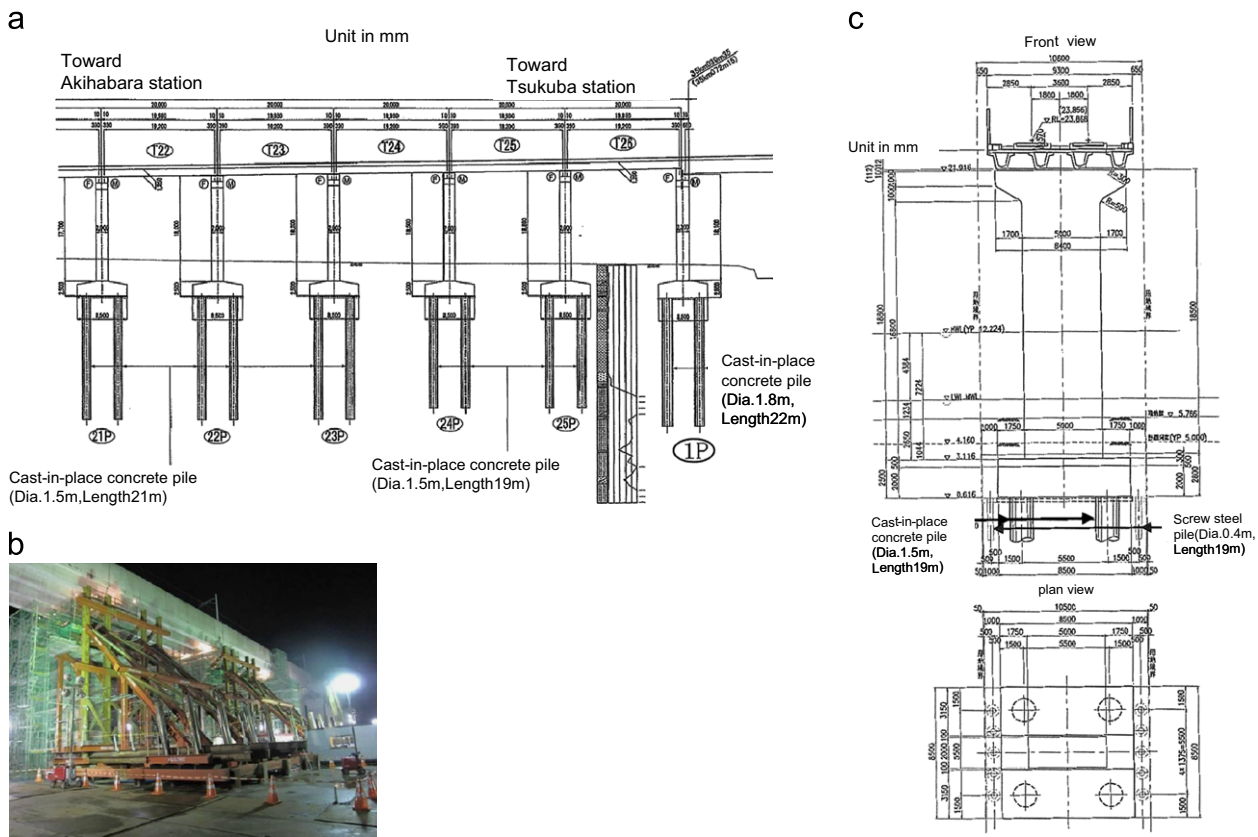
Fig. 14(a) shows a side view of the Tonegawa-higashi Viaduct near 35k000m between Kashiwatanaka and Moriya Stations on the Tsukuba Express Line. The movement at the track surface was a maximum of 151 mm on the top of Piers 24P and 25P (Iwamoto, 2011; Iwamoto and Yonezawa, 2012).

Table 5, a settlement of 80 mm and a lateral displacement of 132 mm occurred at the track surface at Pier 24P, and a settlement of 50 mm and a lateral displacement of 151 mm

Fig. 14. (a) Side view of Tonegawa-Higashi viaduct along Tsukuba express line near 35k00m between Kashiwatanaka and Moriya stations, (b) reaction frames for recovery work of their piers and (c) provisional work (after Iwamoto, 2011; Iwamoto and Yonezawa, 2012).

at Pier 25P. Although no confirmation could be made during the restoration work, it is estimated that, due to the earthquake motion, a clearance may have been formed around the pile, which caused a decrease in its bearing capacity in terms of both skin friction and tip resistance.

To reinforce the foundation, 10 screw piles with a diameter of 400 mm and a length of 19 m were imbedded beside Piers 23P, 24P and 25P and connected to the footing, as shown in Fig. 14(c). In doing so, some of the screw piles that had been employed to support the temporary reaction frame, mentioned above, were reused.

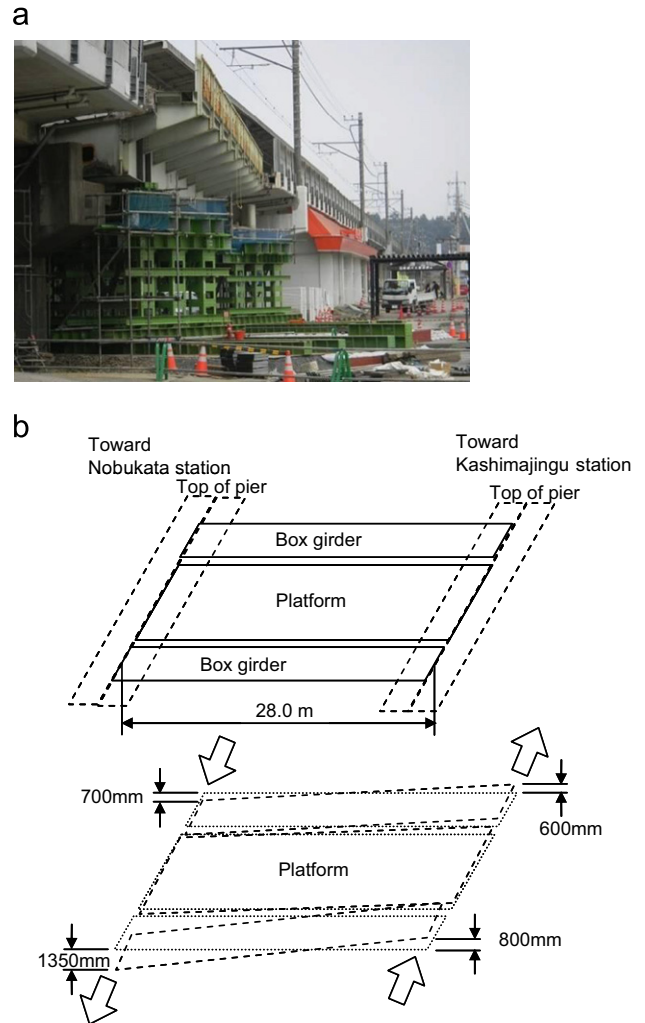
Fig. 15(a) shows the steel beam rotations of the Daiichi-Kyuchu Bridge on the JR East Kashima Line at 14k171m between Nobukata and Kashimajingu Stations. The bridge has 28-m-span steel beams with box sections (i.e., box girders). The piers have a skew angle of 60° with respect to the track line. They were supported by a pile foundation using pre-stressed concrete piles having a diameter of 40 cm and a length of 20–31 m. Between their footing and the supporting firm soil layers, with SPT-N values exceeding 50, there were subsoil layers consisting of about 3-m-thick fine sand layers with SPT-N values in the range of 4 to 15, about a 1-m-thick peat layer with an SPT-N value of 2, an approximately 16-m-thick clayey silt layer exhibiting SPT-N values of zero (i.e., the hammer settled down by its self-weight) and loose to medium-dense fine sand layers between which a 0.5-m-thick peat layer was sandwiched.

In general, the seismic response of the beams and the piers with a skew angle is asymmetric with respect to the track line, inducing a rotational excitation on a horizontal plane. As a result, the beam may suffer residual rotation. This seems to be the case with the above skewed bridge. Similar behavior was reported for road bridges in the 1995 Hyogo-ken Nanbu Earthquake.

Fig. 15. (a) and (b) Steel beam rotation of Daiichi-Kyuchu bridge along JR Kashima line at 14k171m between Nobukata and Kashimajingu stations.

During the restoration work, the beam was temporarily supported by a hydraulic jack and restored to its original position.

Devices to limit earthquake-induced displacement were installed at the top of the piers instead of side blocks.

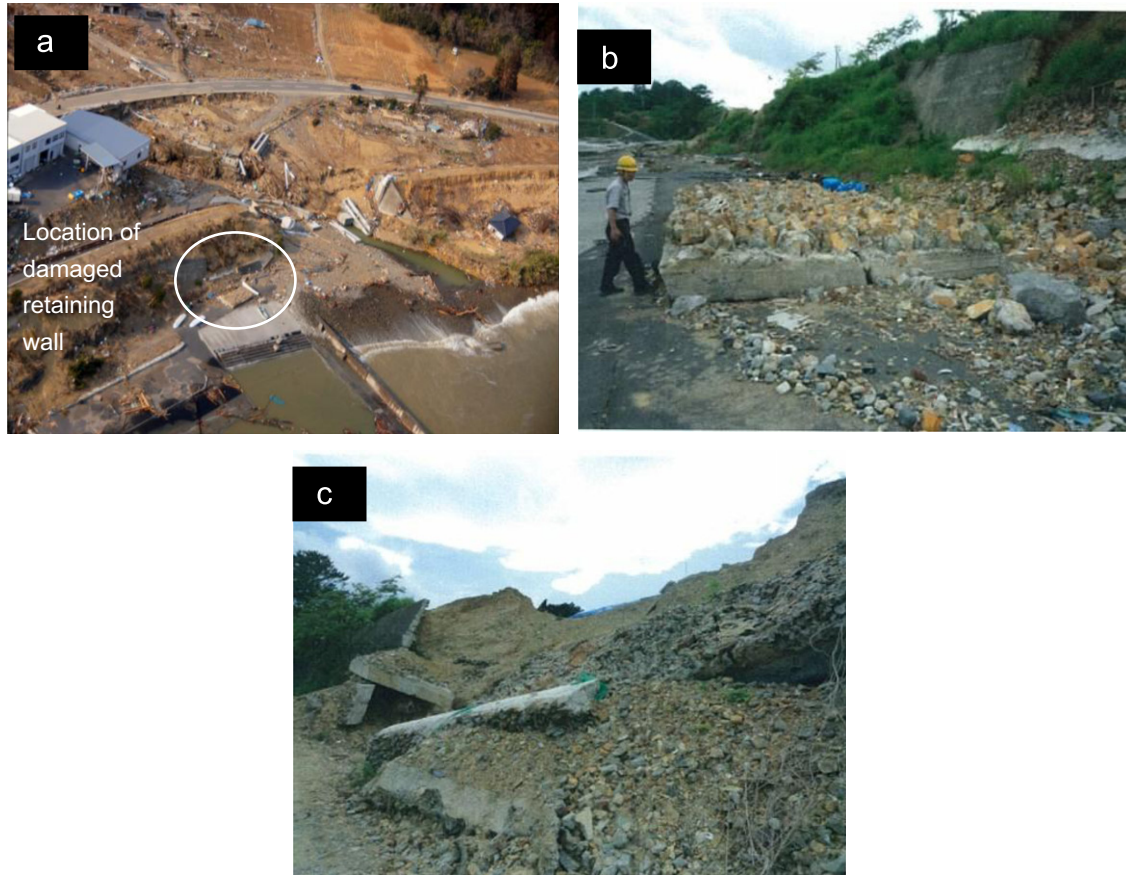
Fig. 19(a)–(c) show the tsunami-induced damage to the retaining wall beside the Ohsawa-gawa Bridge along the JR Kesennuma Line at 54k098m between Motoyoshi and Koganezawa Stations (East Japan Railway Company, 2011). The wall fell down to the seaside, and the backfill soil was eroded by the tsunami.

Fig. 19. (a), (b) and (c) Tsunami-induced damage to retaining wall beside Ohsawa-gawa bridge along JR Kesennuma line at 54k098m between Motoyoshi and Koganezawa stations.

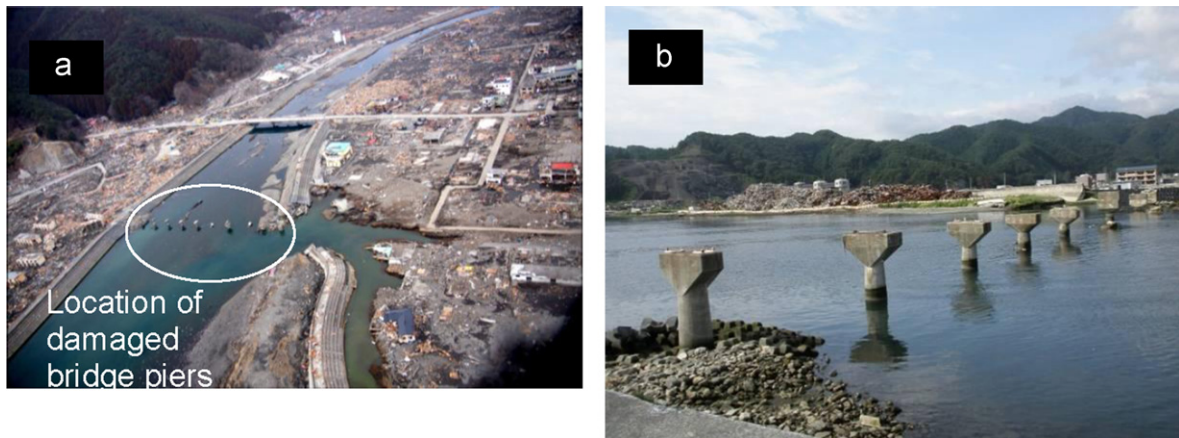
143k279m between Kirikiri and Ohtsuchi Stations (East Japan Railway Company, 2011). The Ohtsuchi-kawa Bridge had a total length of 375 m, consisting of 23 simple steel beams, 22 piers and 2 abutments. All of the steel beams

were washed away by the tsunami. Five piers, which had been on land, and two piers, which had been in the river, were also destroyed by the tsunami. The other piers suffered residual inclination into the upstream direction of the river.

Fig. 20. (a) and (b) Tsunami-induced damage to Ohtsuchi-kawa bridge on JR East Yamada line at 143k279m between Kirikiri and Ohtsuchi stations.

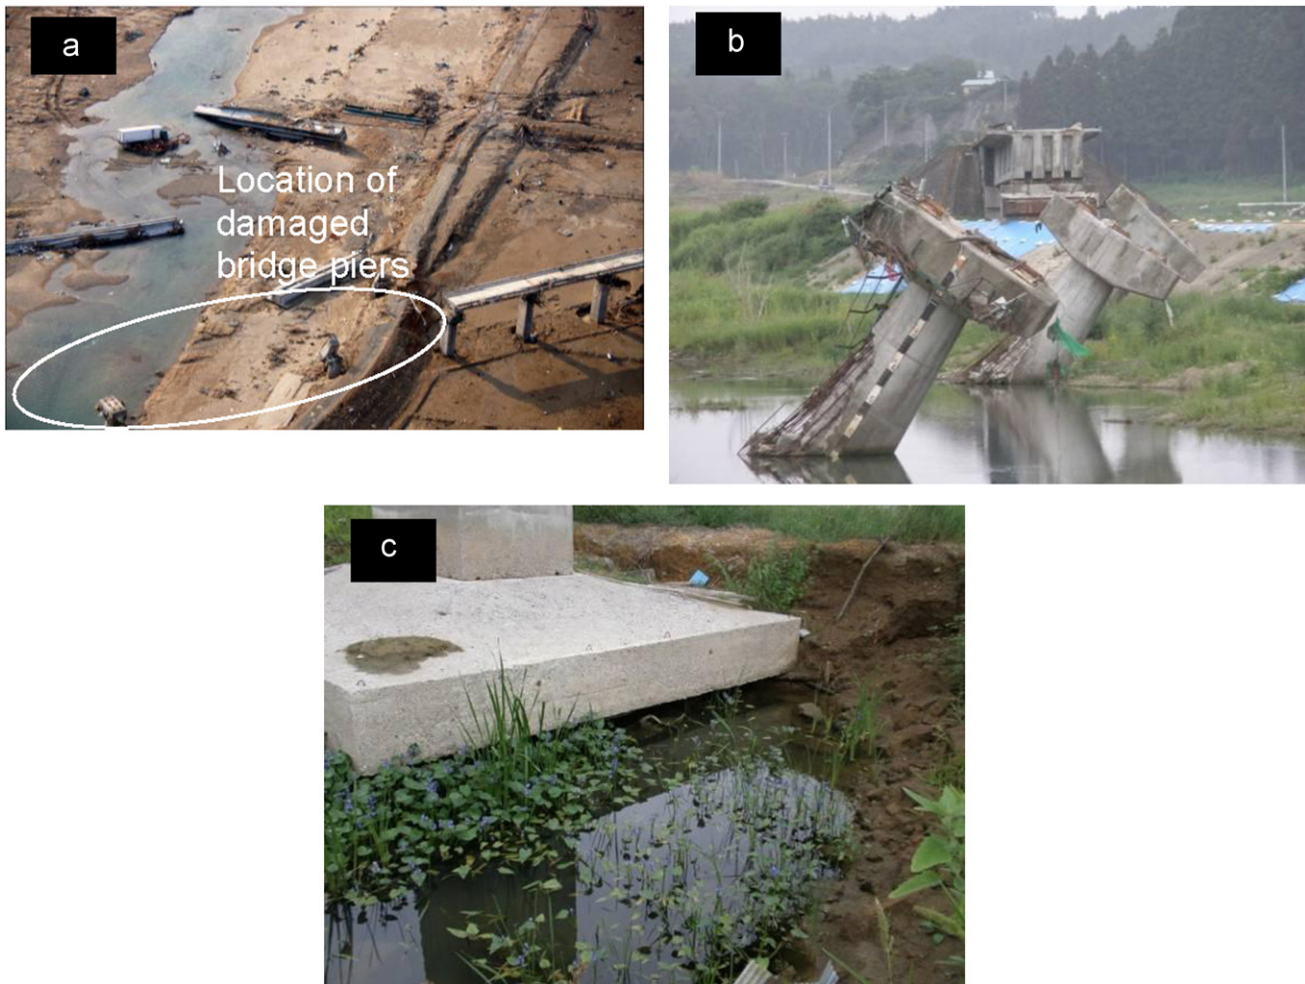
Fig. 21(a) and (b) show the tsunami-induced damage to the Tsuya-gawa Bridge along the JR Kesenuma Line at 50k099m between Rikuzenkoizumi and Motoyoshi Stations (East Japan Railway Company, 2011). The Tsuya-gawa Bridge is 462 m long in total, consisting of 6 pre-stressed concrete beams (PC beams) and 13 reinforced concrete simple beams (RC beams), 17 piers and 2 abutments. All the PC beams, having a length of 35 or 40 m, were severely cracked and washed away by the tsunami. In addition, four piers fell down due to the tsunami. Each of the piers had been reinforced by 48 steel bars with a nominal diameter of 29 mm, while some steel bars were torn down by the tsunami. The backfill soil of one of the abutments was washed away by the tsunami as well. Fig. 21(c) shows the foundation scouring of a pier in a river bed, where the maximum depth of scouring was about 1 m.

Fig. 21. (a), (b) and (c) Tsunami-induced damage to Tsuya-gawa bridge on JR East Kesenuma line at 50k099m between Rikuzenkoizumi and Motoyoshi stations.
