## Case study

# Failure analysis of tube-to-tubesheet welded joints in a shell-tube heat exchanger

Failure analysis was carried out on a tube-to-tubesheet welded joint of a shell-tube heat exchanger to confirm its failure mechanism. The collected evidence suggests that the failure of the tube-to-tubesheet welded joint was induced by fatigue. Under the morphology analysis, the fracture surface exhibit obvious fatigue crack propagation traces. Fatigue striations were observed clearly in the propagation zone. Detecting results showed that chemical composition and mechanical properties of the tubes was consistent with the standard requirements for the 304 stainless steel. The metallographic test showed that the microstructure of both the tube and tubesheet were normal. However, serious defects were found at the tube-to-tubesheet welded joint. The fatigue crack initiated from the defects at the tube-to-tubesheet welded joint. The periodic load might come from the resonant vibration of the tube or the changes in temperature and pressure of the fluid inside the heat exchanger. Bad welding and unsuitable expansion position of the tubes at the tube-to-tubesheet might give rise to the form

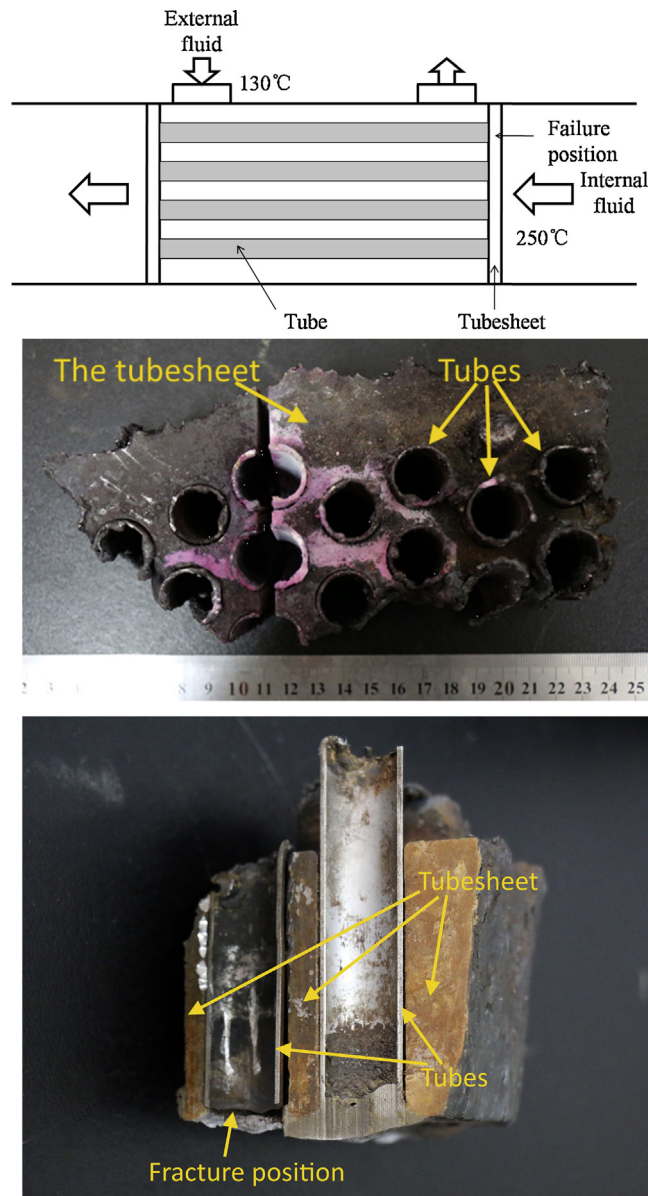
A shell-tube heat exchanger was found failed when it was used about 30 days after assembling. Dozens of leak points were found near the tube-to-tubesheet welded joints of the shell-tube heat exchanger. For some serious positions, the tube ends were broken down from the tubesheet. Fig. 1(a) shows a scheme of the failed shell-tube heat exchanger. The heat exchange tubes were made from 304 stainless steel strip and underwent contour machining, welding, and heat treatment. The diameter of the tube was 19 mm (outer) and the thickness of the tubes was 1.2 mm. After being installed in the heat exchanger, the length of the tubes was 4.5 m. The tubesheet was made from alloy steel of grade SA516 Gr.70. The tube and tubesheet was welded by the way of argon arc welding without weld metal. Then the tube was expanded by hydraulic expanding. The tube side fluid was water vapour at 250 °C and the pressure was 0.25 MPa, while the shell side medium was

Fig. 1. (a) Scheme of the failed shell-tube heat exchanger. (b) An image of a piece of the tube-to-tubesheet welded joint cut from the failed specimen. (c) An image of the longitudinal section of the tube-to-tubesheet welded joint.

circulating water at 130 °C and its pressure was 0.8 MPa. The failed parts of the tube-to-tubesheet were cut from the heat exchanger and taken to the laboratory for analysis. One of the failed specimens was shown in Fig. 1(b). And it was further cut into two pieces by wire cutting. The longitudinal section of the tube and the welded joint can be seen clearly in Fig. 1(c). For this specimen, the left tube fractured at the bottom welded joint.

Visual inspection showed that all the fractures (cracks) of the heat exchanger occurred near the welded joint of the tube end and the tubesheet (within 10 mm) (shown in Fig. 1(c)). Fig. 2(a) shows one of the fractured tubes. The fracture surface of the tube was basically perpendicular to the axial direction. From the longitudinal section of the failed tube, a clear expansion area which started from the end of the tube (the welded point) could be seen. The length of the expansion area was about 50 mm. The fracture surface of this failed tube was then examined using a stereomicroscope to observe the major feature of the fracture. As shown in Fig. 2(b), the fracture surface is divided into different zones. Fracture occurred without obvious plastic deformation. Brittle feature could be seen on the fracture surface. Several radial lines were observed along the thickness direction and in the area near the inner surface. Though the inner and outer surface of the tube was covered by some corrosion production, no pitting corrosion was observed.

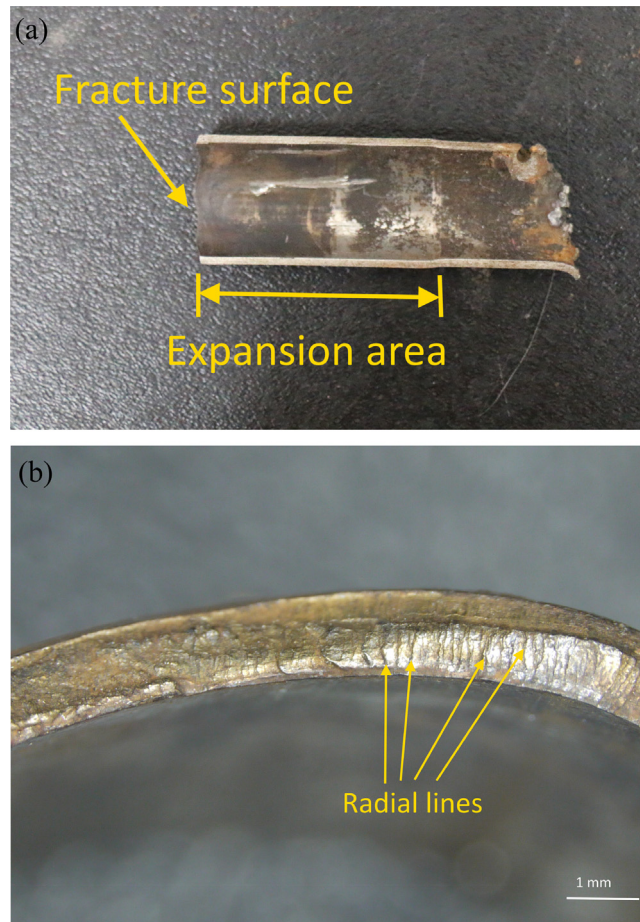
Fig. 2. Images of (a) a fractured tube cut along the axial direction and (b) the fracture surface of the tube at the welded joint.

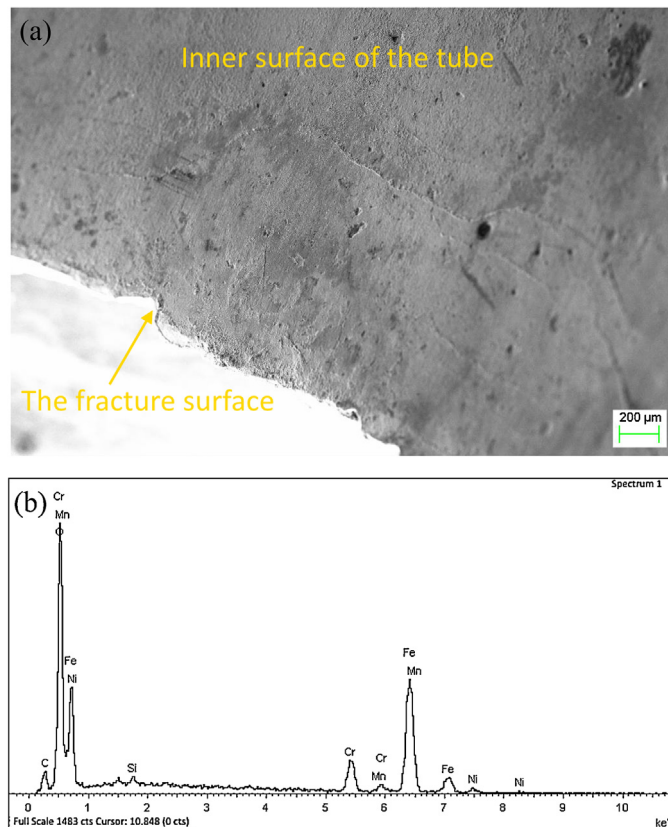
The failed tube was then observed and analyzed using the scanning electron microscopy (SEM). As shown in Fig. 3(a), the inner surface is flat and no obvious corrosion pits were found in the inner surface. The chemical composition near the fracture surface was further confirmed using the energy dispersive spectrometer (EDS). As shown in Fig. 3(b), no corrosive elements such as chlorine and sulphur were detected in the inner surface.

Fig. 3. (a) An SEM image and (b) EDS results of the inner surface of the failed tube near the fracture surface.

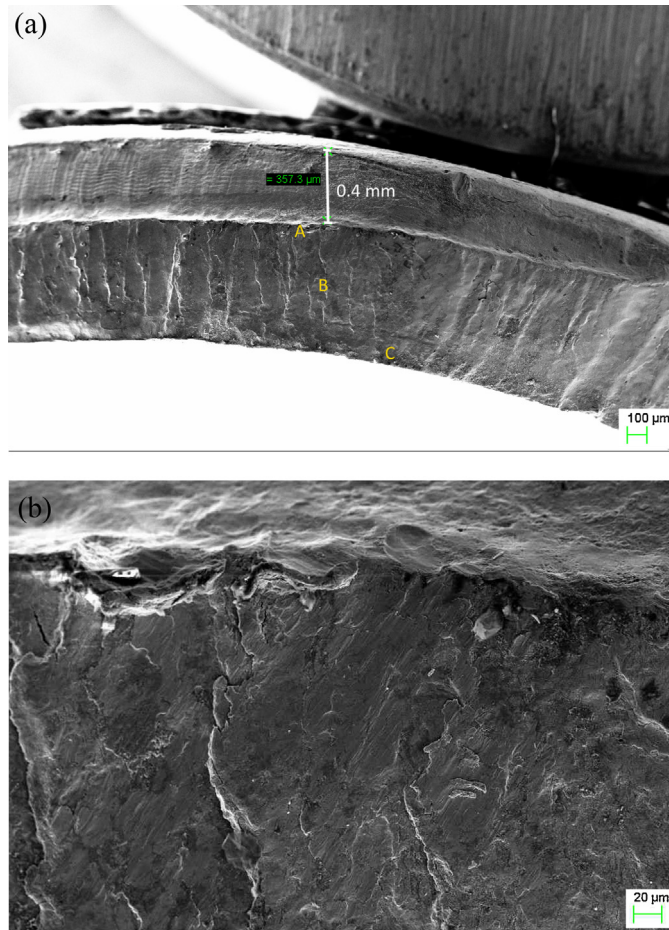
Fig. 4(a) shows the low magnification SEM micrograph of the fracture surface. The two different areas were seen more clearly. The bottom area near the inner surface of the tube was clearly a fracture surface, while the upper zone was an obvious non-fusion welding defect between the tube and the tubesheet. The depth of this area was about 0.4 mm. The

bottom fracture surface started from the interface between these two areas owing to the stress concentration induced by the welding defect. Radial lines were obviously seen from the interface between the two areas to the inner surface. Actually, the welding defect at this area was just like a crack. The interface between the upper and bottom areas in Fig. 4(a) was the tip of this crack which exhibited very high stress concentration and give rise to further propagation of the crack.

As shown in Fig. 4(a), grinding marks, which was formed due to the periodic crack opening and closing, were observed in a large area of the bottom fracture surface. However, when carefully distinguishing the fracture surface, three areas, including the initial region (marked as A), the propagation zone (marked as B), and the final zone (marked as C), could be identified in the non-grinding areas. Thus, the fracture surface showed a fatigue failure feature which was caused by a periodic load. Fig. 4(b) shows that the initial region was located at the interface between the upper and bottom areas mentioned above. Multi-crack origins could be confirmed by the numbers of radial lines. As shown in Fig. 5(a), in the fatigue crack propagation zone, fatigue striations could be seen under higher magnification. Fatigue striations were the microscope characteristic of fatigue, which is the typical evidence of a fatigue failure. Microscopic examination of the fracture further confirmed that the failure of the welded joint was due to fatigue crack propagation, which is a cumulative damage. Fig. 5(b) shows the morphology of the final zone at the inner edge of the fracture surface. Typical dimple feature can be observed in this area. The proportion of final zone area in the whole fracture surface zone was relative low, which indicated that the fatigue stress amplitude was not very large.

Fig. 4. Low magnification image of (a) the fracture surface of a failed tube and (b) the crack origin.

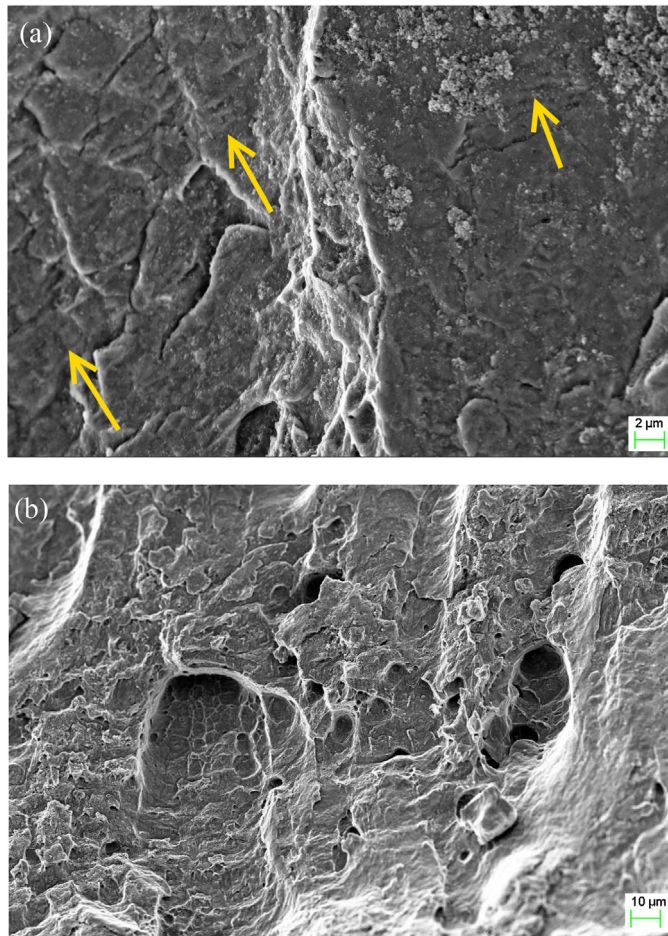
Fig. 5. SEM images of the fracture surface. (a) The fatigue propagation zone and (b) the final fracture zone.

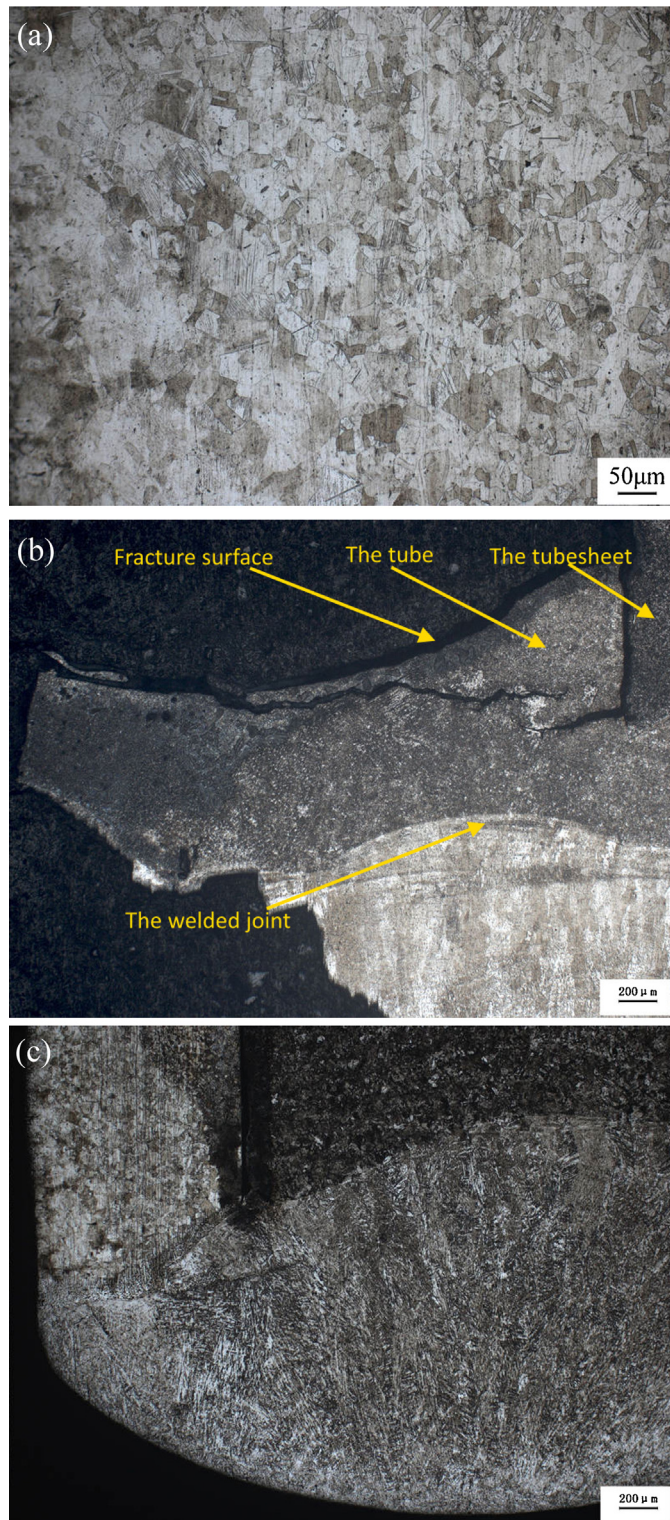
prepared as a reference. Fig. 6(a) shows the metallurgical structure of the tube near the fracture surface. A typical austenite structure can be observed clearly which is a normal structure for a 304 stainless steel. In addition, metallographic examination also indicated that microstructures of the tubesheet and the welded joint were normal. However, as shown in Fig. 6(b) and (c), when comparing to the reference specimen, many cracks were found in the failed welded joint and its heat affected zone. These cracks might be caused by (1) just the welding defects; (2) the propagation from the welding defect; and (3) damage due to the mechanical expansion process.

Fig. 6. Metallographic structures on the section of (a) the failed tube, (b) the failed welded joint and (c) a well reference specimen.

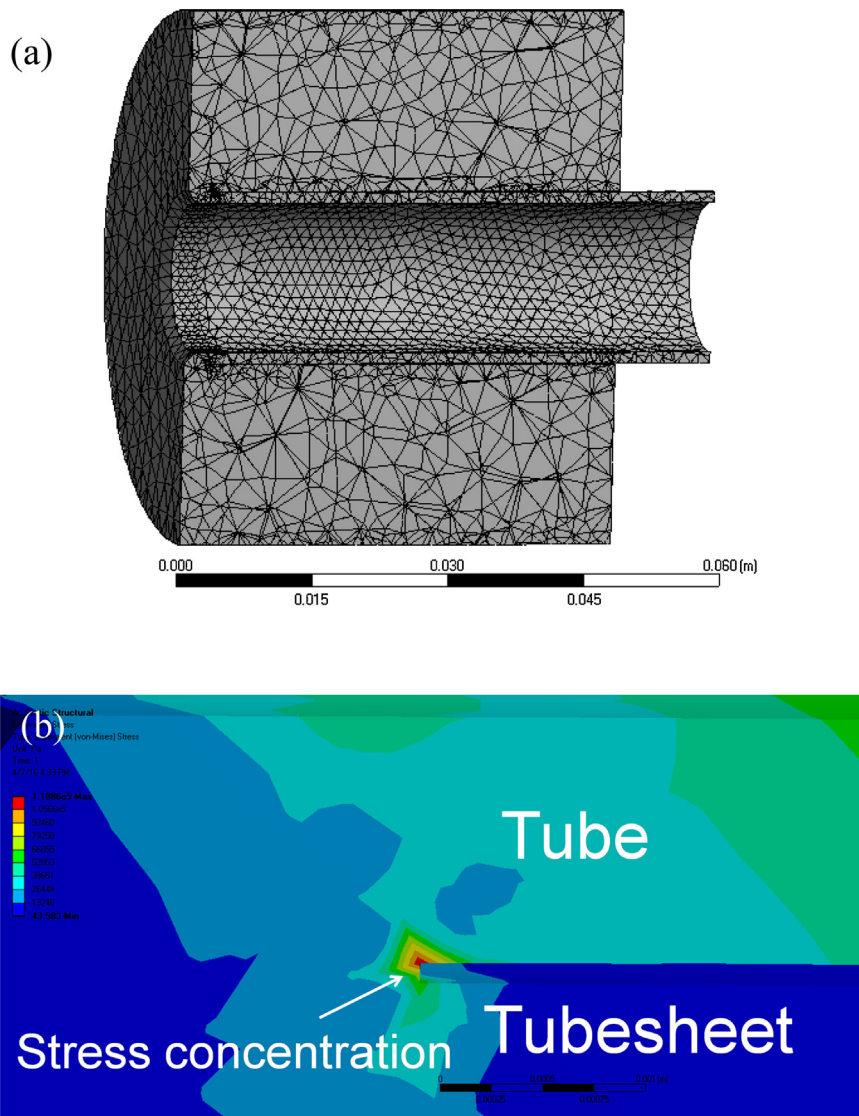
Either the welding defects or the bad expansion process might introduce stress concentrations at the welded joint. To confirm the exact position of the stress concentration, a finite element analysis was performed on the welded joint. A three dimensional model containing the tube, tubesheet and the welded joint was constructed and analyzed. As shown in Fig. 7(a), 96,553 nodes and 57,282 elements were meshed in the model. Elastic strain was simulated using the isotropic Hooke's law with Poisson's ratio and Young's modulus. As shown in the Von-Mises stress distribution (Fig. 7(b)), stress concentration, which was coincident with the crack initiation location of the failed welded joint, could be seen obviously.

Fig. 7. (a) Finite element mesh of the welded joint model; (b) Von-Mises stress distribution of the tube-to-tubesheet structure.
