Distribution of blue stain in untreated and DMDHEU treated Scots pine sapwood panels after six years of outdoor weathering

Stergios Adamopoulos · Yanjun Xie · Holger Militz

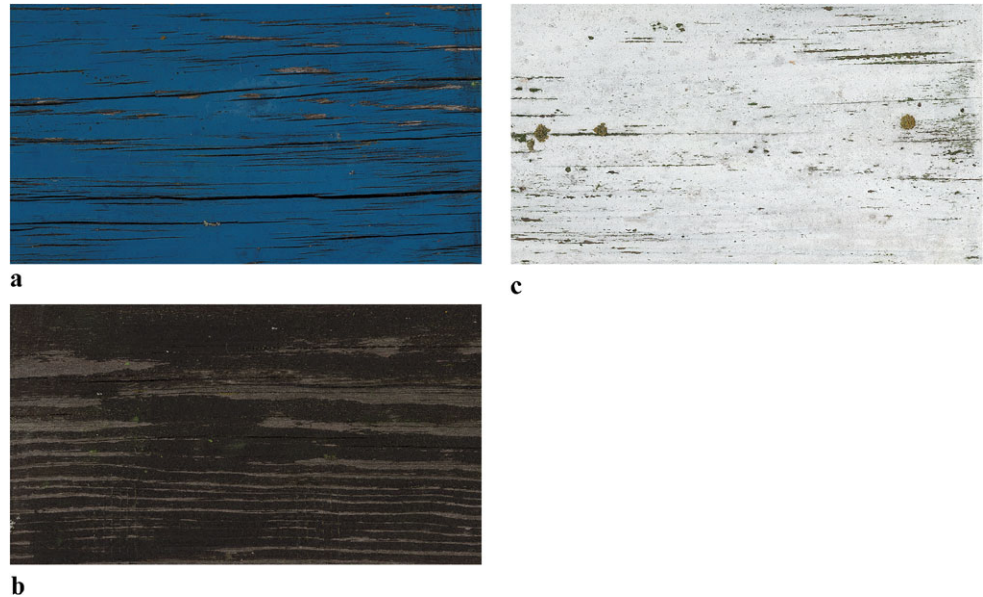
Fig. 1 Appearance of the front surfaces of panels after six years of outdoor weathering: untreated and coated panel with PB (a), DMDHEU treated and coated panel with SB-3 (b), and mDMDHEU treated and coated panel with PW (c)**Abb. 1** Erscheinungsbild der Vorderseite von Prüfkörpern nach einer 6-monatigen Außenbewitterung:

Weathering of coated panels over a six year period caused extensive surface cracking and discoloration due to fungal colonization which was more severe in the case of untreated panels (Fig. 1a, b and c).

Six-year weathering resulted in a failure of the coating film on the untreated sample surfaces, mostly flaking and peeling for acrylic stains but cracking for acrylic paints. The very thin layers of stain coatings were mostly gone; however, the somewhat thicker white and blue paint coatings remained on the surfaces at a higher degree. The coating films on the treated panels displayed a comparable degradation to the one on the untreated controls. After 18 months of weathering, an improved effect of the coating performance due to wood substrate modification was observed (Xie et al. 2008). After six years, such improvement is likely to become obscure due to the thin layer of coatings applied and the fail-

ure of coating itself after suffering from a long term surface photodegradation/leaching. The modified wood substrates, however, showed fewer cracks (CR = 3 or 4 in one case, Table 2) with all coating types compared to the untreated panels (CR = 5). This can be attributed to a lower water uptake and moisture sorption and to the higher dimensional stability of the substrate.

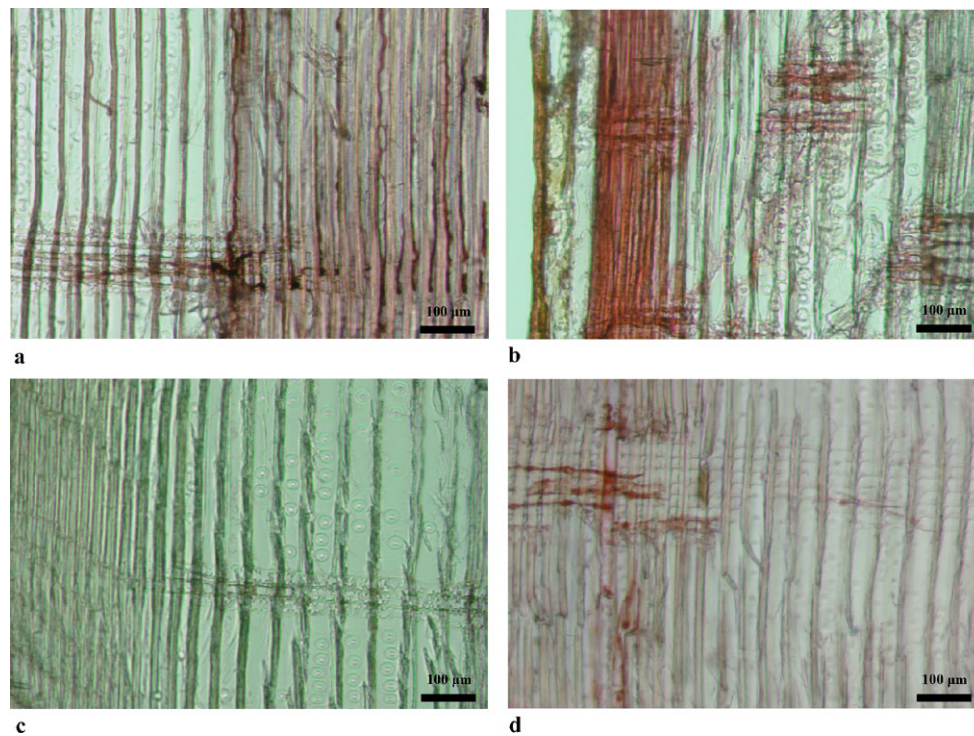
The severe cracking of untreated panels enabled fungal spores to reach the wood substrate, germinate and spread widely due to moisture accumulation (Fig. 2a). The fungi started to grow from the front surface of the panels and reached the reverse through the ray cells. Blue stain hyphae were observed in every part (upper, middle, lower) of radial sections taken along both large and small cracks (Table 2). Slightly less blue stain fungi was noted only in the case of blue acrylic paint coating (PB).

In DMDHEU treated panels, the crosscut surfaces showed considerably less stained area which was restricted only close to the wood and coating interface. Microscopic examination of radial sections along small cracks revealed that the infection was restricted to the upper parts of the panels with hyphae not being able to penetrate further and reach the interior parts (Table 2, Fig. 2b and d). Sectioning along in-

Fig. 2 Micrographs of radial sections: middle part of untreated panel and coated with SB-1 (a), upper part of DMDHEU treated panel and coated with SB-2 (b), upper part of DMDHEU treated panel and coated with SB-3 (c), and upper part of mDMDHEU treated panel and coated with PW (d). Note: sections (a), (b) and (d) were taken along small cracks and section (c) along intact part. Every micrograph, from the left to the right, it was moved from the front surface to the inner part of the wood samples

tact parts showed no evidence of blue stain (Table 2, Fig. 2c) suggesting that coating prohibited fungal growth. The extent of fungal penetration was higher for the brown stain coating SB-2 due to a higher crack ranking (CR = 4). The lowest degree of blue stain colonisation in DMDHEU treated panels can be explained by changes in the properties of wood, e.g. reduced water uptake and increased dimensional stability (Xie et al. 2008).
