Energy Procedia 15 (2012) 379 – 387

## Why Do PV Modules Fail?

Claudio Ferrara\* and Daniel Philipp

*Fraunhofer Institute for Solar Energy Systems, Heidenhofstrasse 2, 79100 Freiburg, Germany*

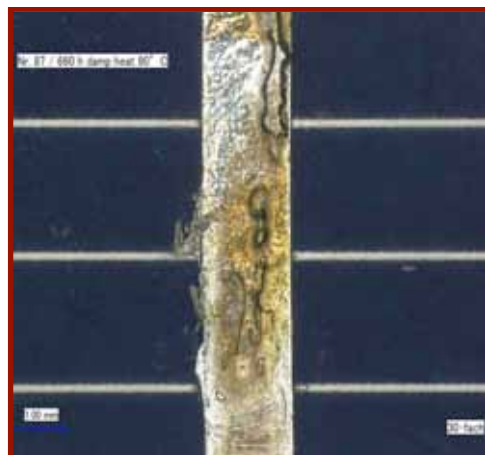
Different metals (aluminium alloys, stainless steel, copper, soldering agents, etc.) are used for frames, connectors, cables, fingers and grids. All these metals can show defects. Corrosion of metals can be caused by atmospheric humidity alone or in combination with gases. Higher temperatures will accelerate the reaction. Figure 1 shows the corrosion of the ribbon at solder joints of a sample exposed to 660 h in the damp heat chamber at 90°C.

Fig. 1. Details of a connector after an exposing time of 660 h at 90°C and 85% r.H.

Here, the corrosion process was caused by humidity penetration of the sealant in combination with high temperature. Additives of polymers can also cause corrosion, e.g. acetic acid ( $\text{CH}_3\text{COOH}$ ), which cannot evaporate because of a non-permeable back sheet. Mechanical loads, resulting from snow or wind, can cause distortion of the metal frame which as a consequence leads to a weakening of the static systems

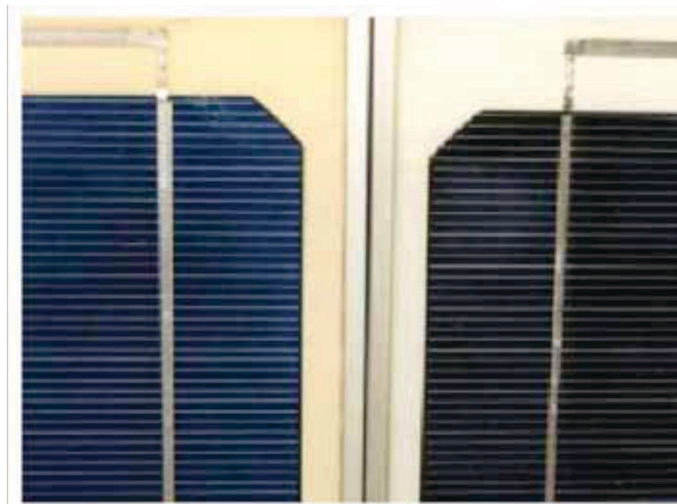
Yellowing or browning of encapsulation and polymeric back sheets can be caused by heat, humidity and UV irradiation (see Fig. 2). Until today there is no clear relation between the yellowing level and the electrical performance, see e.g. Ref. [9]. Heat and humidity are also reasons for blistering and, in an extended form, for delamination. This is a process where the different polymeric and/or other layers are not adhesive anymore. The reduction of adhesion of adhesives e.g. for the junction box causes by UV irradiation, heat and humidity can result in a detachment of it. If water vapour and/or gases penetrate the sealant, it can cause chemical changes of the polymers. UV irradiation is a reason for the bleaching respectively fading of the module, e.g. cable envelope. Dry heat like in a desert climate can lead to exsiccation of the polymer material and as consequence to embrittlement and at the end to cracks in the polymer surface.

Fig. 2. Aged PV module after damp heat test (left) and unaged PV module as reference (right).

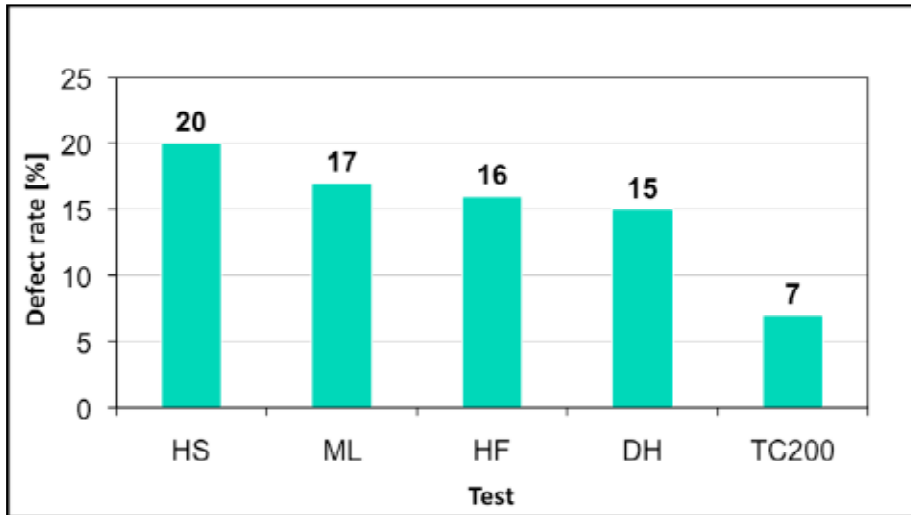
During the years 2006-2009 we performed 297 tests projects for certification. In 105 projects of this 297 at least one of maximum 11 PV modules failed in one test. These are 35% of the performed projects, which have contained 7% PV modules with thin-film technologies and 93% crystalline technologies (35% mono-crystalline wafer, 58% polycrystalline wafer). The diagram (Fig. 3) shows a more detailed view on the test where PV modules failed during the certification testing. The most severe tests for PV modules in these projects were the hot spot test (HS) with a failure rate of 20%, followed by the mechanical load test (ML) with 17%. The climate chamber tests are responsible for roughly 40% of the failures during testing, in detail: humidity-freeze test (HF) with 16%, damp heat test (DH) with 15% and finally the thermal cycling test with 7%. All five tests are responsible for 75% of all PV modules with failures in the 105 certification projects.

Fig. 3. Defect rate related to the performed test: Hot spot test (HS), mechanical load test (ML), humidity freeze test (HF), damp heat test (DH), thermal cycling with 200 cycles (TC200). From Ref. [11]

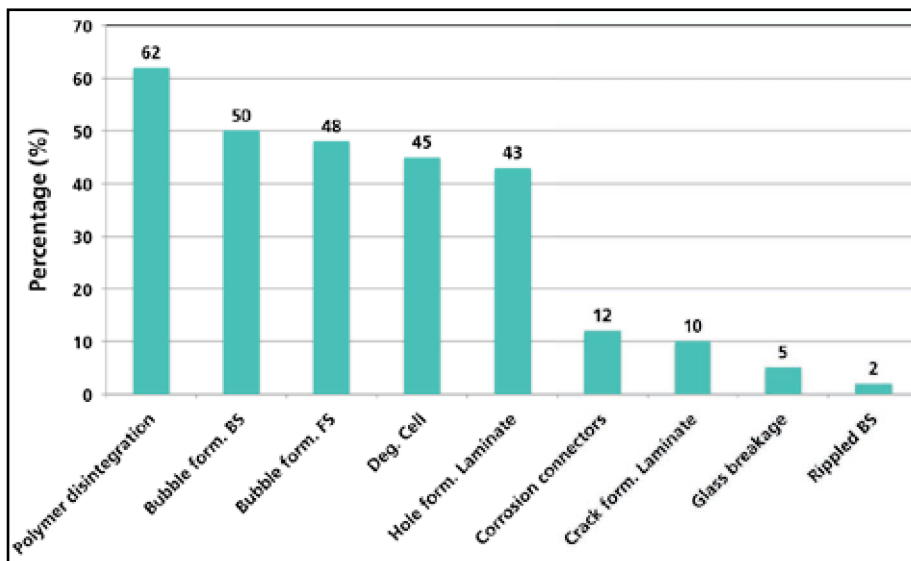
Fig. 4. Percentage of defects modes observed after hot spot test. From Ref. [11]

Further analysis, e.g. after the hot spot test (which is the test most failures were detected in), show that defects are mostly on polymers. The reasons for the failures are the high temperatures produced during the hot spot test. These high temperatures, with an average of 240°C, cause multiple failure modes simultaneously. An analysis of failure modes observed after the hot spot test is shown in Fig. 4. Figures 5(a) to 5(c) present examples of the first most found failures after the hot spot test. These are the disintegration of polymers (62%) and the formation of bubbles at the back (50%) and the front side (48%), caused by the high temperatures during the hot spot test. These high temperatures are causing also degradation of the

solar cell (45%), formation of holes in the polymers (43%). Failure modes with less occurrences are corrosion of the connectors (12%), crack formation of the laminate (10%), glass breakage (5%) and rippling of the back sheet (2%).

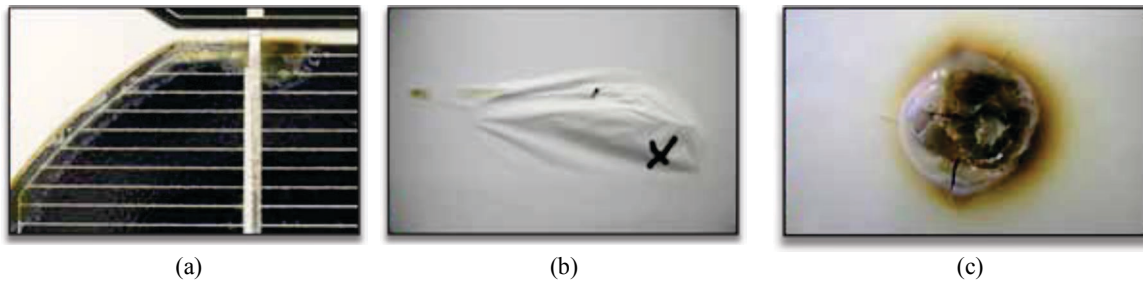
Fig. 5. Examples of the first most found failures after the hot spot test: (a) Bubble formation at the front side; (b) Bubble formation at the back side (50%); (c) Disintegration of polymers after hot spot test. From Ref. [11]
