# Masonry Construction Remedial Measures in Case of a Multi-Story Housing Facility Caused by Floor Extension Process

This paper presents remedial measures of a multi story housing facility located in Novi Sad, Serbia. The analyzed building was built in traditional masonry construction with precast rib ceiling including unreinforced slab. The damage was caused after the floor extension (overbuilding) process of the existing facility, expressed through cracks on constructive walls. The cause of such damage is a non-analytical approach during upgrade. The work presents a case study of the applied measures at conditions when the material incorporated in the existing part of the building is not of adequate quality. The specificity of this recovery was that during the execution the flats' users remained in their apartments.

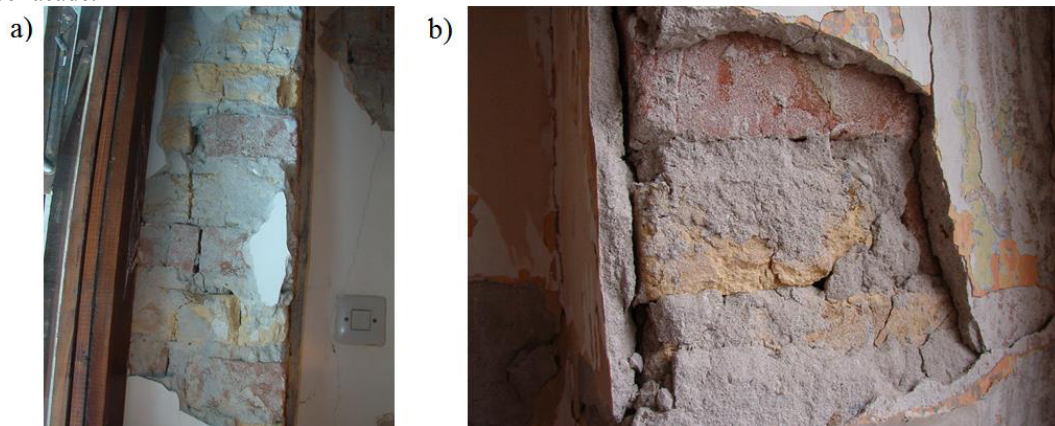
Fig. 4. a) Damages of basic material, b) Unequal thickness of the vertical and horizontal joints in wall

In areas of extreme damage and fallen plaster it was observed the following: the walls are plastered with lime mortar, the bricks which used for making the bearing wall are out of expected quality (well roasted red, yellow slightly roasted), mortar for brick cement is a flexible mortar, which is, based on visual views, can be said that good quality, uneven thickness of the vertical and horizontal joints in walls. It was performed the design and

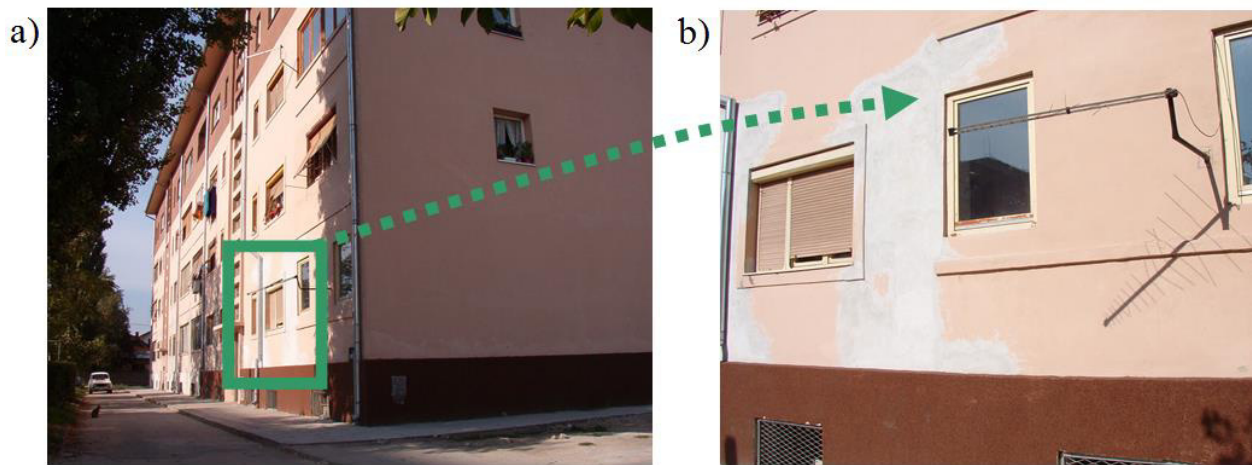
Fig. 5. a) South-east (entrance) facade, b) Partial recovery that prevented demolition of the ground floor walls

The greatest damage in the apartments are on the walls (columns among windows) south-east (entrance) facade, as well as close to them cross-walls (supporting). The level of damage to the lateral walls and the level of damage to apartments in general decreases with removal from the southeast (entrance) facade. A loggia on the northwest side of the building have a hole the size of 259cm and less than those on the south facade and on the walls of this orientation have not observed significant damage.

Southeast facade has suffered such damage because the structure of the wall: large windows (144cm) at close distance (112cm) the loggia, which opening amounts 360cm, a portion of the wall which divides the loggias is 65cm, 25cm cross walls are weakened by 65cm wide opening for the door at a 50 cm distance from the connecting with the southeast wall facade. Walls with small openings (or without them), with the same disposition as previously mentioned above, have significantly less damage to itself. Damage in the form of cracks and falling plaster (ground floor) is also occurring on the walls of which are bearing doors and windows lintel as well as the walls which connects with the parapet to a height of 90cm (from floor). At places the greatest damages to the walls where the plaster has fallen away it can be said that the walls entered the stage c.) (Fig. 2, c)) - the division of the wall vertical cracks on several more or less independent parts.

reconstruction of the walls of the entrance facade. Restoration was carried out making ten reinforced concrete, 25/25cm pillars, which are placed between the ceiling above the ground (below "unknown" a horizontal concrete element in the ceiling above the ground level) and the wall plinth (basement  $d = 51\text{cm}$ ), with that a pillar in the place reliance the basement wall with trapezoidal enlargement (Fig. 5).

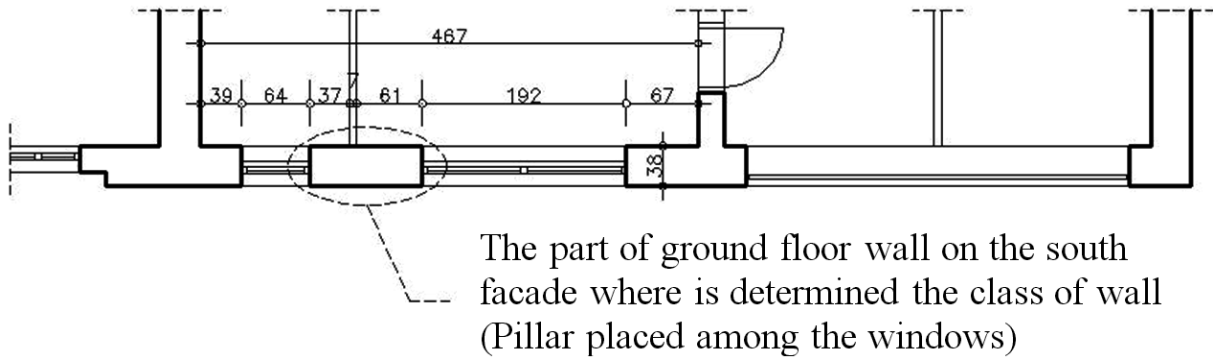
Fig. 6. Typical pillar that placed among the windows.

For the state of the walls where the border wall bearing capacity is exceeded, the experimental determination of mechanical properties (sampling) is recommended (in addition to their reduced capacity). Determining the quality of the wall was made to calculation model based on the load data (taken from the main project), the characteristics of the wall at floor level and the fact that due to this load has been exceeded limit state. For a typical pillar that placed among the windows (given in Fig. 6) the calculation of load capacity has been done.

1. Determining the load on the pylon which placed up among the windows on the south facade, due to which there has been significant damage:

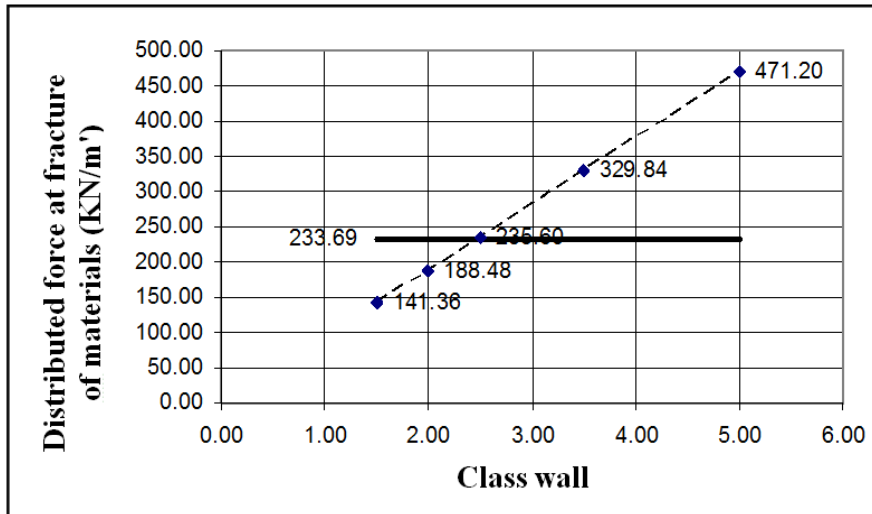
Fig. 7. Dependence of distributed force to the class wall

Dependence distributed force at wall failure  $d = 38$ cm of the class wall on the south-east facade is shown in Fig. 7.

Based on the presented analysis can be concluded that the class of the wall on the south facade is very close to CW 2.5.
