# Journal of Rock Mechanics and Geotechnical Engineering

## Impact of weathering on slope stability in soft rock mass

Predrag Mišćević\*, Goran Vlastelica\*\*

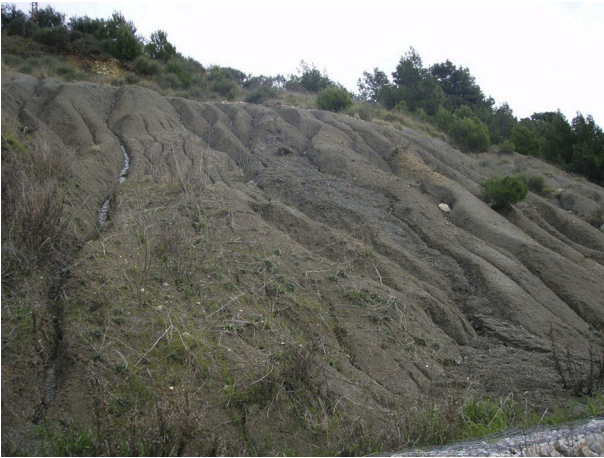
An example of surface deterioration induced by weathering of a natural slope, situated on the Adriatic Highway in the Podstrana municipality, is presented in Fig. 1. Here we can see a developed

**Fig. 1.** Marl degradation on the surface of a cut slope on the Adriatic Highway (Podstrana municipality).

process of marl degradation on the slope surface, with accumulation of detached fragments at the bottom of the slope. The understanding of the degradation process such as that in this example is of great interest to many engineers, as these processes lead to reduced stability of such slopes and hence to higher maintenance costs.

Firstly the process develops on the exposed surface of the rock which results in constant “ravelling” of material from the surface (Fig. 1). Transported by gravitation and precipitation, the degraded material is eroded and accumulated at the bottom of the slope, where it eventually disintegrates into material that can be classified as soil (clayey silt) rather than as rock. This process has a greater impact on maintenance costs than that on the global stability of the cut slope. In fact, the material accumulated at the bottom of the slope must regularly be removed. The slope “moves away” from initial position, and becomes unseemly from the aesthetic point of view (Fig. 1). It was established, by observation of existing cut slopes and by laboratory testing on samples, that the influence of weathering on the surface of the slope can spread from several centimetres to some ten centimetres in depth. The depth of this influence depends on the proportion of carbonate and clayey components in marl, orientation of bedding joints and secondary joints with respect to the slope, and slope inclination or “rate” at which the disintegrated material is removed from the surface. The total depth of the surface layer that detaches from the surface with the passage of time is also dependant on meteorological conditions, i.e. on the number of dry and rainy periods, the quantity and intensity of precipitation, the exposure of slope to the influence of sun, and the change in air temperature in the area where the slope is located.

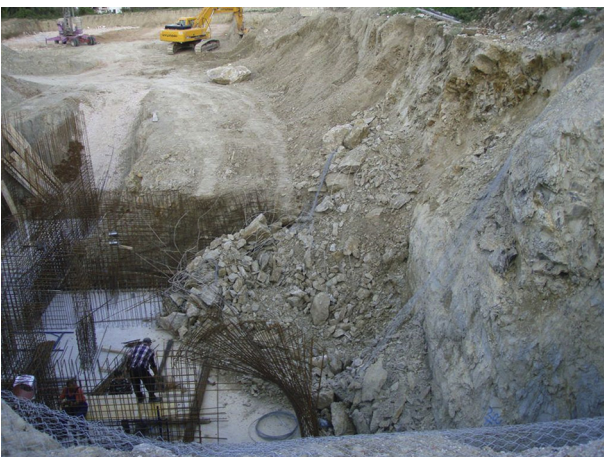
Examples of impact of weathering processes on stability of unprotected cuts can be found on many locations in these geomaterials. For instance, such situations are quite frequently reported in the vicinity of Split when excavations are made in flysch rock mass. The landslide formed several months after excavation at the building site of the Medical School in Trstenik, Split is shown in Fig. 2. Fortunately, the landslide occurred during the night, therefore the lives of workers at the bottom of the foundation pit were not endangered.

**Fig. 2.** Collapse of slope in foundation pit excavated in marl (Trstenik, Split).

the vicinity of the joint along which the slope sliding was initiated, as shown in the example given in Fig. 2.

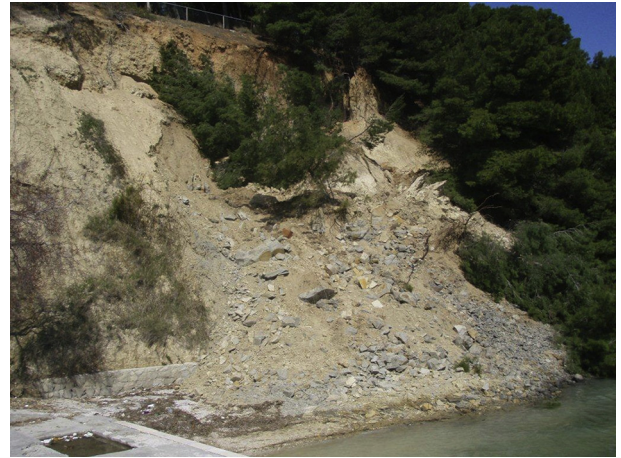
An example of landslide at natural cliff in flysch formation along the coast is shown in Fig. 3. The sliding process is usually continuous if it is not interrupted by remediation works, a kind of instability that is quite frequent along the coastline near the town of Split. The material deposited at the bottom of the slope is carried away by the sea and thus the space is liberated for the next “sliding phase”.

**Fig. 3.** Landslide along the coastal cliff in flysch formation (Duilovo, Split).

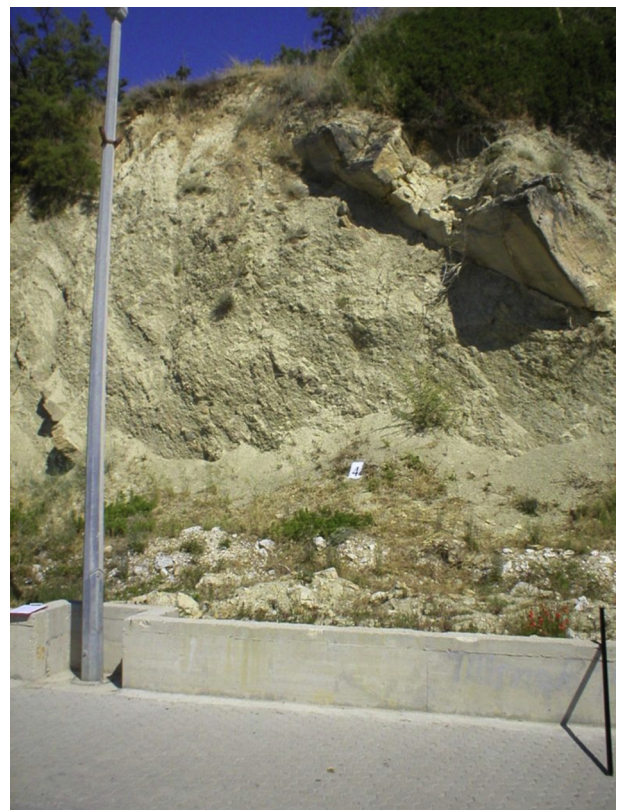
A formation of greater sandstone blocks at a natural cut in flysch formation, caused by weathering of marl, is shown in Fig. 4. The

weathering rate of sandstone layers within the flysch formation is not the same as that of marl. It could be stated that the sandstone is almost unchanged in the engineered time scale. Because marl is significantly influenced by weathering around the sandstone layer, it disintegrates quickly and is gradually removed by the action of gravity and precipitation (Neiman, 2009; Admassu et al., 2012), i.e. we can witness here the process of differential weathering. Sandstone layer outcrops remain on the slope as a kind of “cantilever” and when the length of this overhang becomes sufficient, the blocks detach due to bending action. Resultant rockfall poses a serious threat to the zone at the bottom of the slope.

**Fig. 4.** “Cantilever” of harder sandstone layer on the slope (differential weathering along the slope).

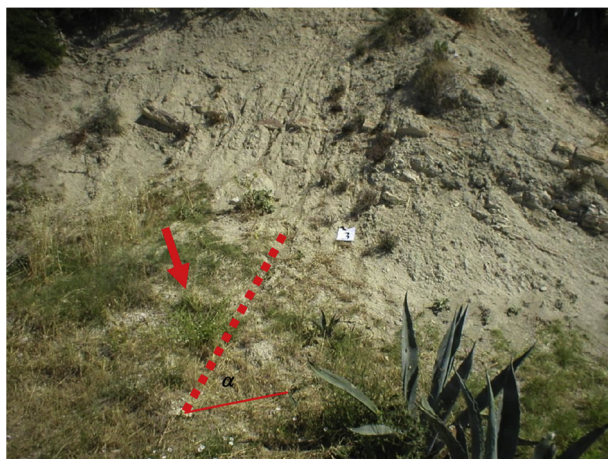
If the back analysis of a stable slope built of marly clay is conducted using shear strength parameters measured for marly clay, the obtained slopes have the values that correspond to field measurements of inclination of deposited weathered material. It was established by field measurements that the inclination of the weathered marl deposited at the bottom of the slope amounts to  $\alpha = 31^\circ\text{--}38^\circ$  (Roje-Bonacci, 1998) (example shown in Fig. 6). The weathered material at the bottom of the slope indicates marly clay properties.

**Fig. 6.** Measured inclination of weathered marl deposited at the bottom of the slope (arrow), inclination range  $\alpha = 31^\circ\text{--}38^\circ$ .

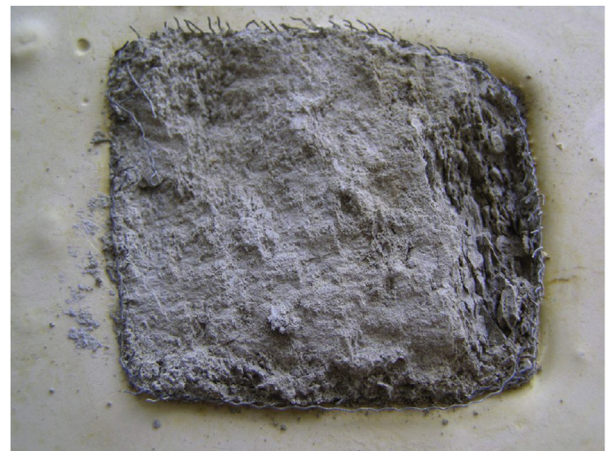
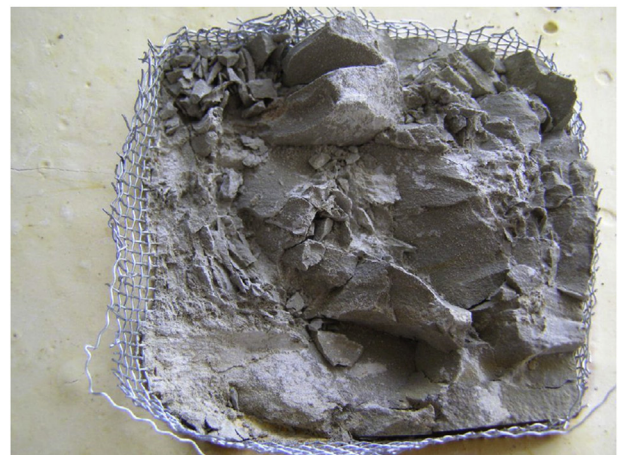
**Fig. 8.** Examples of failure surfaces during weathering simulated in laboratory. (a) Failure surface after 4 drying–wetting cycles. (b) Failure surface for the sample that was disintegrated into smaller fragments due to weathering action.

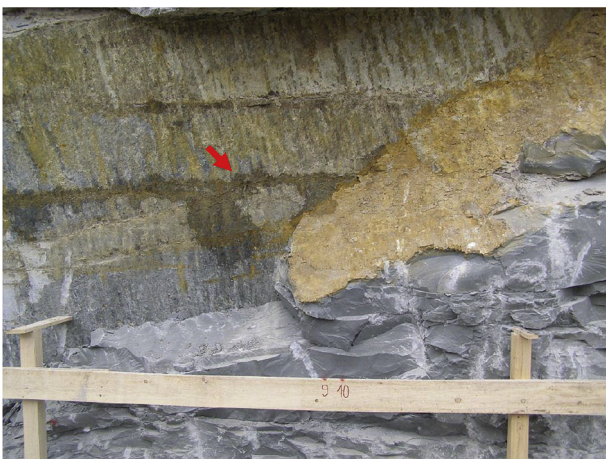
Secondly, the weathering process also spreads deeper inside the rocks and through the joint system that can easily be penetrated by water. An example of cut slope on which wet zones near the joints can be seen, while the basic material is “dry”, is shown in Fig. 9.

In this example, yellow brown deposits on the surface of the bedding joints and secondary joints point to the fact that seepage had been observed even prior to excavation. However, as can be seen in this example, the actual disintegration of material occurs only after excavation, in form of material bursting in the vicinity of joints (arrow in Fig. 9). The bursting (fracturing) started some 20 days after excavation despite the fact that there was no precipitation in the meantime. The depth that the process can advance is presented in Fig. 10, where pronounced moisture can be noticed in

Fig. 9. Water seepage through joints formed in flysch.

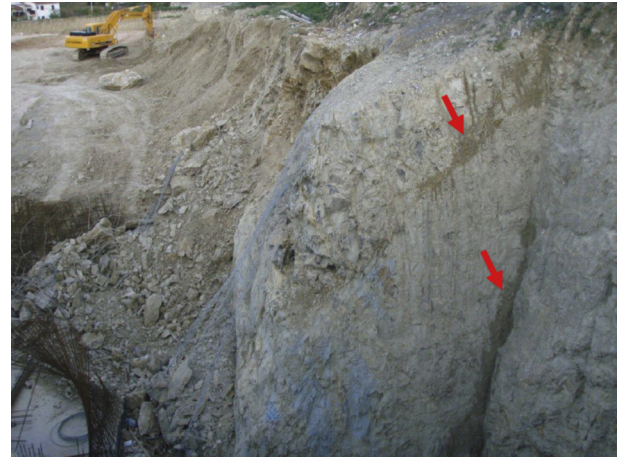
Fig. 10. Seepage through secondary joints along which the sliding occurred.

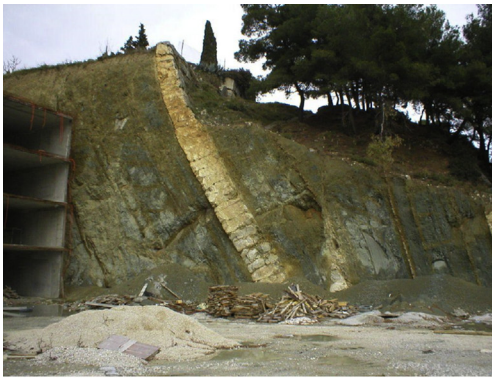
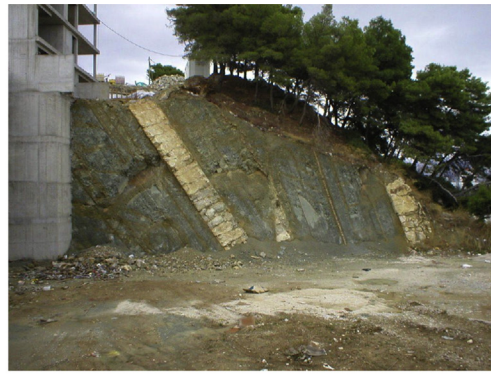
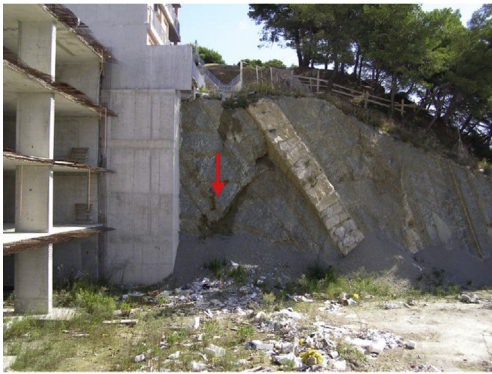
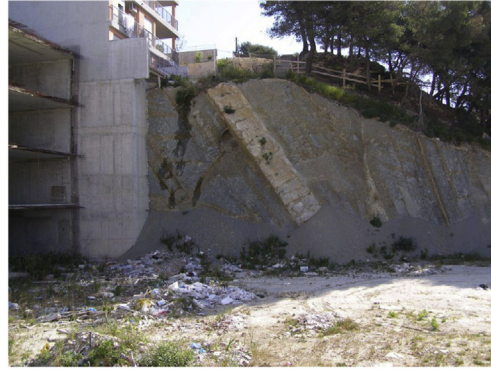
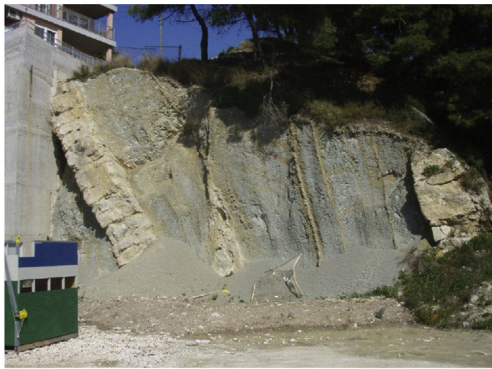
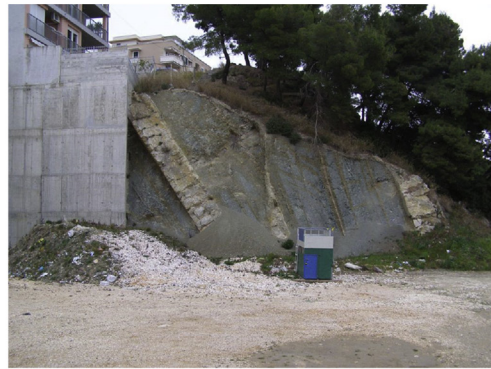
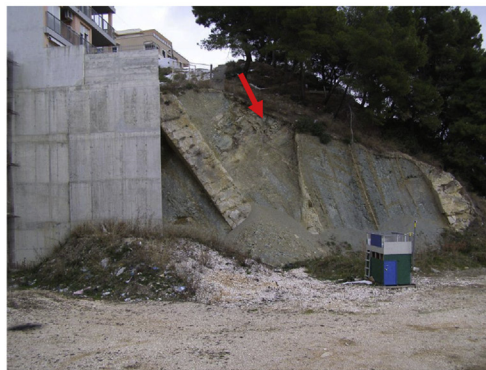
Both of the above-described forms of weathering are documented with a number of pictures of the same slope in flysch formations, which were taken during the observation period of 9 years after excavation (Fig. 11). The quantity of material that is detached from the slope surface can be considered as material accumulated at the bottom of the slope. This material had been removed on several occasions during the observation period. The “depth” of the surface part of the slope that was eliminated from the surface through weathering can easily be noticed as the change in the length of the harder sandstone layers “overhanging” from the slope surface. This sandstone had been initially excavated to the same level as the surrounding layers, but was not eliminated with weathering. It can be concluded that the weathering rate in this example is: 0.8 m of the sandstone overhang/8 years = 10 cm per year. The observations made on similar slopes have shown that the minimum depth of the material disintegrated from the surface of cut slopes in Dalmatia amounts to 1–2 cm annually.

The sliding and weathering caused by seepage through joints can be seen on the given example at the left side of the slope. Several greater blocks, formed at joints through which the water penetrated, have been affected by sliding over elapsed time. The arrow in Fig. 11 shows the position of the last material fall. In 2004 and 2010, the concrete protective structure was extended in order to protect the man-built facility situated above the cut slope, as the foundations of this facility were endangered by weathering and disappearance of slope material underneath the foundations. At that, it can be seen that the excavation was conducted very favourably with respect to bedding joints, i.e. it was made perpendicular to bedding joints.

**Fig. 11.** Slope at Žnjan district in Split, in the period from 2003 to 2012.

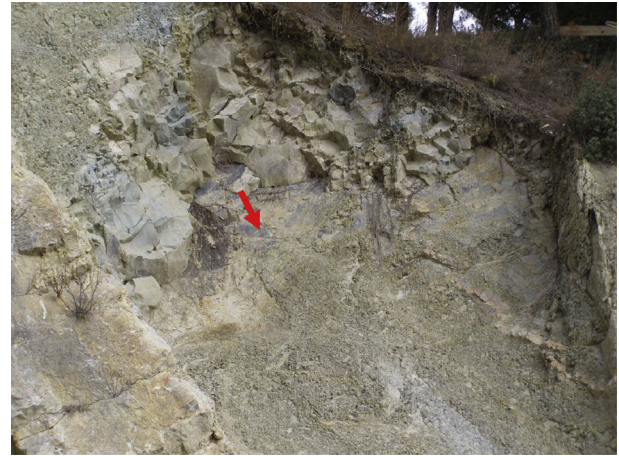
An example of landslide along secondary joints is shown in Fig. 13 (enlarged detail from Fig. 11g). The fact that water seeps through these joints is proven by plant roots (marked in the figure) which follow the spreading of such secondary joints.

Fig. 13. Sliding along secondary joint set.
