8th International Conference on Asian and Pacific Coasts (APAC 2015)

Shoreline devastation of Hota coast by man-made causes

Akio Kobayashi^{a,*}, Takaaki Uda^b, Yasuhito Noshi^a^a*Department of Oceanic Architecture & Engineering, College of Science & Technology, Nihon University,
7-24-1 Narashinodai, Funabashi, Chiba 274-8501, Japan*^b*Public Works Research Center, 1-6-4 Taito, Taito, Tokyo 110-0016, Japan*

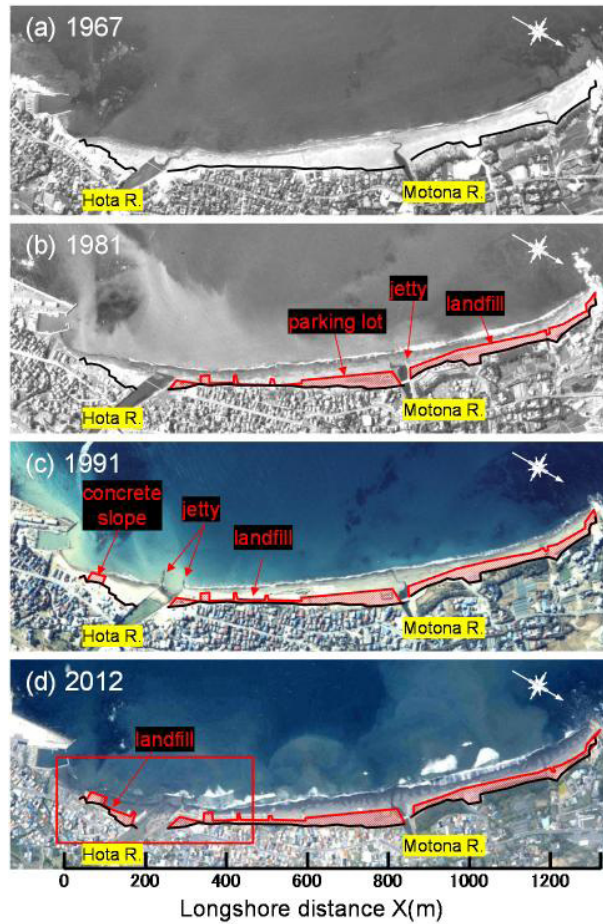
The changes in land use of the Hota coast were investigated using aerial photographs. Figure 2 shows the aerial photographs taken in 1967, 1981, 1991, and 2012. In 1967, a natural sandy beach with an approximately 50 m width extended on the Hota coast. In what follows, the boundary between the sandy beach and the hinterland in 1967 is drawn by a solid line in each aerial photograph, along with the landfill areas. By 1981, the landfill mainly to produce a parking lot had been carried out on both sides of the Motona River mouth and on the public beach immediately north of the Hota River mouth. By 1991, a concrete slope for fishing boats was constructed on the sandy beach 160 m south of the Hota River, while burying the natural sandy beach. At this time, however, a sandy beach was left on both sides of the concrete slope, and the foot of the concrete slope coincided with the shoreline. By 2012, the landfill area expanded on both sides of the Hota River mouth and a coastal road was constructed, resulting in the narrowing of the natural sandy beach. Furthermore, the beach south of the Hota River has been eroded, exposing the seawall protecting the landfill area to waves. Thus, on the Hota coast, beach changes were closely related to anthropogenic factors.

Fig. 2. Aerial photographs of Hota coast taken between 1967 and 2012.

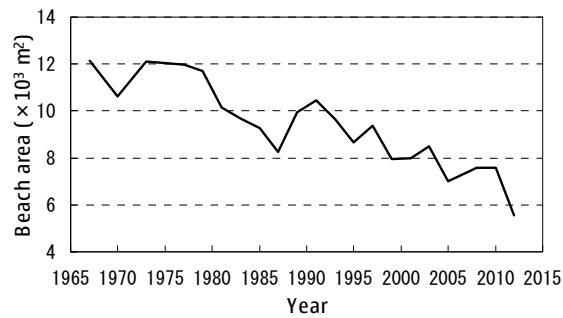
To investigate the changes in foreshore area associated with the change in land use, the foreshore area of the sandy beach shown in Fig. 2 was calculated and is shown in Fig. 3. The foreshore area monotonically decreased between 1967 and 2012 with some scatters. Therefore, the beach widths in 1967 and 2012 at the beginning and the end, respectively, are shown in Fig. 4. The sandy beach of 30-80 m width extended in 1967, but it was markedly narrowed up to less than 20 m by 2012 owing to the erosion and the seaward advance of the landfill areas.

Fig. 3. Change in foreshore area since 1965.

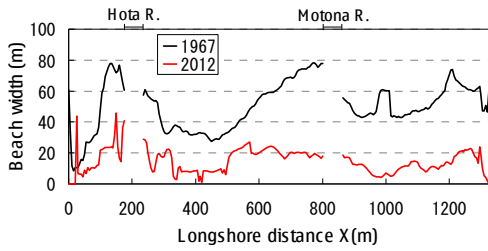
Fig. 4. Changes in beach width between 1967 and 2012.

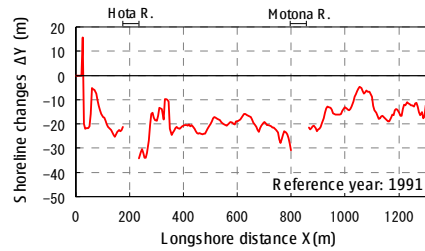
Because the foreshore area monotonically decreased since 1991, as shown in Fig. 3, the shoreline changes between 1991 and 2012 were calculated, as shown in Fig. 5. It is seen that a large amount of sand disappeared from the shoreline area. At the Hota River mouth, river mouth dredging has been recurrently carried out to remove sand deposited at the river mouth as one of the measures against the deposition of sand in the river mouth, and this is

Fig. 5. Shoreline changes up to 2012 with reference to that in 1991.

As shown in Fig. 5, the shoreline of the Hota coast receded by 17 m on average between 1991 and 2012, resulting in an entire eroded area of $2.1 \times 10^4 \text{ m}^2$ with a rate of the decrease of $1.0 \times 10^3 \text{ m}^2/\text{yr}$. The characteristic height of beach changes, which is defined as a regression coefficient between the change in cross-sectional area of the beach and the shoreline changes, and by which the change in the foreshore area can be transformed into volumetric changes by multiplying the height by the change in the foreshore area, is unknown on this coast, because bathymetric surveys have not been carried out. Therefore, the characteristic height of beach changes of 2.4 m estimated on the Nako-Funakata coast (Hoshigami et al., 2002) located 15 km south of the present coast, and facing the Uraga Strait was used for the calculation. By multiplying the change in the foreshore area by 2.4 m, we obtained the change in sand volume of $5.0 \times 10^4 \text{ m}^3$ between 1991 and 2012, with a rate of decrease of $2400 \text{ m}^3/\text{yr}$ in the volume of the foreshore

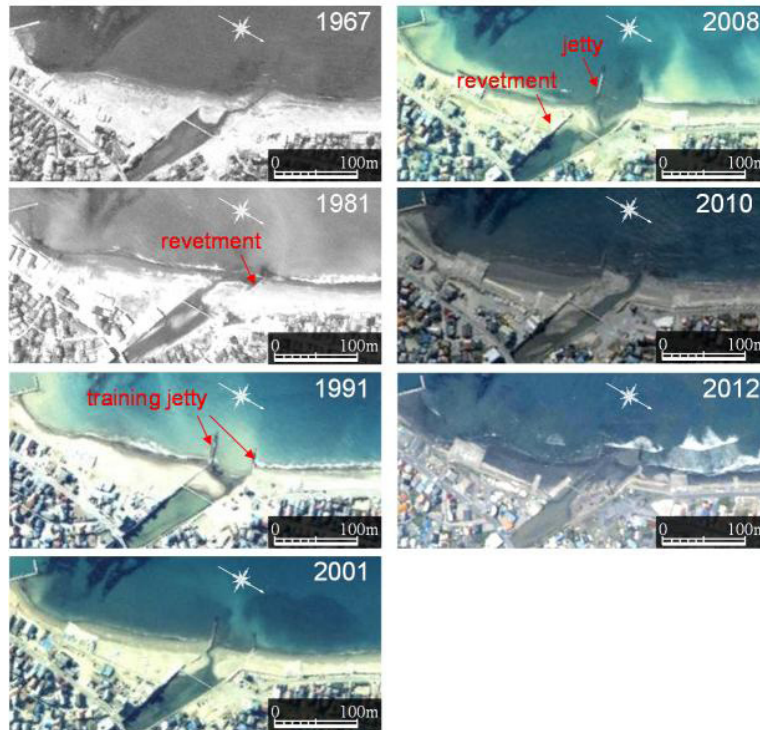
Fig. 6. Change in river mouth topography of Hota River between 1967 and 2012.

At the Hota River mouth, the removal of sand has been carried out as a measure against the river mouth closure, and this is assumed to be the primary cause of the beach erosion, resulting in the net loss of sand volume of the beach. Therefore, the shoreline changes of the river mouth bar were investigated, as shown in Fig. 6. In 1967, a narrow river channel was formed across the river mouth bar, and a wide sandy beach extended on both sides of the river mouth, which is the natural beach before the artificial alteration. In 1981, a river mouth bar had still developed in front of

the right bank revetment, while forcing the stream toward the left bank, and a wide sandy beach existed on both sides of the river mouth, similarly to that in 1967.

By 1991, the training jetties were extended on both sides of the river mouth normal to the direction of the mean coastline. After the construction of the jetties, the sand deposited at the river mouth was removed, and then a river mouth bar newly developed from the left bank, in the direction opposite to that in 1981, while leaving a narrow channel along the right bank revetment. In 2001, a river mouth bar reversely developed from the right bank, closing the river mouth, and sand was also transported into the river mouth through the gap in the left bank jetty, resulting in the formation of a sand bar along the left bank. The almost complete closure of the river as shown in this figure demonstrates the necessity of the excavation of the river mouth bar. In 2008, sand was further transported through the gap in the left bank jetty, resulting in the shoreline recession immediately north of the concrete slope for fishing boats. The same condition continued up to 2012, and the seawall was exposed to waves because of severe beach erosion south of the river mouth. The sandy beach north of the concrete slope for fishing boats was severely eroded, leaving no dry beach. Similarly, the beach was eroded between 2001 and 2012 north of the river mouth. Thus, the beach erosion of the Hota coast is strongly related to the river mouth dredging, which was carried out recurrently after the closure of the river mouth owing to the excess sand deposition.

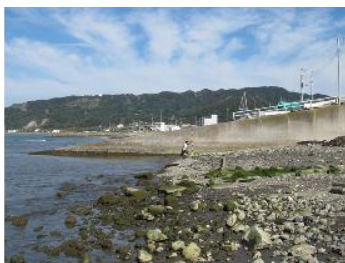
The number of observation sites on the Hota coast, which is the same as the number of figures, is shown in Fig. 1. First, Fig. 7 shows a concrete slope of 1/7 protruding from the shoreline. Although this concrete slope was originally built for small fishing boats on a sandy beach, it was abandoned for the boating slope because of erosion, and the shoreline scenery was spoiled because of the protrusion. Taking into consideration that the foot of this concrete slope coincided with the shoreline position in 1991, as shown in Fig. 2, it is seen that the area shown in Fig. 7 had been eroded, and gravel particles of large diameter and concrete debris buried under the sandy beach were left on the surface of the seabed, while forming the armor coat.

Fig. 7. Isolated concrete slope for boating and eroded beach.

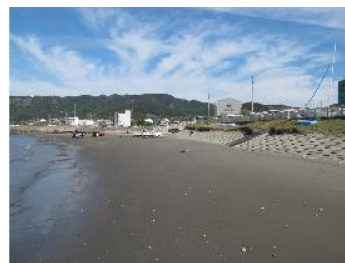
Although a wide sandy beach of a gentle slope extended north of the concrete slope, a gentle slope revetment, which was constructed along the shoreline and covered with a sand layer, was exposed to waves and a scarp was formed on the concrete slope because of the erosion (Fig. 8). There was a sandy beach in this area up to 1991, as shown in Fig. 6, and a large amount of sand was transported away from this beach toward the river mouth through a gap in the left bank jetty. It is inferred that a sandy beach of a gentle slope was left behind as a result of the erosion, and no dry beaches were left seaward of the gently sloping revetment.

Fig. 8. Eroded beach of a gentle slope and scarp formation on gently sloping revetment.

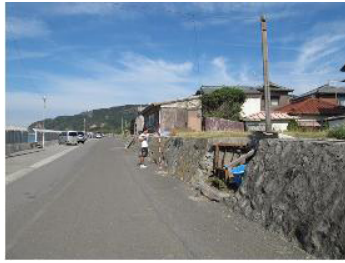
North of the Hota River mouth, a road extended in parallel with the coastline from a location 120 m north of the river mouth, and a seawall was built along the road. On the other hand, an old seawall was found in front of the houses, as shown in Fig. 9. Several gaps can be seen along this old seawall shown in Fig. 9, and the winches for raising small boats from the shoreline to the backshore were placed in these gaps. An example is shown in Fig. 10; a rusted winch was left in the gap of the seawall.

Fig. 9. Gaps in old seawall left on landward side of road.

The ground elevation of the hinterland was 1.2 m above the elevation of the road, as shown in Fig. 9, and the area with a slightly high elevation was a sand dune in the past, with a seawall constructed on top of the sand dune. Small fishing boats were placed inside the gaps of the seawall near the top of the sand dune. From these facts, it is clear that the past coastline was located along the line smoothly connecting the past seawall, and small fishing boats placed on the sand dune were moved down to the shoreline across the backshore. However, a landfill was formed on the backshore to build a new coastal road in parallel with the coastline.

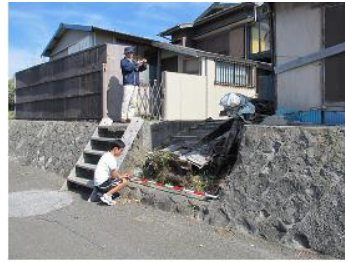
Fig. 10. Rusted winch left in gap of seawall.

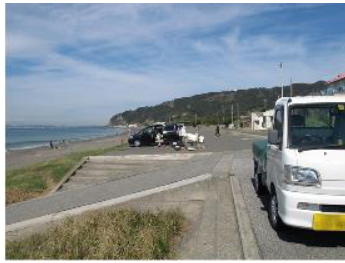
Fig. 11. Parking lot markedly protruded on backshore.

In the north part of this road, a parking lot markedly protruded seaward, while burying the natural sandy beach, as shown in Fig. 11. The coastal vegetation was destroyed and covered with concrete structures by the excess seaward advance of the parking lot. Figure 12 clearly shows the devastation of the coastal vegetation, as a result of the high utilization of the land close to the shoreline. The elevation of the backshore in front of the seawall was low and coastal vegetation was barely being grown.

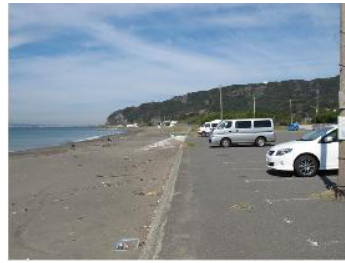
Fig. 12. Relation between parking lot and sandy beach.

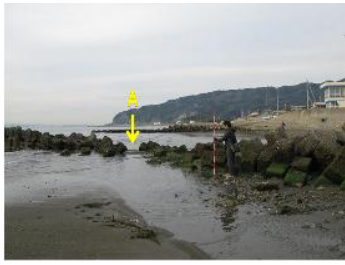
Figure 13 shows the tip of the permeable-type left bank jetty composed of concrete armor units. The concrete block near the low tide shoreline, as shown by arrow A, had markedly subsided, and there was an opening between the river mouth and the south beach, implying that longshore sand transport from the south beach to the river mouth is barely blocked by the left bank jetty. This implies that sand transport from the south beach to the river mouth could be possible through the gap, as shown in Fig. 6, since 2001. Figure 14 shows the foundation of the left bank jetty. On the south side of the jetty, a steel curtain wall was exposed by a height of 0.8 m, and also, a change in color was found on the surface of the concrete wall at an elevation of 1.5 m above the present ground level. This means that the sandy beach with an approximately 1.5 m thickness was eroded, decreasing the ground level.

Fig. 13. Opening in left bank jetty caused by subsidence of concrete blocks.

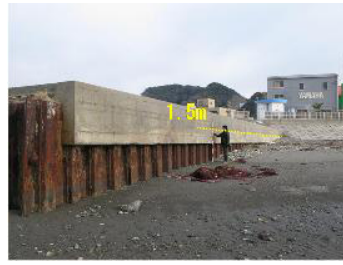
Fig. 14. Exposed foundation of left bank jetty .

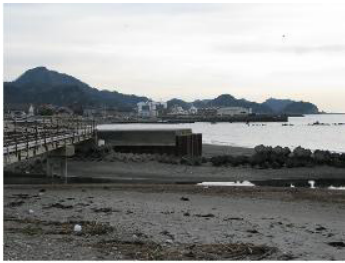
Figure 15 shows a photograph of the left bank jetty. At the tip of the left bank jetty, concrete armor units of low crown height were placed as a result of the subsidence. From this fact, it is inferred that sand movement between the south beach and the river mouth was possible, and each time that the sand dredging inside the river mouth was carried out, sand was transported from the south beach to the mouth. Figure 16 shows the inside of the sidewall on the left bank of the river mouth, and the change in the color of the seawall shows that the ground elevation was lowered in this area, showing evidence of the removal of the sand deposited inside the river mouth. Finally, Fig. 17

Fig. 15. Photograph of left bank jetty taken from right bank of river mouth.

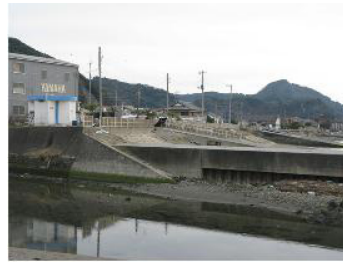
Fig. 16. Change in color of inside wall in river mouth.

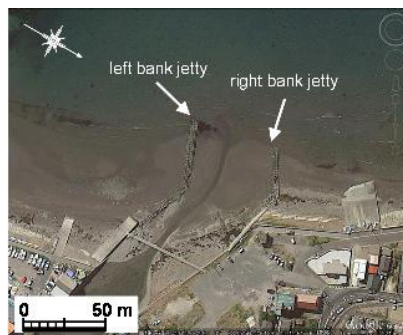
Fig. 17. Satellite image of Hota River mouth on March 29, 2012.

shows the satellite image of the Hota River mouth taken on March 29, 2012. The concrete armor units of the attachment of the left bank jetty to the impermeable jetty markedly subsided, making the sand transport from the south sandy beach to the river mouth possible.
