Procedia Engineering 132 (2015) 190 – 196

The Manufacturing Engineering Society International Conference, MESIC 2015

Experimental study of tapping wear mechanisms on nodular cast iron

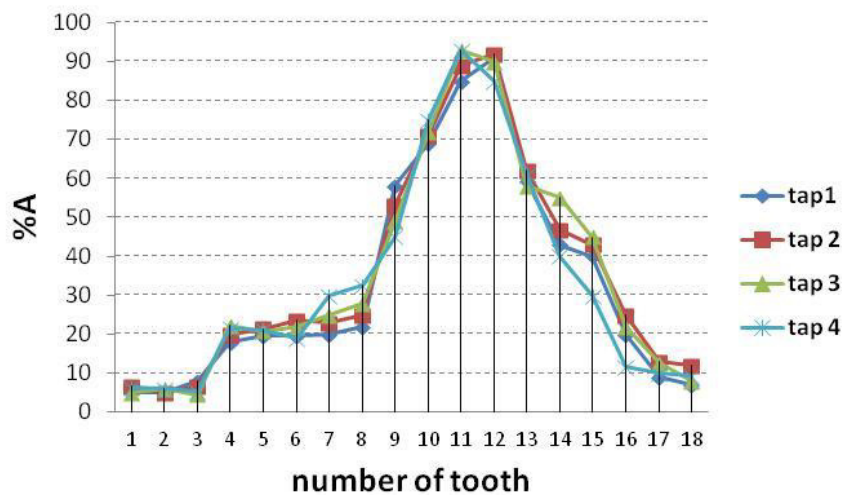
Figure 3 represents the %A parameter along the teeth of each tap. The wear profiles of all taps are similar. The first three teeth have a low level of wear, then the wear is incremented (15%) between the third and fourth tooth and

this level is kept until the sixth tooth. From the seventh tooth, the wear level increases quickly until the maximum is reached in the 11th or 12th tooth depending on the tap. The maximum average of all taps is 90%. The wear decreases gradually and in the 18th tooth has the same level as the first tooth.

Fig. 3. Evolution of %A on the teeth of taps

This graph indicates that the last chamfer teeth and the first cylinder teeth of a tap (see Figure 1) are the critical points. These last chamfer and first cylinder teeth are in a charge of sculpting the thread profile and keeping the tolerances, respectively. In this case the lack of quality is when the threads are under-sized. Therefore, the high wear levels are on the 11th and 12th teeth.

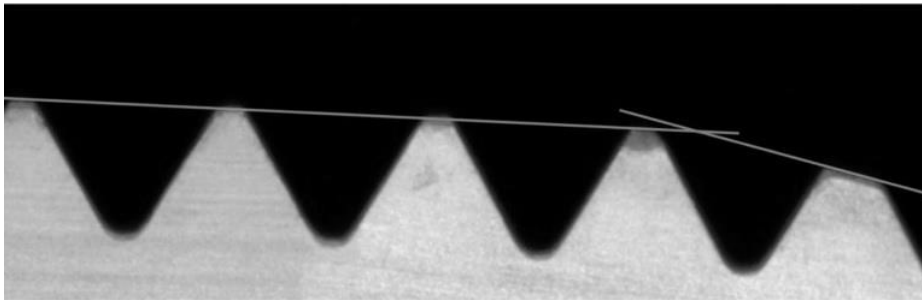
To illustrate the wear in detail, two images from new and worn taps are joined in Figure 4. The reason why the tapped threads become unacceptable (when the go gauge is unable to go) is always that the tapped threads major diameters are smaller than the dimensional tolerance permits because the wear of the tap teeth makes the main edges of all active teeth recede.

Fig. 4. Lack of quality: new and worn tap profiles.

These following teeth (11th, 12th, etc) present a shape, when they are new, closer to the thread profile since they are designed to calibrate the thread and not to remove work-piece material. Thus, the wear is propagated through the cylinder teeth (see Figure 4) generating a lack of thread quality, that is, the height of it is out of tolerance range and, therefore, the head of go gauge does not enter into the thread.

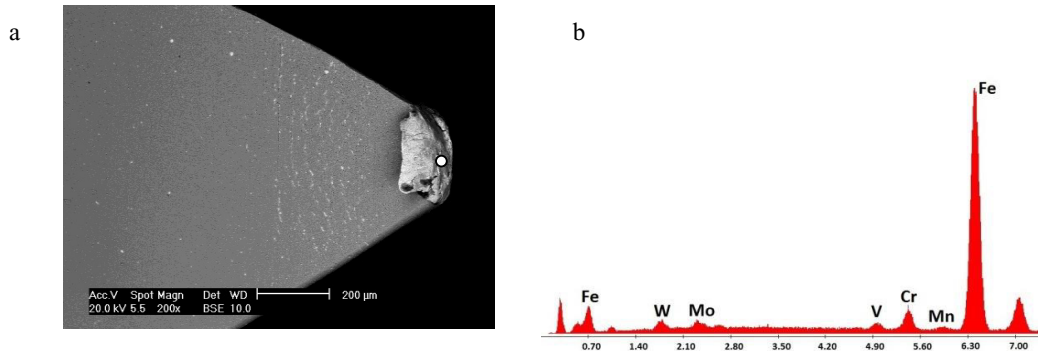
Figure 5 illustrates the adhesive wear on the clearance face of the 11th tooth and EDS analysis confirms the existence of adhesion owing to appearing Si or Mn from work-piece material on clearance face. These last chamfer teeth have to remove the work-piece material that the previous chamfer teeth have not eliminated it. The heat between tooth and piece increases and, consequently, adhesion mechanism appears.

Fig. 5. (a) The adhesion on the clearance face; (b) EDS analysis in the white point.

Figure 5b shows the existence of vanadium on the clearance face. This is evidence of coating removal that will be described below.

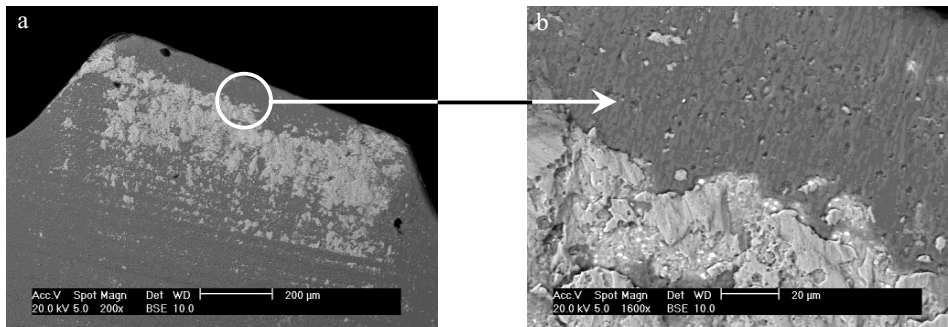
Not only is the adhesion mechanism on the clearance face but it also appears on the rake face as it is observed in Figure 6a. For more detail, see Figure 6b.

Fig. 6. (a) The adhesion on the rake face; (b) this adhesion in more detail.

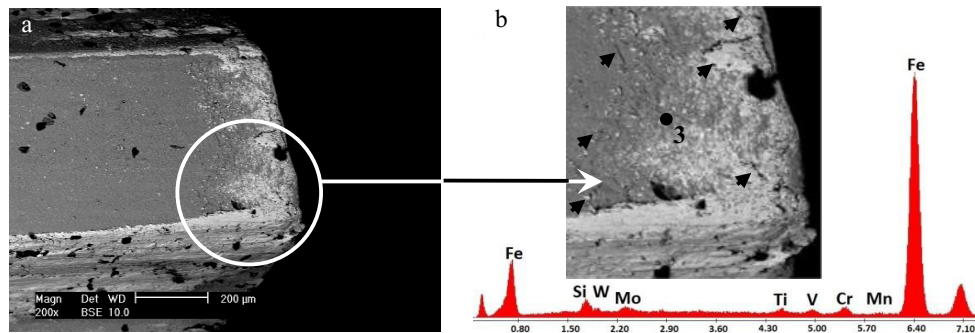
Coating removal is shown in Figure 7a. There are two lines (number 1 and 2 in the Figure 7b); the first line separates the TiN coating and the coating removal layers and the second line separates the coating removal and micro-welded layers. These layers diminish in height due to micro-chipping. The micro-welding material from work-pieces, when a thread is mating at high speed, is welded on TiN coating and then, when the tool is tapping the next thread, the cutting forces remove the welded material and the TiN coating together. Consequently, the substrate appears.

Fig. 7. (a) Coating removal on the clearance face; (b) this coating removal in more detail and EDS analysis in the black point.

The EDS analysis in a black point (number 3) of clearance face corroborates the existence of micro-chipping and coating removal as Mo, V and W are in the Figure 7b and they are the components of substrate (see Table 2).

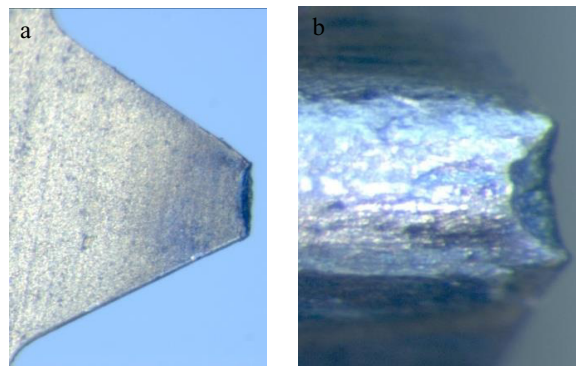
Figures 8a and 8b show the edge chipping in the 10th tooth. This great crater transforms this active tooth into inactive. Thus, the following teeth have to remove the material that this tooth has not removed.

Fig. 8. Edge chipping shown from (a) the rake face; (b) the clearance face, 5x image and 10x image, respectively.
