Case Studies in Engineering Failure Analysis

Failure analysis of a machinable brass connector in a boiler unit installation

George A. Pantazopoulos*, Anagnostis I. Toulfatzis

ELKEME Hellenic Research Centre for Metals S.A., 252 Pireaus Str., 17778 Athens, Greece

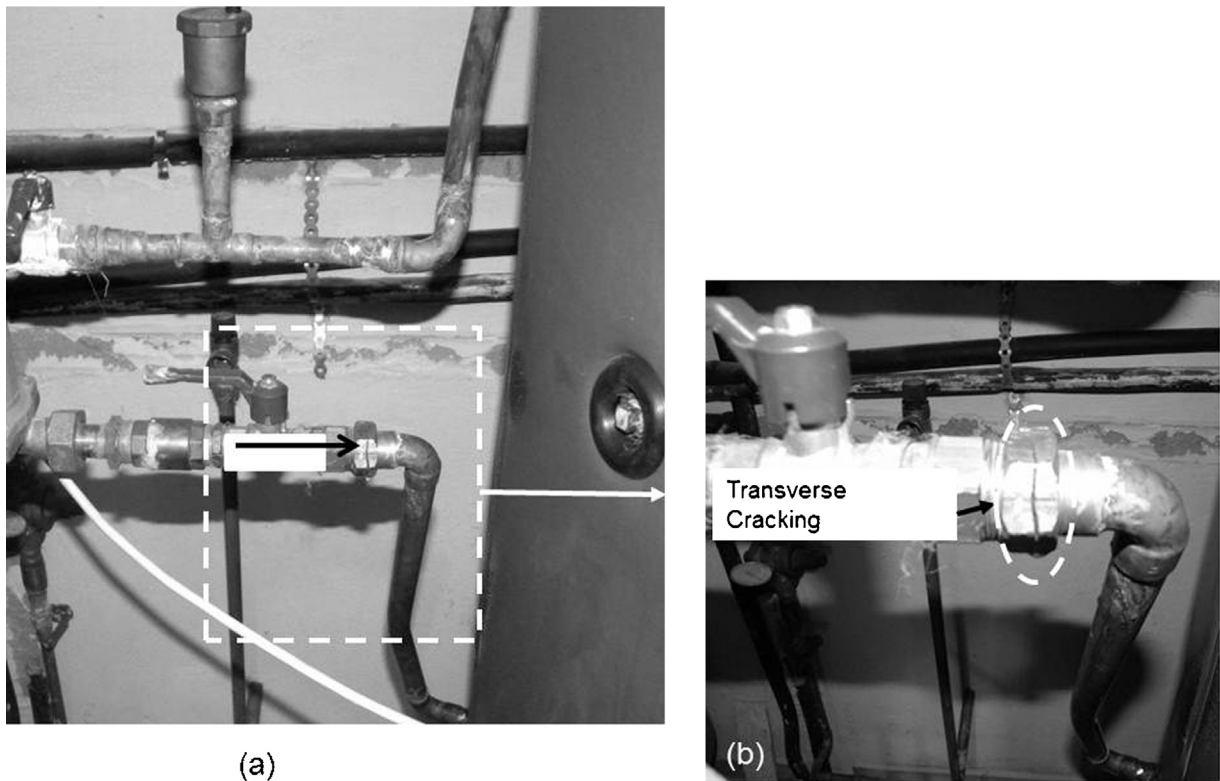
A failure of brass hexagonal threaded connector (nominal Across Flats = 33 mm) consisted of transverse cracking, was the reason for extensive leakage and interruption of water heating installation, being for almost two years in-service (Fig. 1). Operating conditions of boiler circuit are reported in Table 1. Visual inspection, light microscopy and SEM/EDS analysis were used as the principal analytical methods in the present investigation.

Fig. 1. Image showing the boiler installation and cracked hexagonal brass connector.

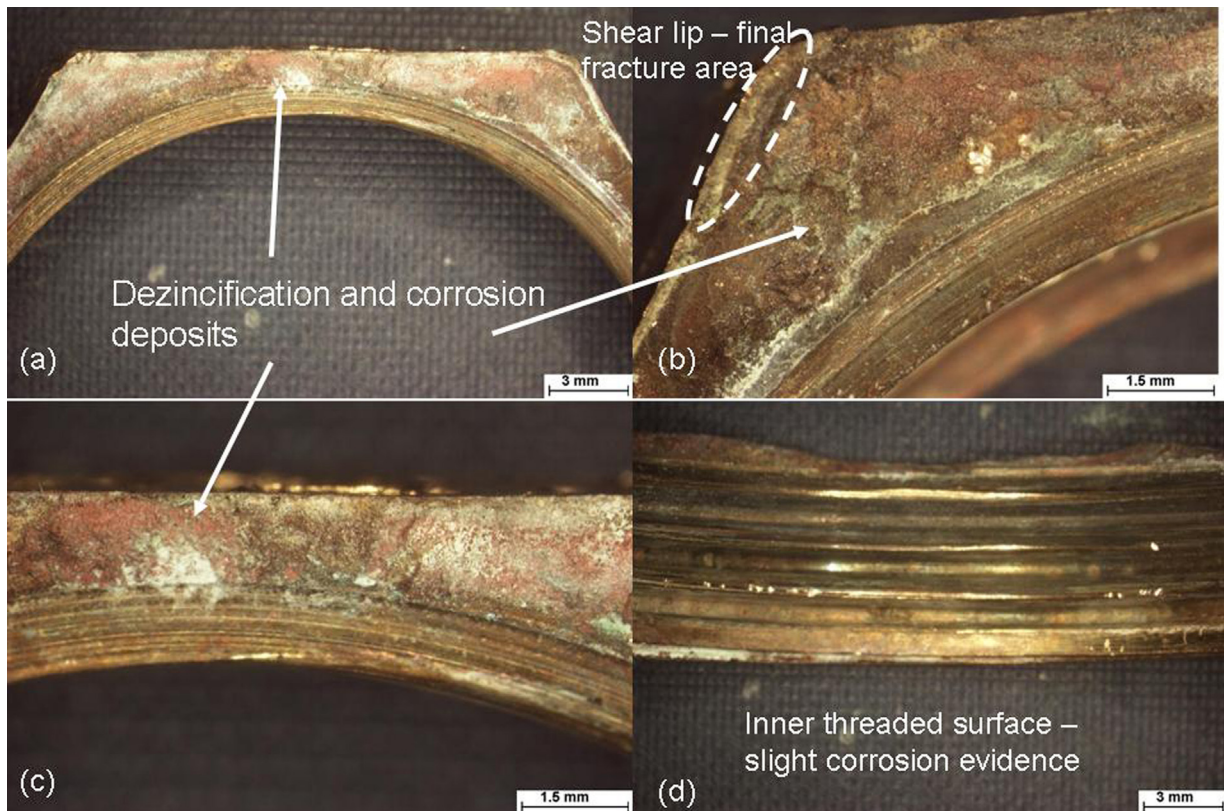
The failed brass connector was examined after disassembly from tubing and appropriate sectioning to expose the fracture surfaces. Metallographic sampling was also made normal to the direction of crack propagation. Macro-fractographic examination showed intense surface damage due to the accumulation of corrosion deposits and dezincification phenomena (red-coloured areas) attributed to and post-fracture processes (Fig. 2a–c). However, slight dezincification processes were noticed on the outer connector surface at the leakage area. No macroscopic plastic deformation was involved. These preliminary stereo-microscopic observations advocate that crack was initiated most probably on the inner threaded area and propagated towards the outer showing a characteristic shear-lip as the final fracture area (Fig. 2b). The inner threaded surface did not show significant corrosion damage (Fig. 2d).

Fig. 2. Optical stereo-micrographs showing the fracture surface of the brass connector. Note intense corrosion scale accumulation and evidence of dezincification phenomena. (For interpretation of the references to color in the text, the reader is referred to the web version of the article.)

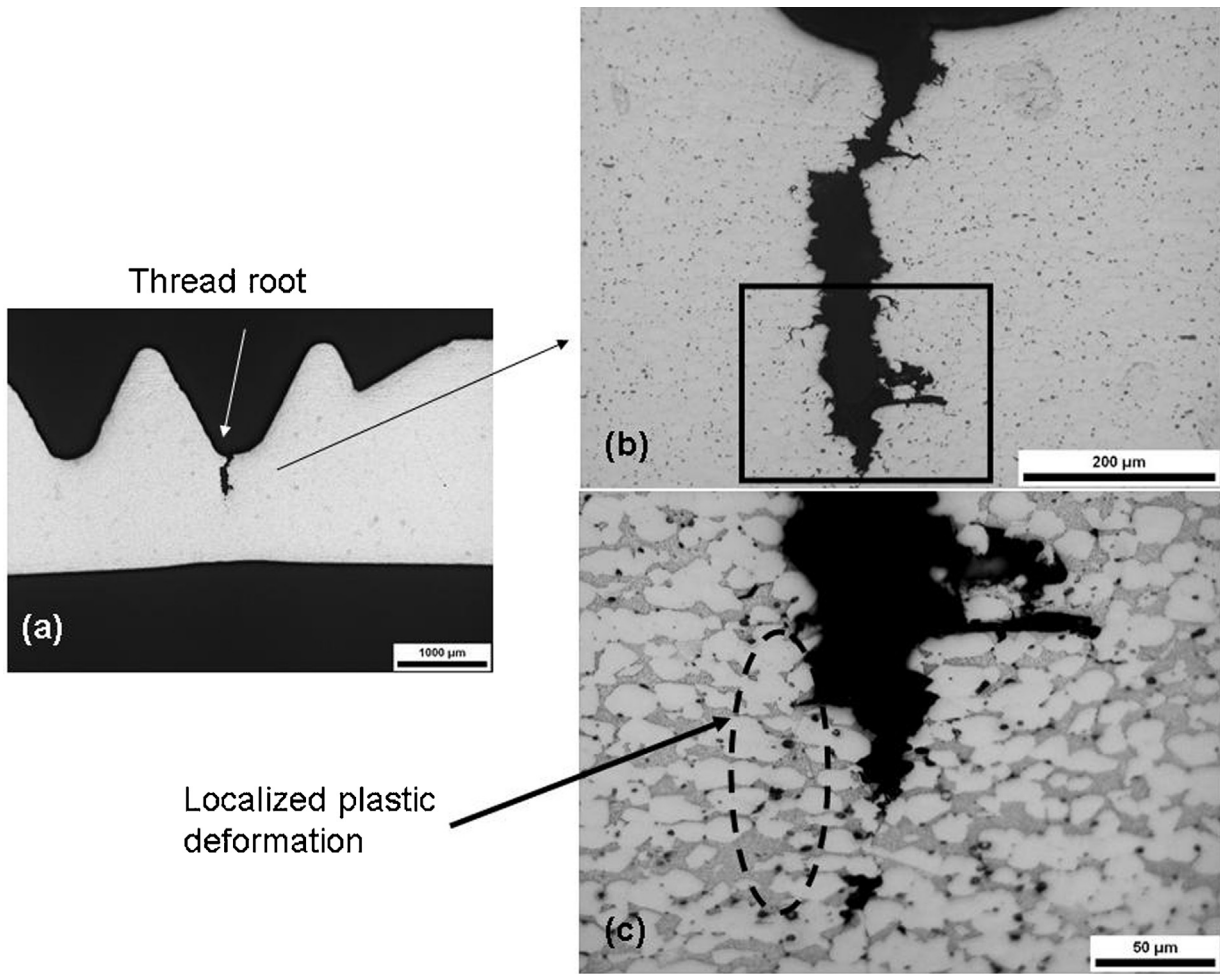
Metallographic observations confirmed the hypothesis of the inside-out crack propagation (Fig. 3a). Moreover, the crack was initiated at the thread root due to local stress concentration and at the transition area from engaged thread to the connector shank. Crack initiation shows a slight deflection due to the associated shear stresses applied at final thread cutting or fastening during installation period (Fig. 3b). The main crack front manifests principally a radial transgranular

propagation mode accommodating secondary crack branches (Fig. 3b and c). The microstructure is typical of α - β machinable brass manufactured by extrusion and drawing showing an almost uniform Pb-particle distribution (Fig. 3c). Hardness values are in a relative narrow range, i.e. 127–139 HV_{0.2} from outer to threaded surface area respectively, consistent to half hard temper. Localized plastic deformation occurred close to the crack tip (Fig. 3c).

Fig. 3. (a) Optical micrograph of the transverse section showing the origin of crack, emanating from the inner thread root; (b) and (c) details of (a) showing the cracking mode. Note the presence of α (light areas) and β phase (dark areas) together with uniform Pb particle distribution (black dots).

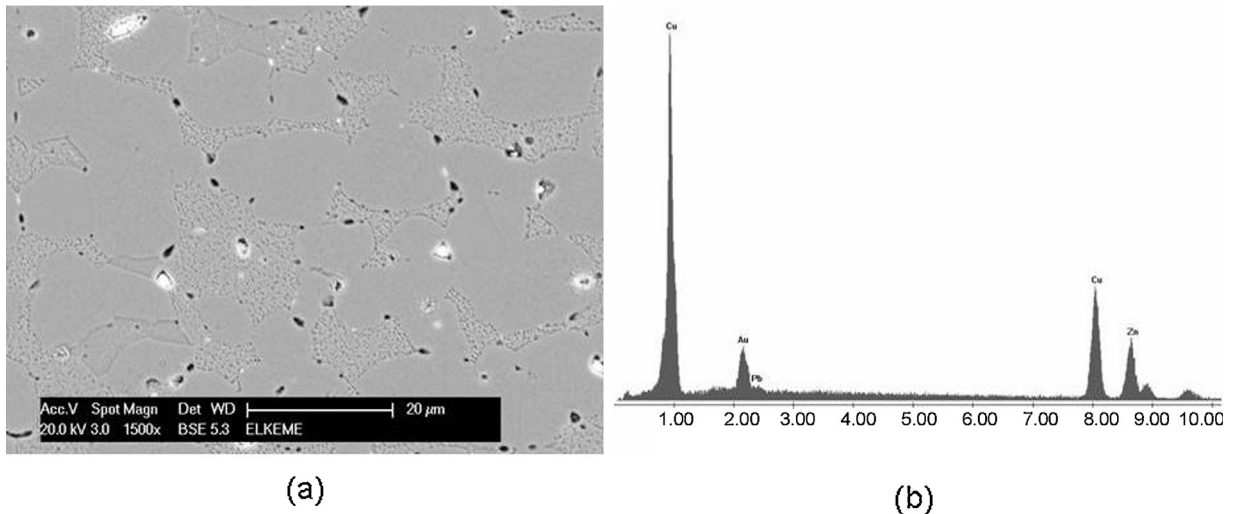
SEM observations and semi-quantitative EDS microanalysis suggest that the alloy used for connector matches approximately to CuZn40Pb2/CuZn39Pb3 grades which are commonly used for the production of machined components for hydraulic installations (Fig. 4). Close observations of the principal crack revealed surface damage and localized plastic deformation while coarse Pb particle concentration is noticeable at the crack initiation area. Mechanical damage and high local Pb concentration may constitute inherent weaknesses assisting crack initiation (Fig. 5a). Secondary intergranular branches may be originated from stress-corrosion-cracking occurred as a post fracture process, inducing radial stress relaxation (Fig. 5b). Searching adjacent thread root areas, surface flaws constituting prominent areas for crack initiation were discovered (Fig. 5c and d).

Fig. 4. (a) SEM micrograph and (b) corresponding full-frame EDS spectrum showing the elemental composition of the selected area. The semi-quantitative chemical composition indicates that the alloy matches approximately to CuZn40Pb2/CuZn39Pb3 machinable brass grades.

The substitution of the present material with an alternative brass alloy, such as the DZR (Dezincification Resistant) CuZn36Pb2As alloy will increase the dezincification resistance and reduce the SCC sensitivity. The addition of trace elements such as Sb or, in this case, As (up to 0.15%) and, on the other hand the lower amount of β -phase ($\leq 5\%$) provides a shielding effect against dezincification. Moreover, this alloy exhibits higher ductility and fracture toughness demonstrating, therefore, higher resistance in crack propagation. A comparison study of mechanical properties of brass alloys CuZn39Pb3 and CuZn36Pb2As is presented in [3]. Finally the assurance of proper installation following the torque and alignment specifications during assembly will keep internal stress at low level, improving the reliability of the operation of the boiler unit.

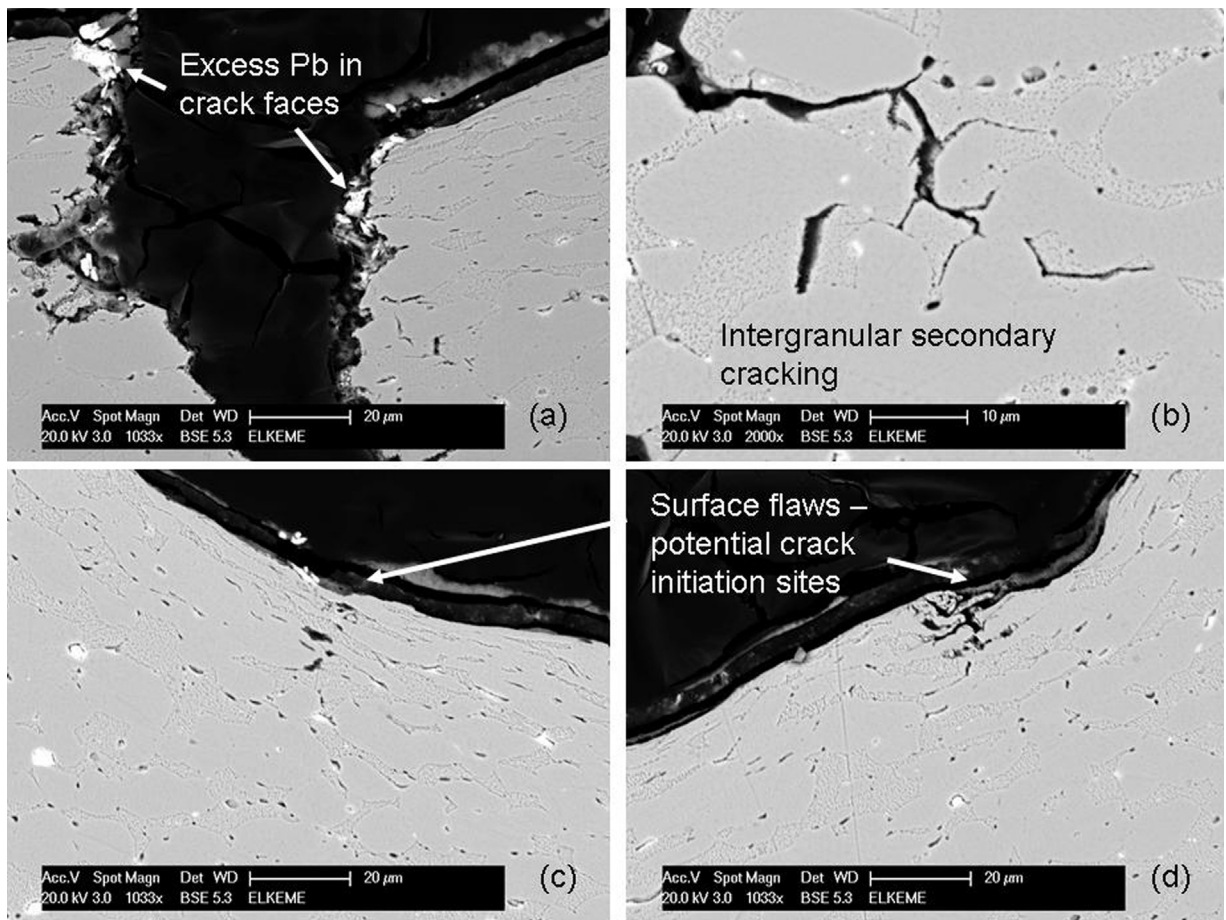
Fig. 5. SEM micrographs depicting details of cracking mode: (a) initiation area showing locally the presence of higher Pb particle size, (b) secondary intergranular branching, (c) and (d) surface flaws observed on the inner threaded surface which constitute potential crack initiation sites.

region which acts as stress raiser. In addition, the inclined form of the initiation site suggests prior existence of surface flaw that triggered the crack. The existence of coarse Pb particles on the crack faces could be an additional weakness assisting in crack initiation. Overheating incidents in metal working processes could cause hot-shortness coming from Pb particle melting and coalescence, see also [6]. However, the overall Pb distribution seems fine and uniform through the entire section examined. Surface flaws were also evident in adjacent areas of the inner thread grooves attributed to mechanical damage and/or localized dezincification (Fig. 5c and d). It is noteworthy also to mention that dezincification was also noticed on the outer surface (red-coloured areas) at the leakage region, verifying the sensitivity of the material against dezincification. Moreover, this grade of brass alloy exhibits also a considerable susceptibility in stress-corrosion-cracking (SCC), which constitutes a common in-service failure mechanism.

- Alloy selection revision: dezincification brass alloy (e.g. CuZn36Pb2As) will offer a protective effect against dezincification and SCC together with higher ductility and fracture toughness.
- Quality assurance of the installation and assembly procedure: compliance with fastening torque and alignment requirements, foreseen by boiler unit assembly.
