Safety and Health at Work

Large Steel Tank Fails and Rockets to Height of 30 meters – Rupture Disc Installed Incorrectly

At a brewery, the base plate-to-shell weld seam of a 90-m³ vertical cylindrical steel tank failed catastrophically. The 4 ton tank “took off” like a rocket leaving its contents behind, and landed on a van, crushing it. The top of the tank reached a height of 30 m. The internal overpressure responsible for the failure was an estimated 60 kPa. A rupture disc rated at < 50 kPa provided overpressure protection and thus prevented the tank from being covered by the European Pressure Equipment Directive. This safeguard failed and it was later discovered that the rupture disc had been installed upside down. The organizational root cause of this incident may be a fundamental lack of appreciation of the hazards of large volumes of low-pressure compressed air or gas. A contributing factor may be that the standard piping and instrumentation diagram (P&ID) symbol for a rupture disc may confuse and lead to incorrect installation. Compressed air systems are ubiquitous. The medium is not toxic or flammable. Such systems however, when operated at “slight overpressure” can store

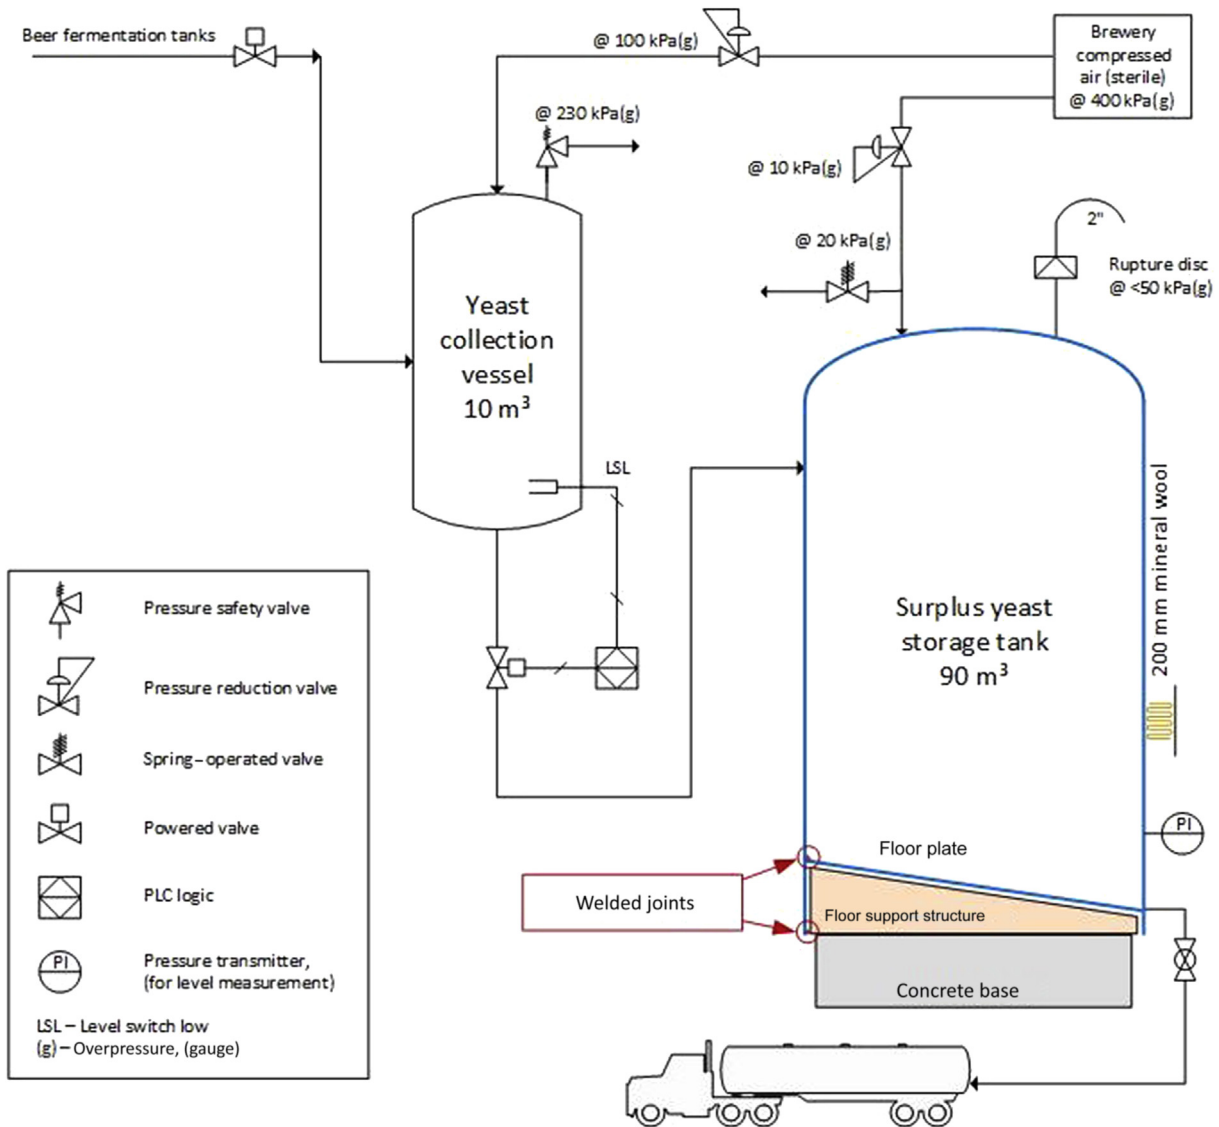
At a Danish brewery, surplus yeast slurry is first collected in an indoor yeast collection vessel and then transferred to an outdoor storage tank (Fig. 1).

Fig. 1. Schematic representation of the surplus yeast system.

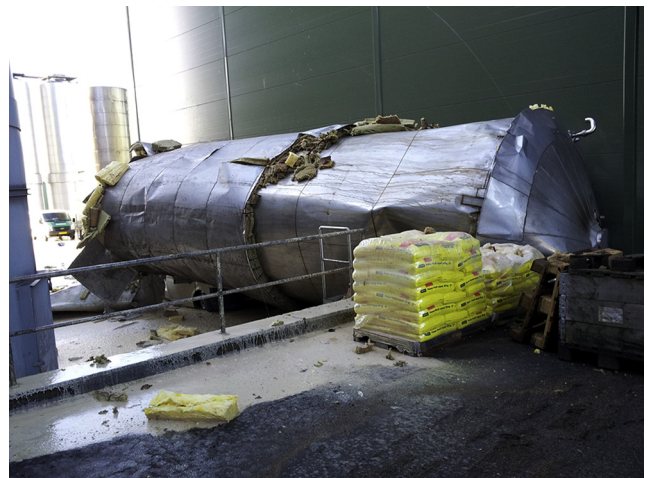
Fig. 2. The van is visible under the tank. The tank contents washed up on the elevated platform. (Photo courtesy of the company.)

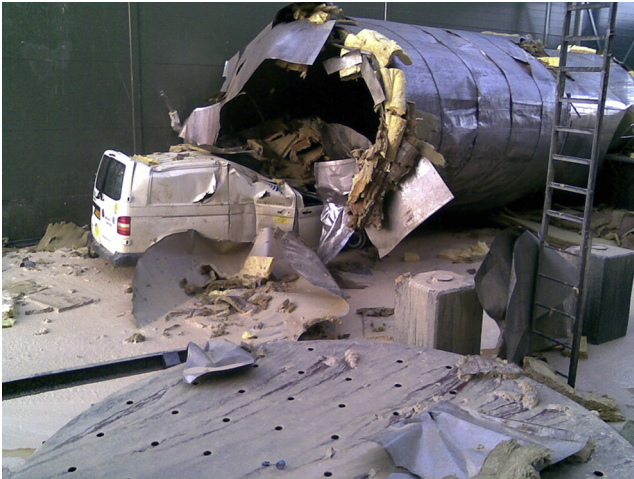
Fig. 3. The tank landed on the van and crushed it. The tank's original position (the sloping support structure for the tank floor plate) is in the foreground. The tank floor plate is center left. (Photo courtesy of I.W. Michaelsen.)

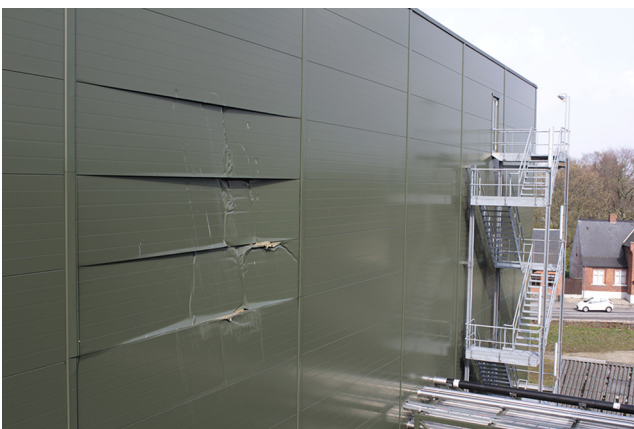
were absent from two adjacent arc sections each of which was ~ 0.5 m long. This was identified as the probable point of failure initiation. The two arc segments were positioned opposite the tall green building which would imply that the tank would tilt towards that building immediately before rocketing. This is consistent with the impact damage to the building's exterior panels when the tank descended (Fig. 4).

Fig. 4. The tank rose nearly vertically in the air, and the base of the tank rose higher than the 19-m tall green building. While descending, the tank impacted and deformed the building's exterior wall panels. (Photo courtesy of F.H. Hedlund.)

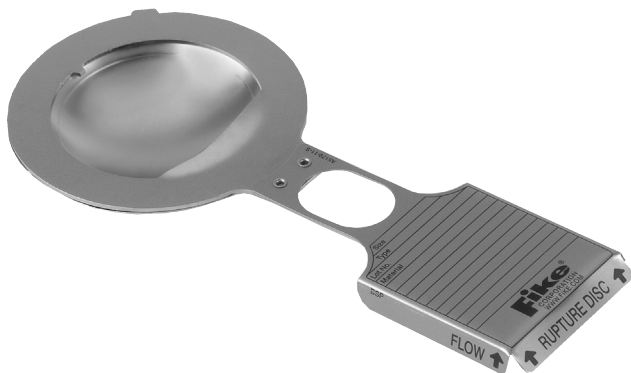
The rupture disc was intact. It was a reverse buckling type device that had been installed upside down (i.e., with the dome facing away from the tank). The vendor stated that the rupture disc likely

could withstand an overpressure of at least three times the pressure marked on the rating plate (i.e., ≥ 150 kPa) before bursting, if it were installed upside down.

To guide correct installation, the arrow printed on the rating plate indicates the direction of the pressure relief (Fig. 5). However, the dome itself can point either way, depending on the type of design, and gives no reliable indication of the correct direction of installation.

Fig. 5. The reverse buckling type rupture disc (the dome points towards the fluid under pressure) is similar to the one installed on the incident storage tank. Proper flow direction of pressure release is marked on the nameplate. (Photo courtesy of Fike Corporation.)

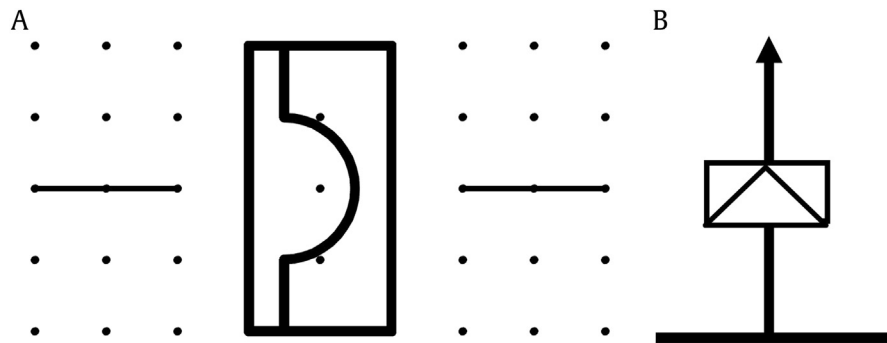
Fig. 6 shows the symbols used to represent a rupture disc on piping and instrumentation diagrams (P&IDs) recommended by the ISO 10628 standard [17] and the American National Standards Institute/International Society of Automation (ANSI/ISA) Standard 5.1 [18]. Assuming a conventional left-to-right reading direction, the ISO symbol clearly depicts a forward-acting disc type. The ISA rectangle symbol could easily be interpreted to do so as well. The installation of a rupture disc requires no specialized training. The

symbols might possibly mislead a less experienced pipe fitter to believe that the dome should be installed facing away from the tank. This would result in the upside down installation of a reverse buckling type disc.

Fig. 6. The recommended symbols used to represent rupture discs for overpressure protection bear resemblance to the conventional forward-acting type and may confuse workers about the correct installation of the reverse buckling type. (A) ISO 10628 standard [17]; (B) ANSI/ISA Standard 5.1 [18].
