## Case report

# Adverse tissue reaction to corrosion at the neck-stem junction after modular primary total hip arthroplasty

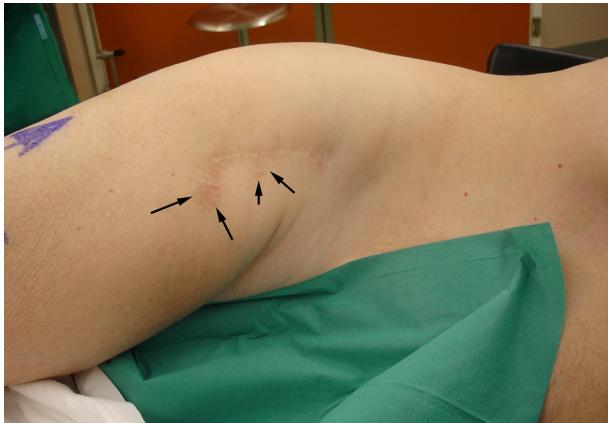
The patient reported gradually worsening hip pain 1 year later. The scar showed no signs of infection but was surrounded by dry eczema lesions typical for hypersensitivity (Fig. 1). Plain radiographs showed osteolysis of the calcar adjacent to the neck-stem junction (Fig. 2). Serum C-reactive protein was 56 mg/L, without leucocytosis. Cobalt and chromium levels were 7.72 µg/L and 1.61 µg/L, respectively. Milky fluid was aspirated from the joint and

**Fig. 1.** Eczema at revision surgery, located around the scar left by the direct anterior approach used for the primary procedure.

The eczema observed before revision surgery was not further evaluated. However, metal-induced cutaneous hypersensitivity reactions have been reported after arthroplasty [15]. The resolution of the skin lesions after implant removal in our patient suggests metal-induced eczema.

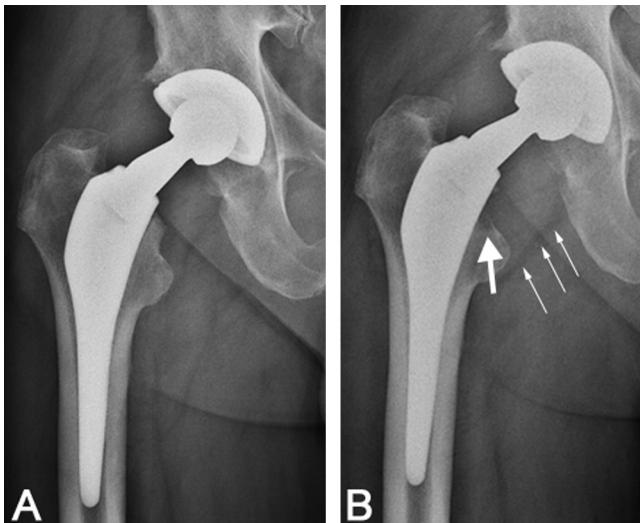
**Fig. 2.** Radiographs obtained immediately after total hip arthroplasty (A) and 1 year later (B): note the osteolysis of the calcar (bold arrow) and the periarticular soft-tissue lesion (small arrows).

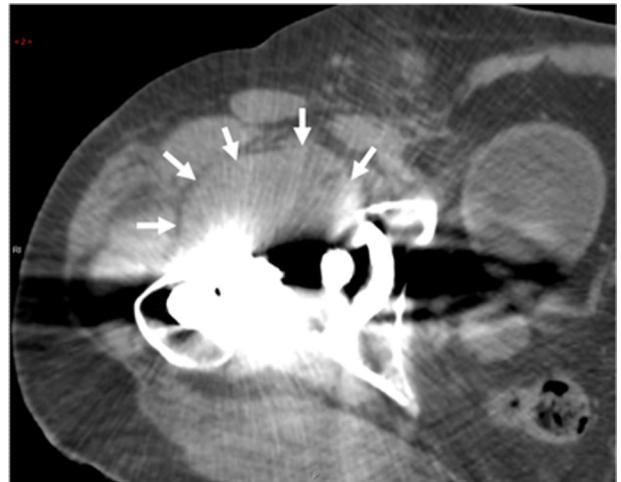
showed no growth upon culturing. A pseudo-tumour was visible around the prosthesis by both CT and magnetic resonance imaging (MRI) (Figs. 3 and 4).

**Fig. 3.** Axial computed tomography image with multiplanar reconstruction along the axis of the prosthesis neck, showing a periprosthetic lesion of tissue-density (white arrows) in contact with the anterior aspect of the prosthesis neck.

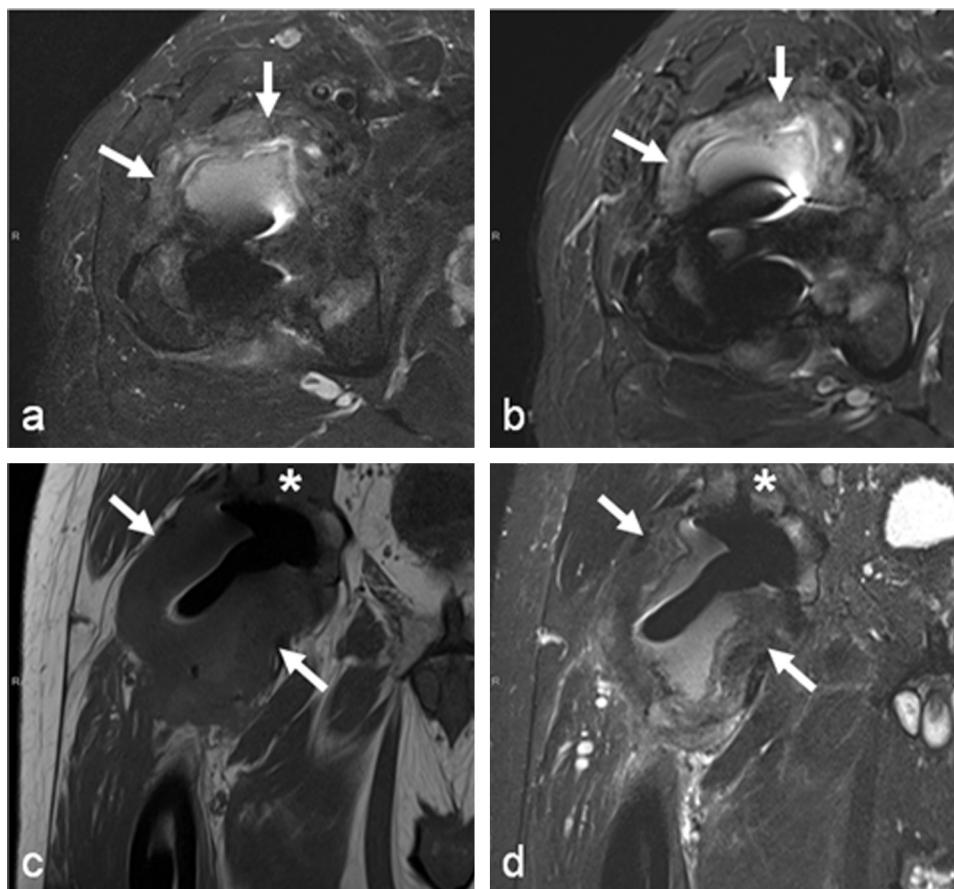
**Fig. 4.** Axial (a and b) and coronal (c and d) magnetic resonance images (MRI), processed using metal-artefact reduction software (MARS): note the periarticular lesion ( $8 \times 9 \times 10$  cm) generating hyperintense signal (arrows) on fat-suppressed proton density (FSE, a) and STIR (d) images and hypointense signal on T1 FSE images (c), with a thick enhancing rim but no nodular enhancement (b). The iliac muscle is involved (asterisk).

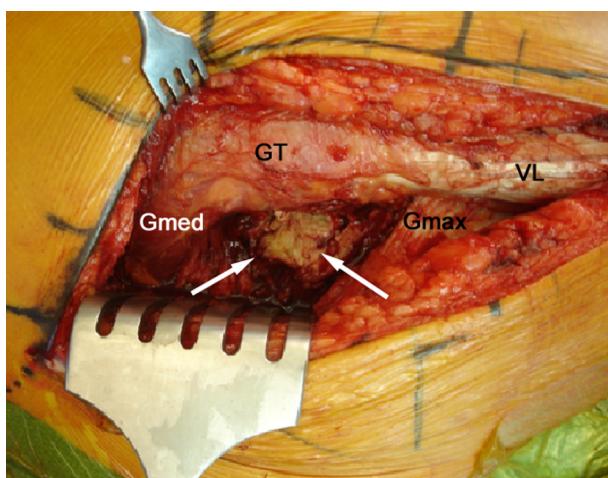
Revision arthroplasty with exchange of the stem, head, and liner was performed. An extensive periprosthetic cystic lesion surrounded by a thick fibrous capsule (Fig. 5) and filled with milky fluid was drained and excised. Reconstruction was with an all-titanium modular revision stem (Lima Corporate, Udine, Italy) and ceramic head. The postoperative course was uneventful. Weight bearing was protected for 6 weeks. Serum cobalt and chromium ion levels were 4.83 µg/L and 1.87 µg/L, respectively, after 6 weeks.

**Fig. 5.** Pseudo-tumour (arrow) at revision surgery. GT: greater trochanter; VL: vastus lateralis; Gmed: gluteus medius; Gmax: gluteus maximus attachment site.

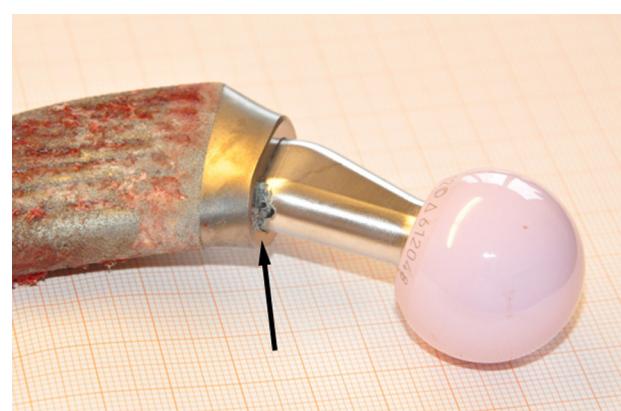
Histological analysis of the resected tissues was consistent with aseptic lymphocytic vasculitis and associated lesions (ALVAL). Disassembly of the retrieved implant (Fig. 6) required the use of a pneumatic press. Gross damage to the interface was visible (Fig. 7). Scanning electron microscopy and energy dispersive X-ray analysis (EDX) detected evidence of fretting corrosion at the cone of the neck-stem junction (Figs. 8 and 9) with deposits measuring several micrometres in thickness and composed of oxidised chromium, molybdenum, and titanium. The presence of titanium indicated transfer of material from the stem onto the cobalt-chromium neck during fretting. Changes were minimal at the neck-ceramic head interface.

**Fig. 6.** Explanted stem showing signs of corrosion at the neck-stem junction (arrow). Of note, the junction could not be disassembled manually.

The stem was replaced by a revision stem, which was also of modular design. However, all revision stem components were made of titanium, and consequently, no recurrence of metal-related adverse reactions was expected. We are not aware of reports of metal-related pseudo-tumours due to titanium alloys.

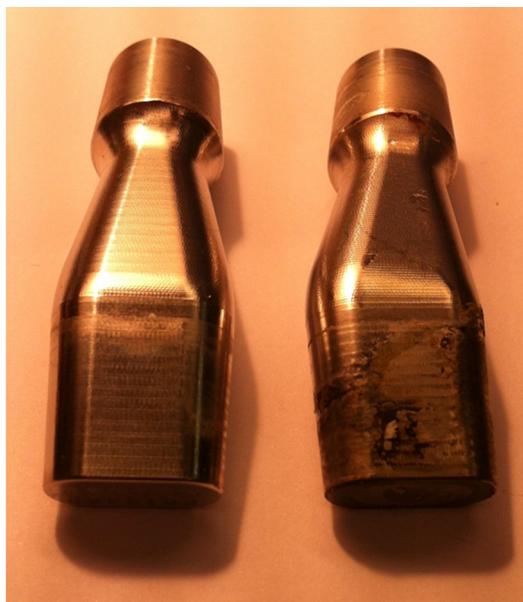
**Fig. 7.** Significant damage to the surface of the retrieved cone (right) compared to an unused cone (left).

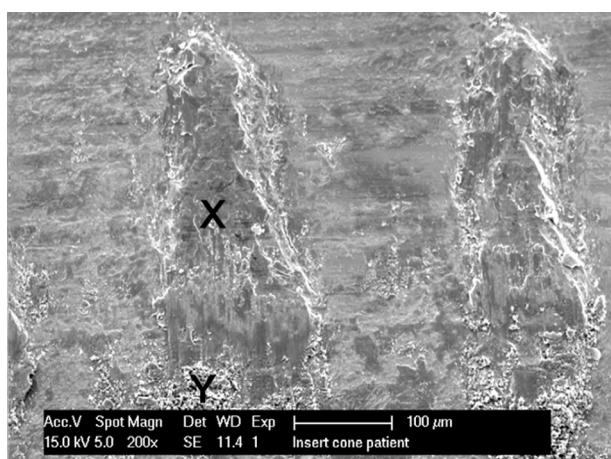
The deposits on the neck taper were composed of oxides of cobalt, chromium, and titanium. As the neck was made of cobalt-chromium alloy, the presence of titanium indicated transfer of titanium from the stem onto the neck. Interestingly, the deposits contained more chromium than cobalt. This finding, together with the high serum cobalt levels, was consistent with the marked solubility of cobalt ions and strong tendency of

**Fig. 8.** Scanning electron microscopy of the cone at the neck-stem junction: note the smeared deposits (X) of compacted metal debris (Y) shed during micromotion.

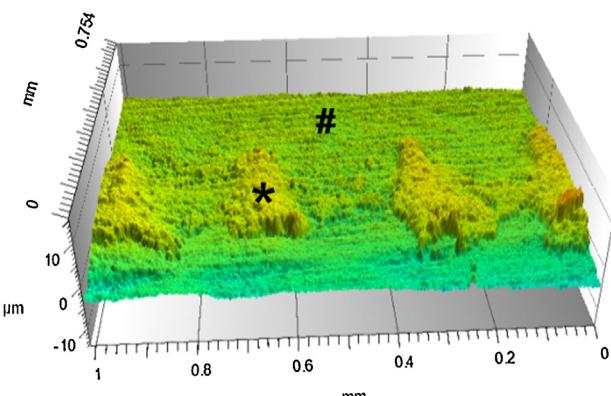
Analysis of the retrieved implant indicated fretting corrosion [4]. Thus, the morphological assessment of the cone at the neck-stem junction revealed corrosion-related deposits alternating with areas of unchanged machined surface. This pattern indicated incomplete contact between the cone and taper, allowing micromotion and promoting corrosion. The microscopic pattern of the deposits smeared on the taper further supported micromotion. Although the neck-stem junction was too strong to allow manual disassembly, micromotion occurred. Of note, it is our practice to take great care with dry assembly of the neck-stem junction on the back table [16]. We selected the best neck option based on preoperative 3D CT findings [9].

**Fig. 9.** White light interferometry of the cone: deposits about 4 μm in thickness (\*) surrounded by zones of unaltered machined surface (#). This pattern indicates incomplete contact between the neck and stem.
