Procedia - Social and Behavioral Sciences 170 (2015) 27 – 36

A Case Study on Moisture Problems and Building Defects

Nur Liyana Othman^{*}, Mastura Jaafar, Wan Mariah Wan Harun, Fuziah Ibrahim*School of Housing, Building and Planning, Universiti Sains Malaysia, Malaysia*

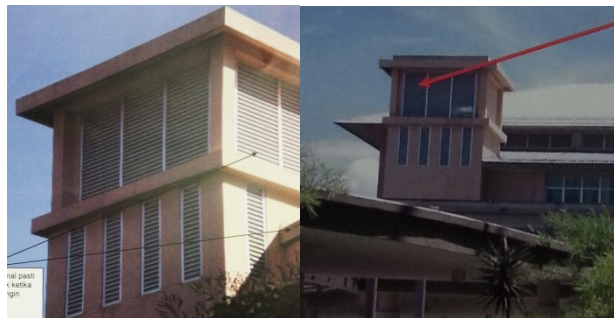
For the ceiling issues, most of the moisture problems are leaking and condensation. One of the leaking causes is improper design. The leaking always happens at the Medical Outpatient Department (MOPD) Specialist Clinic, Administration Office, Intensive Cardiology Laboratory (ICL) Clinic and Store room at High Dependency Ward (HDW) due to rainwater entering the building through the louvres window, then crawling through the air ducting then to the ceiling. Figure 1 below shows the short awning for the roof which enable the rainwater to enter into the building. Hospital Sultanah Bahiyah is a high rise building, surrounded by paddy field with no big or huge tree, expose to strong wind and heavy rain.

Fig. 1. Cause of leakage: rainwater enters through the louvres due to shortness of awning

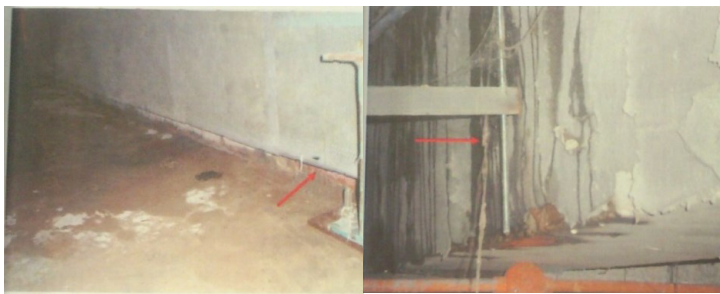
Most of problems arise due to poor workmanship. Ceiling leakage also caused by improper installation of waterproofing. Figure 2 shows the leakage problems came from AHU room which is located above the Operation Theatre room area. There are no waterproofing layers at the AHU room slab. Besides that, the improper plastering works at the AHU room wall had cause water seepage through the exterior wall then spread into the concrete slab and beam to the Operation Theatre room ceiling. The improper drainage such as scupper drain contributed to this matter. Result from this issue are stains of water marks, stalactite and stalagmite and mould growth at the Operation Theatre concrete ceiling. Indoor pollutants like this could contribute to: 1. failure of bacteria count test at the operation theatre and 2. the movement of the beam that supported the wall. The movement of this structural element could happen due to deterioration of the concrete and corroded steel reinforcement because of continuous in contact with water or aggressive chemicals over the years and will jeopardize the structures. The leakage problem also happened at many roof areas due to no inadequate gradient level and waterproofing failure will contribute to the water seepage through the wall then spread into the concrete slab and beam then to the ceiling.

Fig. 2. Leakages due to poor workmanship at AHU room above Operation Theatre (a) The improper wall plastering at AHU room, the water can enter through the wall (b) The leakages sign at the beam under the AHU room slab

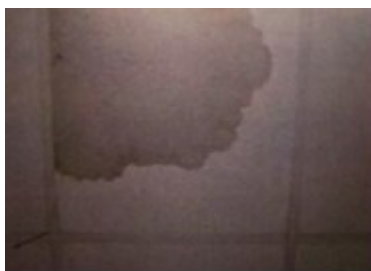
The next cause of defect is condensation. The issue of condensation affect the ceiling because the different temperature has created the water drop below the floor slab and above the ceiling. The issue of water drop above the ceiling also caused by no insulation layer on an outlet pipe, refrigerator pipe, ducting air conditioner and other type of pipe as shown in Figure 3 below. Thus, it creates the watermarks on the ceiling.

Fig. 3. Watermarks on ceiling due to water drop (condensation) from Exhaust Fan Ducting system at Pharmacy Store

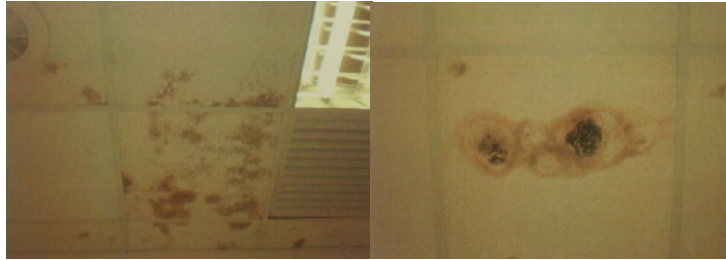
Figure 4 shows the ceiling dampness and has mould growth due to condensation problem. The condensation happened due to different temperature between the floors above and below. This picture explains at the Rehabilitation Unit which is below the Pathology Unit and Blood Bank Room. The temperature of Rehabilitation Unit is 22°C compared to Pathology Unit, and Blood Bank is 19.5°C. The separation floor has not been equipped with any thermal barrier to avoid the heat transfer between two

floors. The situation happened because the room above operated 24 hours however the room below only operated for 8 to 12 hours. Therefore, the difference of temperature between two floors created the heat transfer.

Fig. 4. Condensation cause dampness and mould growth at the Rehabilitation Unit's ceiling

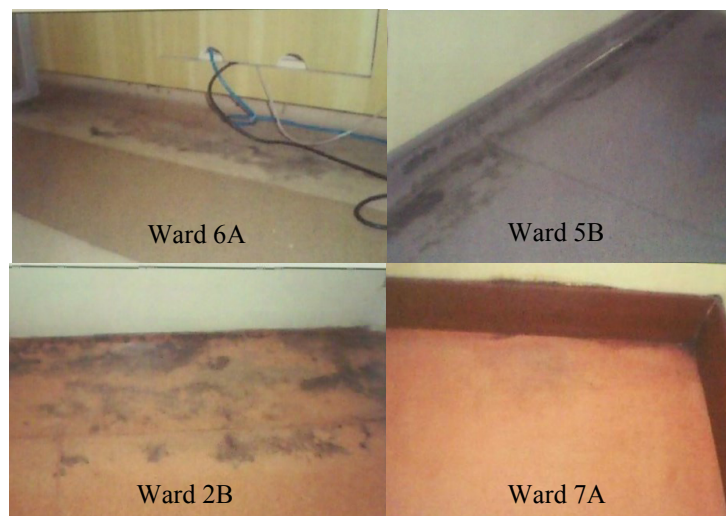
The moisture problem that happens on the floor is water seepage that is related to the improper waterproofing installation. The affected area is at vinyl and carpet floorings outside the toilet areas as shown in Figure 5 below. The water from the toilet area penetrated through the concrete slab. Based on inspection in year 2008, the areas that were affected from this leakage problem were medical area level 2 and Toilet, Corridor, Room 2B, Room 5-8, On Call Room (OCR) and Ward 2A at level 3. However within the next 4 years, the leakage problem has spread to the whole 7 Storey Ward Block. As a result, it creates building defects such as black staining and mould growth. If this problem is not resolve, it will rust the reinforcement bar and cause concrete spalling problem at the soffit slab.

Fig. 5. Black staining and dampness on floor finishes at 7 Storey Ward Block due to water seepage from toilet area

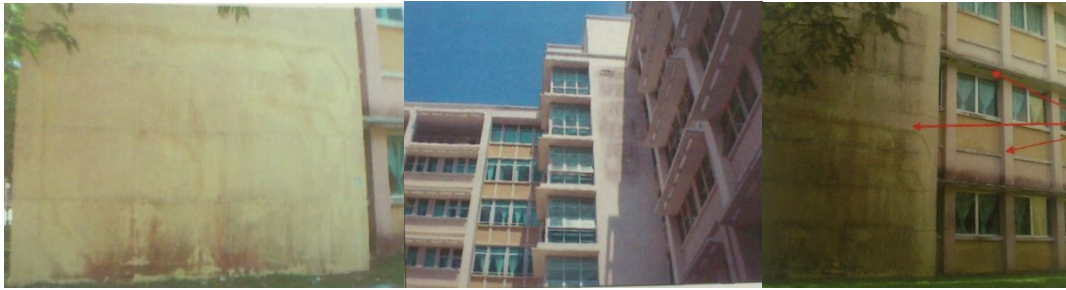
After four (4) years running the operation, the defects were clearly seen at the external wall of Hospital Sultanah Bahiyah building. The external wall paintings at a few locations of the building started to faded and were stained. Fungus and algae infected due to continuous dampness of the wall, dirt collection on wall and natural causes. On the other hand, the temperature inside the hospital building and outside has a

huge different that causes the sweating of wall due to the condensation process. As a result, mould growth appeared and there was discolouration to the wall. All the moisture problems arise due to environment factors and condensation as shown in Figure 6 below.

Fig. 6. Wall staining and paint discoloured at Hospital's external wall due to environments and condensation factors

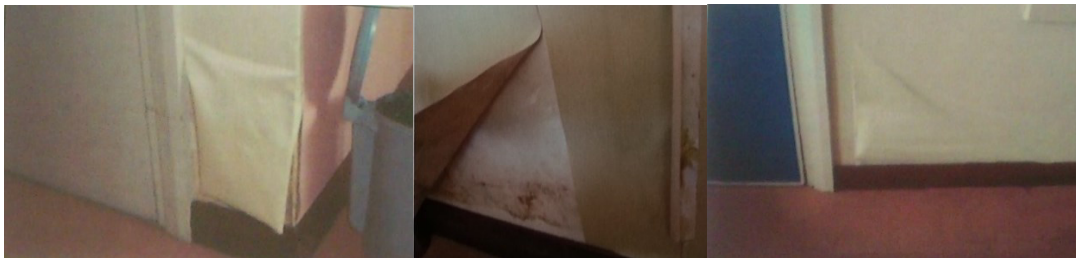
Besides that, the water seepage from the toilet areas also affected the internal wall buildings. Observation showed that the peeling paint and blistering of wallpaper finishes occurred due to failure of water proofing layers on the toilet wall that caused water to penetrate through the toilet wall and affect the perimeter wall outside as shown in figure 7 below. It happened at medical ward 7A and 7B at level 7, 6A and 6C at level 6 Ward Block.

Fig. 7. Peeling of wallpaper at level 7 and 6 Ward Block due to waterproofing failure

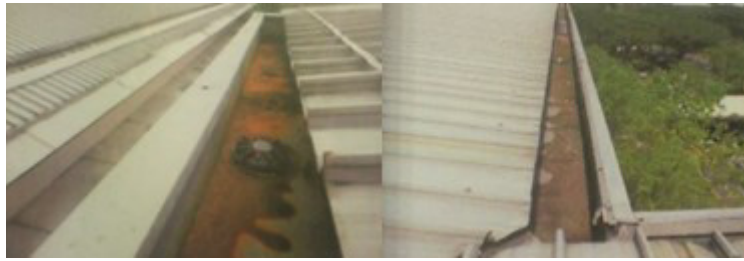
For roof element, the defect is corrosion at the roof gutter which leads to the leakage problem as shows in figure 8 below. The improper installation of galvanized iron gutter which is the gradient of roof gutter was not levelled well to flow the rain water into the rainwater downpipe. As a result, it has created the stagnant water at the roof gutter and the oxidation process happened. Besides that, the galvanized iron gutter was not painted as mentioned in the contract drawing "500mm width GI Gutter, Painted finish c/w Siphonic Rain Water Outlet system to detail" and as-Built drawing specification "GI Gauge 18 Gutter, Painted Finishes c/w Rainwater Outlet System, to detail". Therefore, this condition will lead to corrosion, leakages and shorten its life span. There is potential of mosquito breeding.

Fig. 8. Corrosion at roof gutter due to poor workmanship
