Thrombus formation on a defibrillator lead with conductor externalization

Nicholas A. McKeag^{a,*}, David J. McEneaney^b^a Cardiology Department, Royal Victoria Hospital, Belfast Health and Social Care Trust, Belfast, UK^b Cardiology Department, Craigavon Area Hospital, Southern Health and Social Care Trust, Craigavon, UK

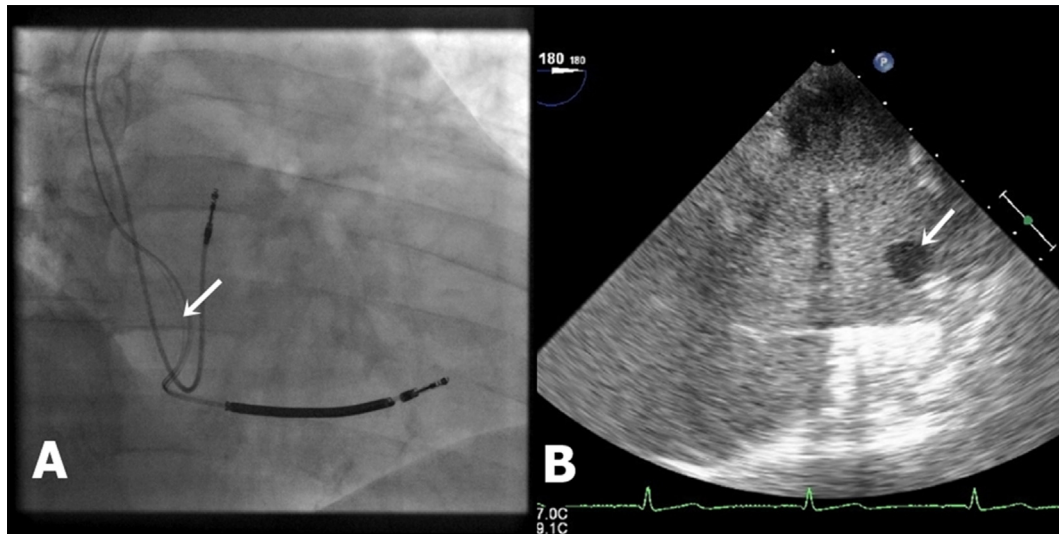
A 51 year old man with arrhythmogenic right ventricular cardiomyopathy reported non-specific symptoms of muscle aches and shivering at outpatient review. A dual chamber implantable cardioverter defibrillator (ICD) had been inserted seven years previously. Fluoroscopic lead screening had previously demonstrated conductor externalisation (Figure and Video) of a single coil Riata ICD lead (model number 1582-65, St. Jude Medical, Sylmar, CA, USA). All electrical parameters were normal.

A transoesophageal echocardiogram (TOE) with ultrasound contrast revealed a well circumscribed, 1 cm diameter, echo-

bright mass attached to the ICD lead in the right atrium (Fig. 1). The patient was admitted for further investigation. Clinical examination was unremarkable. Investigations revealed a normal full blood count, electrolyte profile, C-reactive protein concentration and erythrocyte sedimentation rate. Multiple blood cultures were sterile. The echocardiographic findings and clinical picture were felt to be in keeping with thrombus formation and the patient was anticoagulated with warfarin. A repeat TOE after 3 months of warfarin therapy revealed complete resolution of the right atrial mass.

Fig. 1 – Panel A: Fluoroscopic image demonstrating conductor externalisation (arrow) affecting the implantable cardioverter defibrillator (ICD) lead. Panel B: Contrast transoesophageal echocardiogram image demonstrating a 1 cm mass in the right atrium (arrow) associated with the ICD lead.

A number of studies have demonstrated that Riata family ICD leads are at greater risk of insulation breach resulting in conductor externalization [1]. The optimal management of patients with a Riata lead is unclear. The U.S. Food and Drug Administration has recommended that lead replacement should be considered in patients with a Riata lead with evidence of conductor externalization and abnormal electrical parameters [2]. We believe that thrombus formation in the present case was related to conductor externalization. A small number of similar cases have been described previously [3]. Thrombus formation with the risk of pulmonary embolism is a serious complication of Riata lead conductor externalization. If the lead remains in place, lifelong anticoagulation and careful serial echocardiographic monitoring is indicated. Thrombus formation may be asymptomatic or minimally symptomatic as in this case. If a significant degree of conductor externalization is noted during fluoroscopic screening, consideration should

be given to echocardiographic assessment with contrast to exclude thrombus formation.
