# Case Studies in Engineering Failure Analysis

# Failure analysis of firewater pipeline

This paper presents the failure analysis of a fire water pipe line from a petrochemical industry. Leakages were noticed at the top portion of the pipeline. Severe deep pits were observed at the top inner surface and deposits found at the bottom inner surface of the pipe line. Visual inspection, microscopic examination, chemical and water analyses were employed in the present failure analysis. The analysis results showed that the failure occurred due to the severe oxygen corrosion attack at the top portion of the pipe while the bottom surface of the pipe suffered from under deposit corrosion. The fire water pipe line was made of low carbon steel.

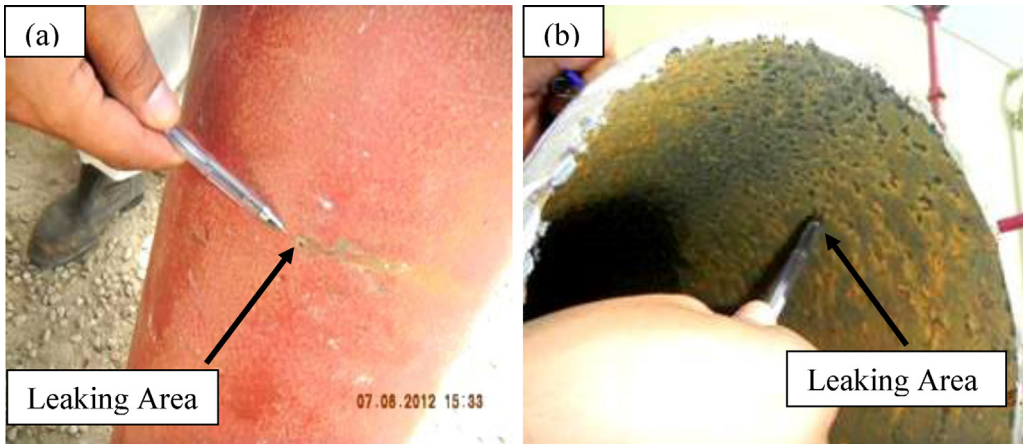
A portion of the leaking pipe from the fire water system was received as representative sample from a Petrochemical Industry. This failure was occurred first time after commissioning the pipe water line system about 25 years. Leaking was noticed on the top side of the pipe as shown by arrow (Fig. 2). The material of construction of the pipeline is carbon steel. The pipeline is operated only twice a week during the call fire under a batch flow rate. Potable water is used in this fire system.

Fig. 2a and b shows the location of leakages of the water pipe line. The representative failed section pipe was received for investigation is shown in Fig. 3a. Visual examination revealed severe localized pitting attacks at the inner surface of the

Fig. 2. Images showing the failed section of the pipe with the exact location of leakages.

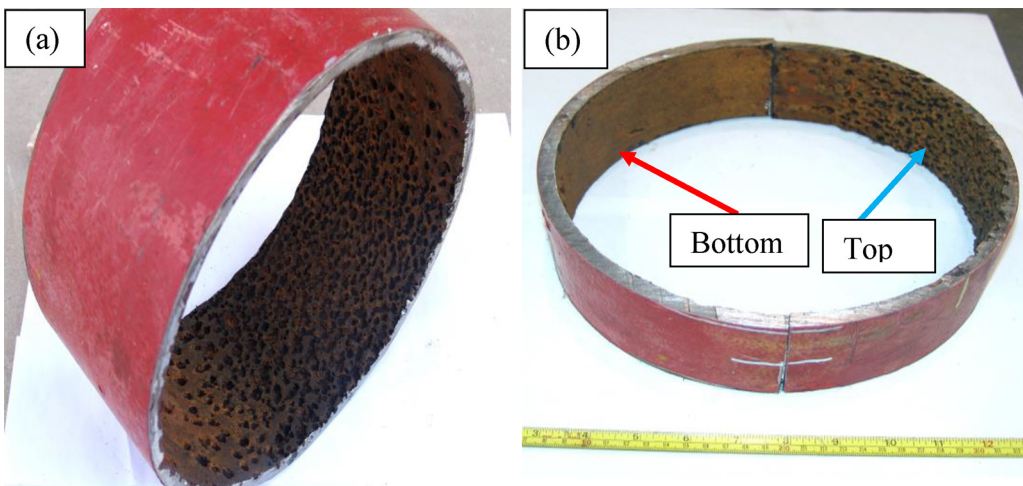
Fig. 3. Images of the sample received for investigation (a) failed section pipe, (b) two halves after cutting as top and bottom side by arrow.

pipe. These pitting attacks took place only in the upper half of the pipe inner surface between the 9 and 3 o'clock positions. Whereas, smooth deposits were observed on lower half of the inner surface of the pipe as shown Fig. 3b.

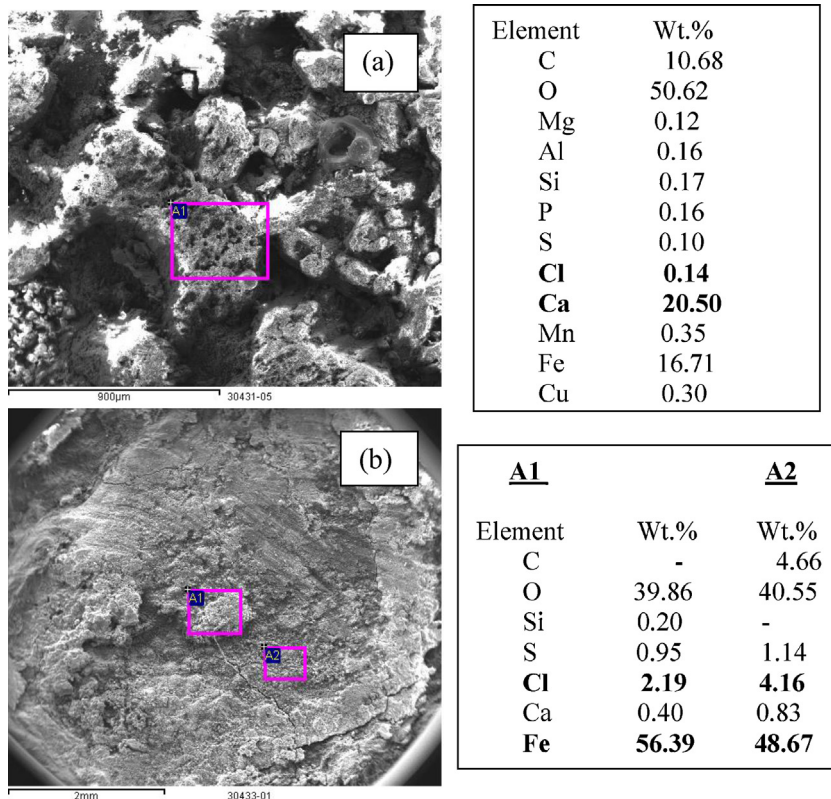
Scanning Electron Microscope (SEM) and Energy Dispersive X-Ray (EDX) techniques were used to analyze bottom and top inner surface of the pipe, using FEI Quanta 200 scanning electron microscope, Fig. 4a and b shows topography and elemental

Fig. 4. SEM/EDX analyses for different locations on the bottom surface of the pipe.

compositions of the deposit formed on the bottom surface of the pipe, contains high amount of calcium and oxygen. Significant concentrations of Chloride ions (2.19 and 4.19 wt.%) were accumulated at the two areas within the corrosion product from bottom inner surface of the pipe is shown in Fig. 4c.

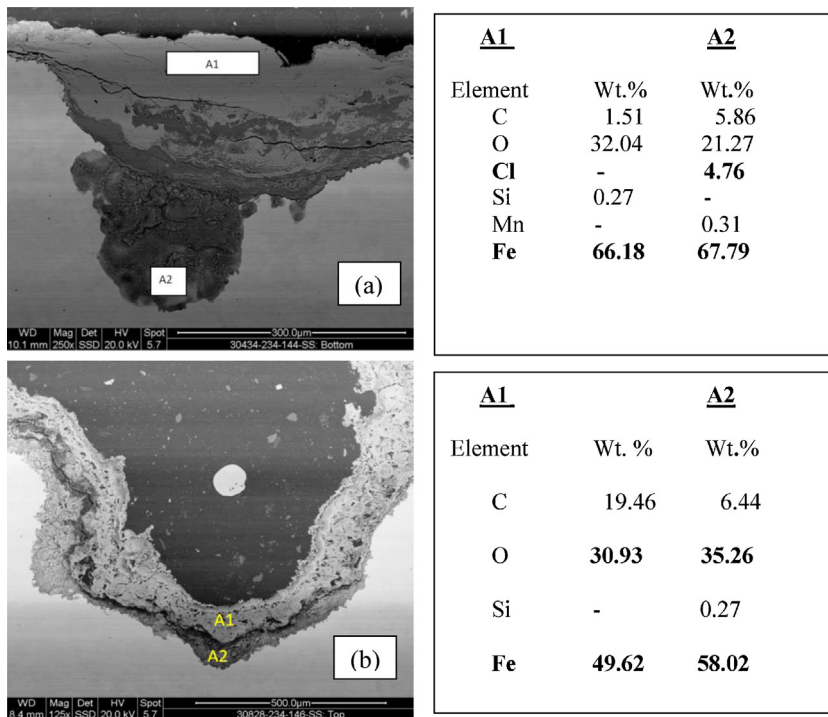
Further SEM and EDX analyses were performed on polished cross sections of samples previously prepared from the top and bottom surface of the pipe. Fig. 5a shows one area on the bottom inner surface of the pipe with cap of mound of corrosion product (iron oxide) covering the pit. Also, as confirmed by the EDX analysis, high concentrations of chloride ions were accumulated inside the pit, A2 location in Fig. 5a. SEM micrograph and the EDX results for the pit on the top inner surface of the pipe was shown in Fig. 5b, the result shows mainly iron oxides as corrosion product.

Fig. 5. SEM/EDX analyses for cross section (as-polished) at different locations of the pipe (a) bottom inner surface, (b) top inner surface.

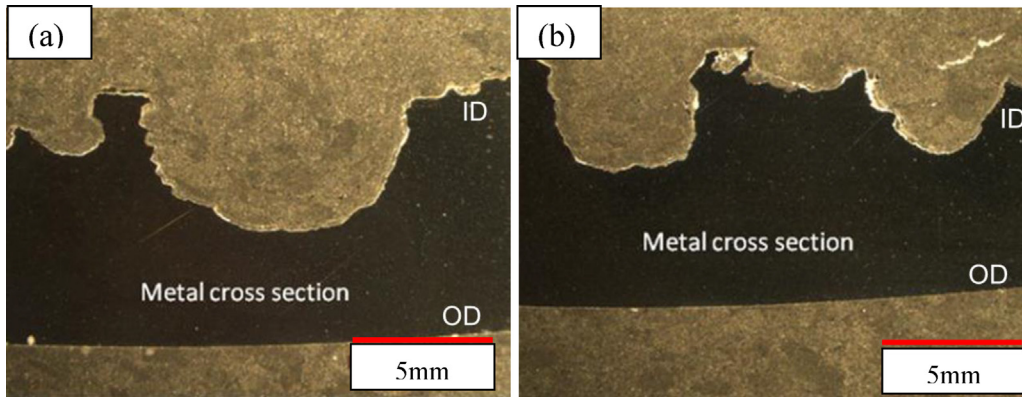
Samples were prepared from top inner surface of the pipe line at different locations for metallography. Cross sectional views of the polished samples were revealed under stereomicroscope as shown in Fig. 6(a–b). Different shapes of pits were detected in inner diameter of the tube.

Fig. 6. (a–b) Shows stereomicroscope images at different location with different shapes of pits from top inner side of the pipe.

In the present case, dissolved oxygen in the system accelerated the pitting corrosion of the top portion of the pipe. This was evidenced by the rusty appearance of most of the inner surface of the pipe and presence of pits/tubercles, classic oxygen corrosion features, along the lengths of upper inner portion of the pipe.
