# Leakage-type-based analysis of accidents involving hydrogen fueling stations in Japan and USA

Junji Sakamoto <sup>a</sup>, Ryunosuke Sato <sup>b</sup>, Jo Nakayama <sup>b,c</sup>, Naoya Kasai <sup>d,e</sup>,  
Tadahiro Shibutani <sup>a,e</sup>, Atsumi Miyake <sup>a,d,e,\*</sup>

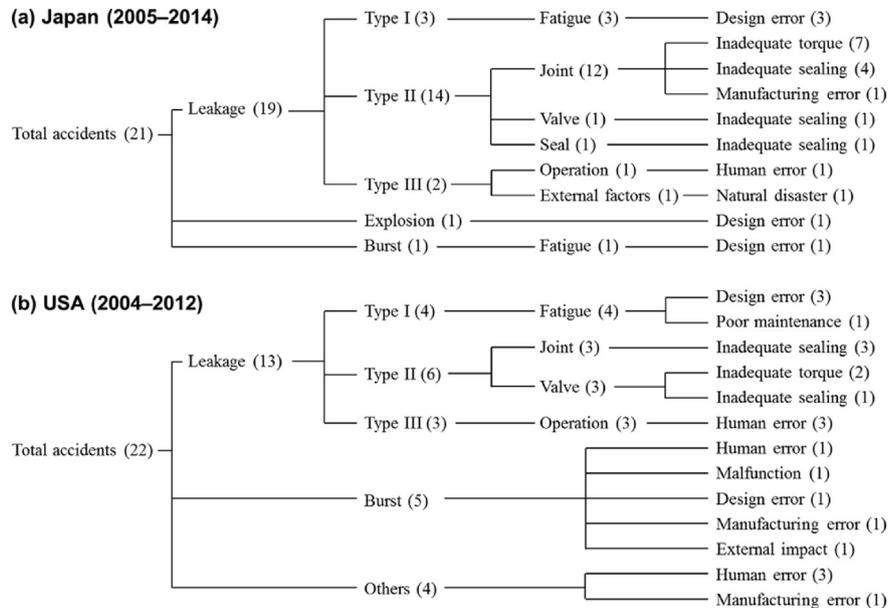
Fig. 1 shows the tree diagram of the incidents and accidents involving hydrogen fueling stations in (a) Japan and (b) the USA. The cause of leakage I in Japan and the USA is mainly design error, that is, poorly planned fatigue. Regulations regarding fatigue pertain to the rule of material selection. In Japan, the materials that can be used in hydrogen environments are seriously restricted; for example, only steels that have a certain relationship among its nickel equivalent, temperature, and pressure can be used. The National Aeronautics and Space Administration has provided guidelines for hydrogen system design, materials selection, operations, storage, and transportation [36]. Thus, the USA also has regulations regarding materials for hydrogen embrittlement.

**Fig. 1 – Tree diagram of incidents and accidents involving hydrogen fueling stations in (a) Japan (b) the USA.**

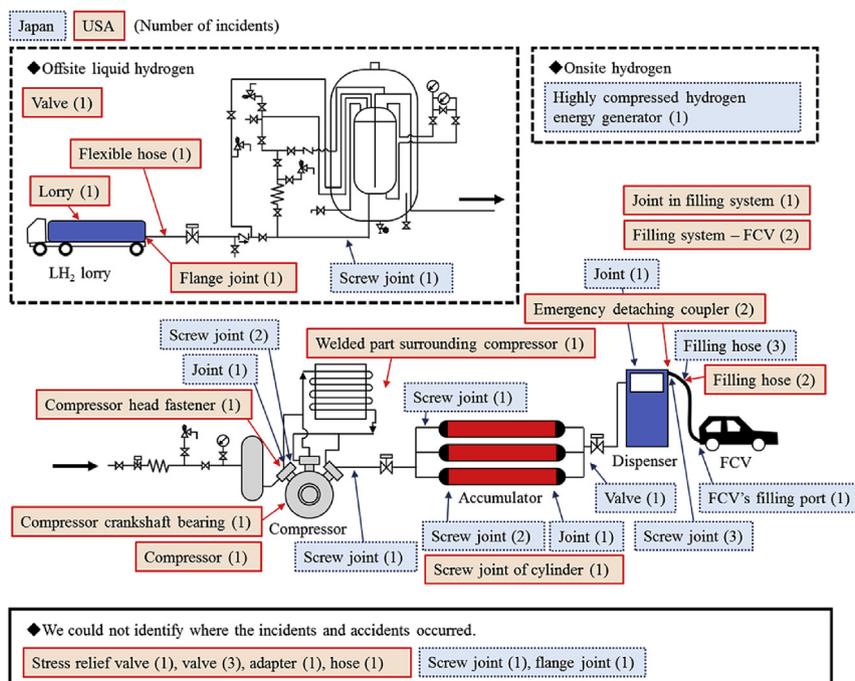
Fig. 2 shows the details of the positions and parts involved in the incidents and accidents at hydrogen fueling stations in Japan and the USA. The facilities, chemical substances, and chemical substance states depend on the type of hydrogen fueling stations. Thus, risk analysis should be performed and safety measures devised for each type of hydrogen fueling station. Most incidents examined in this study occurred in

Fig. 2 – Details of positions and parts involved in incidents and accidents at hydrogen fueling stations in Japan and the USA.
