2<sup>nd</sup> CIRP 2nd CIRP Conference on Surface Integrity (CSI)

## Computed Tomography as a Tool for Examining Surface Integrity in Drilled Holes in CFRP Composites

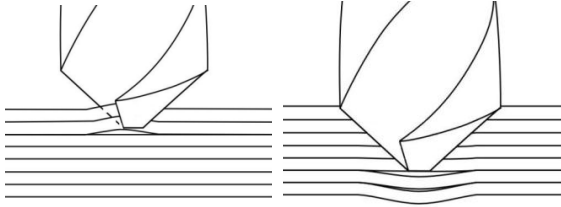
Figure 1. Pull at the drill entrance and push at the drill exit.

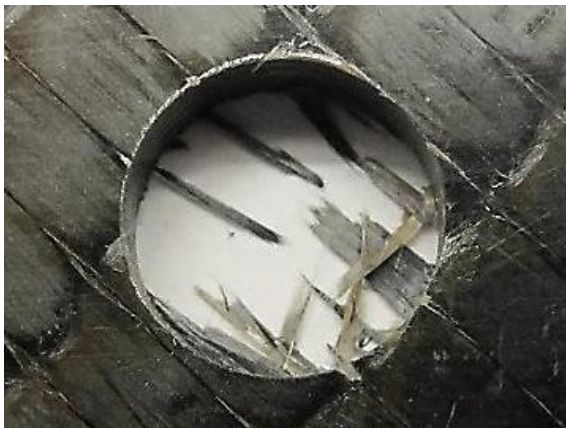
Figure 2. Typical de-bonding damages detected by optical microscopy. The hole has a nominal diameter of 9,5 mm.

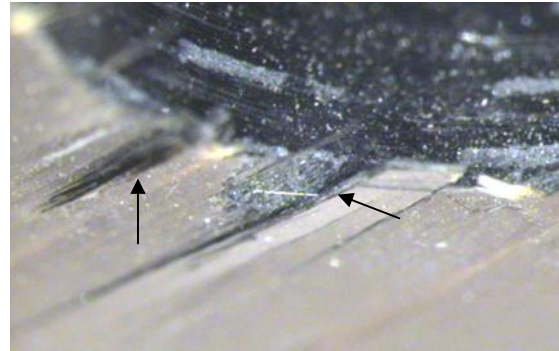
Figure 3. Typical fiber pull-out damages at the hole edge as detected by optical microscopy. The hole has a nominal diameter of 9,5 mm.

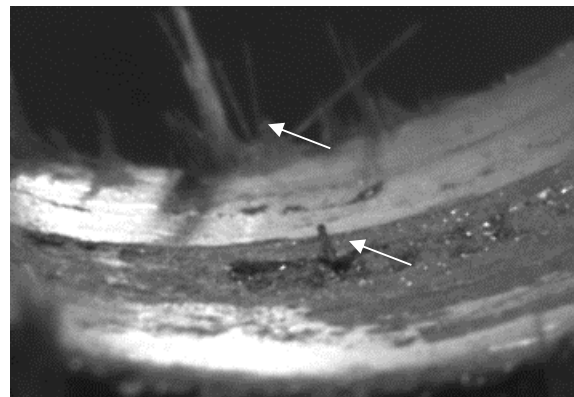
Figure 4. Internal surface of a 9,5 mm diameter drilled hole. Typical cracking and de-bonding damages as detected by optical microscopy.

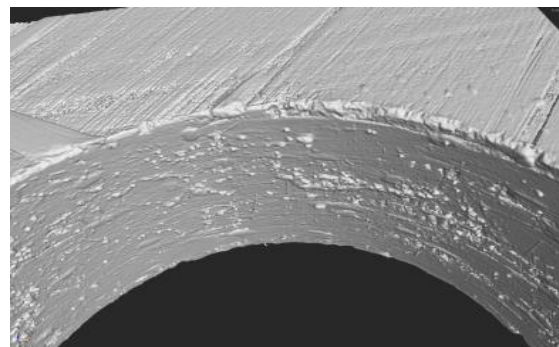
Figure 5. A 3-D model reconstructed from CT scan of the drilled hole, outer surface. The hole has a nominal diameter of 9,5 mm.

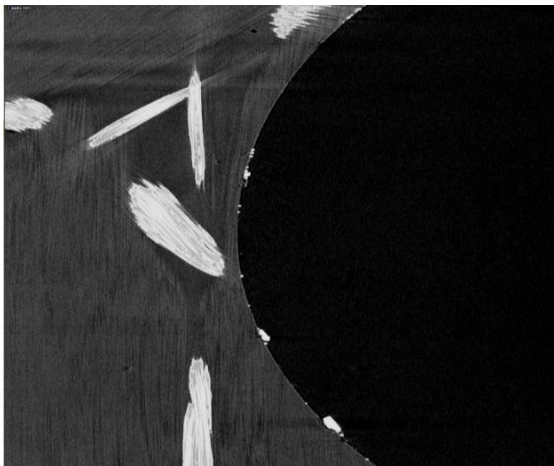
Figure 6. CT slice with glass particles residue in the hole wall shown in white. Hole diameter 9,5 mm.

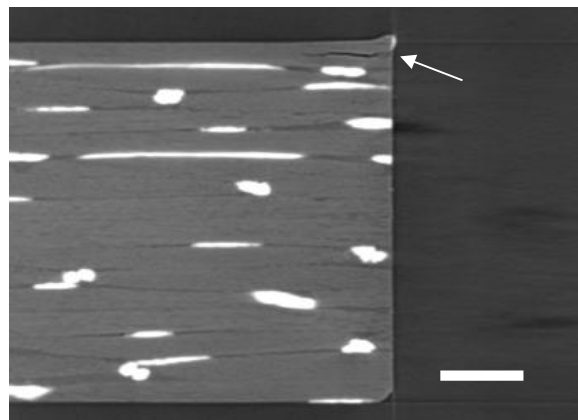
Figure 9. A virtual slice from a CT scan of a drilled hole in a CFRP composite with a delamination crack at the exit side (top) of the hole. White in the picture is glass fibre material. White bar 1 mm.

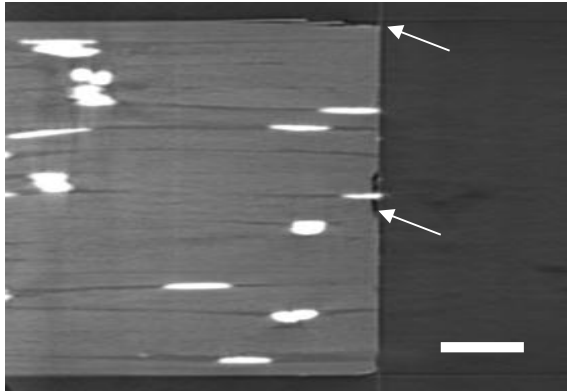
Figure 10. A virtual slice from a CT scan of a drilled hole in a CFRP composite, fibre fracture at the exit (top) side and in the hole wall. White bar 1 mm.
