Failure Analysis of a Reactor after Explosion Accident

X.L. Xue^{a,*}, X.Y. Tang^a, H.L. Lu^a, X.F. Geng^a^aShanghai Institute of Special Equipment Inspection and Technical Research, No.399 North Nuijiang Road, Shanghai 200333, China

Abstract

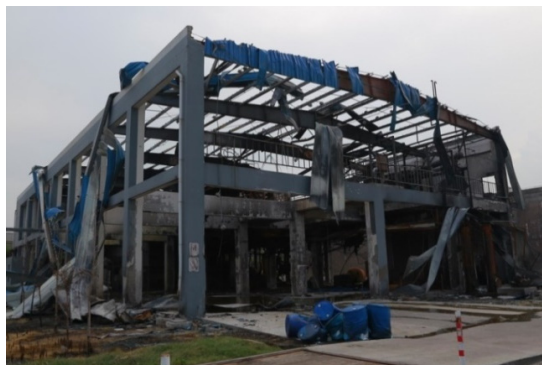
An explosion and combustion accident occurred in an antistatic workshop during the process of production. In the accident, a reactor exploded and then the whole workshop was burned-out, see Fig. 1. 2 workers were killed in the accident and 4 were seriously injured, the direct economic losses were about 8,540,000 Yuan. In order to analyze

Fig. 1. The burned-out workshop.

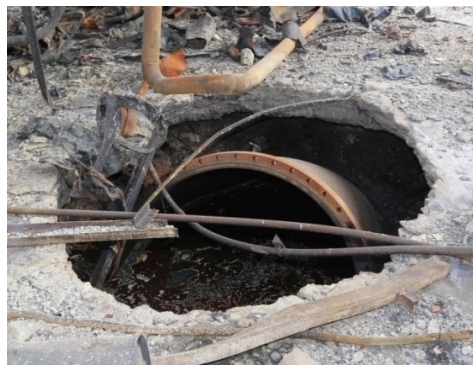
The reactor was installed on the second floor by lifting lugs. In the accident, the reactor was divided into 2 parts from the flanges. The lower part of the reactor (shell and bottom head) crashed into the ground, resulting in a pit of about 1 m deep, see figure 2. It can be seen that there were 44 bolt holes in the flange, and it is visible that all bolts were installed. Along with the accident rescue, some components had been cleared from the accident scene. Therefore, only 5 pieces of bolts of the reactor were found. The upper head of the reactor flew into an adjacent factory, resulting in a hole in the bounding wall. It is also visible that the bolts had been installed on the flange of upper head.

Fig. 2. Lower part of the reactor.

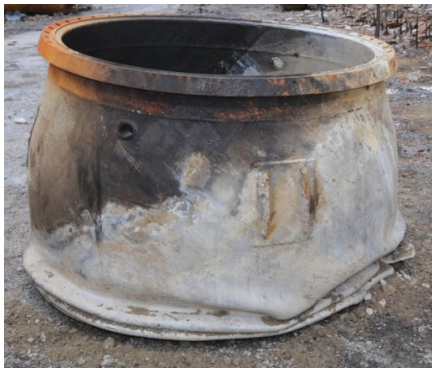
The lower part of the reactor took out from the pit is shown in Fig. 3. It can be seen that the shell was bulged under high pressure. However, no crack appeared in the shell. The deformation of upper end of the cylinder is smaller due to restriction of flange. The flange leaned inward. Instability occurred in the bottom head due to hitting onto the ground. The maximum circumference of the deformed cylinder is 5020 mm, and the diameter is 1598 mm accordingly. The outer diameter shown in the product delivery documentation is 1420 mm, an increase of 178 mm occurred.

Fig. 3. Lower part of the reactor.

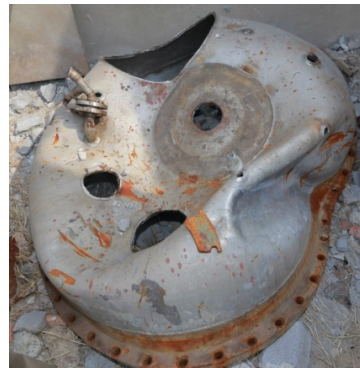
The upper head of the reactor was distorted, as shown in Fig. 4. 7 of the 9 nozzles had fallen off completely, and the remaining 2 nozzles were distorted and torn.

Fig. 4. Upper head.

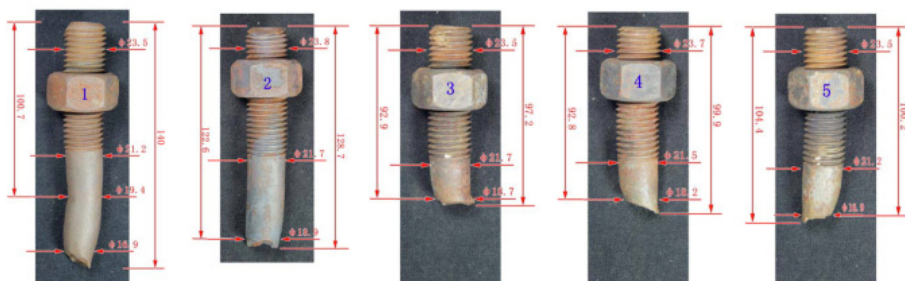
It can be seen from Fig. 3 that the reactor flange had been deformed. That is the bolts were under tensile and bending stresses during the explosion. The 5 pieces of bolts found on site had been corroded. The morphology and size of the bolts after cleaning are shown in Fig. 5.

Fig. 5. Size of the bolt pieces.

It can be seen from Fig. 5 that the fracture occurred at the no-thread part. The 5 pieces cannot be fit mutually, indicating that they are independent pieces. Among the pieces, the longest is 140 mm and the shortest is 97.2 mm. The diameter of thread section is 23.5 mm. Other physical characteristics are shown in Table 2.

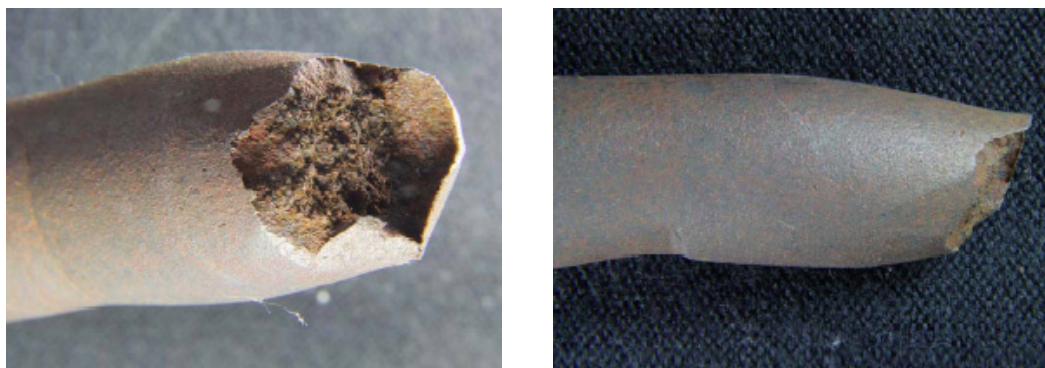
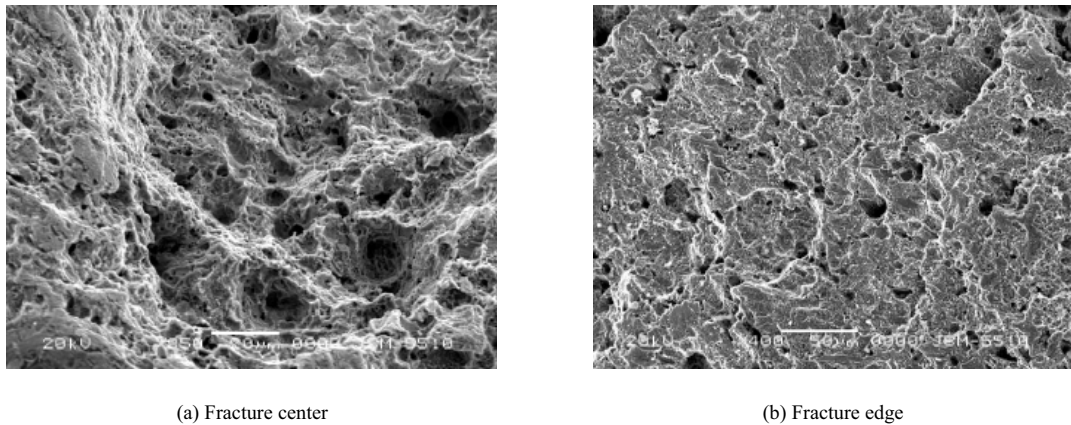
Fig. 6. Fracture morphology of 1#.

Fig. 7. Scanning electron micrographs of 1#.

It can be seen from the macroscopic examination that, there were no obvious metallurgical defect at the fracture. There was obvious fracture tightening in 1#, indicating that the bolt was overloaded. The tensile shrinkage region of 2# is large, showing large plastic performance. 3# shows the same failure characteristics as 1#. 4# and 5# show inclined tensile fracture morphology.

According to the results of scanning electron microscopy analysis, the 5 bolt pieces show dimple fracture, and the edge show tearing dimple fracture.

It can be concluded that the bolts were broken due to overload. The bolts were bearing tensile and bending load while cracking. There are no obvious metallurgical defects at the fractures.

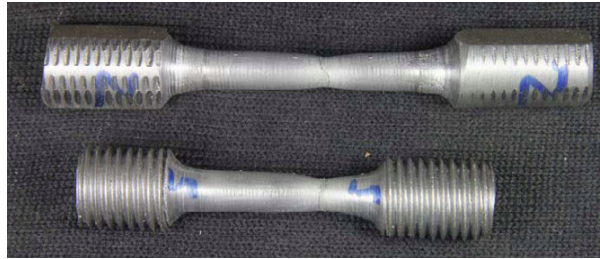
Due to limitation of test pieces, 2 longitudinal samples for tensile test were taken from the thread section of 2# and 5#. The lengths of the samples were 40 mm and 30 mm respectively, as shown in Fig. 8. The results of tensile test are shown in table 4.

Fig. 8. Test samples of 2# and 5#.

According to the results of mechanical test, the minimum tensile stress is 661MPa, the minimum yield strength is 433MPa, and the impact energy is 12J. The bolts do not meet the 8.8 grade high strength bolt ($d > 16\text{mm}$) requirements.
